## SEISMIC PERFORMANCE ASSESSMENT OF EXPANSION JOINTS FOR WATER LIFELINES

**ABSTRACT:** In the 2011 Great East Japan Earthquake, the largest water leakage flows occurred at failed expansion joints in 2400mm and 1200mm diameter water pipelines in Miyagi Prefecture. The damage mechanism of buried expansion joints was investigated by site damage inspections and seismic response analyses, which suggested that the expansion joints had absorbed certain settlement before the earthquake, and as a result, the seismic shaking triggered expansion joint failure. This study proposes a new seismic design method for expansion joints, especially those used in arc-welded steel pipelines.

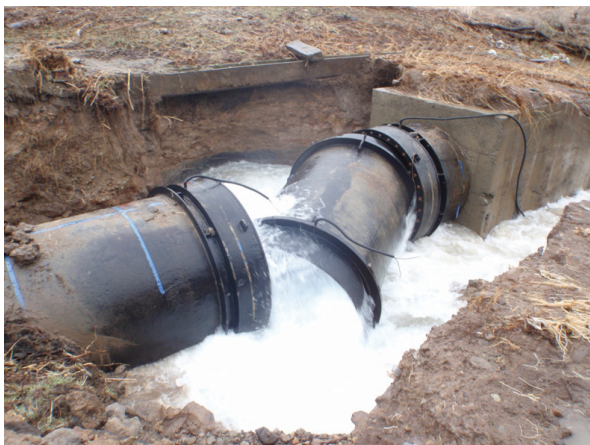
Photo 1 shows the large-scale water leakage from the expansion joint in the 2400mm diameter water pipeline immediately after the main shock. The accident occurred at both sides of the concrete encased pipeline under-crossing a water stream, as shown in Figure 4. It must be noted that this leakage occurred at the same time from both expansion joints. The concrete encased structure moved 700mm in the anticlockwise direction at site A and 100mm at site B.

Photo 1 Water leakage from expansion joint.

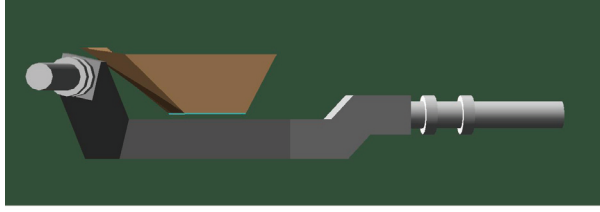
Fig. 5 Three-dimensional illustration of under-crossing concrete encased structure.

According to site observations, there were no ground changes triggering liquefaction, ground slippage or uneven settlement. As shown in Figure 5, this under-crossing concrete encased structure has an unstable configuration and is not symmetrical even in the two-dimensional plan view.

(1) Asymmetrical shape of a structure can produce unstable responses. Actually, in this example, rotational motion caused simultaneous destruction of the expansion joints. Special attention should be paid to the seismic design of asymmetrical structures.

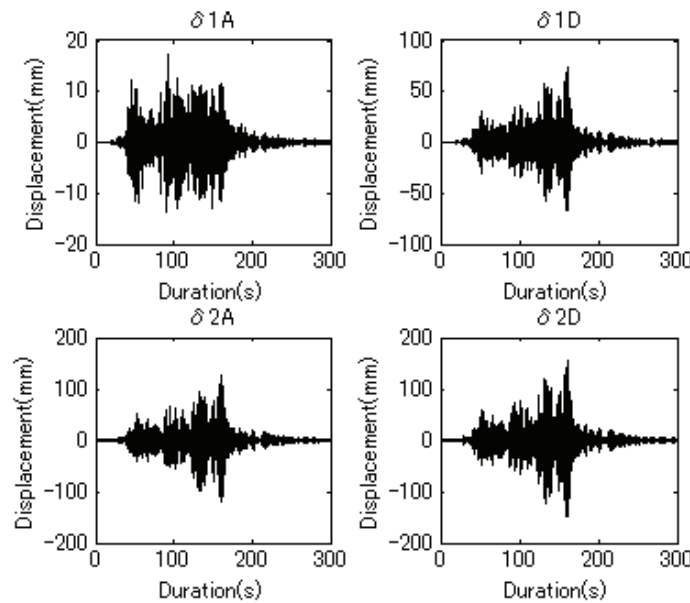
In the numerical analysis, the spring modulus was randomly modified from the original value to smaller ones in order to obtain the largest responses that can exceed the limit boundary of the expansion joint. Figure 7 shows the excessive displacements between the ground responses and the structural responses in the axial and transverse directions at points A and D in Figure 6.  $\delta_{1A}$  and  $\delta_{1D}$  are the responses in the axial direction, and  $\delta_{2A}$  and  $\delta_{2D}$  are the responses in the transverse direction, respectively. These figures show that the maximum response appears in the transverse direction of point D, as shown by  $\delta_{2D}$ . This result does not conflict with the observation that the largest movement at the encased concrete structure occurred at point D in the transverse direction. The second largest response is given by  $\delta_{2A}$ , which might support the observation that both expansion joints were simultaneously destroyed by the main shock. Figure 8 is the rotational response of the concrete encased structure. These structural responses as shown by the triangular and square marks in the multiple limit state diagram for the expansion joint failure modes in Figure 9. In this figure, three different performance limit curves are shown as boundary conditions of the joint failure. Here, two modified performance curves were prepared for reduced allowance conditions which correspond to existing settlement before the earthquake. The numerical results suggest that the expansion joints at the site might have produced an existing settlement equivalent to 1/3 to 2/3 of maximum performance before the earthquake.

Fig. 7 Excessive displacement between structural response and ground displacement at expansion joint points A and D, where  $\delta_1$  is axial displacement and  $\delta_2$  is transverse displacement to the pipe axis.

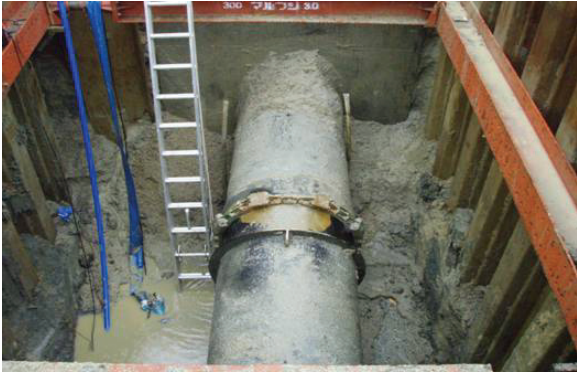
Photo 2 shows the damaged expansion joint in which leakage failure occurred at the upper portion of the expansion joint. The sealing bolt and ring at the upper portion were hydro-blasted by high pressure water and the half portion was worn out, as shown in Photo 3.

From this, the following failure mechanism could be deduced: (1)The main shock of March 11,2011 produced high pressure water leakage from a small gap in the joint; (2) this water leakage started to wear the metal portion of the sealing parts, and this wear continued for one month; (3) the deteriorated sealing ring could not stop the large scale leakage caused by shaking due to the aftershock of April 7<sup>th</sup>. In order to confirm this failure scenario, the possibility that these failure steps could occur as a result of the main and aftershocks must be evaluated by the numerical approach.

Photo 2 Excavation of joint failure portion.

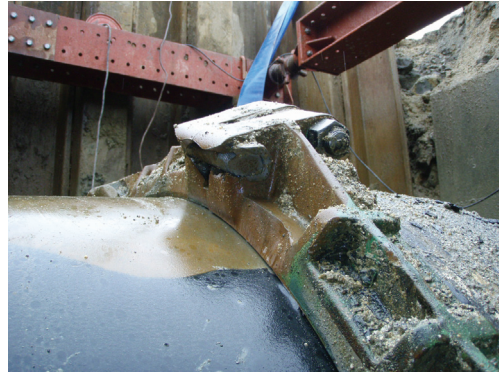
Photo 3 Sealing bolt worn out by hydro-blasting.

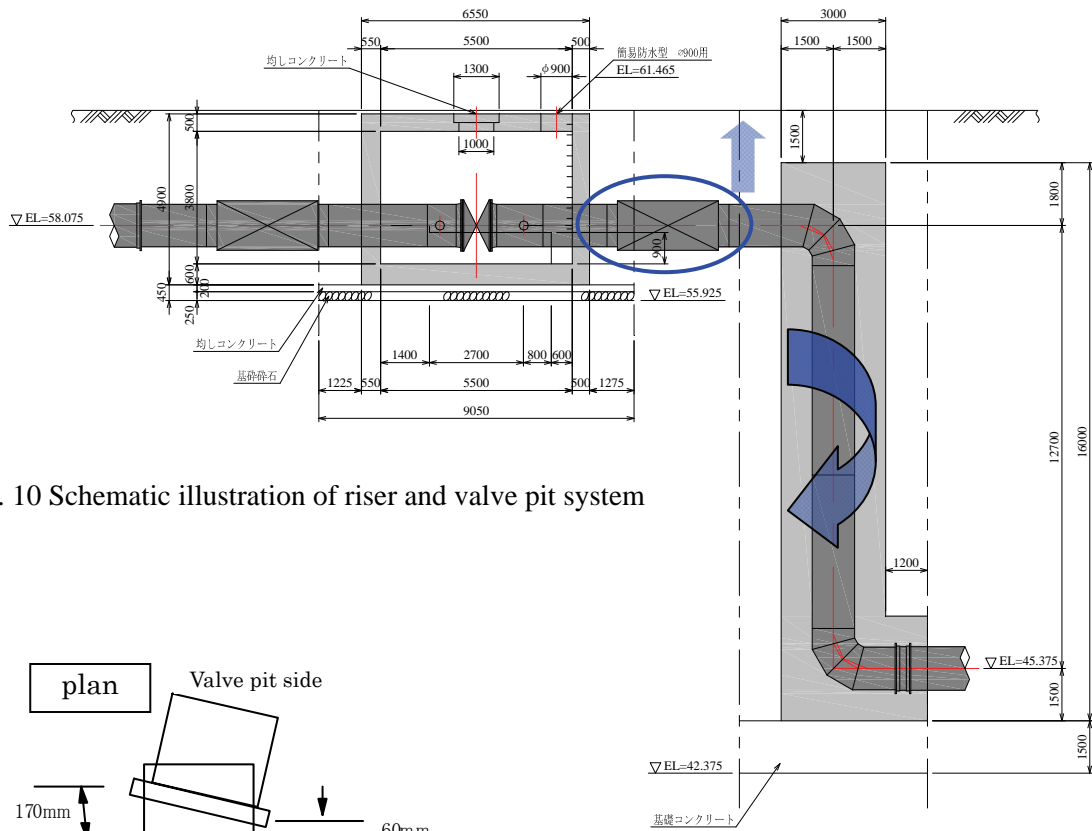
Fig. 10 Schematic illustration of riser and valve pit system

The expansion joint, which is located between the valve pit and the riser structure as shown in Figure 10, had a potential risk of uneven settlement, so that the expansion joint was forced to absorb vertical displacement. As a result of this settlement, the residual allowance for the seismic effect was limited. Based on the site investigation on April 7<sup>th</sup>, 2011, different vertical settlements were measured at the two ends of the expansion joint, as shown in Figure 11. This suggests that the joint had rotated to an angle of 3.5 degree before the earthquake. Using the site soil conditions shown in Figure 12, the seismic response of the concrete riser was analyzed with a single-degree-of-freedom system as follows.

vicinity of the valve pit. Therefore, it should be noted that the expansion joint must not be connected to a pipe which may be subjected to additionally forced settlement.
