DAMAGE AND EFFECTS CAUSED BY TSUNAMI FIRES: FIRE SPREAD, FIRE FIGHTING AND EVACUATION

ABSTRACT: The Great East Japan Earthquake triggered fire outbreaks in many structures and buildings including hazardous-material facilities. The tsunami induced by the Earthquake also produced a huge impact under which various tank and gas-cylinder facilities, automobiles, etc. were damaged and caused to leak hazardous materials, such as gas and gasoline. In addition, the tsunami swept away numerous objects, causing collisions between objects and sparks from broken electric cables. Under such situations, fires broke out at various points in the affected region, some escalating to large-scale urban fires or forest fires. Many of the people that had been evacuated from the tsunami-affected zone had to be evacuated a second time to escape from the spreading and escalating fires.

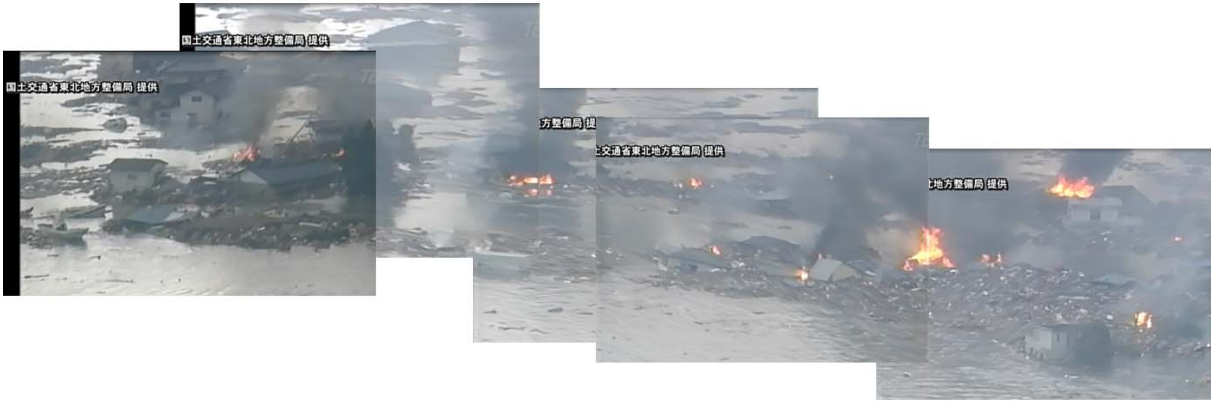
Fig. 1 shows fires which had simultaneous occurred in each houses after the shock of the tsunami in Natori City. In Otsuchi Town, official record of fires are just one, but at least seven tsunami fires could be counted through videos and photographs taken by the local people and cameramen of self-defense force, governmental bureau and mass media. Fig. 2 shows one fire site in Otsuchi Town at 16:00 about forty minutes after the tsunami. As this site is covered with six meters high water, the fire did not spread so much and this fire was not officially recorded.

Fig. 1 Video taken from an airplane on 11th March 2011 at a coastal lines of Natori city, Miyagi prefecture offered by the Tohoku Regional Developing Bureau of Ministry of Land, Infrastructure, Transport and Tourism (TBC,2011)

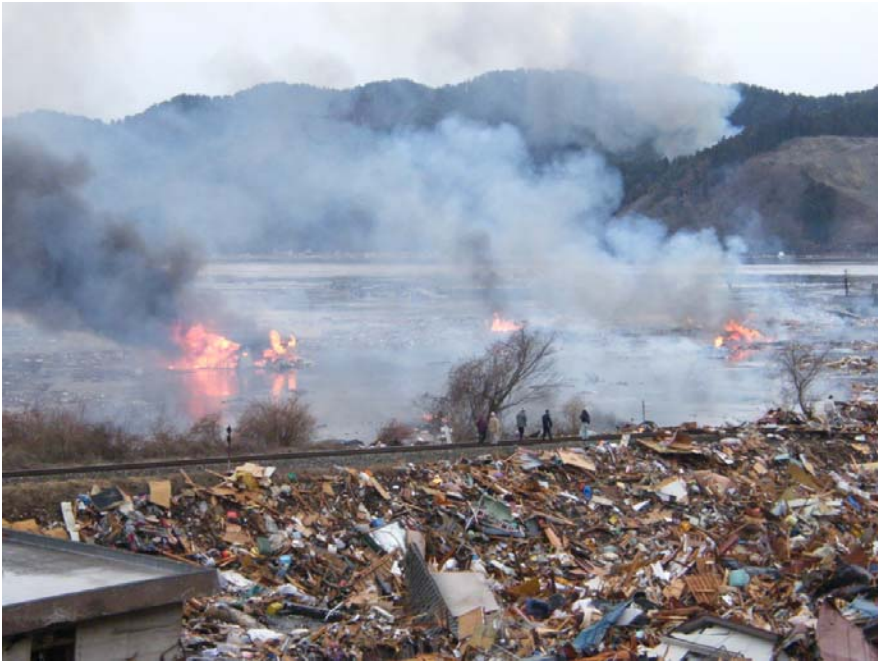
Fig. 2 Tsunami fire at 16:00 11th March 2011 in Ando district of Otsuchi town, Iwate prefecture (offered by Mr.Toru Suzuki, a volunteer fire fighter of Otsuchi town volunteer fire company)

Table 1 shows that number of tsunami fires are dominant in Iwate and Miyagi Prefectures. Besides these tsunami fires there are many small fires which is not recorded as the fire of Fig. 2 because there are scarce evidence of fire remained afterwards. For the estimation of tsunami fire occurrence and countermeasure of these fires, it is necessary to collect data of these fire occurrences through videos and photographs and interviews to local people who were at the fire sites.

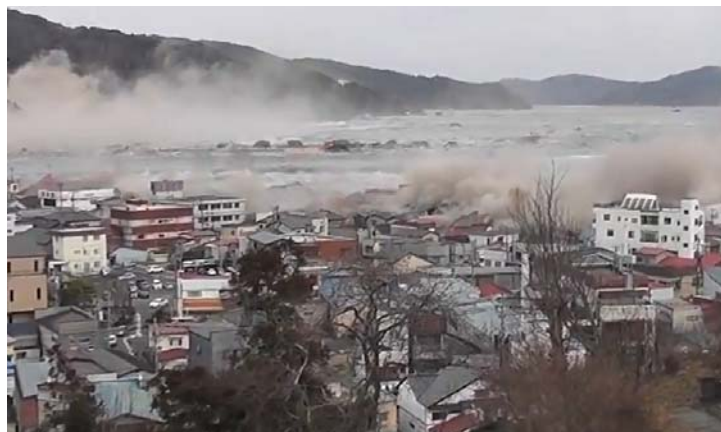
- 1) valves and gas-pressure regulator of propane tanks at home were destroyed in the rolling wooden one or two story houses which were hit by tsunami, and then leaked propane gas caused fires in a room of floating houses or sometimes rolling propane tanks floating in the water with flame jet ignite a fire at reaching buildings or materials of collapsed wooden houses. There were also some cases that rolling propane tanks drifted in the water ejecting white smoke of flammable gas with no flame and reached to edge of flooded area and afterward exploded;

Fig.3 Rolling houses which were hit by tsunami at Otsuchi Town with sand smoke (video taken by Akihiro Sato(2011))

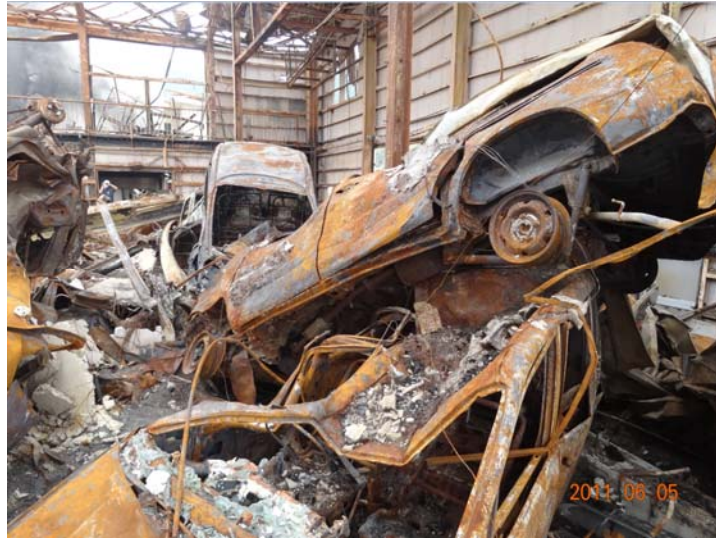
- 2) fuel tank and vehicle fuel filler pipe were destroyed when automobiles swept away by the tsunami were smashed against buildings, and leaked gasoline caused fires;

Fig.4 Automobiles were smashed into a gymnasium of Kesen elementary school in Rikuzen Takada city and caught fires.

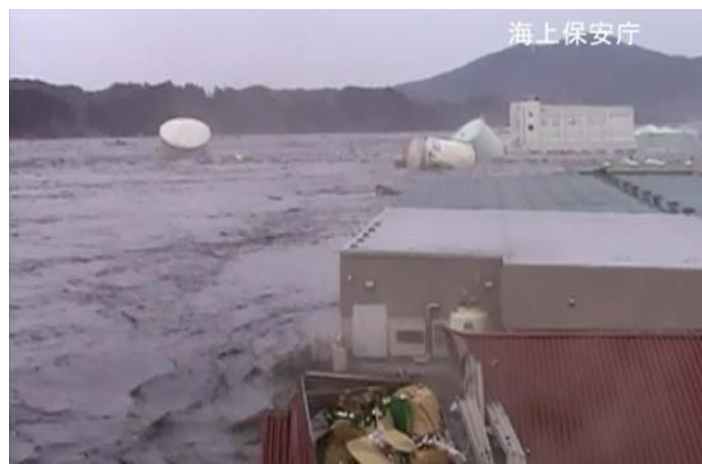
- 3) Oil-storage tanks etc. of industrial plants handling flammable liquid in harbors, ships and fish boats were destroyed by the tsunami, and the leaked oil being absorbed to timber and other materials from collapsed buildings etc. caused fires like wick combustion.

Fig. 5 Floating Oil-storage tanks which were destroyed by the tsunami in Kesenuma Harbor.
(video offered by Japan Coast Guard)

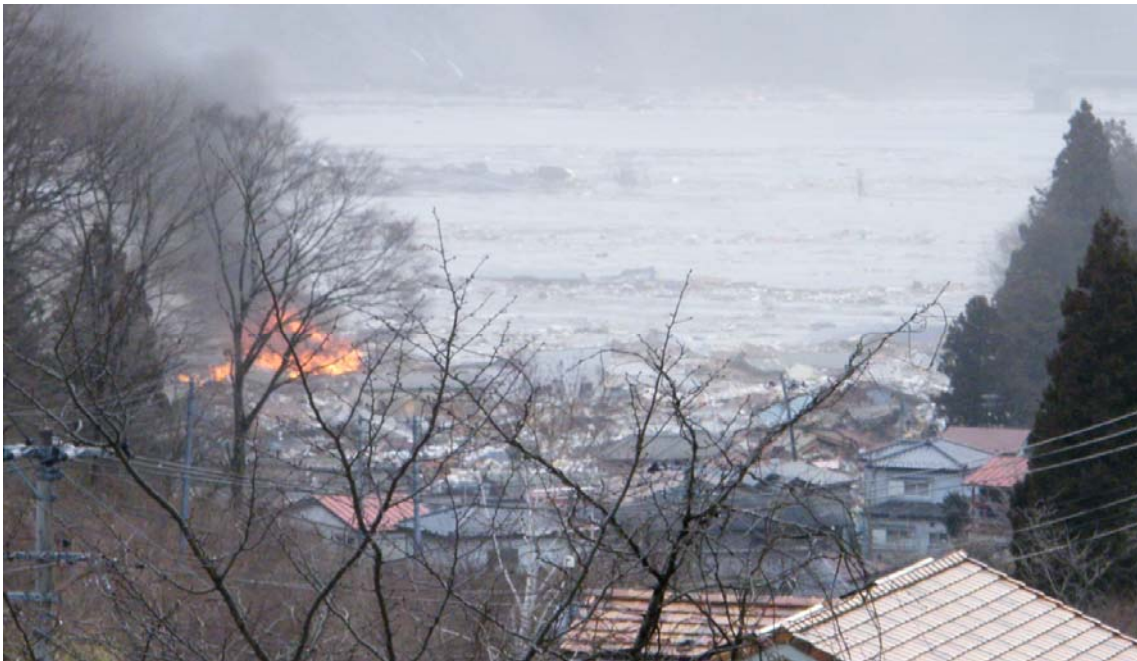
Fig. 6 shows one case of this pattern-1 without direct eyewitness. Mr. Toru Suzuki a volunteer fire fighter of Otsuchi Town volunteer fire company took this photograph at 15:26 (six minutes after the hit of the tsunami) 11th March 2011 in Ando District of Otsuchi Town. He passed through this point before the tsunami and did not notice a fire around here and heard the sound of propane gas tank explosion after the hit of tsunami before he reached this viewpoint. He noticed that materials of collapsed building were burning.

There are some possibilities of fire caused by gasoline leaked from automobiles or fish boats, but it may have taken some more time for propagation of gasoline fire to building materials. So the cause of this fire may be leaking propane gas tank. The tank may have been pushed into a house and there may have been an explosion inside of the house. This estimation meets the size of fire of Fig.6. The situation of this fire at 16:00 is shown at Fig.2. The location of Ando District is upper left side of Fig.3 where the district was covered with dust smoke and this means the impact of the tsunami was devastating.

Fig. 6 Fire situation at 15:26 (six minutes after the hit of the tsunami) 11th March 2011.

One case of Pattern-1 at Ando district in Otsuchi town, Iwate Prefecture.

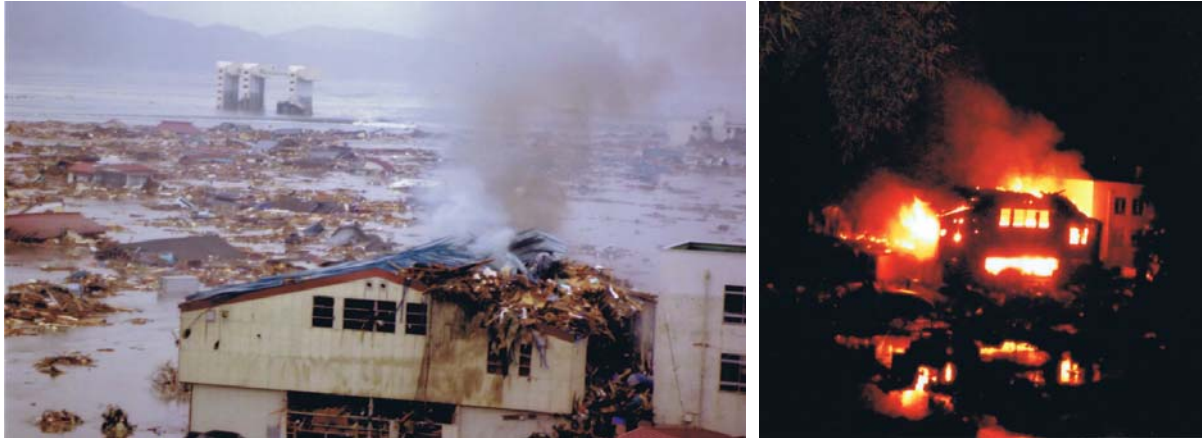
In many cases of pattern-2 fire, a number of automobiles parked in front of a building were washed up by the tsunami and crashed against the building, bursting into flames near the wall of the building. Fig.7 shows one typical case. After the earthquake, local people came to the ground of this elementary school with their automobiles in anticipation of tsunami. There was about thirty to forty parking automobiles in front of the gymnasium. When the tsunami reached here, about ten automobiles were pushed into the gymnasium and seven automobiles were piled up between the gymnasium and the elementary school building. A teacher at the school who have evacuated to a mountain behind the elementary school heard the sound of electric short and explosion from the gymnasium and noticed a smoke coming out of the gymnasium. Local people also heard the sound of explosion few minutes after the hit of tsunami and notice that the third of roof of the gymnasium blown off as shown in the left side photograph of Fig.7. There may have been a explosion of gasoline which were leaked from the tanks of automobiles pushed into the gymnasium by the tsunami. Fig.4 shows inside of the gymnasium.

Fig.7 Automobiles fire inside of the gymnasium at Kesen elementary school
(photograph taken and offered by local people)

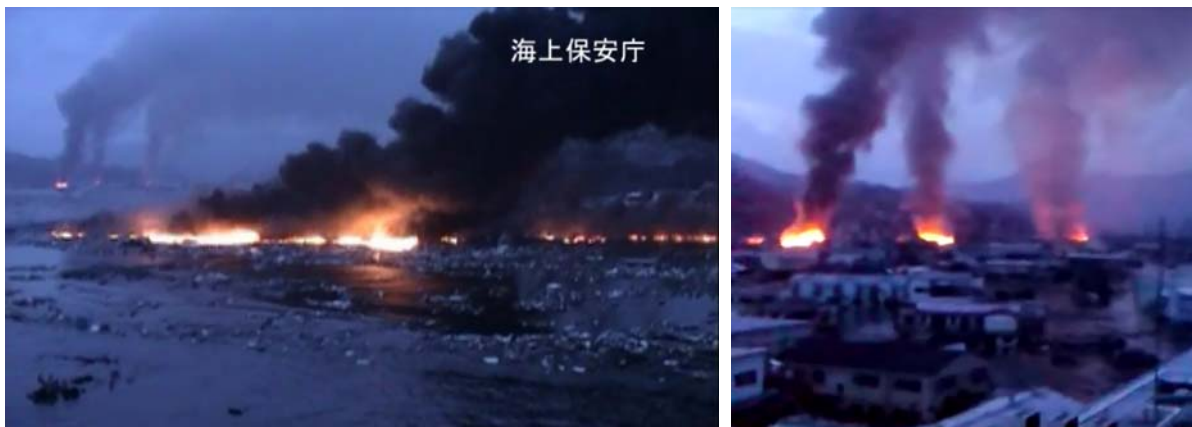
The massive fire at Kesennuma Bay was a typical pattern-3 fire. Oil flowing out of the destroyed oil tanks at Kesennuma Port adsorbed to farming rafts and to the materials of collapsed wooden houses swept by the tsunami, and was ignited into flames. These blazing objects, covering some water surface, drifted from Kesennuma Bay outwards to Oshima Strait and reached the tsunami-flooded coastal area where the fire spread to ships, automobiles, factories, houses and forests. These blazing objects also drifted inwards to Shishiori District where already pattern-1 fires broke out just after the tsunami reached there as shown in Fig. 8 and Fig. 9. The people who evacuated to tsunami evacuation buildings near the pier of Shishiori were surrounded by these two types of fires until next morning.

Fig. 8 Blazing objects drifting right to left toward Shishiori (video offered by Japan Coast Guard) Fig.9 Pattern-1 fires at Shishiori district (Zerocounts(2011))

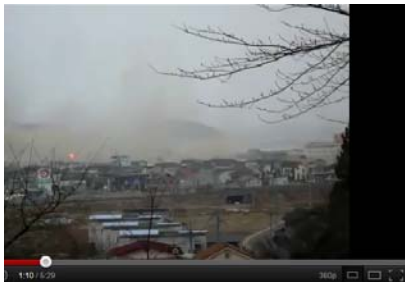
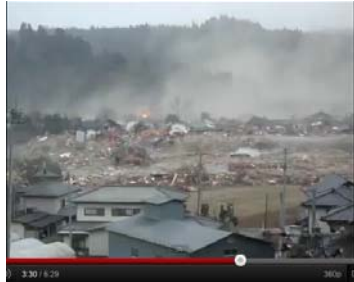
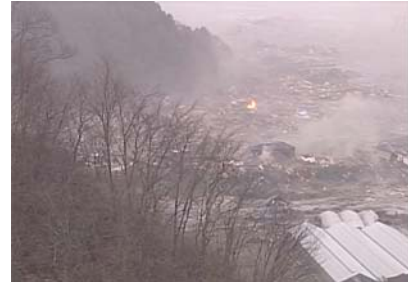
In the pattern-1 fires in rolling houses with propane tanks, wooden houses in which a fire was burning were forced to move with tsunami. Fig. 10 and Fig. 11 show one case of this moving house fire at tsunami flooded area in Minami-Sanriku City. In this case, there is no record of fire because there was no combustible material around this burning house, so the fire didn't spread.

Fig. 10 Moving house fire on water at tsunami flooded area in Minami-Sanriku city (ZANGIEFCHAMP (2011))

Fig. 11 Moving house fire in Minami-Sanriku city (TBC(2011))

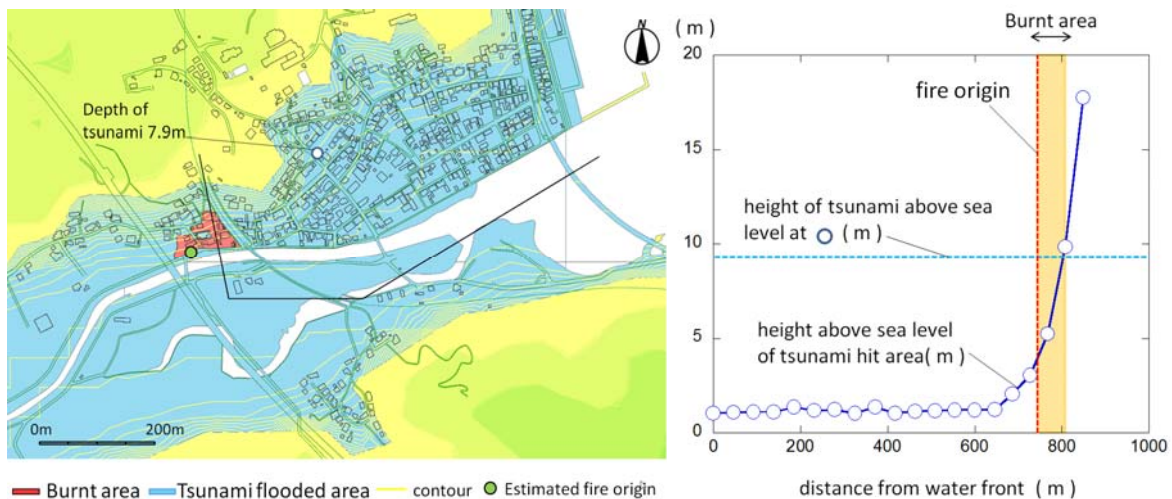
Fig. 12 shows one case of the pattern-1, a rolling propane tank floating in the water with flame jet ignite fire at broken buildings at Origasa District in Yamada Town, Iwate prefecture. Depth of tsunami was about 6 meters at the fire origin of this burnt area. It seems that the height of flooded water decreased when the burning propane tank reached the site to cause a fire as shown in Fig. 13.

Fig. 12 Fire spread of pattern-1 fire to broken houses at the edge of tsunami flooded area (Origasa district in Yamada town, Iwate prefecture)

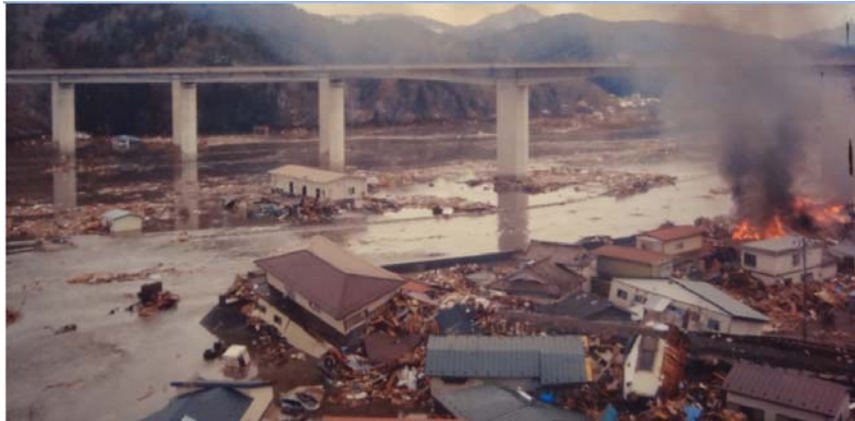
Fig. 13 Fire spread at Origasa district at 16:07 of 11th March 2011
(photograph taken and offered by local people)

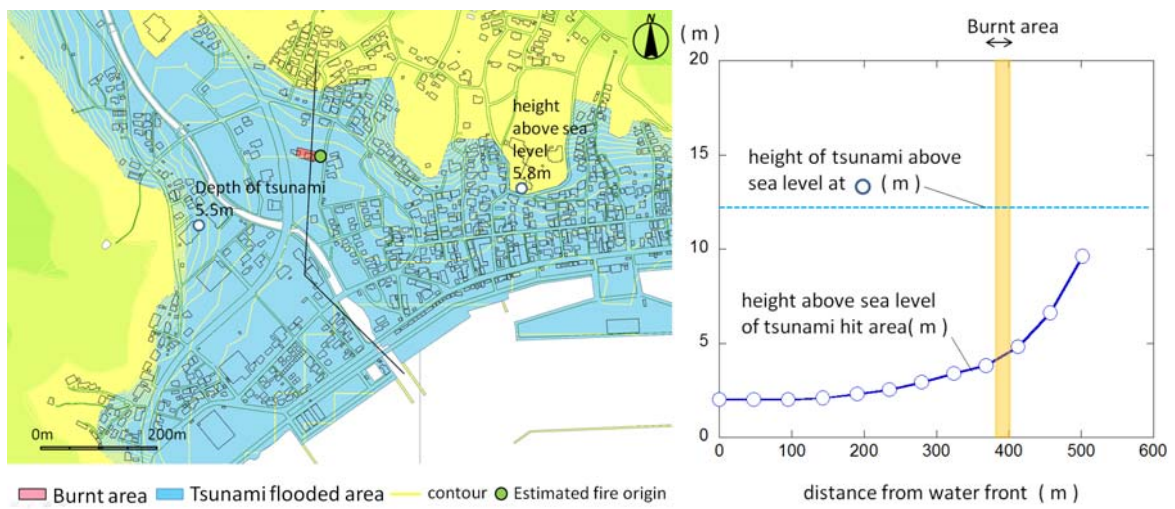
Fig. 14 Fire spread of pattern-1 fire to few houses remained at tsunami flooded area
(Osawa district in Yamada town, Iwate prefecture)

Fig.14 shows one fire site where a drifting burning house reached here to spread fire to remained houses. As the number of existed houses were limited, the area of fire spread is small.

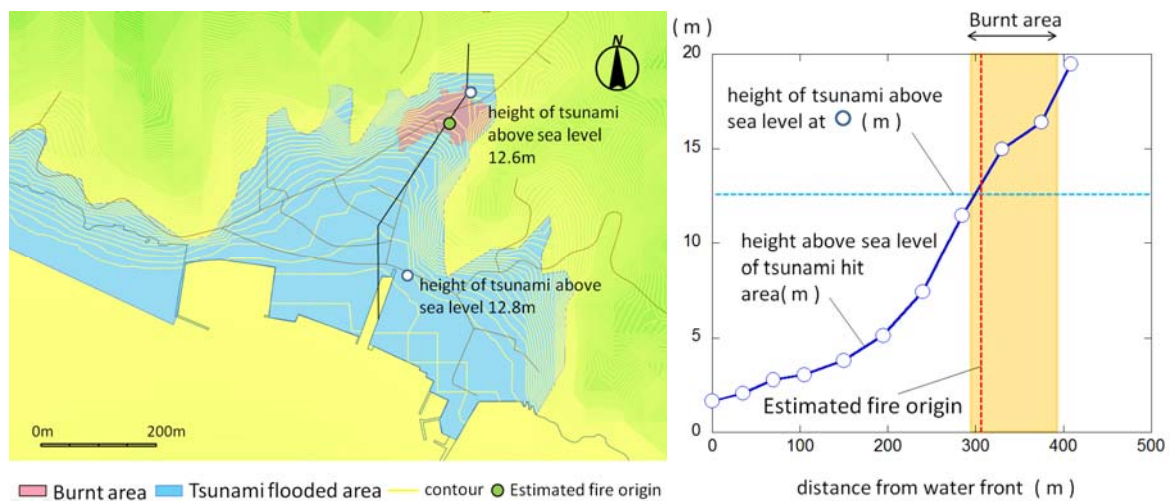
Fig. 15 Fire spread of pattern-1 fire to houses at hillslope of tsunami flooded area
(Akahama district in Otsuchi town, Iwate prefecture)

Fig.15 and Fig.17 show cases where there are testimonies that a leaking propane tank exploded to ignite a fire after the tsunami hit there. Fig.16 shows the fire situation eighteen minutes after the tsunami hit this district. As the height above sea level of this area is about 13 meters, there was no tsunami water here at this time. There were wooden houses existed around here, fire spread to these wooden houses. Four local people around here tried to block fire with hydraulic shovel and extinguished fire with home hose lines (JAFSE, 2011).

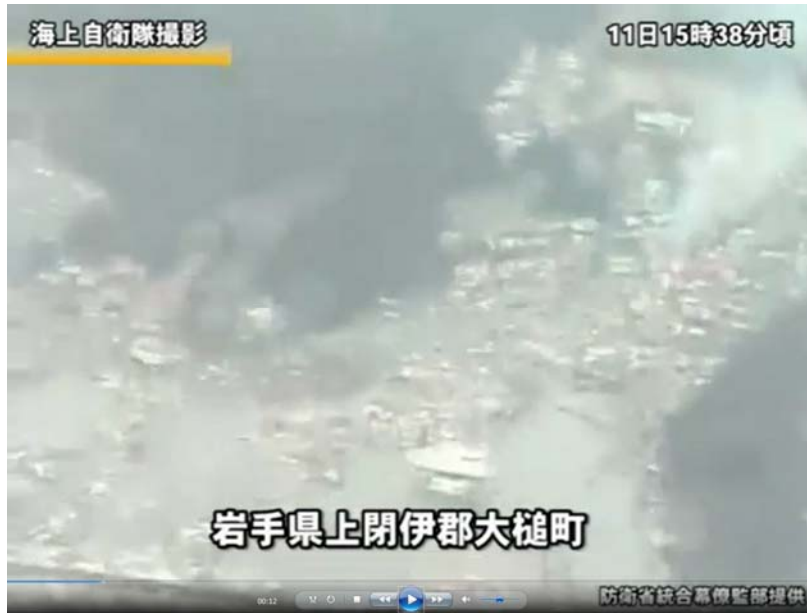
Fig. 16 . Fire situation at 15:38 (18 minutes after the hit of the tsunami) 11th March 2011. at Akahama district in Otsuchi town, Iwate prefecture (JMSDF, 2011)

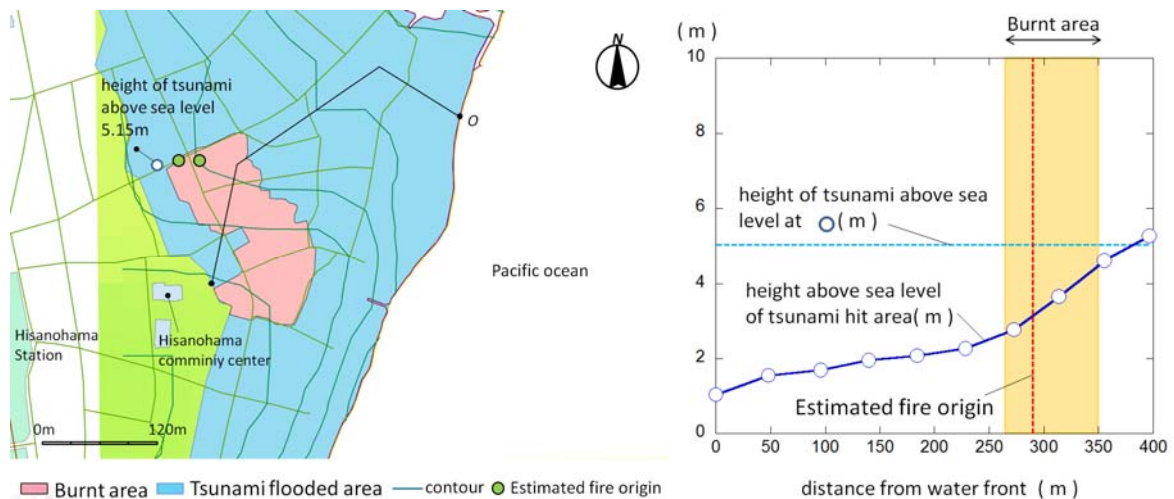
Fig. 17 Fire spread of pattern-1 fire to houses at edge of tsunami flooded area (Hisanohama district in Iwaki city, Fukushima prefecture)

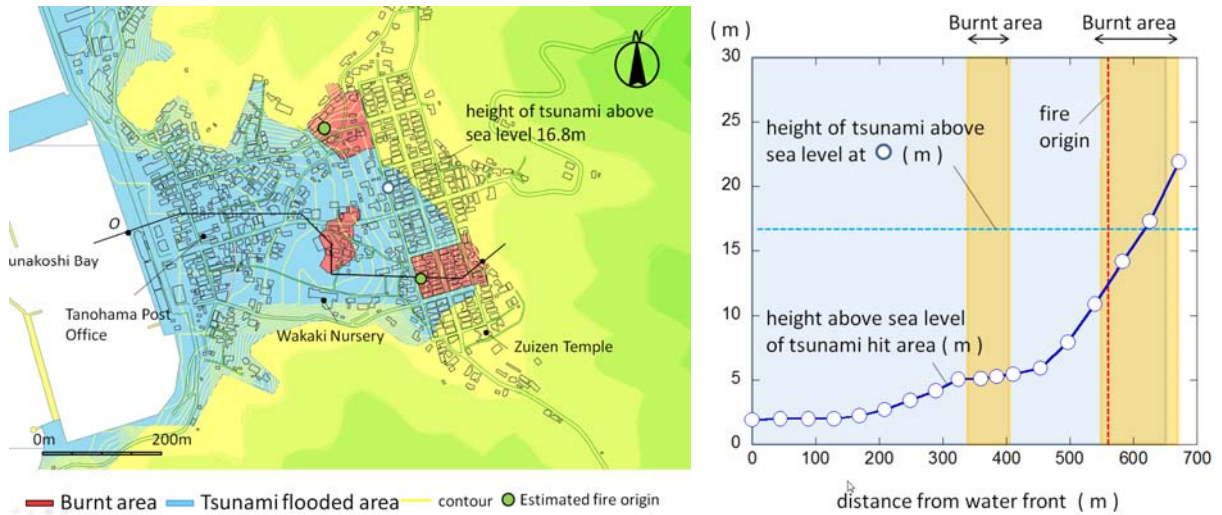
Fig.18, Fig.21, Fig.24, Fig.27 and Fig.28 show fire sites where multiple fires occurred in combustible material bed along hillslope of tsunami flooded area. This means that there is high probability of fire occurrence in this kind of beds and fires tend to spread widely around these beds.

Fig. 18 Fire spread of fires to houses at hillslope of tsunami flooded area (Tanohama district in Yamada town, Iwate prefecture)

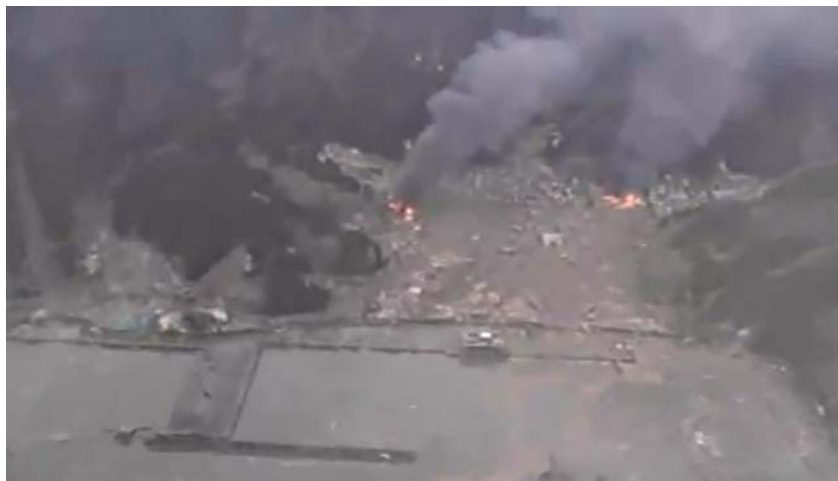
Fig.19 Fire situation at 16:15 11th March 2011 about one hour after the tsunami hit here Tanohama district in Yamada town (JGSDF, 2011)

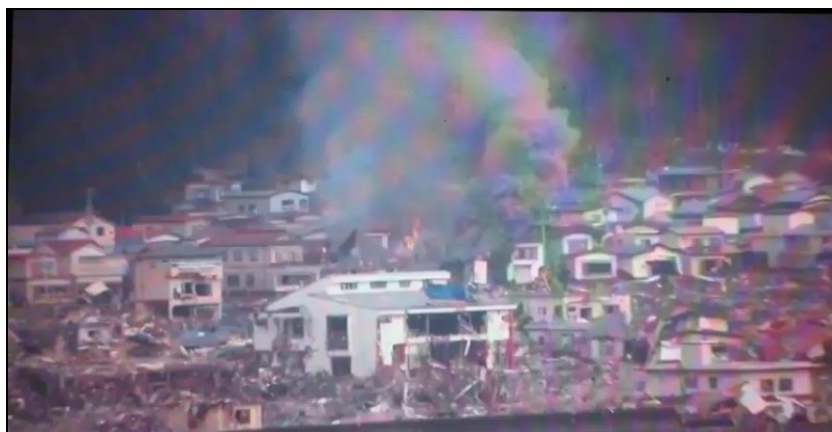
Fig.20 Fire situation earlier time than Fig.19 still after the tsunami hit here Tanohama district in Yamada town (Lakita, 2011)

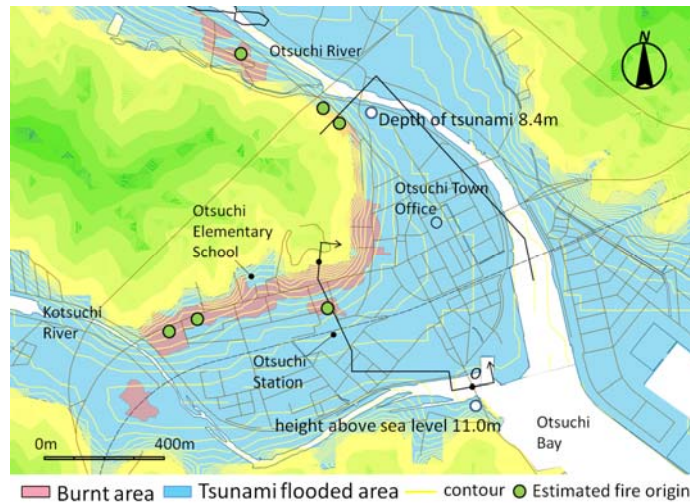
Fig. 21 Fire spread of fires to houses at hillslope of tsunami flooded area (Center district of Otsuchi town, Iwate prefecture)

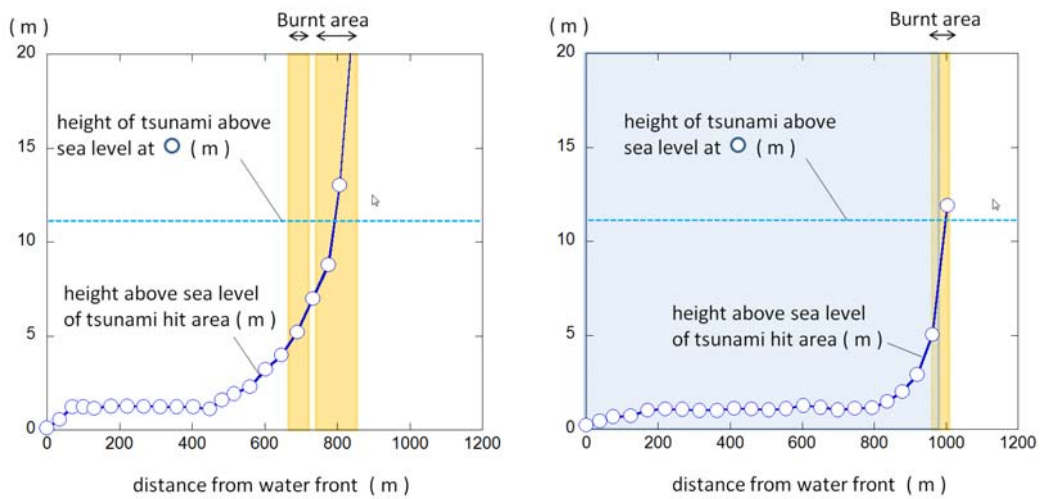
Fig. 22 Height of tsunami above sea level at fire spread area. (Center district of Otsuchi town, Iwate prefecture)

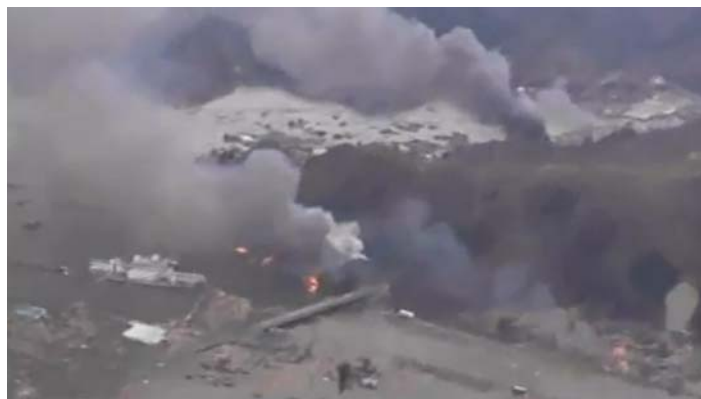
Fig. 23 Fire situation at 16:15 11th March 2011 about one hour after the tsunami hit here Center district of Otsuchi town (JGSDF, 2011)

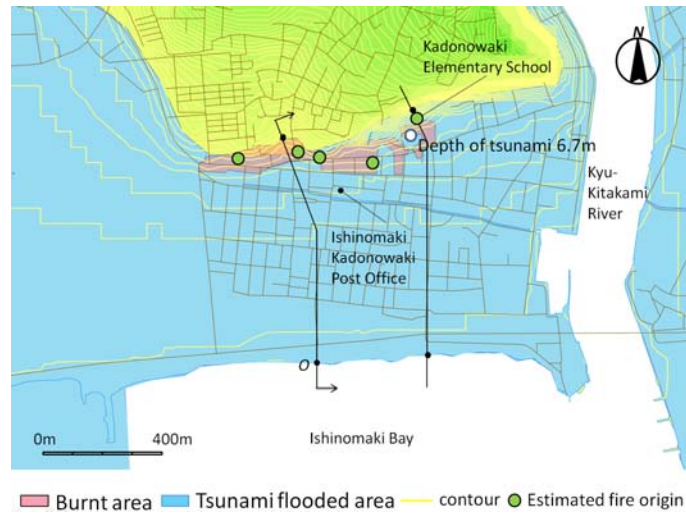
Fig. 24 Fire spread of fires to houses at hillslope of tsunami flooded area (Kadonowaki district of Ishinomaki city, Miyagi prefecture)

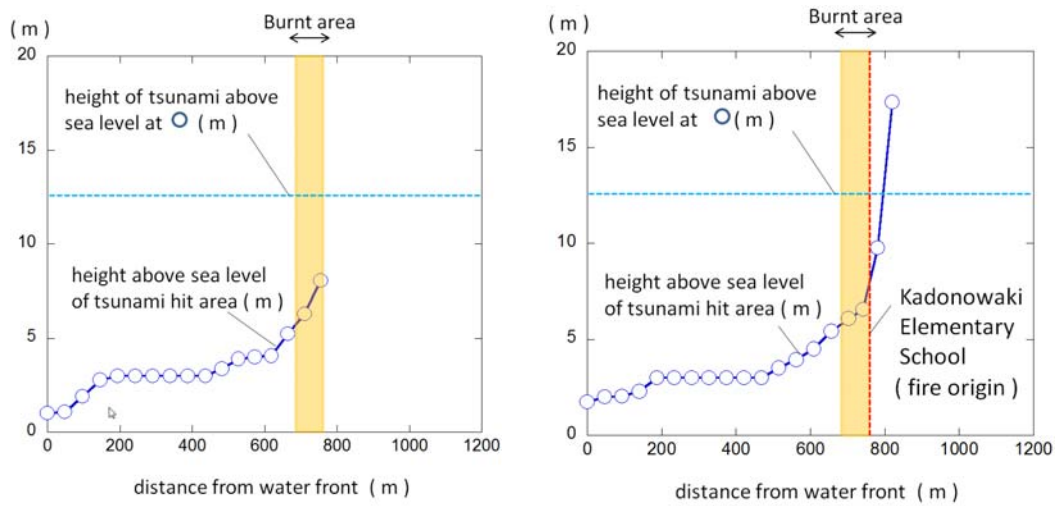
Fig. 25 Height of tsunami above sea level at fire spread area. (Kadonowaki district of Ishinomaki city, Miyagi prefecture)

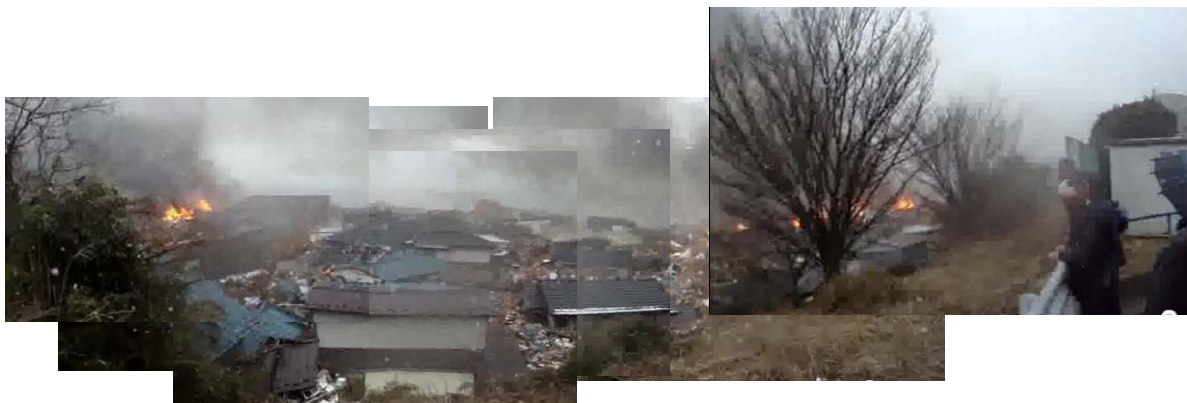
Fig. 26 Fire situation at 15:53 11th March 2011 about one hour after the tsunami hit here Kadonowaki district of Ishinomaki city, Miyagi prefecture (Cocoxom ,2011)

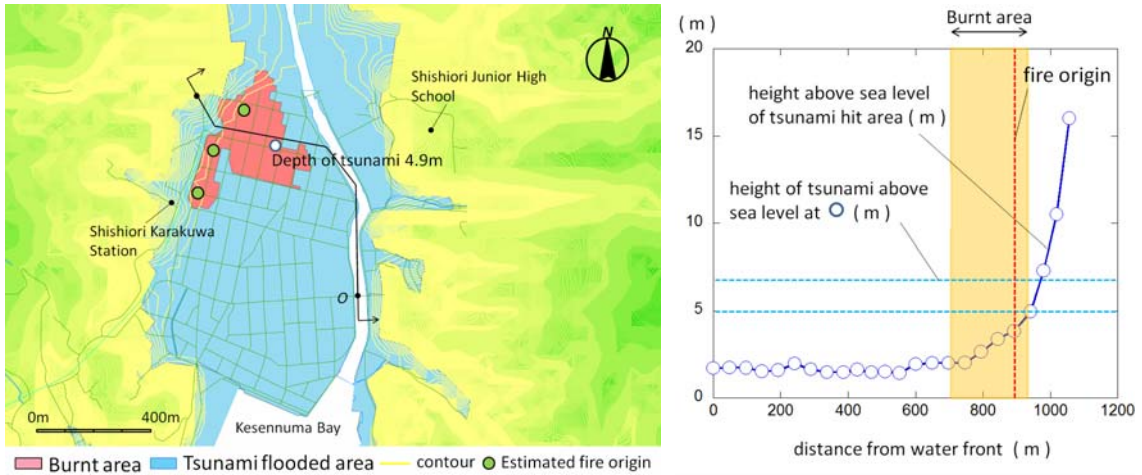
Fig. 27 Fire spread of fires to houses at slope of tsunami flooded area (Shishiori district of Kesennuma city, Miyagi prefecture)

Slope gradients of the fire sites of Fig.27 and Fig.28 are not so steep compared with other fire sites shown in Fig.18 to Fig.26. It could be said that the burnt area tends to be wide at glacial slope. Fig.29 shows that width of combustible material bed is wide at this glacial slope.

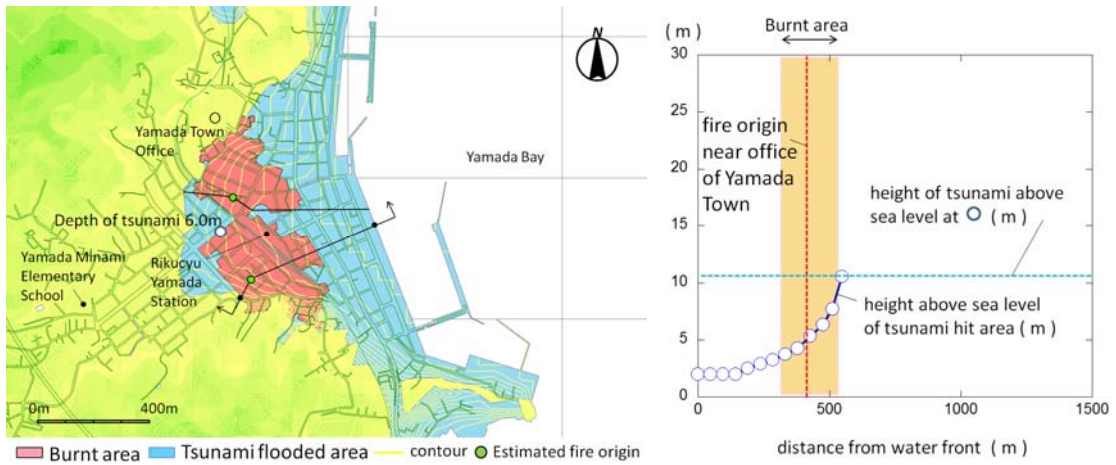
Fig. 28 Fire spread of fires to houses at slope of tsunami flooded area (Yamada district of Yamada town, Iwate prefecture)

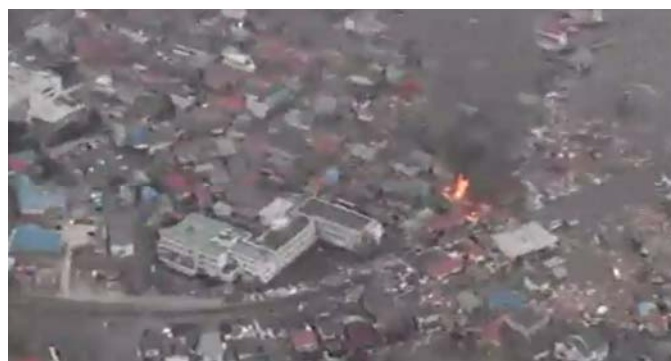
Fig. 29 Fire situation at 16:15 11th March 2011 about one hour after the tsunami hit here Yamada district in Yamada town (JGSDF, 2011)

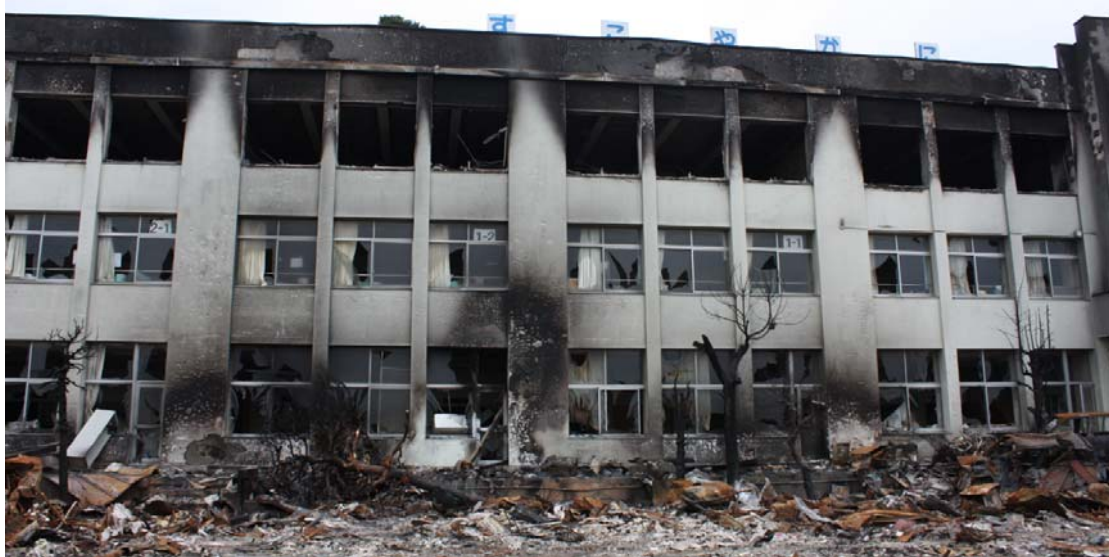
Fig.30 Burn mark of pattern-2 automobile fires at the wall of Kadonowaki elementary school building. (Kadonowaki district in Ishinomaki city, Miyagi prefecture, photo taken on 11th April 2011)

Fig.30 shows one example of this kind of fire site. This fire site is rightmost fire origin shown in Fig.24. The wall shown in Fig.30 has three automobile fire burn marks at the bottom of each columns. The automobiles themselves seems to be removed in Fig.30. Fig.31 shows another example of this pattern-2 automobile fire shown in Fig.4 and Fig.7. Some fires shown in Fig.27 are said to be caused by propane gas tank and automobiles on which wooden materials piled up.

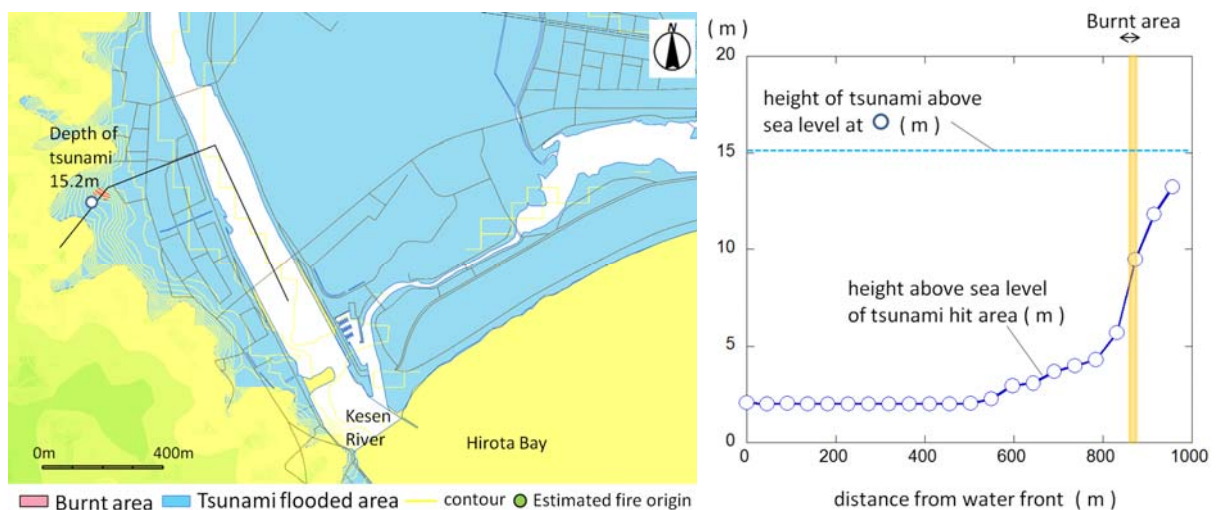
Fig. 31 Fire site of pattern-2 automobile fire at hillslope of tsunami flooded area (Kesen elementary school, Rikucyutakada city, Iwate prefecture)

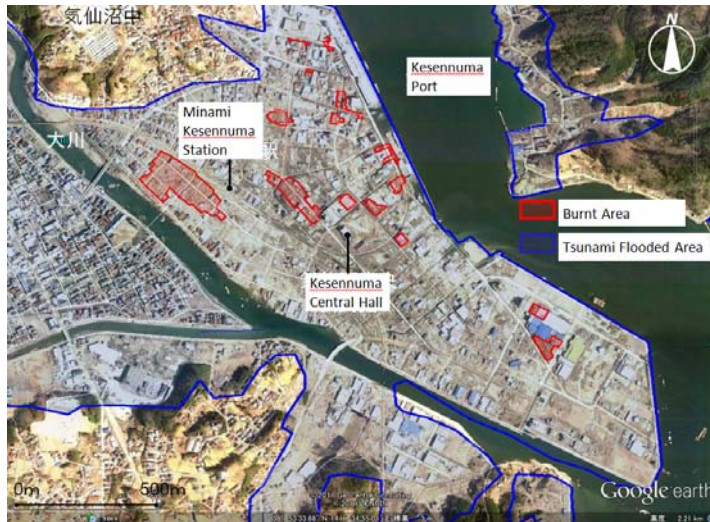
Fig. 32 Fire site of pattern-3 leaked oil fires at Haber district Kesennuma city, Miyagi prefecture

Fig.32 shows one example of pattern-3 leaked oil fires. Some small burnt areas and the biggest burnt area in Fig. 32 are not related to leaked oil fires. Small burnt areas are fires occurred at factories. Hazardous materials used in the factories are seems to be ignited when the tsunami hit there. Because the factories are not wooden structure, the buildings are not swept away by the tsunami, so the fires spread only inside of the factory buildings. The biggest burnt area near Minami Kesennuma Station is a fire occurred on 14th March 2011 by unknown reason. This area before the fire is shown in Fig.33. The rightmost area was combustible materials bed which was formed by the tsunami. Because of the depth of the water after the tsunami around here might have been shallow or in chance, the drifting fires didn't reach this combustible materials bed. As this site is flat as shown in Fig.35, the shape of combustible bed was formed like pyramid. There is a robust building at the top of the pyramid. In other condition of tidal wave, the drifting fire could have been reached wider combustible material bed to spread wider area.

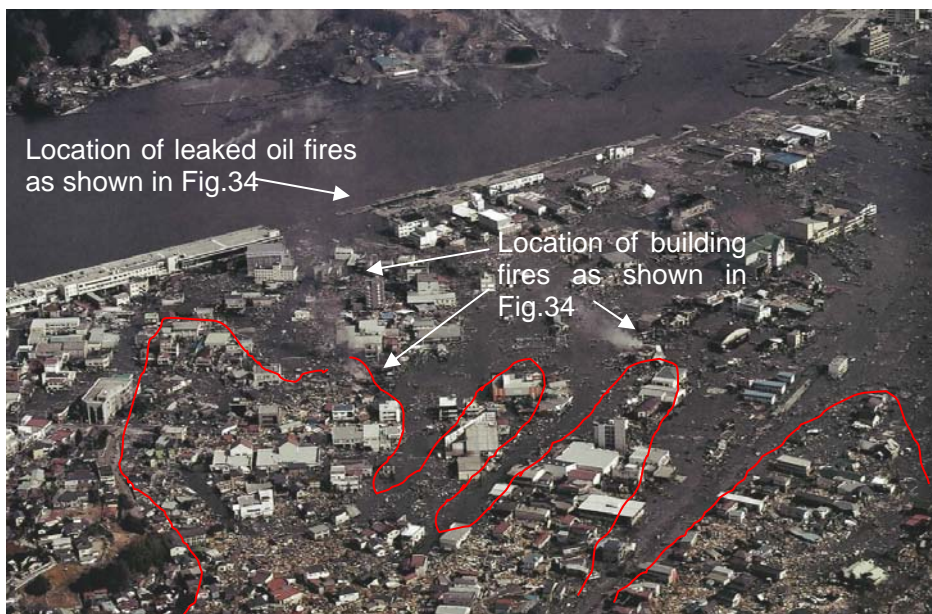
Fig. 33 Combustible material bed surrounded with red line in Haber district on 12th March 2011
The rightmost area caught fire on 14th March 2011 by unknown process (Bon Ishikawa ,2011)

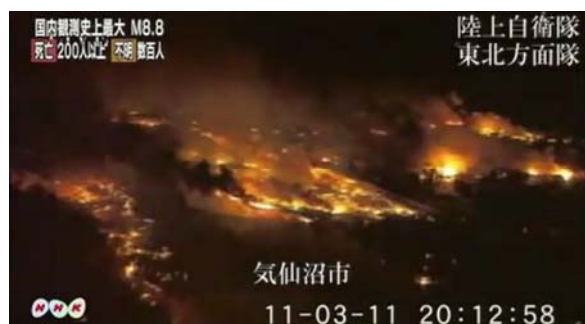
Fig. 34 Flames at the rightmost are building fires ignited by drifting fires from left.
Flames at the center are oil leaked fires on the water. (NHK, 2011)

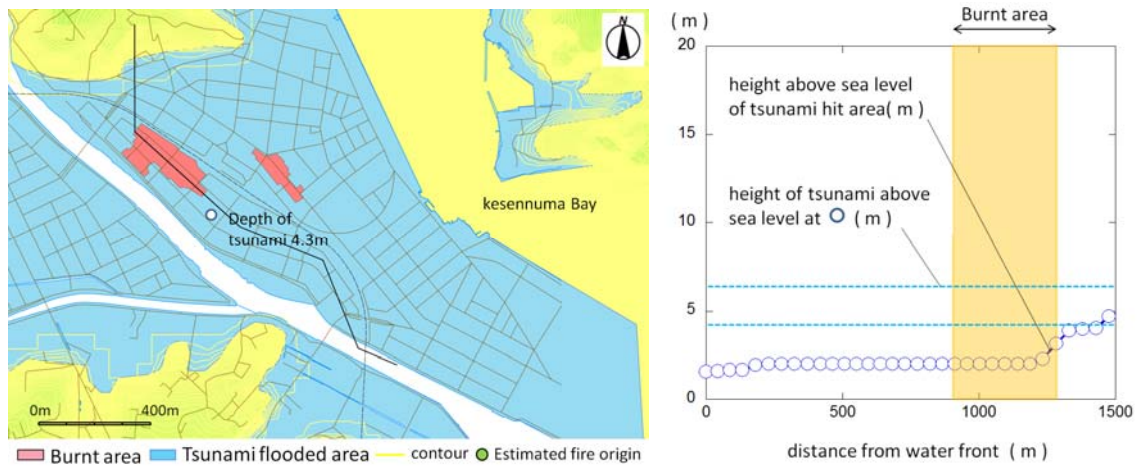
Fig. 35 Fire site of pattern-3 leaked oil fires at Haber district Kesennuma city, Miyagi prefecture

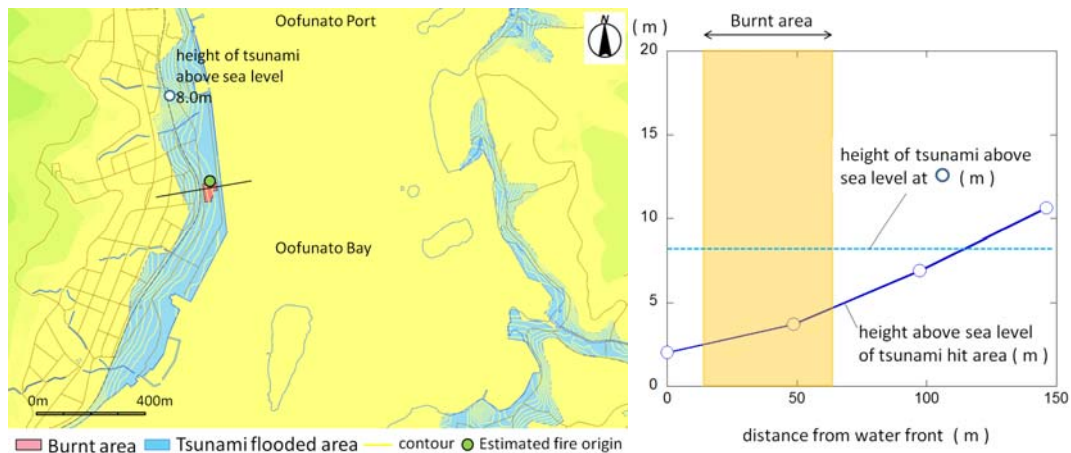
Fig. 36 Fire site of factory fire at Sunakomae district of Oofunato city, Iwate prefecture

Fig.36 shows other type of fire spread formation. In this fire site, there were some factories involved. The stream of tsunami around here was very strong from south to north, combustible materials accumulated between buildings of few factories and there propane tank fire or automobile fire might have occurred.

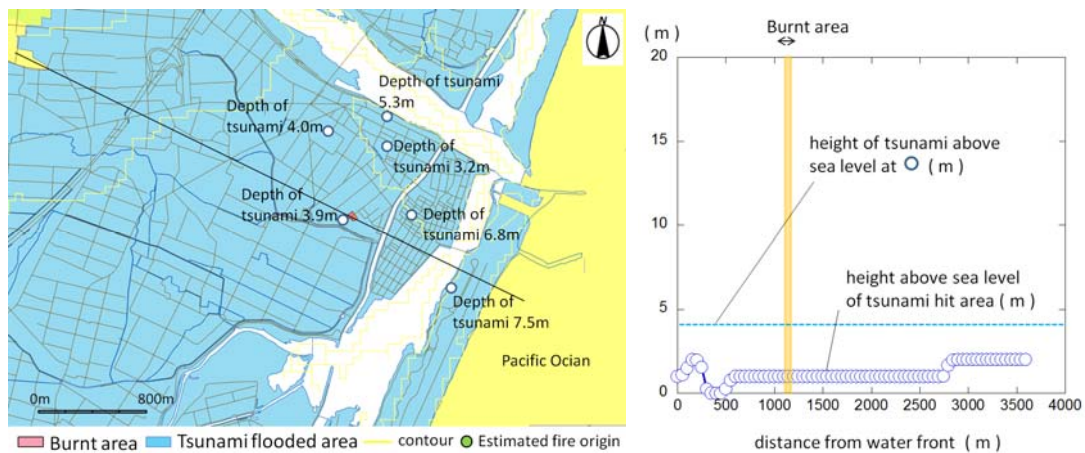
Fig. 37 Fire site in flat area, Yuriage district in Natori city, Miyagi prefecture

Fig.37 shows one example of fire spread in flat area. Burnt area depends on distribution of combustible materials and densely built up wooden housing area. There are variety of distribution of combustible materials from wooden houses hit by tsunami. Conditions of density of housing, open spaces and obstacles like railroad and highway banks make this variety. This time burnt areas in flat area were limited.

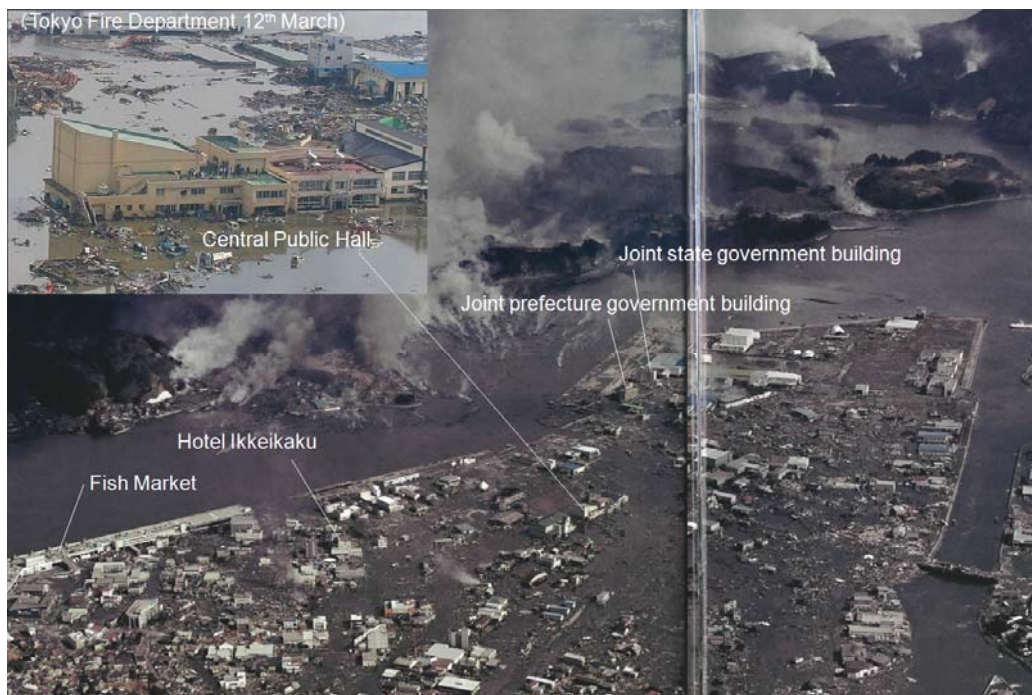
Fig. 38 Tsunami Evacuation Buildings at Harbor district in Kesenuma (Bon Ishikawa, 2011)

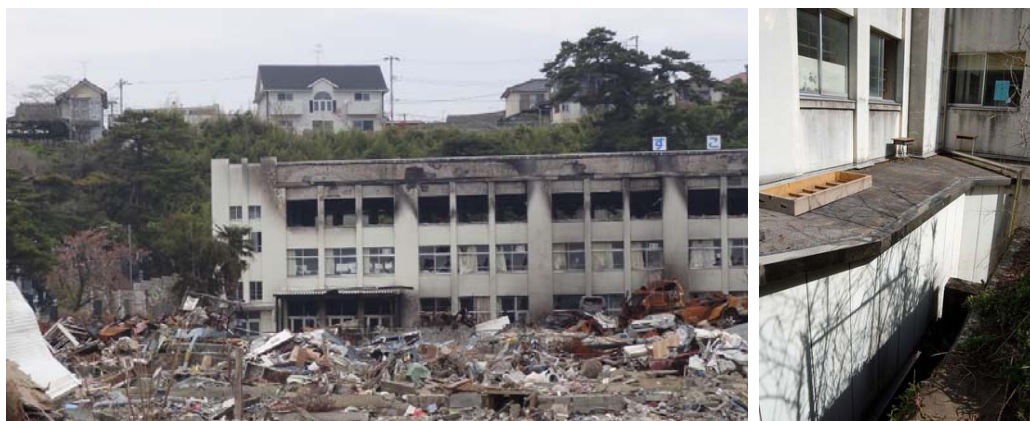
Fig. 39 Local people evacuated up to hillside after automobile fire occurred in front of Kadonowaki elementary school where they evacuated from the tsunami
