DAMAGE ANALYSIS OF BRIDGES AFFECTED BY TSUNAMI DUE TO GREAT EAST JAPAN EARTHQUAKE

Kenji KOSA¹

ABSTRACT: The Great East Japan Earthquake and the resulting tsunami hit the coastal areas of Japan. It is found that the outflow of steel and steel truss bridges is more serious than concrete bridges. By the use of videos, the tsunami velocities in 5 severely affected areas were estimated and the overall average is about 6.0m/s. In Rikuzentakata, 30% RC buildings suffered structural damage and 40% bridges flowed out. Besides, it is found that the outflow of superstructure is able to be judged by the level of ratio β between superstructure resistance and wave horizontal force primarily.

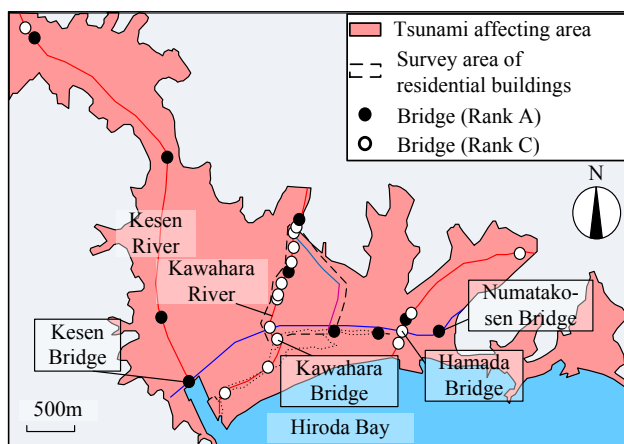
Fig. 6 Research region of Rikuzentakata

From the investigation of authors and also combined with the satellite photographs, the damage conditions of the main 26 bridges in the tsunami affecting area are evaluated, of which the results for each bridge can be referred from Fig. 6.

From Fig. 6, the authors found 80% bridges in the Kesen River suffered Rank A damage (4 in all 5 bridges); while only 18% bridges in the Kawahara River (2 in all 11 bridges). By using distance measurement function of Google Earth, Kesen River has greater size (width in level of 120m) than Kawahara River (width in level of 15m). Direct run-up of tsunami in the greater size river is considered as the reason for more serious damages of related bridges.

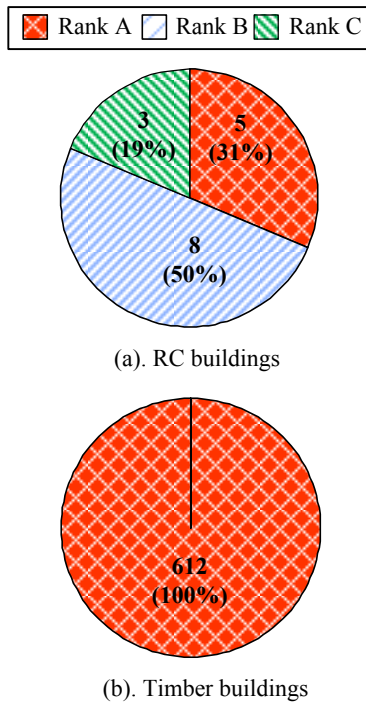
Fig. 7 Investigation result of buildings

Authors defined the damage extents of residential buildings as presented in Table 3. In Fig. 7, among total 16 RC buildings, proportion is 31%, 50% and 19% for Rank A, B and C, respectively. 70% of RC buildings suffered non-structural damage (sum of Rank B and C buildings), which suggests the great resistance to tsunami impact. Further, all 612 timber buildings are washed away or crashed into pieces by tsunami effect (Rank A), from which, timber building is considered not suitable for future design of anti-tsunami building.

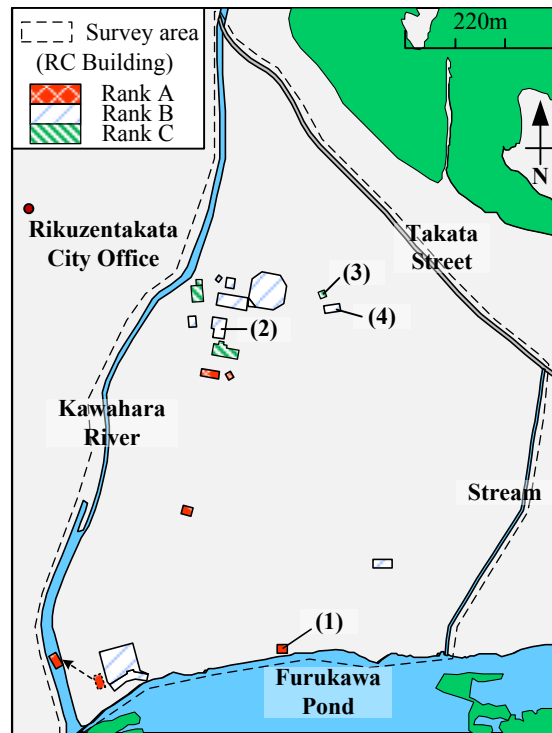
Fig. 8 Survey area to buildings

Fig. 8 presents the distributions of RC buildings in survey area. Compared with Rank B and Rank C buildings, there is the trend that Rank A buildings are relatively in smaller size which makes the building with smaller stiffness to resist tsunami impact. Further, Rank A buildings are mainly distributing in regions relatively closer to the coastline.

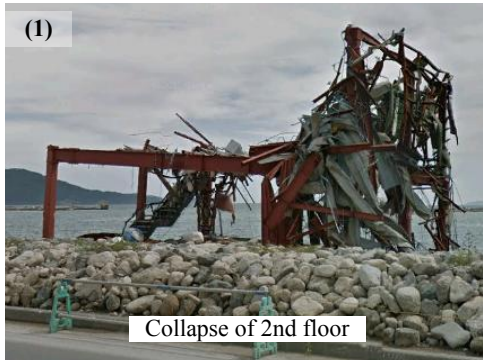
To introduce the detailed damage performances of RC buildings, one typical building is selected for each damage rank with their photos shown in Photo 1 and Photo 2. Positions can be referred from Fig. 8. Typical Rank A building is a two-floor, steel-frame structure with its structural members seriously damaged. Main columns of left side in second floor were washed away and beams in horizontal direction suffered seriously flexural damage and gathered to residual frame at right side; side walls of it have all been washed away; Typical Rank B building is a reinforced concrete building with its non-bearing wall in the first floor damaged; great lateral load of tsunami impact probably caused it; typical Rank C building (building (3)) is also a reinforced concrete building with relatively smaller size. Since building (4) (Fig. 8) with greater size in front of it worked as barrier and weakened

Photo 1 Damage performance of buildings (Rank A, Rank B)

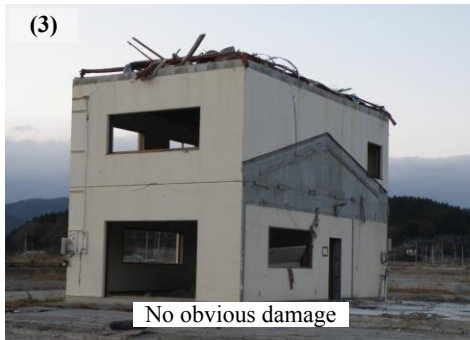
Rank C

Photo 2 Damage performance of buildings (Rank C)

the impact, building (3) did not suffer great damage.

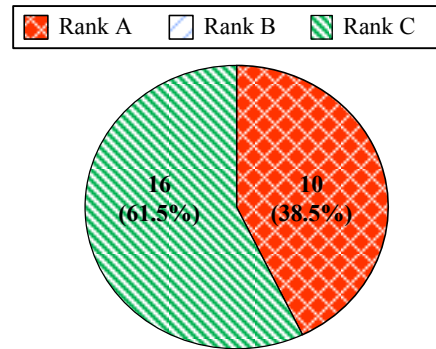
Fig. 9 Investigation result of bridges

As illustrated in Fig. 9, the damage conditions for the surveyed bridges are apparently divided into Rank A and Rank C, with Rank A taking the share of around 39% (10 among all the 26 bridges) while Rank C taking the share of around 62% (16 among all 26 bridges).

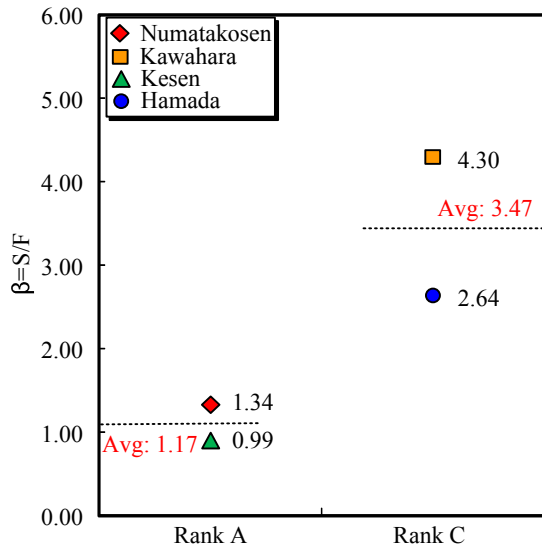
Fig. 10 β Ratios for Rikuzentakata area

Fig. 10 illustrates the relationship between the computed β ratios (from bridge details in Table 4) with the damage conditions. In terms with the two Rank C bridges, β ratios are all greater than 1.0 with average as 3.47, which means resistance is greater than tsunami impact force. Thus, their superstructure survived. For Rank A bridges, the β ratio is 0.99 and 1.34, respectively (average as 1.17). Average β ratio of Rank C bridges is 2.97 times of Rank A bridges.

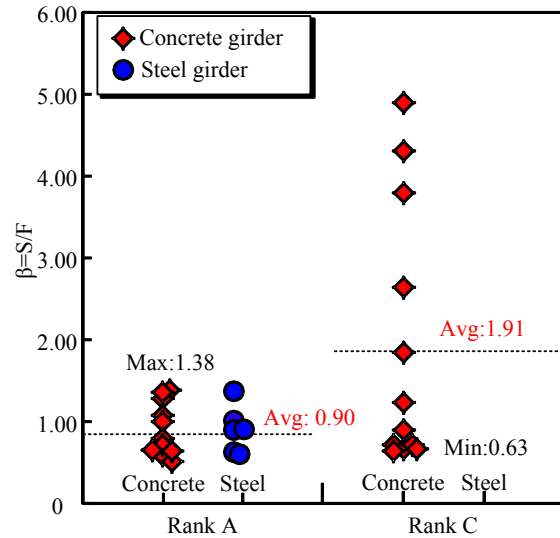
Fig. 11 β Ratios for Tohoku area

Computed β ratios for bridges in entire Tohoku area (total 29 bridges, Rikuzentakata area included) are presented in Fig. 11. Average β ratio of Rank A bridges with their superstructures outflowed is 0.87. Average β ratio of Rank C bridges with their superstructures survived is 1.91 (2.20 times of Rank A).

With respect to β ratios of different girder types (simply divide into concrete girder and steel girder, Fig. 11), concrete girders have relatively great β ratios and 53% of them have survived (12 among total 23, Rank C); all the steel girders have relatively small β ratios and have flowed out (Rank A), inferring the small resistance to the tsunami impact.

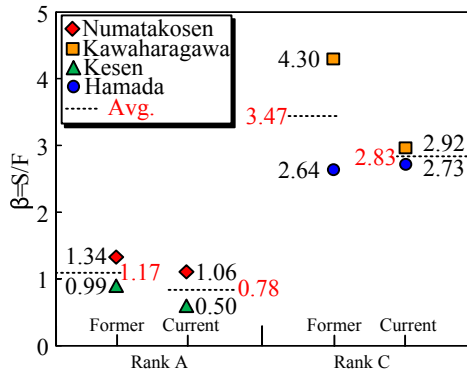
Fig. 14 Recalculated β Ratios for Rikuzentakata

For the Numatakosen Bridge (Rank A damage), which originally has relatively greater β ratio (1.34), the β ratio reduces to be 1.06, indicating the smaller girder resistance. For the Kesen Bridge, as the greater tsunami velocity in the river area, the β ratio decreases to be 0.50, adequately explaining the outflows of its girders. For the Kawahara Bridge, the β ratio becomes 2.92 as the greater tsunami velocities nearby. For the Hamada Bridge, as the tsunami velocity (6.1m/s) is relatively close with what we assumed previously, the β ratio is not changed obviously.

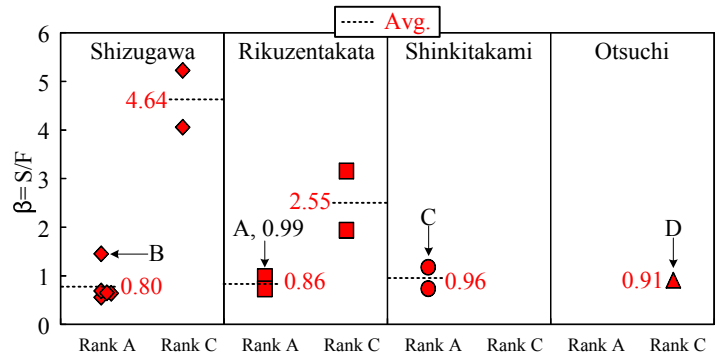
Fig. 15 Recalculated β ratios for entire area

Compared with the summary results of former β ratios (velocity assumed as 6.0m/s) in different areas (Fig. 16), we get to know the following phenomenon. For Rikuzentakata area, as the increasing of velocity (6.0m/s vary to be 7.0m/s), the β ratios have reduced entirely. The β ratio of girders for Numatakosen Bridge (Rank A, Mark A of Fig. 15) reduced to be smaller than 1.0, reflecting outflow

However, after recalculations, there are still some β ratios of Rank A bridges greater than 1.0 (Mark B, Mark C, Fig. 15) while some of Rank C bridges are smaller than 1.0 (Mark D, Fig. 15). Further, for the areas without measurement of velocities, some β ratios also can not coincide with their outflow conditions (Mark E, F, G and Section a, Fig. 16). A series of numerical analysis for getting more detailed and precise velocities will be conducted later. After that, more precise β ratios will be obtained and the evaluations will be continued. Besides that, the average β of Rank A and C bridges after modifications is plotted in Fig. 17. Compared to the average β before modification (Fig. 11), it is found that the β of Rank C become smaller which is 1.81.
