IMPLICATIONS OF BRIDGE PERFORMANCE DURING GREAT EAST JAPAN EARTHQUAKE FOR U.S. SEISMIC DESIGN PRACTICE

Key Words: Great East Japan earthquake, bridge performance, design and retrofit programs, elastomeric bearings, tsunami inundation, duration, implications for United States

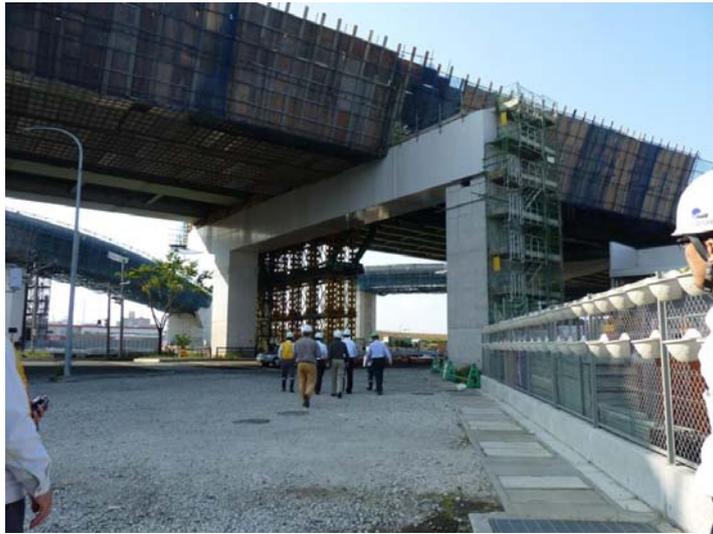
The damage to this 4.4 km long, multi-span viaduct in north Sendai was largely confined to a 10-span section between Piers 52 and 62. Built in 2000, this section of the viaduct was being widened at the time of the earthquake. New on- and off-ramps were under construction between Piers 54 and 56 to connect Route 10, carried by the viaduct, to Route 141 below. The superstructure comprises eight steel plate girders (I-girders) between Piers 50 and 52, three, four, or five steel box girders between Piers 52 and 56, and eight steel plate girders between Piers 56 and 63. Elastomeric bearings are used exclusively with external stoppers to restrain transverse movement at almost every pier. Piers 54, 55, 56, 58, 59 and 60 had recently been converted from single steel box columns to two-column steel box frames to accommodate new on- and off-ramps (Figure 2). The remaining piers (51, 52, 53 and 57) are single-column steel boxes (Figure 3).

Fig. 2 Two-column frame, Pier 56, Sendai-Tobu Viaduct
(photo: E. Monzon)

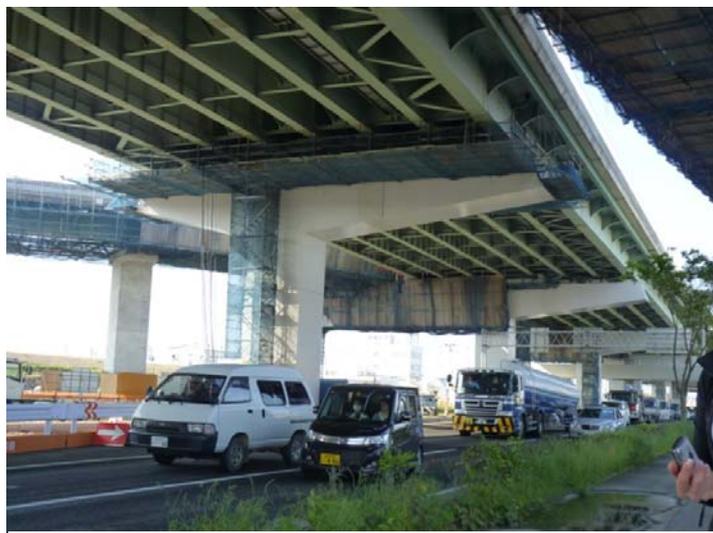
Fig. 3 Single-column pier, Pier 57, Sendai-Tobu Viaduct
(photo: E. Monzon)

The second effect is the generation of high tensile forces in the bearings at these same locations due to the difference in pier type. For example Pier 56 is a 2-column frame and Pier 57 is a single column hammerhead pier. Under lateral load the hammerhead rotates about a longitudinal axis twisting the superstructure about the same axis. But the pier cap in the 2-column frame at Pier 56 does not rotate in this manner and this frame resists the twisting of the superstructure. High tensile forces are developed in the bearings as a result. The simultaneous occurrence of high tension and high shear in the bearings could have led their failure.

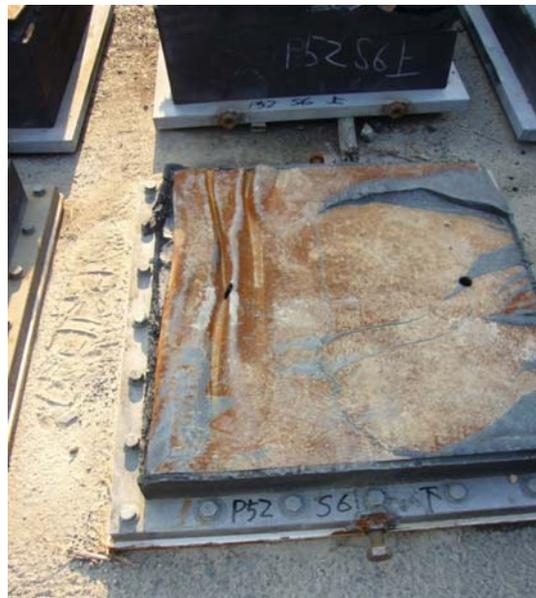
Inspection of the damage to the bearings showed that many had ruptured completely through the elastomer, as if in direct tension. Others showed damage to the internal shims which had been severely

distorted (Figure 4). Typical dimensions of the bearings at Pier 56 were 820 x 870 x 508 mm, with 8 x 33 mm layers of elastomer, 7 x 4.5 mm shims and 2 x 45 mm end plates. The masonry and sole plate connections were detailed to transfer both shear and axial forces (tension and compression) to the bearings.

It seems possible that the bearings failed due to the combination of two effects. First the high lateral forces in the steel stoppers at Piers 52 and 56 were probably not evenly distributed amongst the three effective stoppers. (Although there are six stoppers at each pier, only three are effective at any point in time.) This uneven distribution can arise in situations where the gaps between the stoppers and the sole plates of the bearings are not identical and one stopper engages before the others. Overloading of this stopper may then lead to its failure, followed by the transfer of load to the other stoppers which fail in turn. Once all the stoppers have failed the transfer of load to the bearings places them under very high shear strain.

The shim damage seen in Figure 4 most likely occurred when a ruptured bearing impacted a toppled stopper puncturing the cover rubber layers and distorting the edge of the shim plate.

Fig. 4 Damaged elastomeric bearing from Pier 52 Sendai-Tobu Viaduct (photo: I. Buckle)

3. With the exception of several spans of the Sendai-Tobu Viaduct, elastomeric bearings performed well and considerably better than older-style, steel bearings. The reason for the poor performance of the Sendai-Tobu bearings needs to be determined quickly for it has widespread implication on the use of these devices as expansion and seismic isolation bearings in the United States. It is noted that the damage to the superstructure of this Viaduct reinforces the recent move in the U.S. to require superstructures be explicitly designed for seismic loads and the need for the lateral load path to be clearly identified and designed.

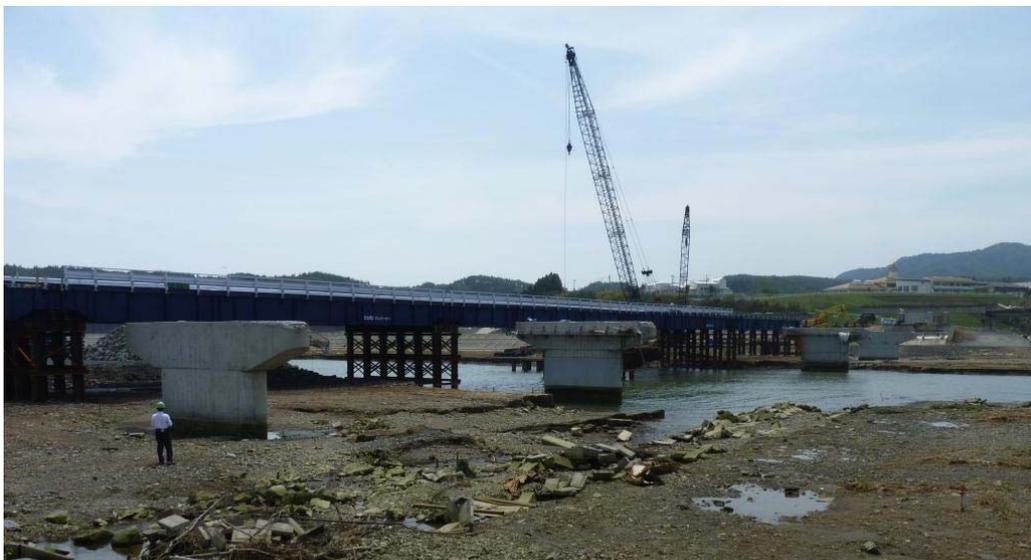
All six spans were swept away during the tsunami (Figure 5). Wave heights of the order of 11.8 m were registered at Ofunato City just north of this site and the tsunami clearly overtopped this bridge taking all six spans upstream. Based on damage to the levee on the north bank of the river (Figure 6), some of these spans were swept along the top of the levee on the north bank, then over the levee altogether on the north side, and later back over the levee into the main channel where they came to rest about 400 m upstream from the bridge (Figure 7). Other spans took a different path and came to rest about 300 m upstream but on the south side of the levee on the south bank of the river. Four of the five piers are still standing, but the center pier (Pier 3) was overturned and believed to be under water in the river channel just upstream of the bridge (Figure 5).

Fig.5 Remaining piers of Koizumi Bridge shown at low tide. Temporary bridge is under construction on seaward-side of bridge (photo: E. Monzon)

It is clear that the longitudinal dampers installed at the abutments and the transverse keys (stoppers) over the piers, offered little restraint to the lateral loads imposed by tsunami. Once these devices failed, the relatively light weight of the steel I-girders, together with the buoyancy effects of air trapped between the girders, enabled the superstructure to be easily lifted and carried significant distances upstream. The loss of Pier 3 was probably due to scour but this could not be confirmed. Despite the low tide at the time of the visit, this foundation was still underwater.

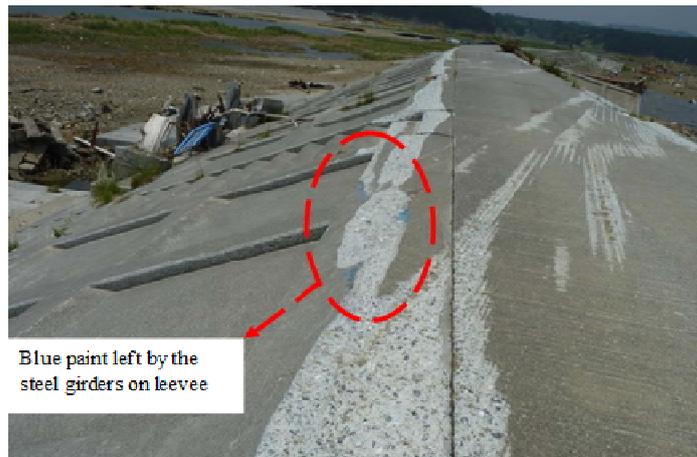
Fig. 6 Drag marks on top of levee caused by girders from Koizumi Bridge (photo: E. Monzon)

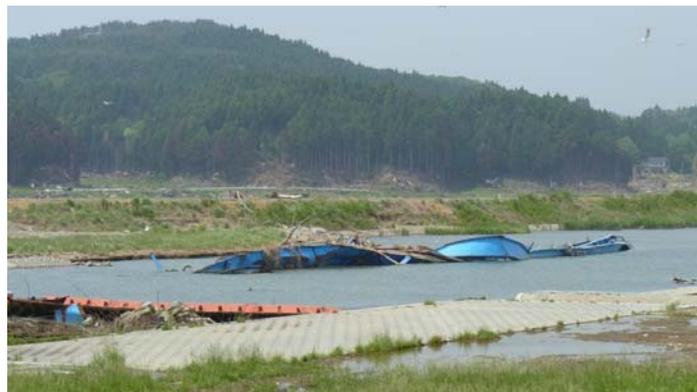
Fig. 7 Girders from Koizumi Bridge 400 m upstream in Tsuya River channel (photo: E. Monzon)

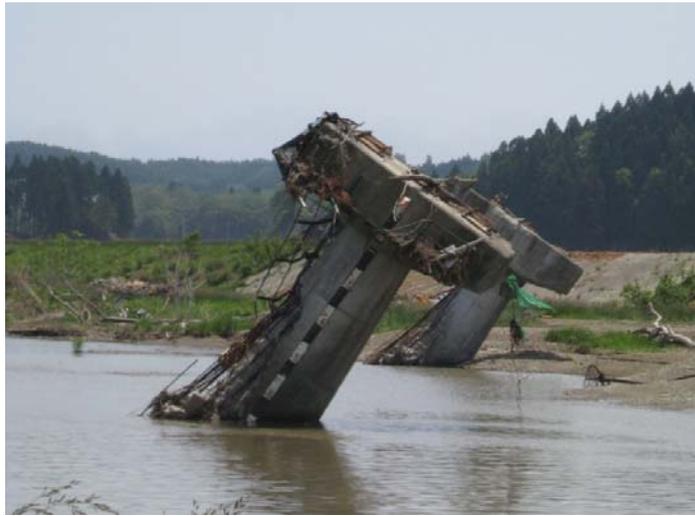
About 900 m upstream of the Koizumi Bridge, the JR East rail line to Kesenuma crosses the Tsuya River on a multispan, prestressed concrete girder viaduct. Five of these spans were washed out, but the piers survived (Figure 8). The in-coming tsunami apparently breached the levee behind the piers allowing flow oblique to the channel. The piers are tilted toward the breach, and the simple span, three-girder superstructures came to rest on the opposite side of the levee.

Of interest is the damage to the lower portions of the piers. The exposed reinforcement seen on the left side of each pier appears to have been pulled outward from the center of the column, rupturing the

Fig. 8 Damaged piers of the JR Rail Viaduct crossing the Tsuya River (photo: S. Dashti)

relatively light transverse steel. This type of behavior is seen in the failure of beams that are unreinforced for shear, where a shear crack precipitates failure and tearing of the tensile reinforcement from the beam. In the case of the JR East piers, potential buoyancy of the superstructure due to trapped air and the hydrodynamic forces produced lateral loads on the piers along with eccentric vertical loading. The piers may have failed in shear above the foundation after plastically deforming under the combined lateral and vertical effects. Following the loss of shear capacity at the base, the tension reinforcement was torn from the piers.

In this postulated mode of failure the tilting of the pier is due to structural failure and not to scour and subsequent rotation of the foundation. Inspection of the columns and footings below the water line is required to confirm this behavior.

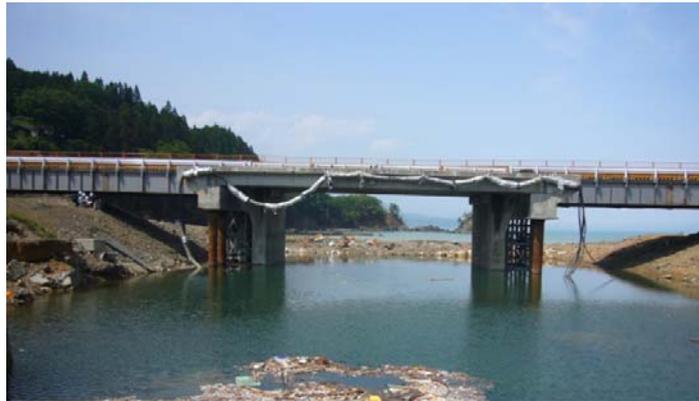
The bridge had been widened on both sides at some time in the past using precast double-tee beams spanning between new abutments each founded on steel piles with heads at a much higher elevation than those of the original structure. The tsunami washed out the backfill behind both abutments and temporary approach spans, using steel I-girders, were placed to open the bridge to traffic. These spans are seen in Figure 9. Temporary steel towers to support these spans may also be seen in this figure.

Fig. 9 Loss of backfill on both approaches to single-span Nijyu-ichihama Bridge (photo: I. Buckle)

Apart from the loss of the seaward extension, this bridge has performed remarkably well from a structural point of view. It is essentially intact and the principal reason for closure was the loss of back fill due to erosion. Despite the buoyancy of trapped air, the superstructure was well anchored both vertically and laterally to the abutment seats and was not dislodged by the tsunami despite being overtopped. It is of course possible that the erosion of the abutment backfills and the creation of two alternative hydraulic channels took load off the bridge, but nevertheless the performance of this bridge is noteworthy.

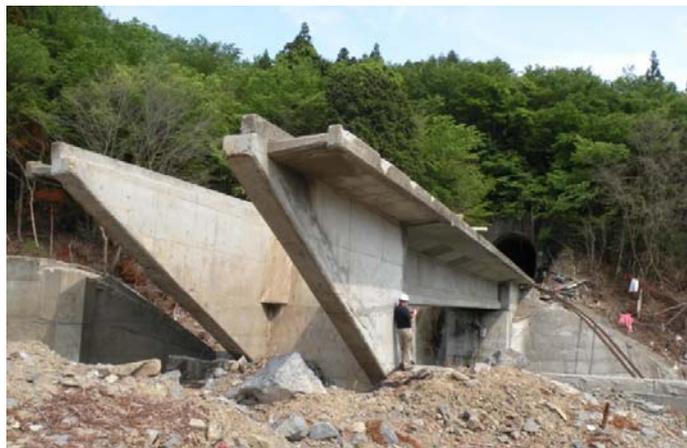
About 100 meters upstream from the Nijyu-ichihama bridge is the JR East line to Kennesuma, which runs a distance of several hundred meters across the valley between tunnels at either end. This section of rail line was supported on a long fill embankment, two box culvert roadway underpasses, and a prestressed concrete, single span bridge over the river (Figure 10). The unprotected embankment appeared to be a granular material. As the wave overtopped the embankment, it displaced the tracks and significantly scoured and removed the upper 4 to 5 m of the fill. Apart from the loss of the approach fills, all the bridges in the valley appeared to be intact.

Fig. 10 Exposed wingwalls of JR Rail Bridge 100m upstream from Nijyu-ichihama Bridge due to loss of approach embankment (photo: D. Frost)
