DAMAGES OF MACHINES AND STRUCTURES IN GREAT EAST JAPAN EARTHQUAKE AND LESSONS FROM THE DISASTER

Masaki SHIRATORI

Professor, Center for Risk Management and Safety Science, Yokohama National University
Chairman of the JSME Investigation Committee on the Great East Japan Earthquake
masaki@ynu.ac.jp

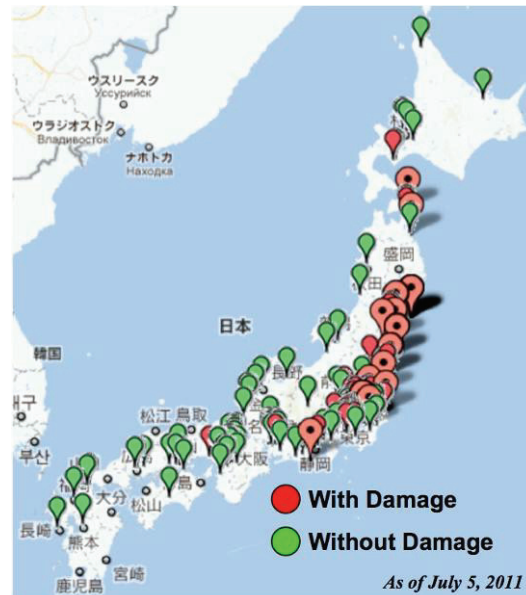
Figure 1 shows the seismic damage distribution of industrial facilities, as of July 5th, 2011, caused by the Great East Japan Earthquake. Red mark indicates the industrial facilities with damage, while green mark without damage. It is confirmed that the seismic damage is located over a wide area in Japan.

Fig.1 Seismic damage distribution of industrial facilities (As of July 5, 2011)

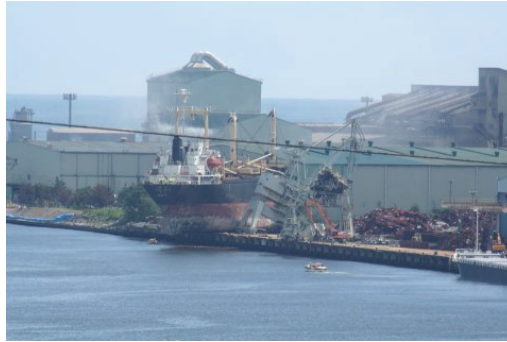
Figure 2a A factory attacked by a large ship carried by tsunami
(Yahoo! JAPAN East Japan Earthquake Picture Record Project,
<http://archive.shinsai.yahoo.co.jp/entry/61926/>)

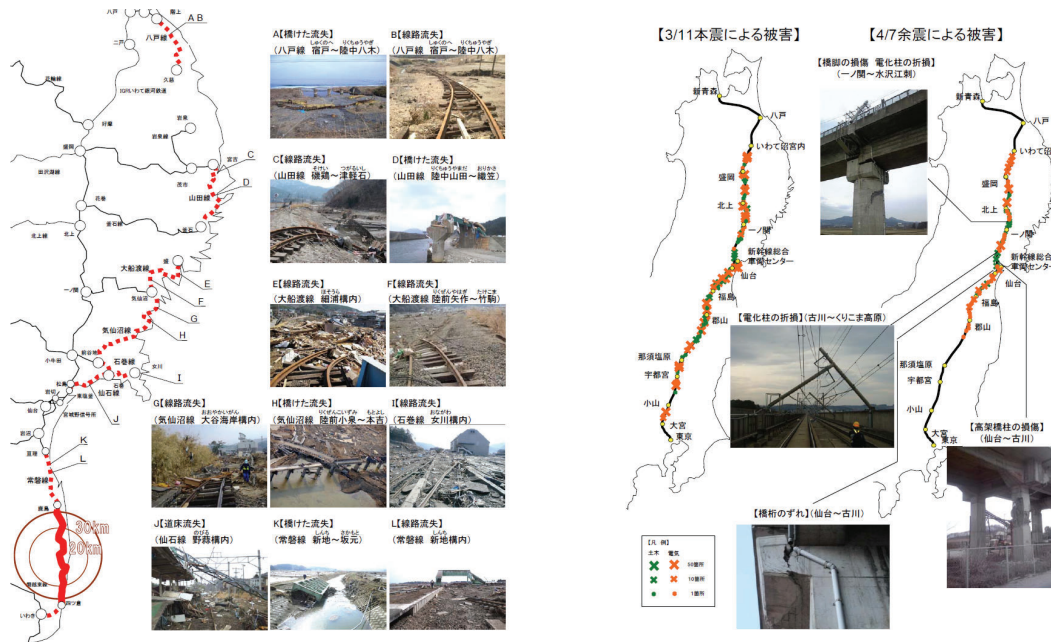
(a) Local railway along Pacific coast

(b) Tohoku Shinkansen line

Fig. 4 Damages of railways by the earthquake and tsunami

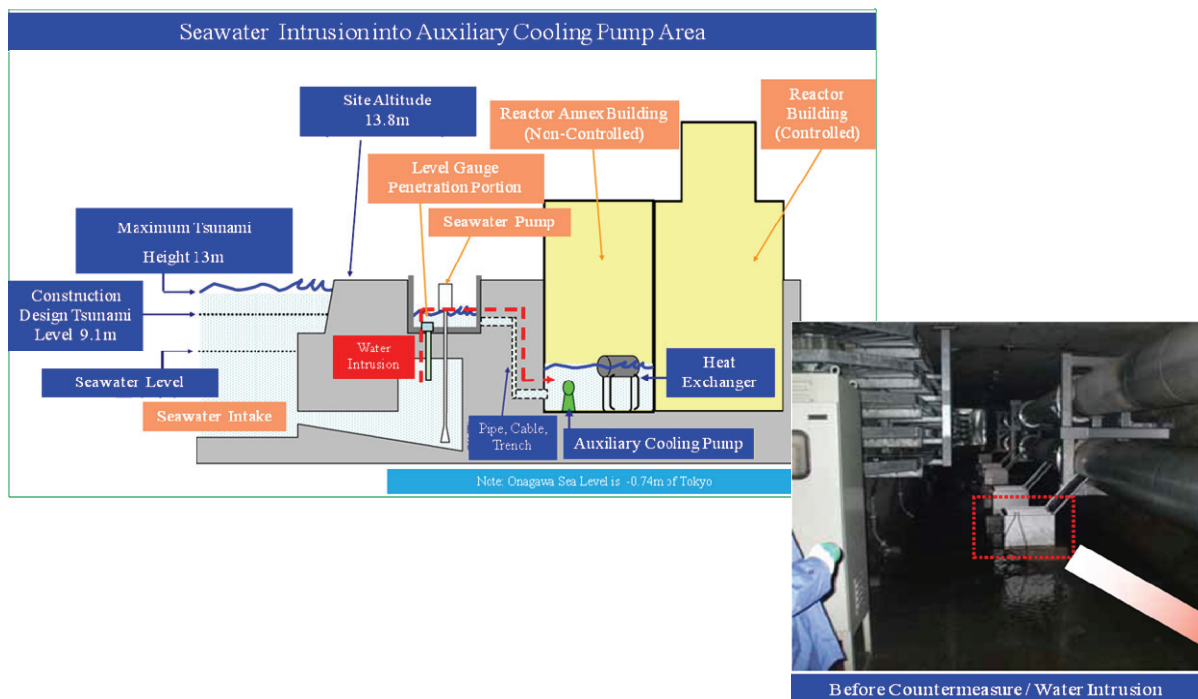
Fig. 6a Sea water penetration pass at Onagawa No. 2 reactor. Water does not fail to notice any tiny cranny to come into inside.

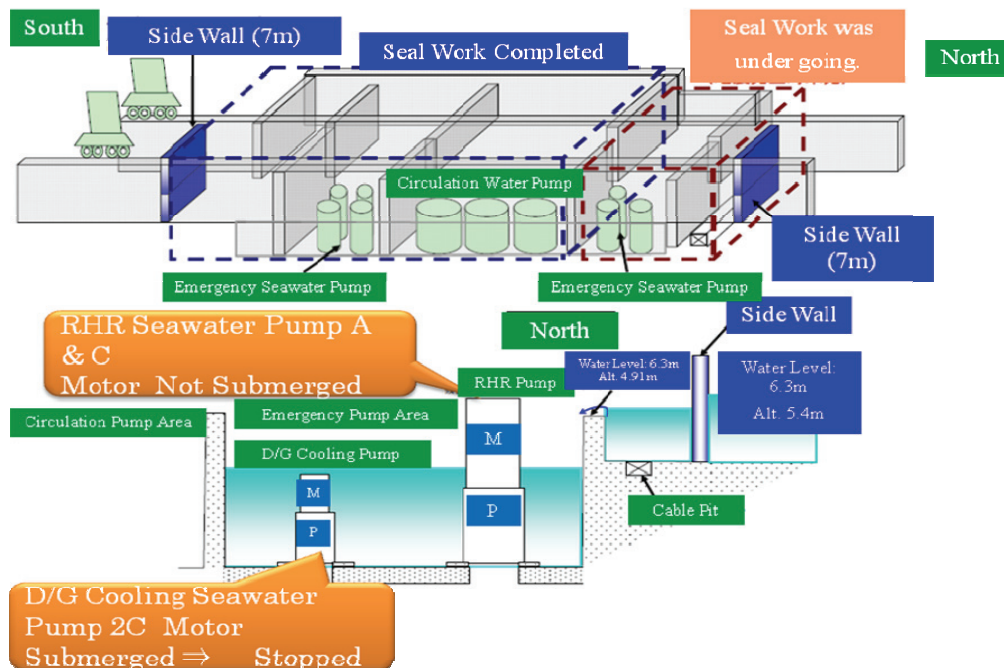
Fig. 6b Sea water penetration was blocked at Tokai No. 2 reactor. Waterproof treatment is important.

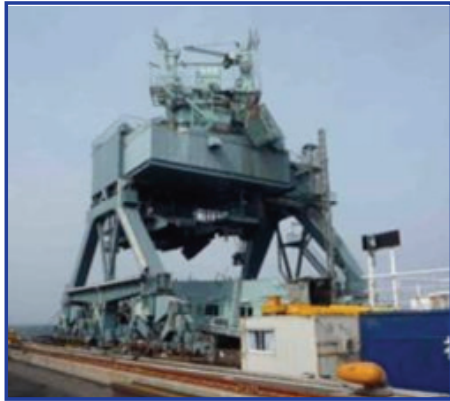
Fig. 7a Damaged coal unloader

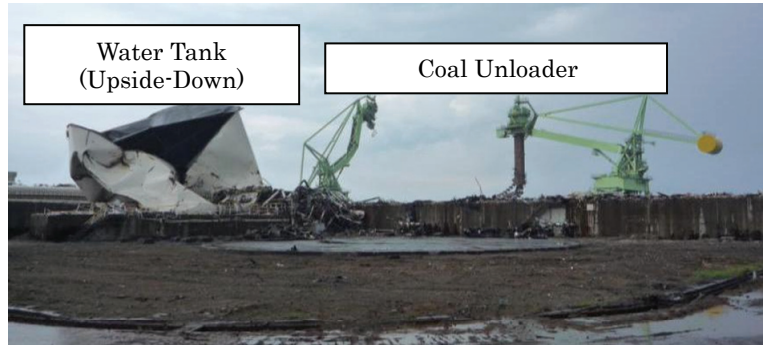
Fig. 7b Crashed and washed-away fuel tank

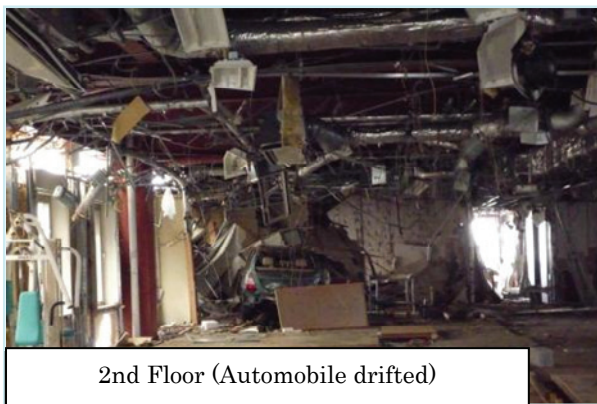
Fig. 7c Second floor of control building

Since the thermal power station located close to the sea, all power stations were damaged by the tsunami which followed the earthquake. The degree of the damage depended on the height of the tsunami and was in wide dispersion. A coal hoist collapsed through the severe pitching/rolling of a coal ship. (Fig. 7a) Fuel tanks were crashed and washed-away by the tsunami. (Fig. 7b) The tsunami invaded into buildings including control buildings (Fig. 7c) and switchboard buildings (Fig. 7d). Power loss was caused, which harmed the communication between on-site and off-site. An emergency power source was installed on a turbine floor at some power station and effectively functioned. It is essential to equip various communication tools.
