DAMAGE ANALYSIS ON BUILDINGS IN TOWNS AND VILLAGES AROUND THE JUNCTION AREA OF SICHUAN AND GANSU IN WENCHUAN EARTHQUAKE

Bo SONG¹, Fuqiang QI² and Shuai HUANG³

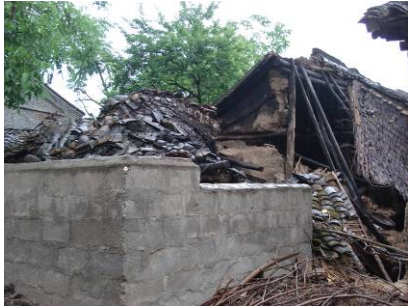
The main problems of timberwork buildings were that the components corroded and decayed, the section of timberwork weakened, the strength of components connection was insufficient, and the floor height was too high. The important reasons of buildings in towns and villages collapsed in the earthquake were that the building were not designed according the seismic design codes and the building materials did not meet the requirements. So in high seismic fortification intensity town area, it is important to strengthen the legality of building construction and the supervision to improve the quality of buildings.

Fig.2 The collapsed timberwork buildings

For raw-soil buildings and timberwork buildings, it is necessary to strengthen the integrity of buildings and the connection of components. And all of the used irons, clinchers, straws and wooden poles only value 2%~5% of the total cost of buildings. Especially for timberwork buildings, walls and timber structures should connect reliably, and the masonry walls should not completely surround the wood column and should be built outside of the column. (Ge, 2005, Wang, 2004, etc)

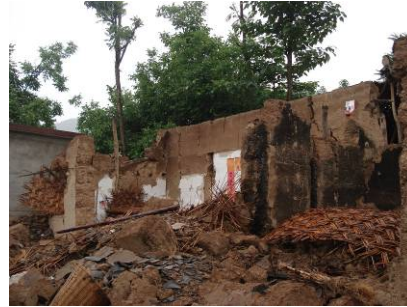
The raw-soil structure buildings and timberwork buildings were the main types of buildings in towns and village, which were basically built before 1970s with single layer and the beams were placed on the walls directly. So the type of buildings were designed without considering aseismic ability and damaged seriously during the earthquake as shown in Fig.2 and Fig.3. Because the raw-soil structure buildings are weak in integrity, if there are not connected structures between the walls, the buildings will be easy to crack and collapse subject to horizontal seismic forces. Though it is specified that the junctions of outer wall and inner wall should set a layer of bamboo muscle, batten and so on, in design of raw-soil structure buildings in Code for Seismic Design of Building (GB50011-2010), the damaged buildings were lack of connection structures, even some buildings were without foundations, the walls were too high and the span were too large comparing with the specifications in the code on the site investigation. So the raw-soil structure buildings collapsed because the shaking crack was too large in the earthquake. The purline and crossbeam were set on the wall directly, and they were not subject to concentrated loads. Because the strength of walls was insufficient, the walls always crack in using. So when the earthquake occurred, the purline and crossbeam collided with walls, which caused the cracks

Fig.3 The collapsed raw-soil structure buildings

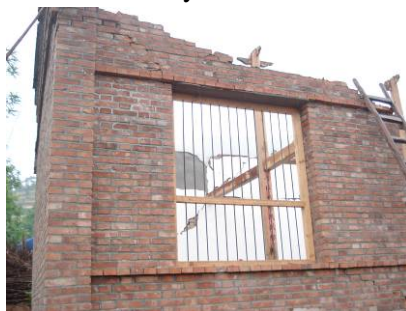
Besides the raw-soil structure buildings and bricks timberwork buildings, masonry timber buildings are also another common type of local dwellings houses. The main support wall were most brick walls with thickness 120mm, 180mm or 240mm, and the roof were triangle wooden frame. The masonry timber buildings were designed without seismic measures and lack of connection components, and the roof trusses were installed on the brick wall directly, so the type of the buildings were always with bad integrity. Under vertical loads, the structures usually relative stable, but subject to horizontal earthquake, the maintenance walls were easy to incline, which leads to severe earthquake damage such as local collapsed or overall collapse. In the earthquake, most masonry timber buildings were damaged seriously and some buildings built relative early completely collapsed as shown in Fig.4. The masonry timber structures have the same problems with the raw-soil structure buildings, such as the purline put on the brick wall directly. The improper constructions and connections made the masonry timber structures loss the aseismic ability.

Fig.4 The destroyed masonry timber buildings

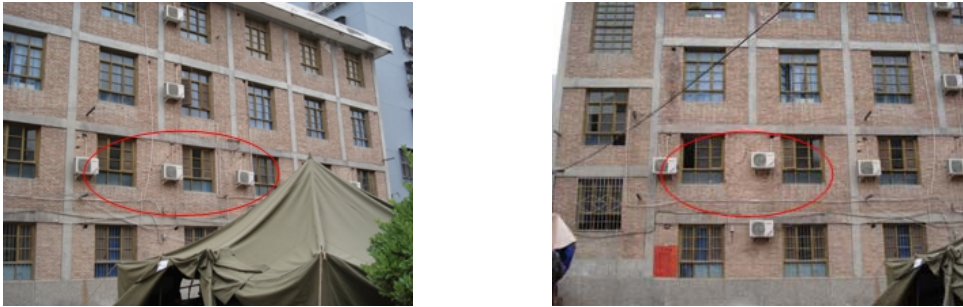
The masonry concrete buildings were a new type of buildings adopted by local residents in recent years, most of which were with two layers. The buildings usually set ring beams at the ground and at top of first floor, but rarely at the top of second roof, and did not set constructional columns. In the earthquake, the damages of the type of buildings contain cracks on the walls, damage at the connection of vertical walls and horizontal walls, damage at doors and windows, walls incline and collapse and so on. Some buildings adopted the improper force transmission structures, which caused some buildings were damaged seriously as shown in Fig.5. It can clearly be seen that the second layer column was cut off. The loads acting on upper layer column can not transfer to the foundation via a proper force

transmission path, but directly acted on the lower beams, which caused big concentrated forces and 'X' form cracks on masonry structure under the beams. The second layer bearing structures were equal to three large bays, and the walls between windows of the three large bays were damaged with 'X' form cracks. The irregular structures are easy to be damaged in an earthquake, so it should be avoided in the design.

Fig.5 The building with improper force transmission path

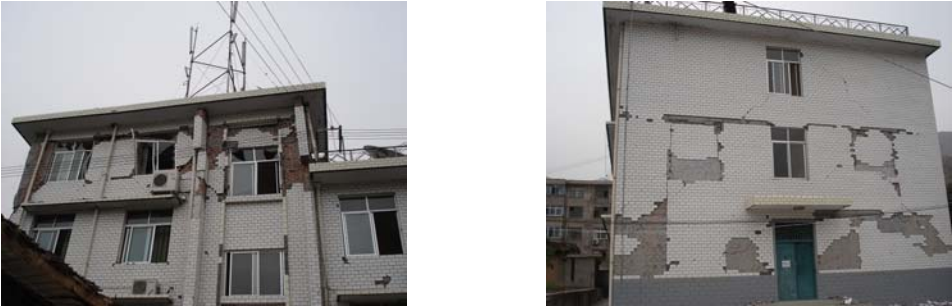
Fig.6 the damages of Meteorological Bureau building in gansu province

The local buildings were designed considering the proper location little, such as the meteorological agency shown in Fig.6, was built on a raised soil, which is 50 meters higher than normal ground. The raised soil has a magnifying effect on seismic responses and the magnifying coefficient can be 1.3-1.5. So the building was damaged seriously not only in the irregular point and but at another side of the building which is shown in Fig.6. So the improper location will bring great hidden dangers to buildings, and it should be avoid in building design.

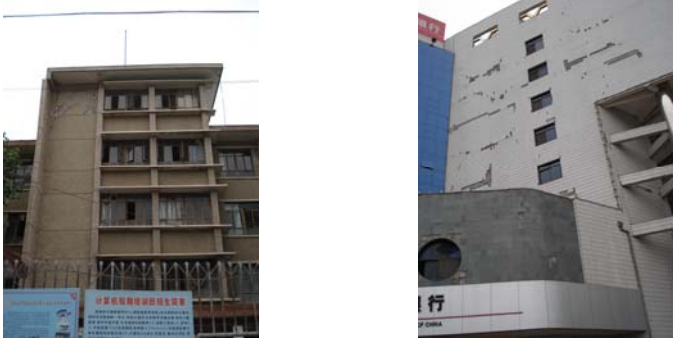
Irregular construction was one type of the seriously damaged buildings in the earthquake. In order to get the novel appearance, many buildings adopted the irregular construction shape, such as split-level building, plane protruding building, and so on. Due to the force transmission pass abrupt change, the change points of the structure are easy to be damaged and lead to the damage of the whole building during an earthquake. The Fig.6 shows a meteorological agency building whose main structures are three layers and local structures are four layers. The three layers part and four layers part were connected together without setting aseismic joint, which leads the top column completely fracture as shown in Fig.6. The top floor of another irregular building was also badly damaged, shown in Fig.7 (a), and the change point of a building cracked in the earthquake, as shown in Fig.7 (b). Because of improper design, the plastic hinges occurred at the end of the columns of irregular building structures in the earthquake, shown as Fig.8. The building damages showed the phenomenon of 'strong beam-weak column', which is opposite with the design goal of 'strong column-weak beam'.

(a) Irregular building in planar direction (b) Irregular building in planar direction and façade

Fig. 7 The damaged irregular buildings

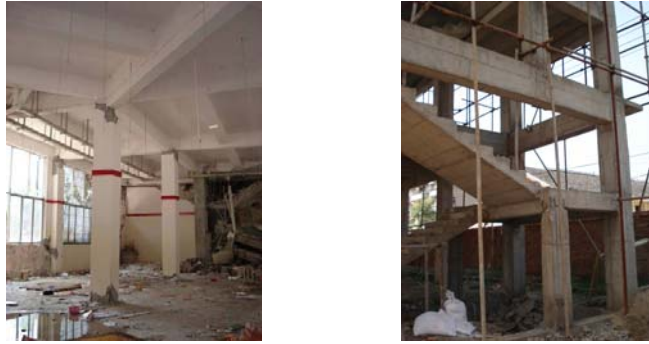
Fig.8 The phenomenon of ‘strong beam-weak column’

For reinforced concrete structures, adopting proper structural measures can ensure that the parts where likely occur plastic hinges will have enough ductility, that is to say, the structures have enough plastic rotational capacity and plastic energy dissipation capacity. For beams, we always expect that the plastic hinges occur at the end of beams, so we should ensure the beam end with good ductility and energy dissipation capacity in design. Except meeting some requirements for calculation, it also needs set a series of structural measures, such as controlling the ratio of reinforcement, the beam with a certain number of compression reinforced bars, the proper quantity and usage of stirrups and the well

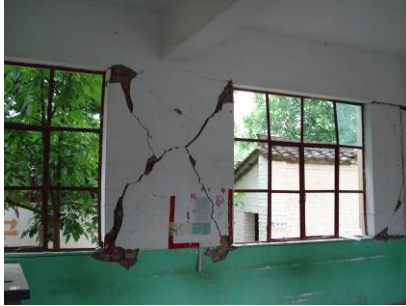
In the investigation of building damages, the large span buildings were also damaged seriously. The Longnan middle school building was an octagonal masonry concrete structure with four floors. The destruction features of the school building with large span showed that the vertical wall of the classroom with cantilevered corridor in one side occurred ‘X’ form shear cracks, as shown in Fig.9. The cross wall of large span classroom occurred diagonal cracks, which was about 45 degrees, as shown in Fig.10.

Fig.9 The ‘X’ form shear cracks of vertical wall

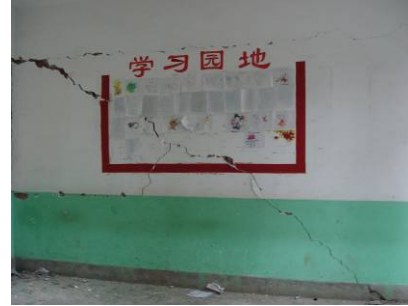
Fig.10 The diagonal cracks of cross wall

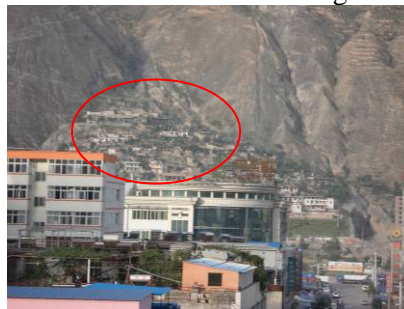
Site investigation also showed that improper location was an important reason of buildings damaged in the earthquake. A large number of buildings were built in bad geological location, such as slope surface area formed by landslide and debris flow as shown in Fig.11.

Fig.11 The buildings built on landslide zone

The site selection of buildings should avoid bad geological location, such as landslide, dilapidation, subsidence, river valley edge, ground fracturing debris flow and seismogenic zone. The foundation should be reinforced according the bearing capacity, deformation characteristics and structural characteristics of buildings to ensure that the building will not be damaged due to instable foundation.

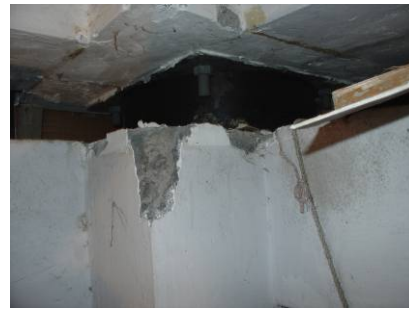
In the earthquake, some buildings were seldom damaged since the adopting of seismic measures. The Fig.12 provided by Gansu civil engineering science research institute shows an apartment building which adopts rubber bearing shown in Fig.13. There did not present any cracks in the apartment building, and also the vase on the air conditioner did not fall. It showed that the proper isolation measures are an effective way to improve the aseismic ability of buildings.

Fig.13 The rubber bearing
