# REPAIR AND RETROFIT OF BRIDGES DAMAGED BY THE 2010 CHILE MAULE EARTHQUAKE

Shigeki UNJOH<sup>1</sup>

**ABSTRACT:** The Chile Maule earthquake with magnitude 8.8 occurred off the coast of the Maule Region of Chile on February 27, 2010. Several bridges were heavily damaged by the strong shaking. Typical and important damage was the rotation and the unseating of superstructures found at skewed bridges supported by rubber pad bearings. Based on such damage experiences, the Chilean Seismic Standards for the Design of Bridges were revised in June 2010. This paper presents the repair and retrofit of bridges damaged by the 2010 Chile Maule earthquake with application of the New Seismic Standards.

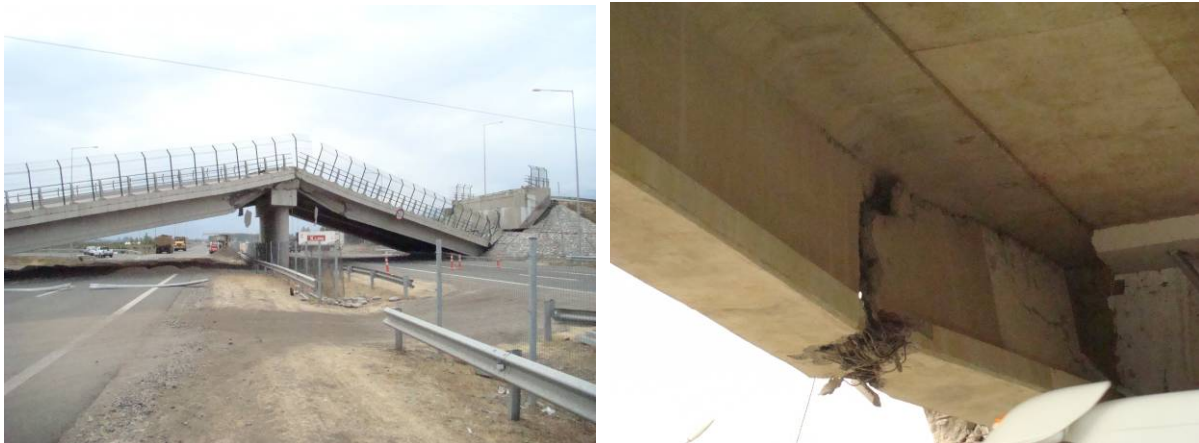
Such damage caused by the in-plane rotation was particularly extensive in skewed bridges. The large rotation motion was developed due to the unbalanced restraint effect by the interaction between superstructure and abutment. The bridges suffered unseating of superstructures from substructures and/or the significant damage at the end of concrete girders. Photo 1 shows a typical collapse of superstructure and damage of concrete girder.

Photo 1 Typical Collapse and Damage of Concrete Girders during 2010 Chile Maule Earthquake  
(Courtesy of Chilean Ministry of Public Works)

(Left: Collapse of Superstructures due to Rotation, Right: Damage at End of Concrete Girder)

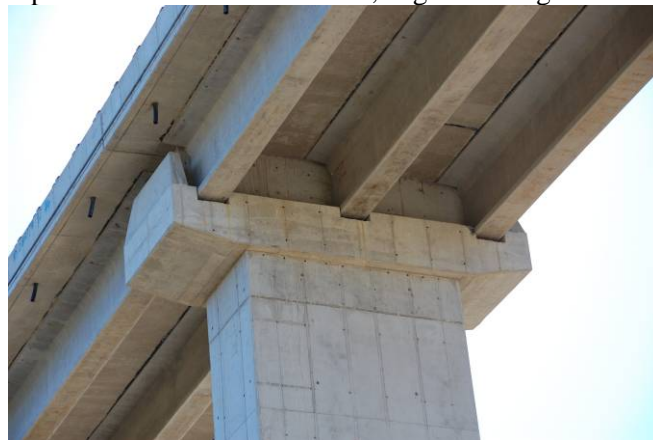
On the other hand, the bridges designed based on the original Chilean design practice including the placement of end diaphragms and lateral stoppers behaved very well even against the strong shaking as shown in Photo 2. It should be noted here that some bridges were damaged in coastal region where soil instability including soil liquefaction and lateral spreading was observed.

Photo 2 Bridges designed by Original Chilean Practice with End Diaphragms  
and Lateral Stopper Mechanism

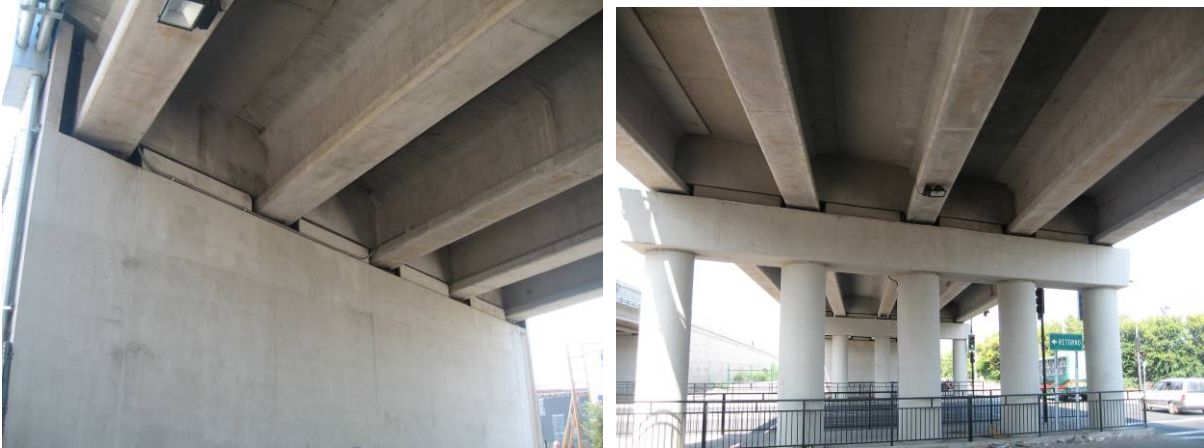
During the earthquake, the acute corner of the superstructures was offset nearly 1.5-2.0m in the transverse direction and unseated from the abutments. There was almost no significant damage to abutment walls and piers.

Photo 3 Repair and Retrofit for Mira Flores Overpass  
(Left: Lateral Stopper at Abutment, Right: Lateral Beam and Lateral Stopper at Pier)

To repair the bridges, the collapsed superstructures were replaced by new PC girders. Based on the new seismic standards, the lateral beams to connect adjacent girders were placed at the girder ends and the concrete block type stoppers were installed between the girders at the cap beam. Photos 3 and 4 show the repaired abutments and piers of Mira Flores overpass and Lo Echeveres overpass, respectively. It should be noted here that the widening of the seat width as well as the installation of the stoppers was also made at the abutment of Lo Echeveres overpass.

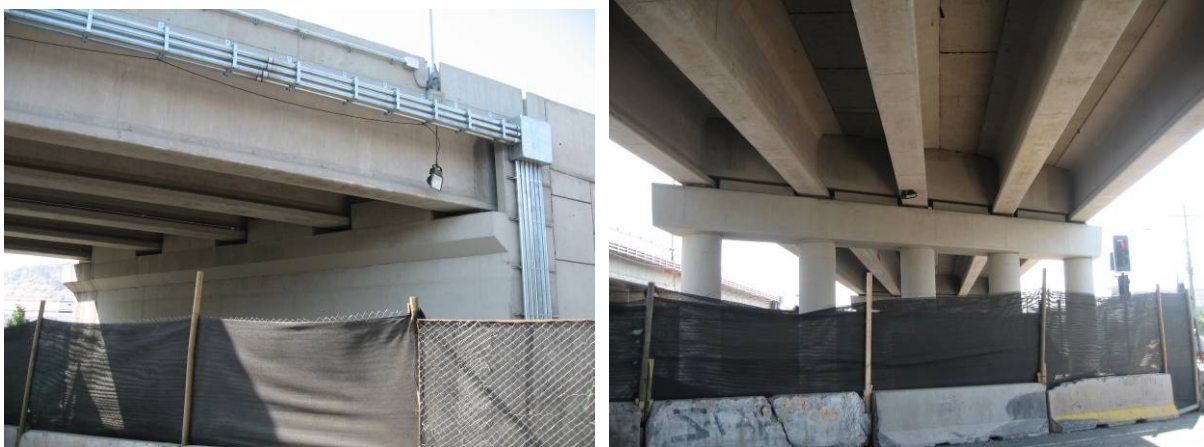
Photo 4 Repair and Retrofit for Lo Echeveres Overpass  
(Left: Lateral Stopper at Abutment, Right: Lateral Beam and Lateral Stopper at Pier)

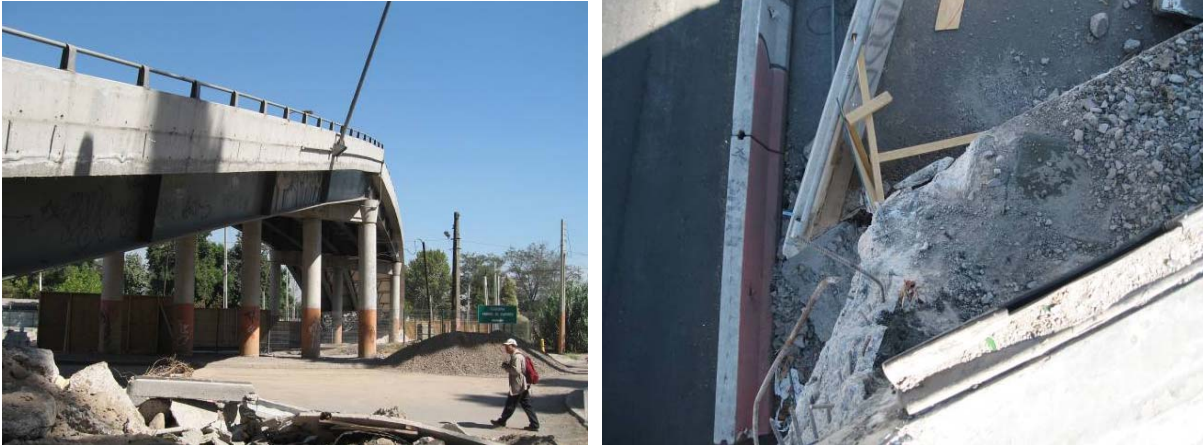
Photo 5 shows the collapse of Antonio Matta Bridge. The bridge is on the Manuel Antonio Matta Street which overpasses the Linea de Ferrocarril Railroad. Superstructure consisted of 3-span simply-supported steel girders and the continuous slab at joints. The skewed angle was about 50 degrees. The piers were reinforced concrete multi-column bent. The steel girders were supported by rubber pad bearings.

During the earthquake, a whole bridge was rotated and the large transverse displacement was developed at both ends, then the superstructures were unseated from their abutments. The displacement in

the transverse direction at the abutment was about 90cm. In contrast, there was almost no damage to the reinforced concrete columns. The collapse mechanism is similar to that found at Mira Flores and Lo Echeveres overpasses.

Photo 5 Collapse of Antonio Matta Bridge  
(Left: Side View, Right: Skewed Seat at Abutment)

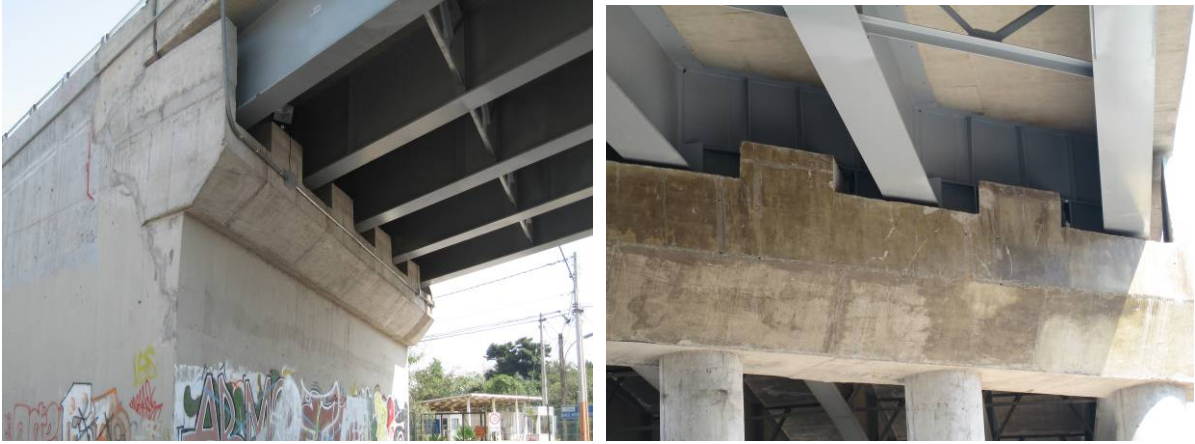
Photo 6 Repair and Retrofit for Antonio Matta Bridge  
(Left: Abutment with Lateral Stopper, Right: Pier Cap with Lateral Stopper)

Photo 6 shows the completion of repair for Antonio Matta Bridge. The existing steel girders were reused. At the abutments and piers, the stopper structures using concrete blocks were provided and the seat width was widened at the abutments as well.

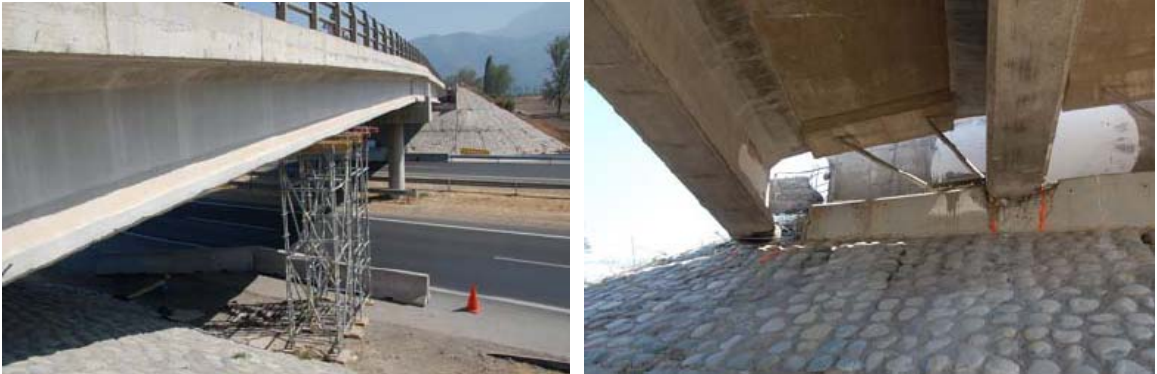
During the earthquake, Las Mercedes bridge rotated around the center pier resulting in transverse displacement around 1.0-1.4m at both ends. Photo 7 shows the unseated PC girders at the abutment. There was evidence of the collision between the end of a deck slab and the abutment parapet wall at both ends.

Photo 7 Damage of Les Mercedes Bridge  
(Left: Side View, Right: Lateral Offset at Abutment)

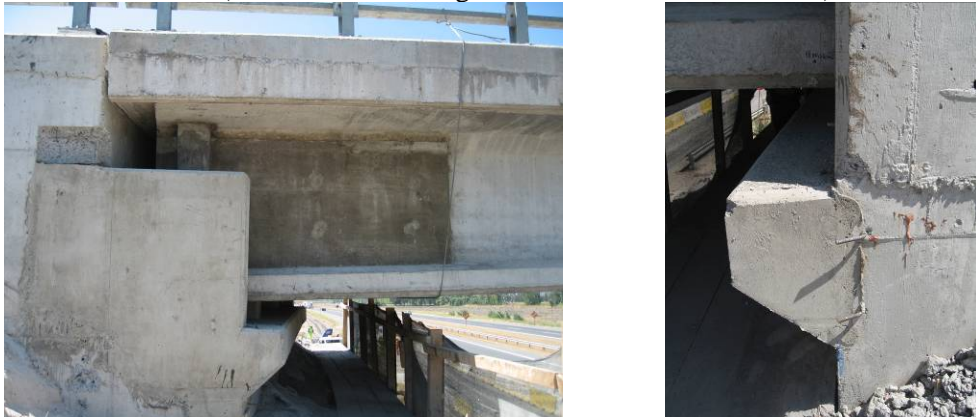
Photo 8 Repair and Retrofit for Les Mercedes Bridge (1)  
(Left: Strengthening of PC Web, Right: Widening of Seat Width at Abutment)

Photos 8 and 9 show the repair and retrofit of Les Mercedes bridge. Both the end sections of concrete girders were repaired and strengthened by adding reinforced concrete to increase the lateral shear strength of the web and flange. Also, lateral beams to connect adjacent girders were placed at the girder ends. The seat width was widened by adding the reinforced concrete at the abutments, and the lateral stoppers made of concrete block were installed at both abutments and pier cap.

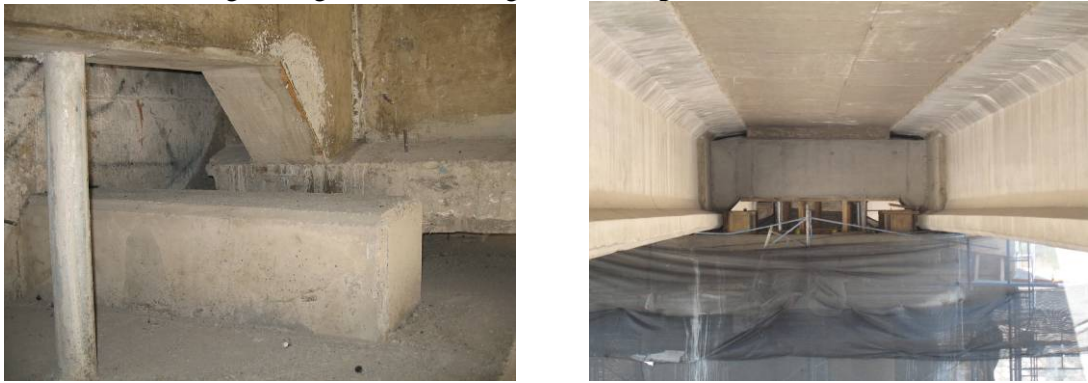
Photo 9 Repair and Retrofit for Les Mercedes Bridge (2)  
(Left: Lateral Stopper at Abutment, Right: Lateral Beams and Lateral Stoppers at Pier)

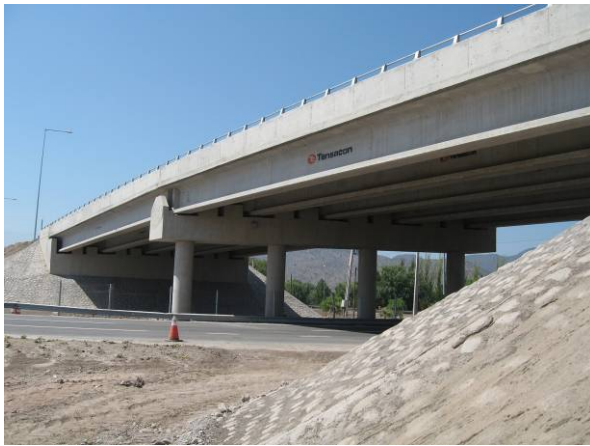
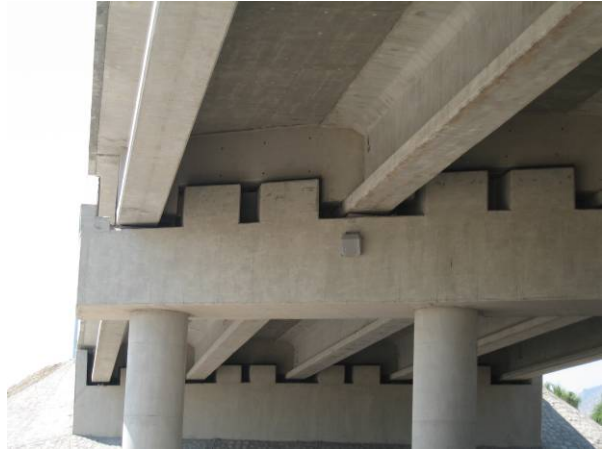
Photo 10 Repair and Retrofit for Los Pinos Bridge  
(Left: Side View, Right: Lateral Beams and Lateral Stoppers at Pier Cap)

The similar repair and/or retrofit methods were employed for several overpasses on Highway Route 5. Photo 10 shows Los Pinos overpass. The lateral beams and lateral stopper were installed at the abutments and piers. It should be noted here that Chilean MOP also employed the strengthening method for the abutments which were constructed on soft soil ground condition. Photo 11 shows Azufradero bridges as an example of the strengthening method for the abutment. Removing the backfill soils, and vertical walls were added to increase the stiffness and stability of abutment walls and foundations.

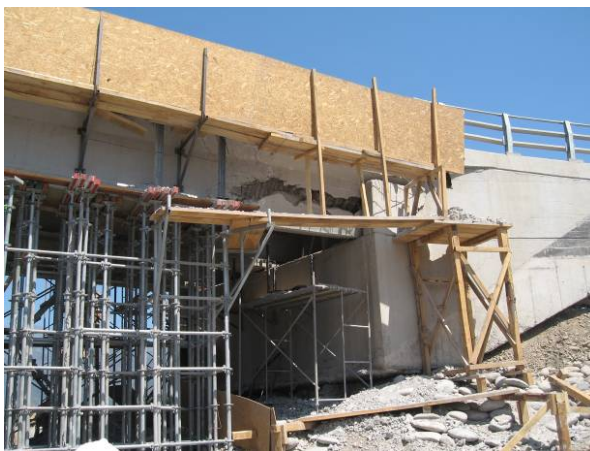
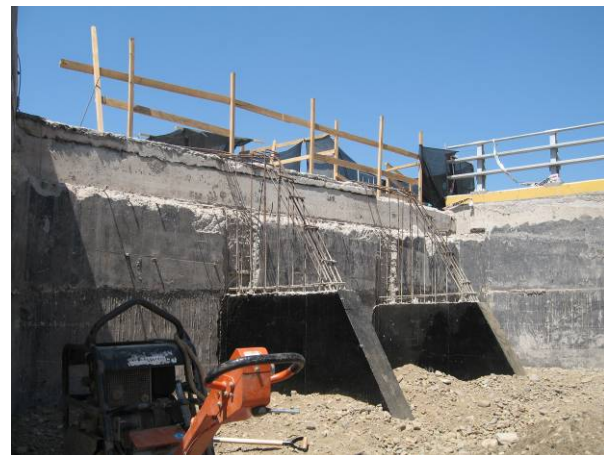
Photo 11 Repair and Retrofit for Azufradero Bridge  
(Left: Damage to Girders and Abutment, Right: Stiffening Wall at Backside of Abutment)

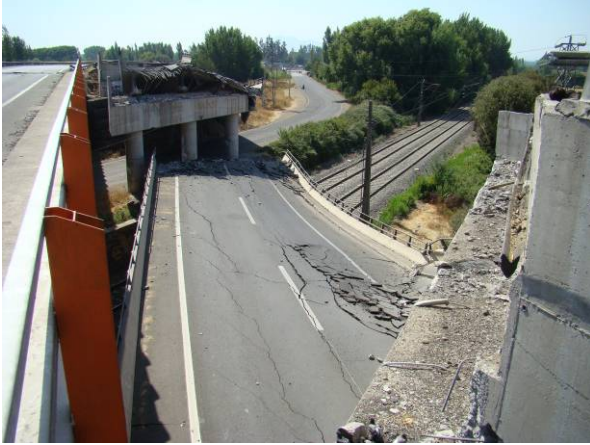
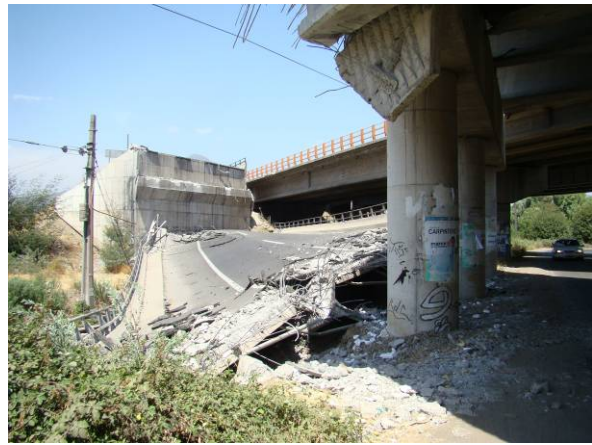
One of the typical examples of collapse due to the rotation of skewed bridges was Hospital overpass on Highway Route 5 at the crossing over railways and a local road. It was a 2-span simply-supported PC girder bridge with deck slab which connected two spans. There were two overpasses to the north-bound and to the south-bound. The north-bound overpass collapsed as shown in Photo 12, whereas the south-bound overpass suffered almost no damage. The south-bound overpass was relatively old and designed based on the original Chilean design practice, in contrast, the north-bound overpass was recently designed bridge. It should be noted here the skewed angle of the collapsed north-bound overpass was 45 degrees, on the other hand, the south-bound overpass was a straight bridge. Both abutments did not suffer damage and pier suffered only minor flexural cracks at the columns.

Photo 12 Collapse of Spans at Hospital Overpass

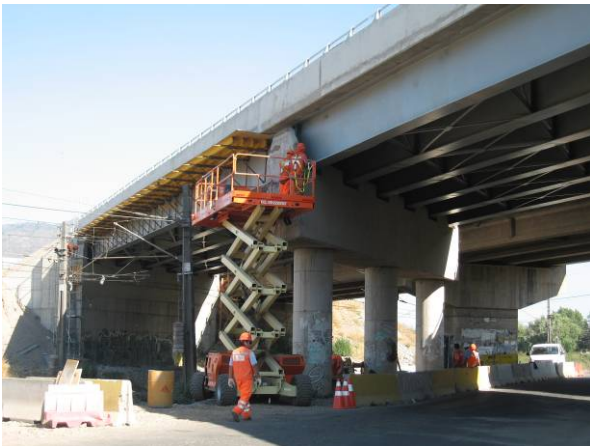
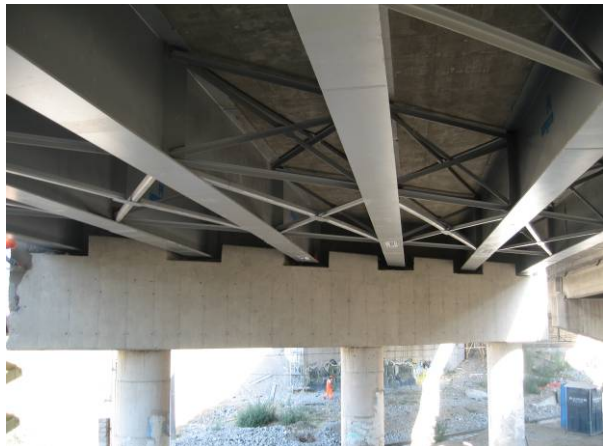
Photo 13 Reconstruction and Retrofit of Hospital Overpass  
(Left: Side View, Right: Lateral Stopper at Cap Beam of Pier)

Photo 13 shows the reconstruction of Hospital overpass. The collapsed concrete girders were replaced by new steel girders. The end lateral beams were provided to connect adjacent girders and the lateral stoppers were provided at the abutments and piers.

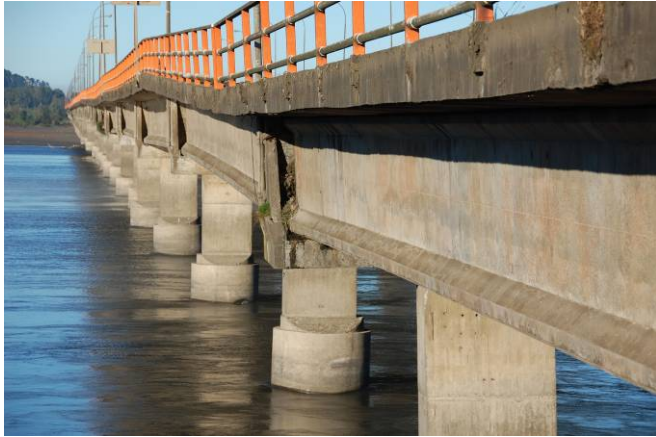
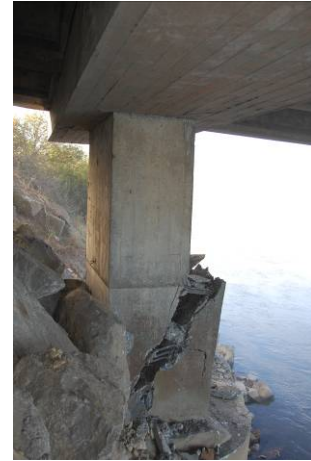
Juan Pablo II bridge is a 2,310m long 70-span simply-supported bridge which crosses over Biobio river in Concepcion city. The concrete superstructures were supported by reinforced concrete piers. Extensive settlement as large as 0.5m occurred at pier foundations and 3 reinforced concrete columns and a lateral cap beam failed in shear as shown in Photo 14. The settlement of pier foundations was estimated to be developed due to the insufficient bearing capacity as well as the effect of soil liquefaction.

Photo 14 Damage of Juan Pablo II Bridge  
(Left: Settlement of Pier Foundation, Right: Shear Failure of Pier Columns)

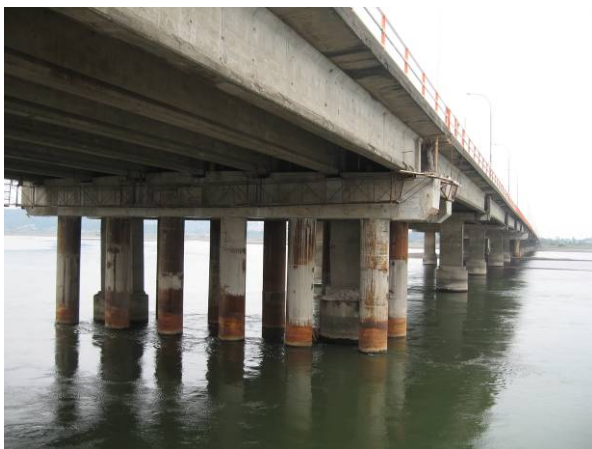
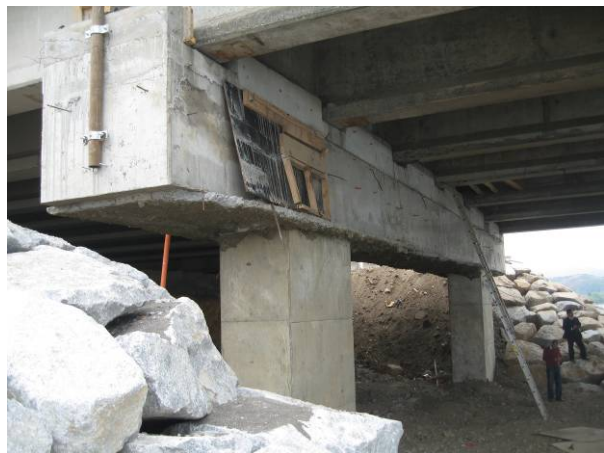
Photo 15 Repair and Retrofit of Juan Pablo II Bridge  
(Left: Additional Piles at settled Piers, Right: Replaced Pier Columns and Lateral Stopper Structures)

Photo 15 shows the repair and retrofit of Juan Pablo II bridge. Additional piles were placed at the both sides of settled piers to support the superstructures. The failed reinforced columns in shear were reconstructed. The lateral stoppers were also provided at the pier cap.

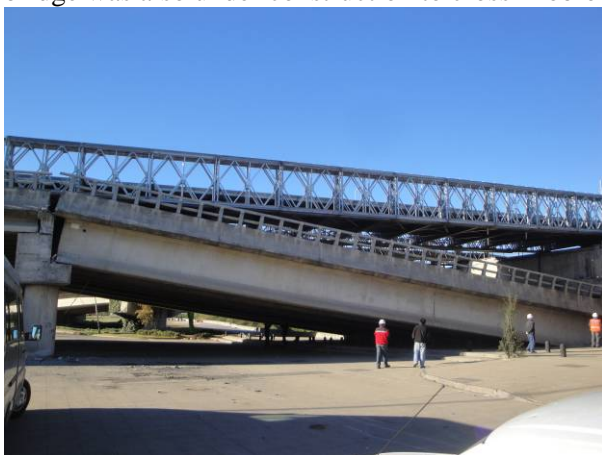
Similar to Juan Pablo II bridge, Llacolen bridge is a critically important bridge crossing Biobio river in Concepcion city. Main spans in the river section did not collapse, but an approach span consisting of PC girders collapsed as shown in Photo 16. Short seat support width resulted in unseating of the approaching span against large longitudinal displacement caused by the strong shaking. Photos 17 and 18 show the replaced span of Llacolen bridge and the retrofit. Collapsed concrete girders were replaced by the steel girders which were connected by lateral beams at both ends.

Photo 16 Collapse of Llacolen Bridge

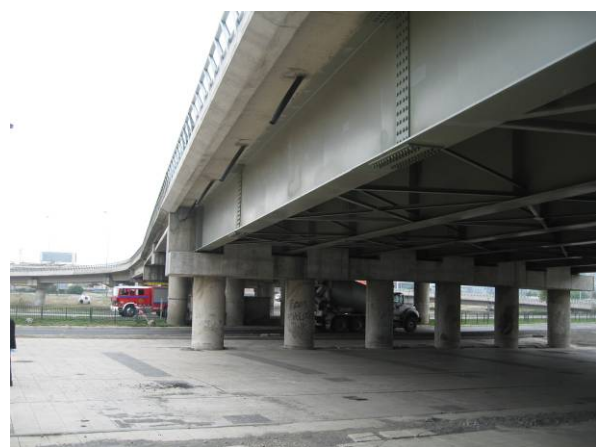
Photo 17 Replaced Collapsed Span of Llacolen Bridge

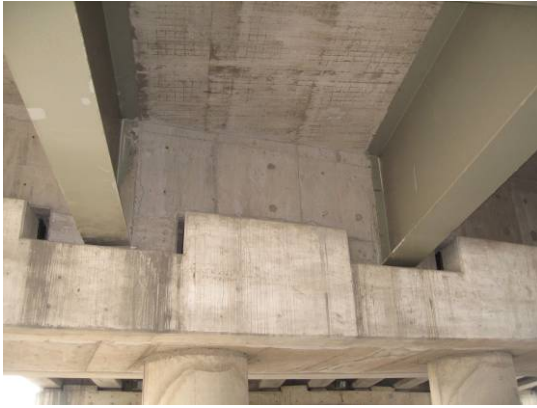
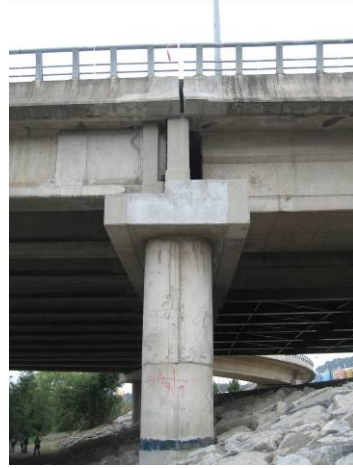
Photo 18 Repair and Retrofit for Llacolen Bridge  
 (Left: Placement of Lateral Beams and Lateral Stoppers, Right: Widening of Pier Cap and Retrofitted Column by Fiber-Sheet Jacketing)

The lateral stoppers were provided at the pier caps. The seat supports was also widened by adding reinforced concrete. Some of the reinforced concrete columns were jacketed by fiber sheets to repair the flexural cracks and to enhance the shear and ductility capacity. It should be noted that a new bridge was also under construction to cross Biobio river in Concepcion city as shown in Photo 19.

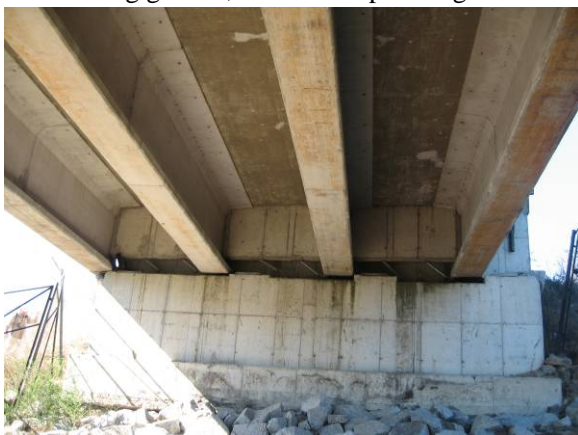
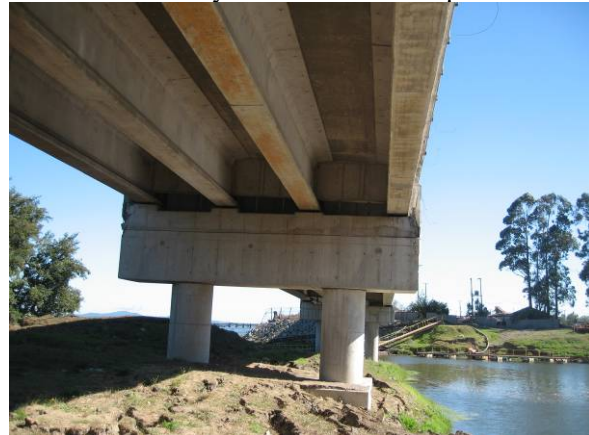
La Mochita bridge is a 4-span simply-supported PC girder bridge which crosses a waterway along the BioBio river. The piers were two column bents. During the earthquake, the large lateral displacement of the superstructures as large as 85 cm was developed as shown in Photo 20. Several cracks were found on the ground surface around the foundations. The foundations were estimated to move laterally because of the lateral spreading of the surrounding soils. Since sand boiling was found at several locations on the surrounding ground, the lateral spreading was estimated to be caused by the effect of soil liquefaction.

Photo 20 Lateral Displacement of Superstructure and Foundations at La Mochita Bridge

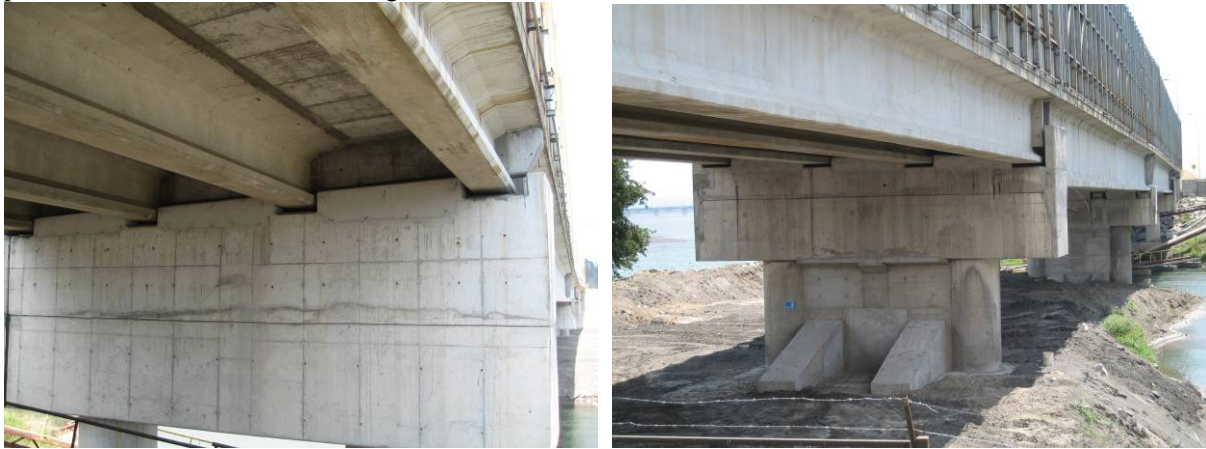
Photo 21 Repair and Retrofit for La Mochita Bridge  
(Left: Pier Cap with Lateral Stopper, Right: Strengthening of Foundations by Placing New Piles)

Photo 21 shows the repair and retrofit for La Mochita bridge. The displaced deck was moved back to the original position and the lateral stoppers were installed at the top of abutments and piers. The two column bents were strengthened to wall type columns and new piles to increase stability were placed and connected the existing columns.
