## PERFORMANCE OF HIGH RISE BUILDINGS UNDER THE FEBRUARY 27<sup>TH</sup> 2010 CHILEAN EARTHQUAKE

René LAGOS<sup>1</sup>, and Marianne KUPFER<sup>2</sup>

**ABSTRACT:** During the earthquake (Mw 8.8), high rise shear wall buildings in the affected area performed well. Less than 1% of these were severely damaged or had to be demolished. Nevertheless, the earthquake produced significant structural damage on some new high rise shear wall buildings in Santiago, Viña del Mar, Chillán and Concepción. Lateral loads systems and design criteria commonly used in concrete buildings in Chile are reviewed. Explanations for the successful seismic performance of concrete buildings and lessons learned from the observed failures are discussed.

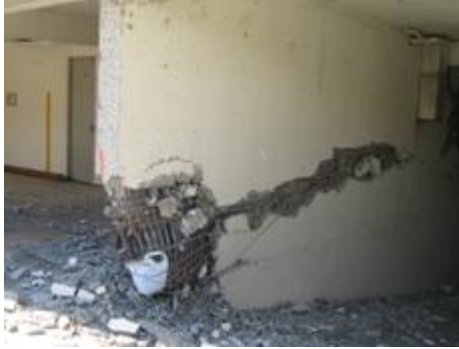
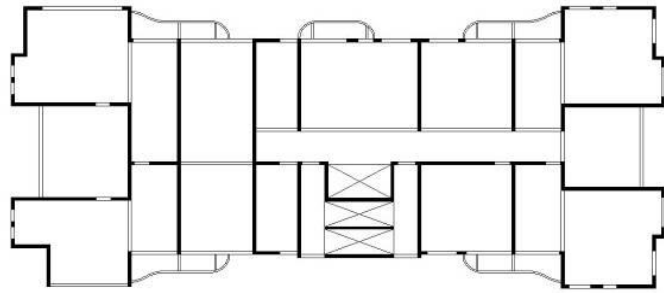
Figures 11 and 12 show typical plan configurations of damaged buildings (Bonelli, 2010). The architecture of this buildings present similar characteristics such as a central corridor with transverse walls of rectangular L or T shape. The walls are continuous from top to foundation. At street and underground parking levels the walls frequently present penetrations or length reduction to facilitate parking. This represents a common structural irregularity on modern high rise buildings.

Fig. 11 Building B, Concepcion: Compression, tension and shear failure on first and second floors

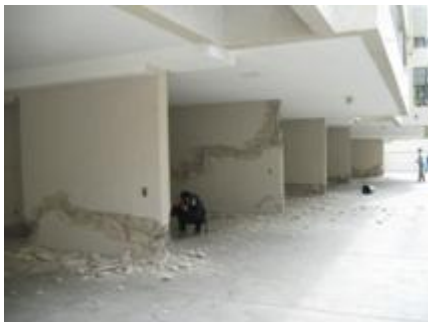
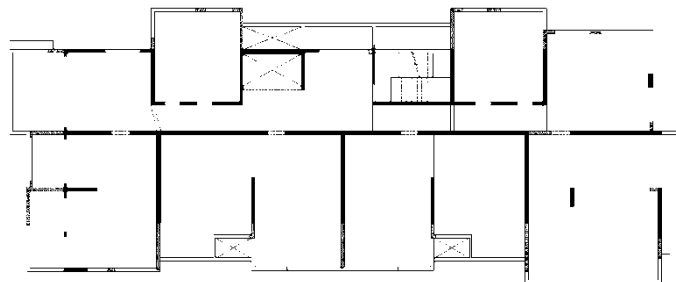
Fig. 12 Building C, Viña del Mar: general wall failure at first floor: 40 cm out of plumb at the top.
