THE CHARACTERISTICS OF THE TRIGGERED 2011 VAN-EDREMIT EARTHQUAKE AND INDUCED DAMAGE

Ömer AYDAN¹, Halil KUMSAR², Reşat ULUSAY³, Onur KÖSE⁴ and Mehmet ÇELEBİ⁵

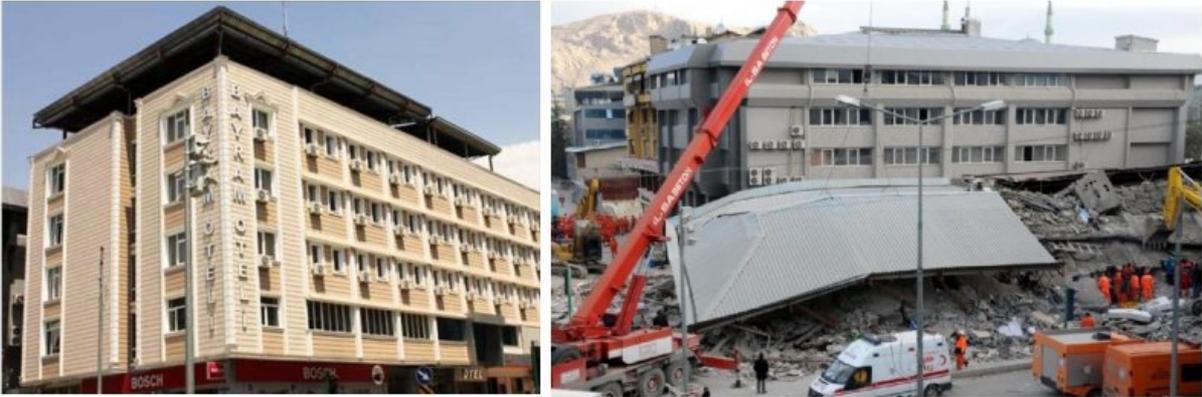
This earthquake caused the collapse of the 30 reinforced concrete buildings, most of which had already suffered substantial damage during the 23 October 2011 earthquake (Photos 1, 2 and 3). Fortunately, 23 of the collapsed buildings had been evacuated due to the damage caused by the earlier

earthquake. However, two hotel buildings were open during this second earthquake and some of the people staying there lost their lives. This earthquake also caused additional damage to some buildings. The collapsed hotels had cracks following the October 23, 2011 earthquake and they were cosmetically repaired. The authors noticed such non-structural repairs in the City of Van during their reconnaissance for the October 23, 2011 earthquake (Photo 4).

Photo 1 Views of Bayram Otel before and after the Van-Edremit earthquake (Anadolu Ajansı, 2011)

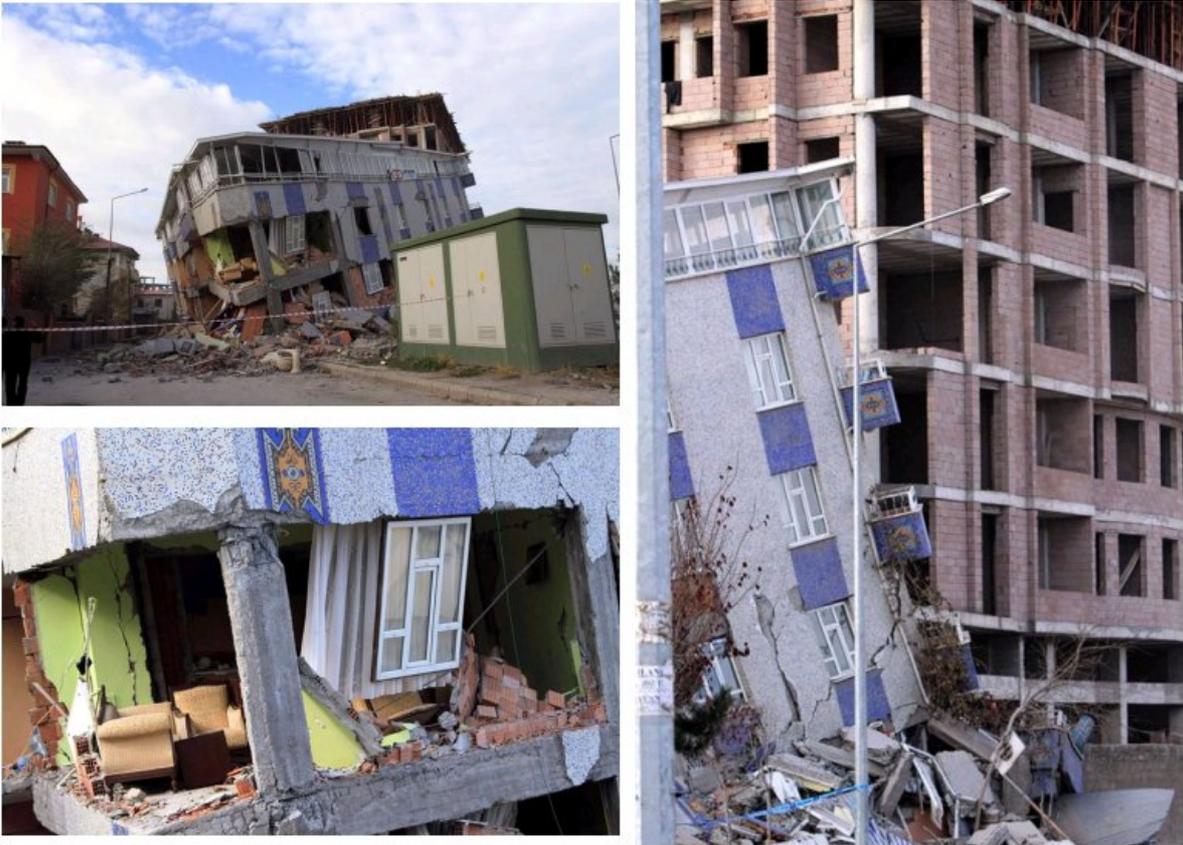
Photo 2 Views of a collapsed reinforced concrete building in Van (Anadolu Ajansı, 2011)

The major causes of the heavy damage to reinforced concrete buildings were basically similar to the previous observations during previous earthquakes in Turkey:

- (a) Quality of construction materials,
- (b) Lack of implementation of design codes (bars, stir-ups, proper column-beam connections, tie-beams, good foundation etc.),
- (c) Existence of soft-floor (weak-floor),
- (d) Pounding,
- (e) Lack of ductility,
- (f) Poor integrity of RC frame with in-fill walls,
- (g) Quality of workmanship.
- (h) Poor ground conditions.

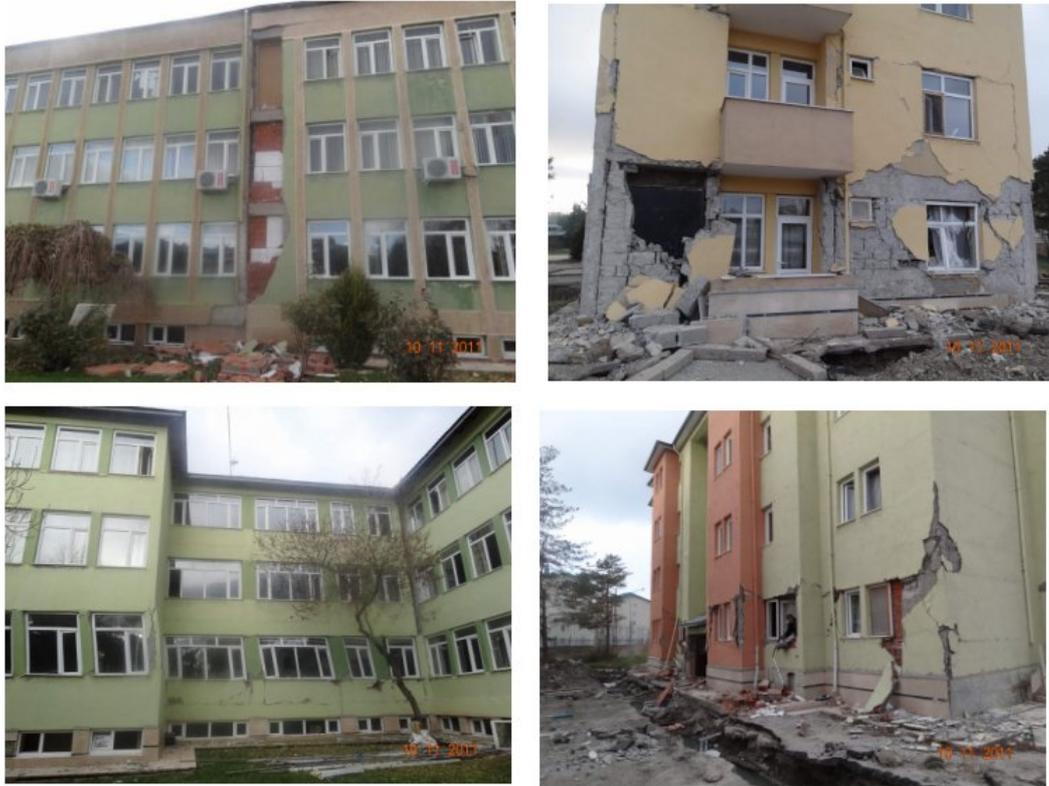
Photo 3 Views of heavily damaged reinforced concrete buildings of DSI in Van

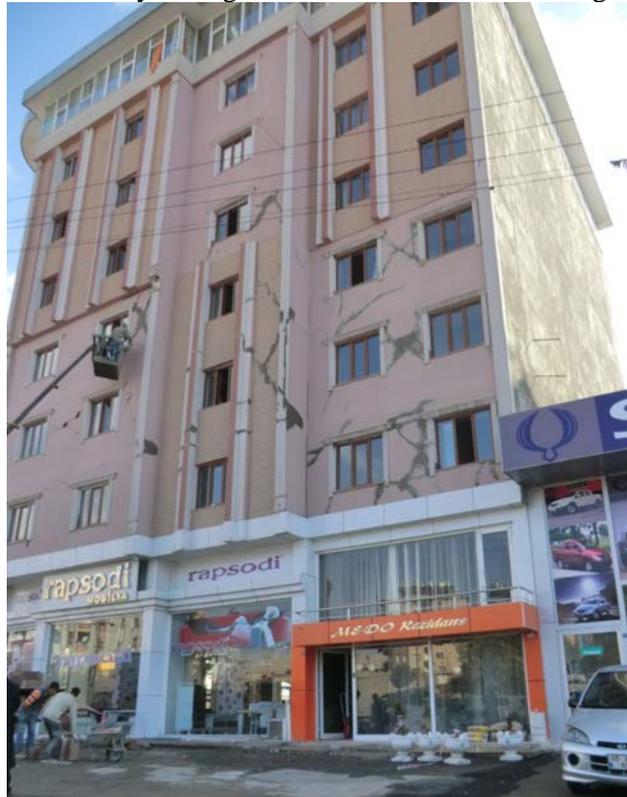
Photo 4. Cosmetic repairs applied to a damaged RC building in Van on November 5, 2011 after the Van-Erciş earthquake

Furthermore, cosmetic non-structural by re-plastering of cracked beams, columns, infill-walls and beam column connections had disastrous effects. Similar problem was observed in buildings damaged by the 1999 Kocaeli earthquake in Düzce during the 1999 Düzce earthquake (Aydan et al., 2000a and 2000b).

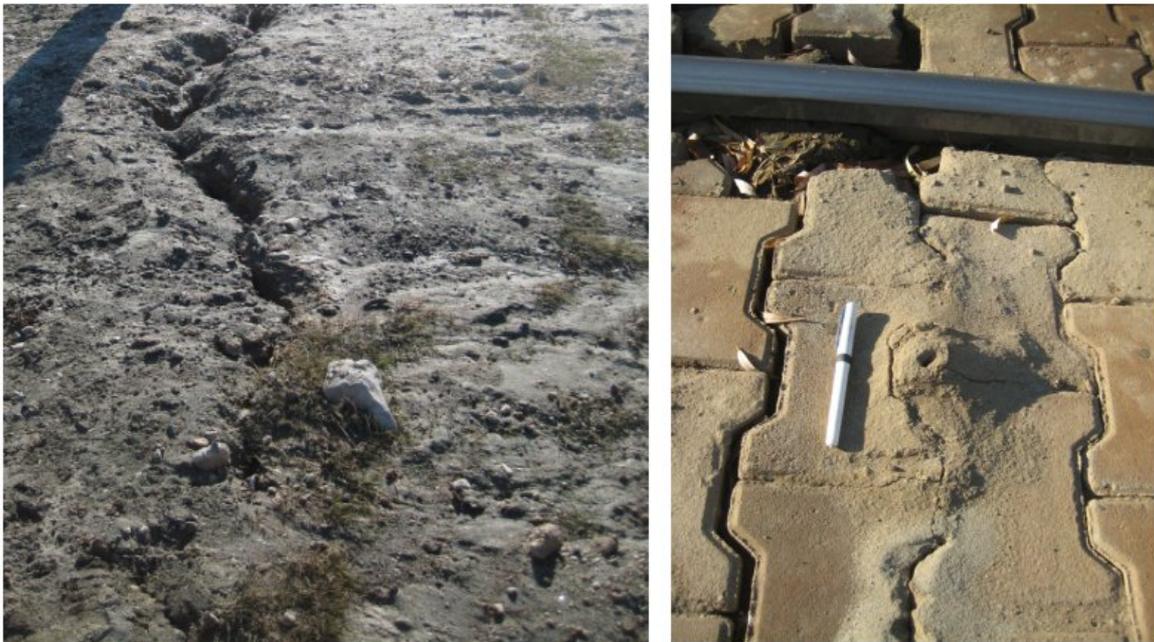
This earthquake also caused some ground liquefaction along the Van lakeshore (Photo 5) and the ground liquefaction again occurred at the Port of Van, where the ground liquefaction was also observed following the 23 October 2011 earthquake. This is probably the smallest magnitude earthquake to cause liquefaction in Turkey so far. Fig. 7 shows the grain size distribution of the boiled sand, which is within the most liquefiable bounds with high percentage of fine content.

Photo 5 Views of boiled sand in Van port due to the M5.6 earthquake

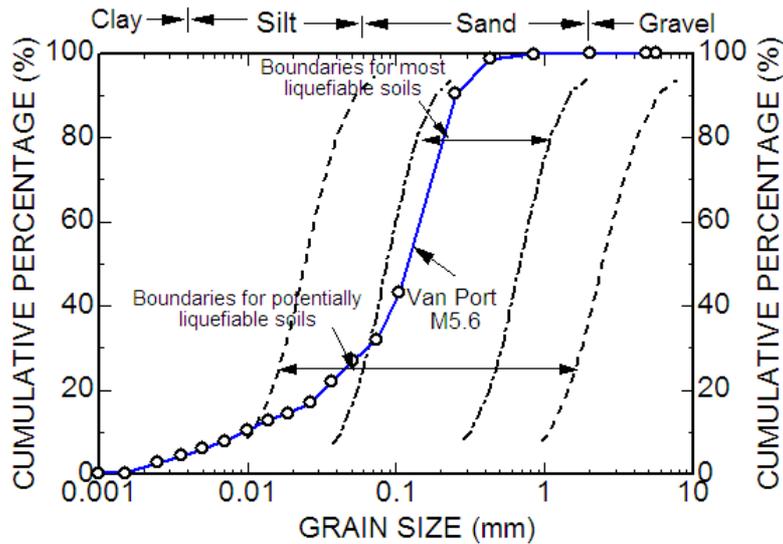
Fig. 8 Grain size distribution of boiled sand sample obtained from Port of Van immediately after the M5.6 earthquake
