THE CHARACTERISTICS OF SEISMIC, STRONG MOTION AND STRUCTURAL DAMAGE OF THE 2011 VAN-ERCIŞ EARTHQUAKE

Kazuo KONAGAI¹, Reşat ULUSAY², Halil KUMSAR³, Ömer AYDAN⁴ and Mehmet ÇELEBİ⁵

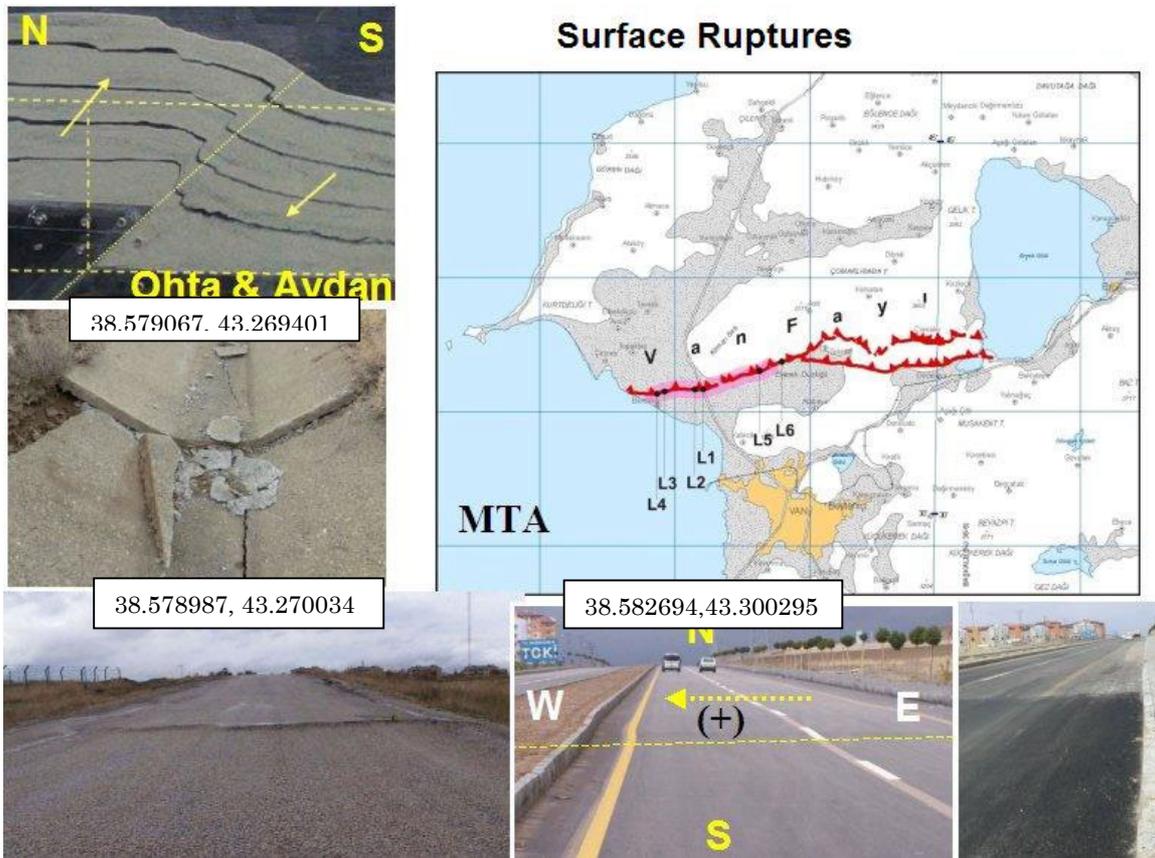
Photo 1 Views of surface rupture along the fault trace (base map from Emre et al., 2011)

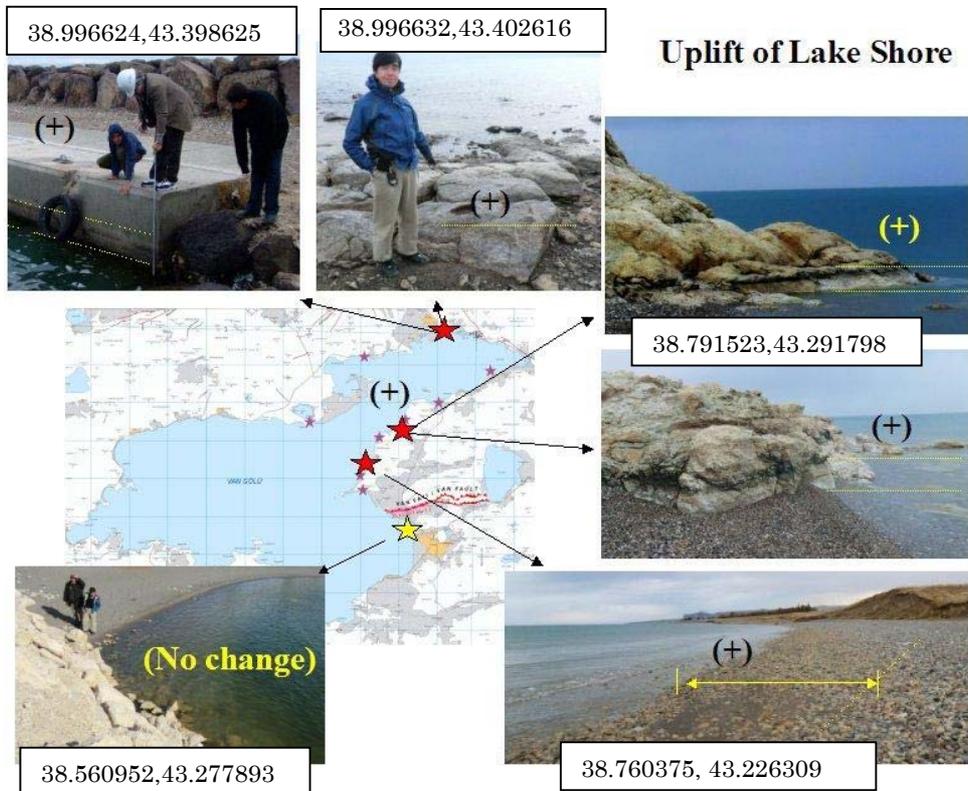
Photo 2 Views of uplift of shoreline at several localities along Van Lake

One of the typical effects of this earthquake is a change in the shoreline of Van Lake as seen in Photo 2. Similar observations were also reported for Erçek Lake (ERD, 2011). The measurements at certain locations on the lakeshore at the northern and eastern parts of the earthquake region by the authors during reconnaissance indicated that uplift of the recent shoreline ranging between 15 and 35 cm has occurred.

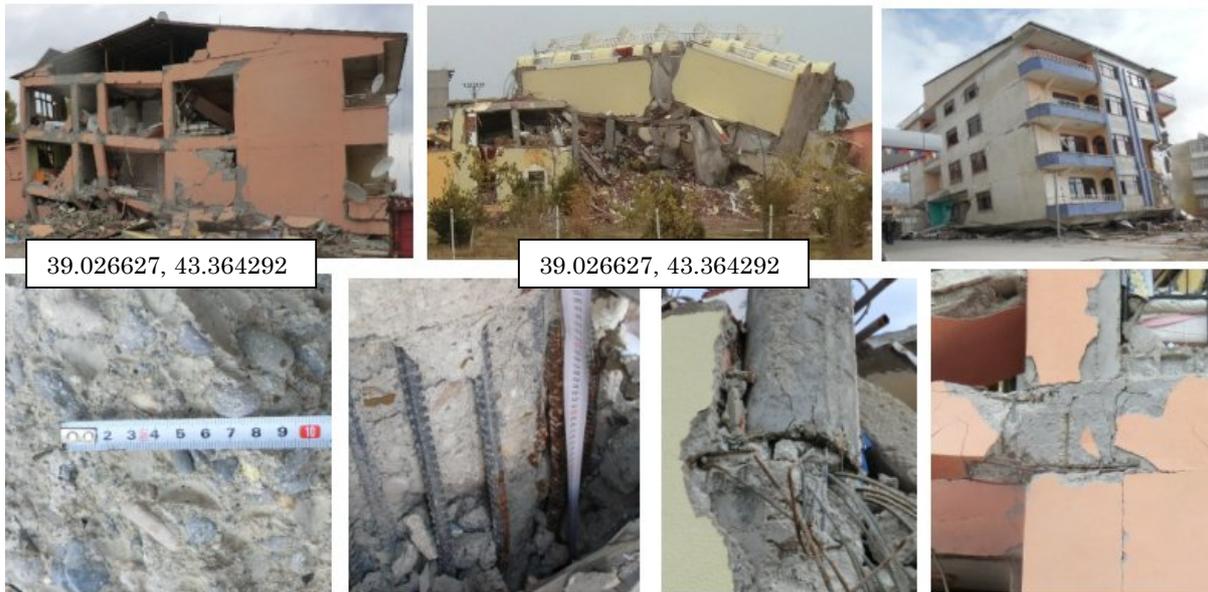
The earthquake resulted in heavy damage to buildings and significant casualties in this province, particularly in Erciş. A number of 6-8 stories RC buildings collapsed particularly in Erciş and Van (Photo 3). The major causes of the heavy damage to reinforced concrete buildings were basically similar to the observations in previous earthquakes such as poor quality of construction materials, lack of implementation of design codes, existence of soft-floor (weak-floor), pounding, lack of ductility, poor integrity of RC frame with in-fill walls, poor quality of workmanship and poor ground conditions. It should be added that site effects most likely contributed to alteration of frequency characteristics of the ground motions to adversely affect the buildings. There are available borehole logs but the depths of the logs are shallow and the depth to bedrock is not known.

Photo 3 Views of collapsed RC buildings and detailing of RC elements

As a result of the observations, it is strongly suggested that the construction practices in earthquake prone areas of Turkey be changed from that of reinforced concrete moment framed system to reinforced concrete shear-wall system. Such a change would reduce drift ratios and prevent collapse of buildings, thus averting loss of lives and property.

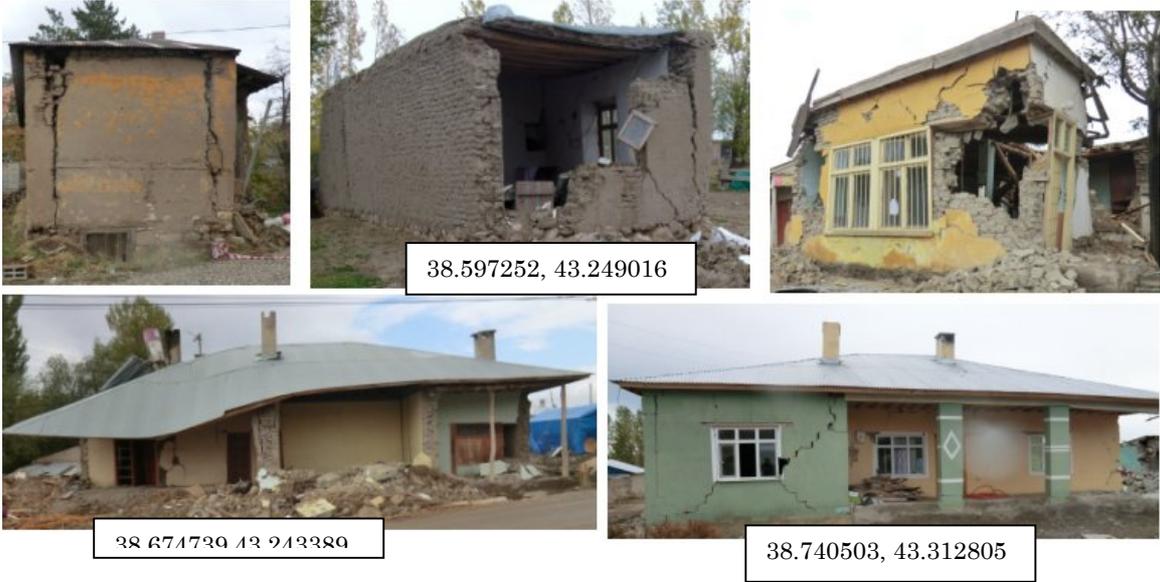
Buildings in rural areas and villages are of brick masonry or stone masonry type (Photo 4). When these buildings are constructed with the consideration of having a mat concrete or firm base, light roof, hatıl (timber or concrete confining beams) at certain intervals, lime (cement)-based bonding, utilization of saman (straws) in kerpiç (adobe) bricks and plastered walls, the damage was none or slight. Such buildings performed very well even some permanent ground deformation occurred beneath their foundations. The bridges are generally constructed using cast-in place technique. The earthquake caused very little damage to bridges. The damage was due to the settlement of piers and settlement and lateral deformation of approach embankments (Photo 5).

Photo 4 Views of heavily damage brick masonry buildings

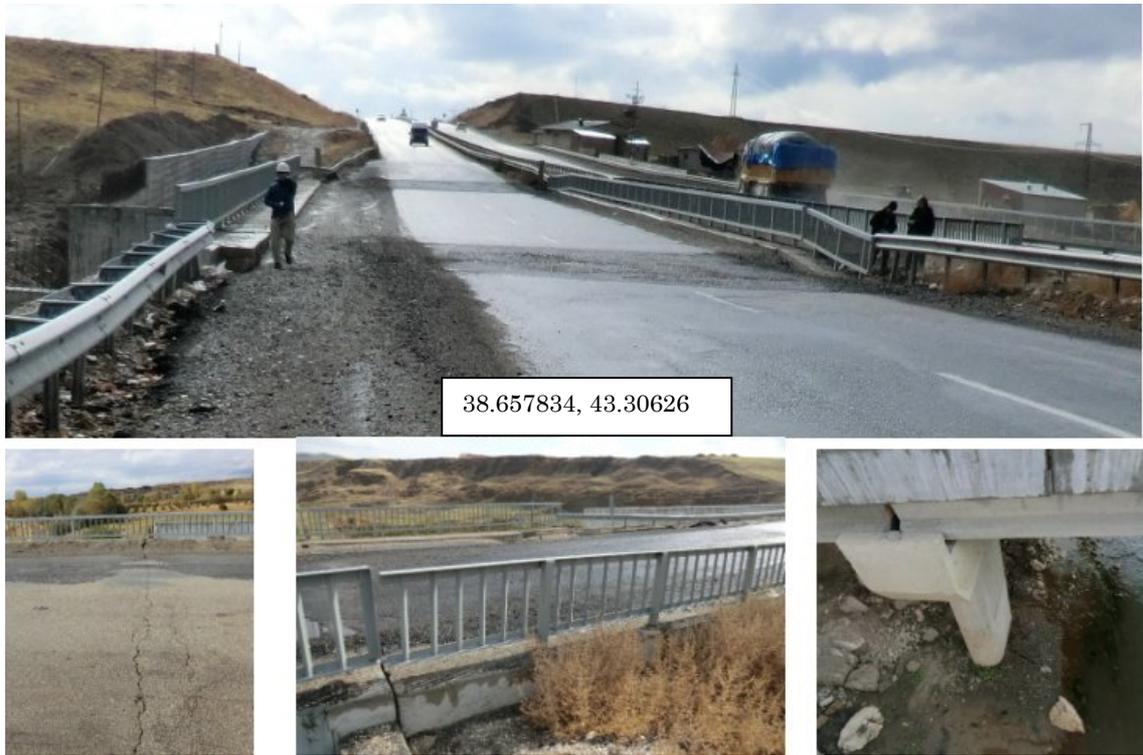
Photo 5 Views of slightly damaged Tirleşin bridge over Karasu on Van-Ağrı Highway

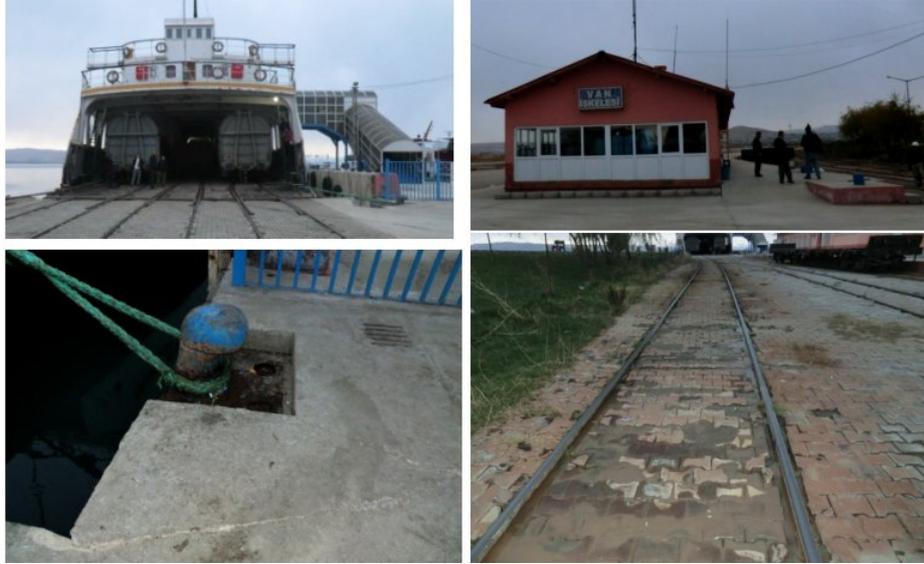
Some ground liquefaction occurred at Van port and there were some slight cracking to RC components and deformation of railways (Photo 6). Nevertheless, the port was functional.

Photo 6 Views of slightly damaged Van port (all photos at around 38.516441, 43.308368)
