THE CHARACTERISTICS OF GEOTECHNICAL DAMAGE BY THE 2011 VAN-ERCIŞ EARTHQUAKE

Reşat ULUSAY¹, Halil KUMSAR², Kazuo KONAGAI³, and Ömer AYDAN⁴

ABSTRACT: An earthquake with a moment magnitude of 7.1 occurred at 13:41 on local time on October 23, 2011 in the Van province of the Eastern Turkey. Brief outlines of geology, hydrogeology and geotechnical conditions in Erciş town and Van City and along the shore of Van Lake are first given. Then, observed ground liquefactions, associated ground deformations, sand boils and their characteristics are presented. In addition, slope and embankment failures are also presented and their characteristics are compared with available approaches. Finally the effects of geotechnical events on structural damages are given and discussed.

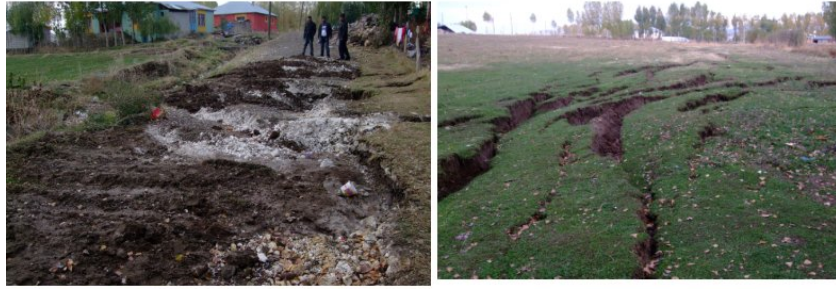
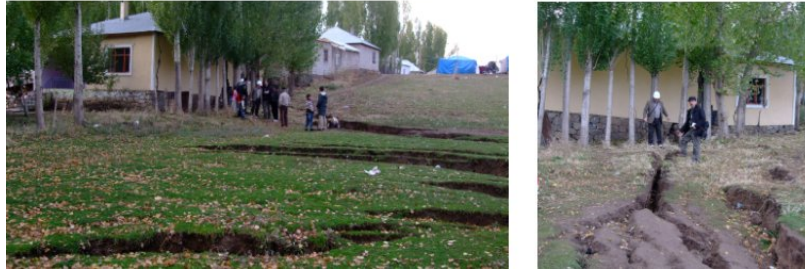
(a) Liquefaction and lateral spreading at Çelebibağı (Erciş)

Aydan et al. (2008) proposed an approach to estimate amount of lateral spreading using the strong motion records. A sample computation was carried out for different base inclination of liquefiable layer using the records taken at Muradiye strong motion station and results are shown in Fig. 8. The amount of lateral spreading is about 69 cm for an inclination of 3% while it becomes about 19 cm for the inclination of 1%. As the inclination of liquefiable layer was probably more than 3% at Çelebibağı (Erciş) as seen in Photo 1a, these computational results can explain the possible reason for large deformation at that locality.

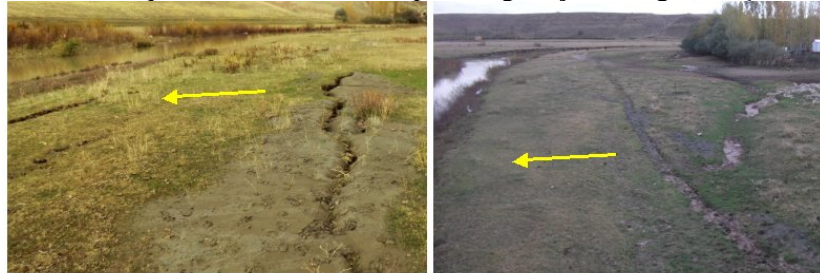
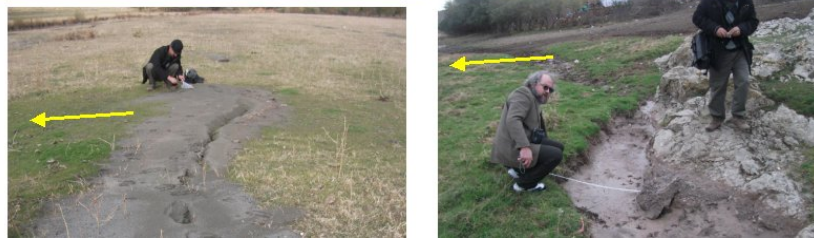
(b) Liquefaction and lateral spreading at Topraktaş village (Karasu plain)

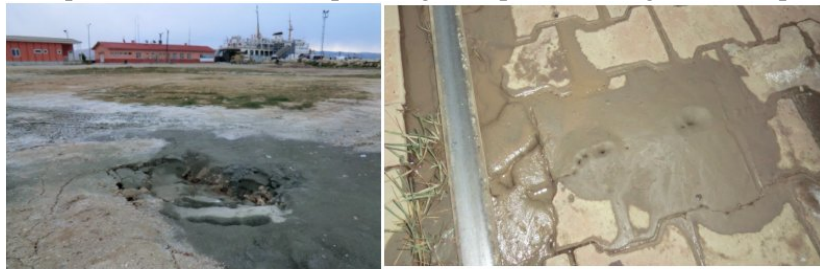
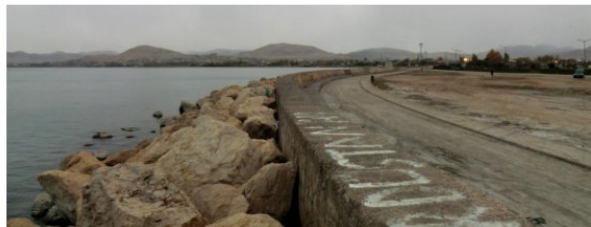
Özvan et al. (2008) considered the maximum ground acceleration as 0.35 g and evaluated the liquefaction potential of Erciş town and its close vicinity using the borehole data. They found that the ground on which Erciş is located would liquefy entirely. As there was no strong motion record for Erciş, it is very difficult to verify the estimations by Özvan et al. (2008). As the maximum ground acceleration recorded in Muradiye was 0.2g, it is expected that some partial liquefaction might occur. The reported and observed settlement of buildings in Erciş town may imply partial liquefaction did occur. Furthermore, ground liquefaction observed in Çelebibağı, Kasımbağı, the bridge on Van-Ağrı Highway over Zilan stream may be a confirmation of their estimation. Similarly, Özvan et al. (2008) pointed out that there is a high potential liquefaction risk for areas in Van City near lakeshore. The authors observed ground liquefaction at Van Port and YYU Port and they may be a confirmation of their estimation.

(c) Liquefaction and lateral spreading at Van Port (Van lake shore)

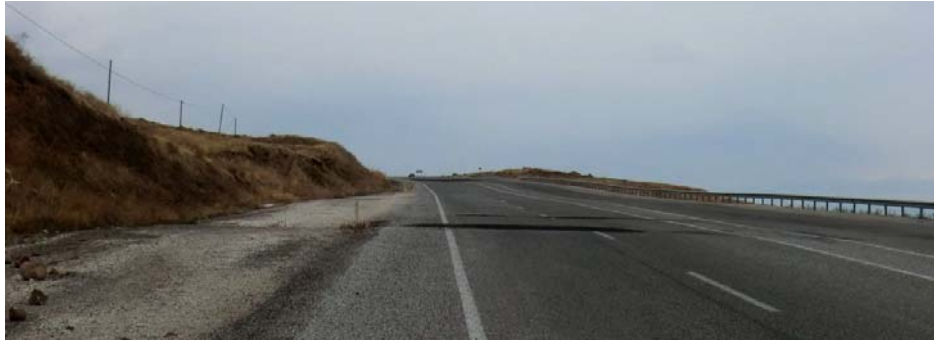
Embankment failures were observed at several localities. Major embankment failures were observed on the Van-Ağrı Highway. Photo 2 shows one example of embankment failure. The embankment seen in Photo 2 moved towards the lake and settled.

Photo 2 Embankment failure on the Van-Ağrı Highway

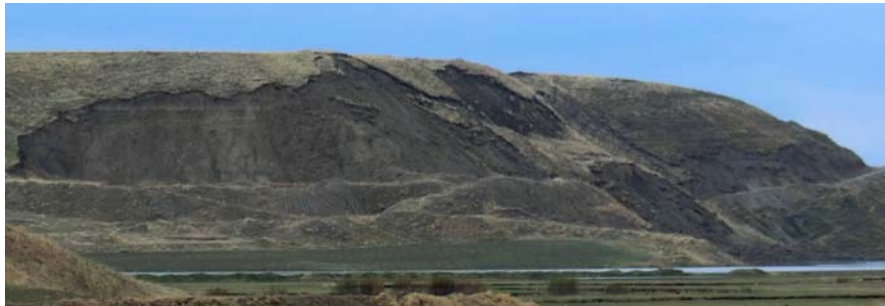
Photo 3 Slope failure near Topraktaş

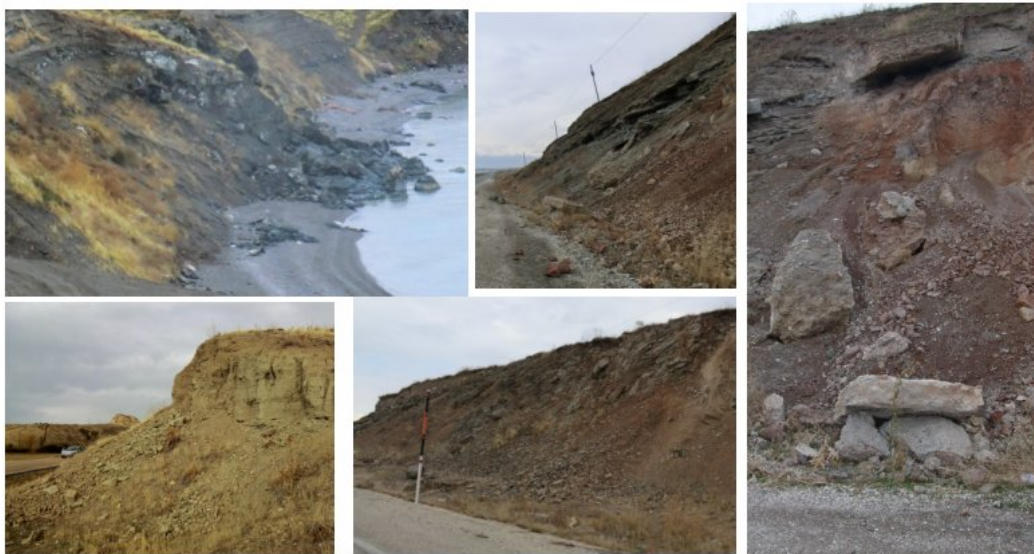
Photo 4 Rock slope failures at several localities

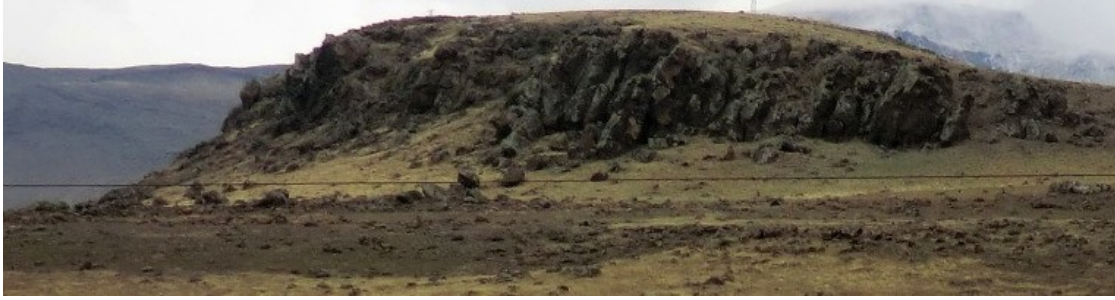
Many slope failures were observed in the epicentral area. Most of slope failures occurred on the hanging wall-side of the fault. Photo 3 and 4 shows several examples of slope failures and Photo 5 shows numerous rock falls from a basaltic slopes near Keçikıran. Some of these rock falls reached to the Van-Ağrı Highway. Nevertheless, they did not result in any casualties.

Photo 5 Rock falls near Keçikıran

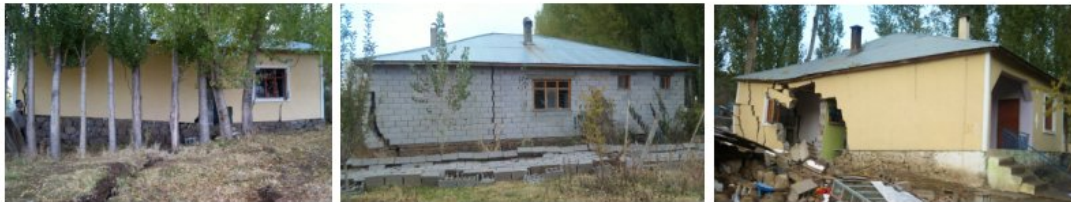
Photo 6 Lateral spreading induced damage to buildings in Çelebibağı (Erçiş)

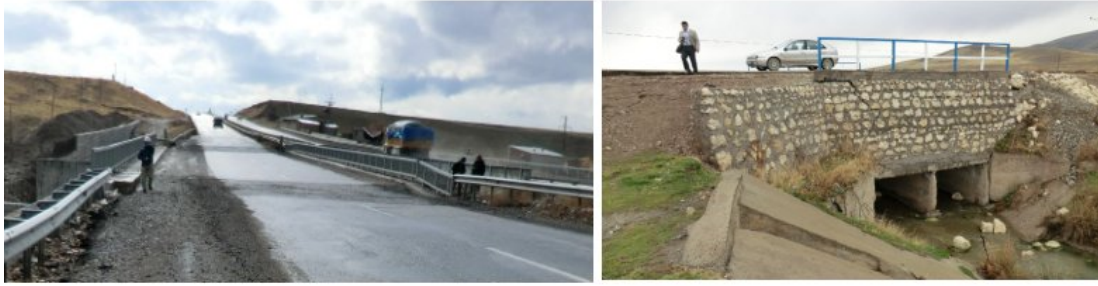
Photo 7 Damage to bridge piers and abutments due to settlement and lateral spreading of ground

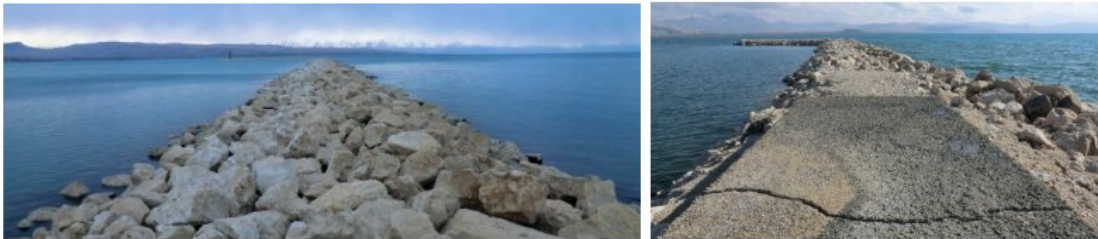
Photo 8 Settlement and spreading of breakwater of Van port and YYU port due to liquefaction of foundation ground

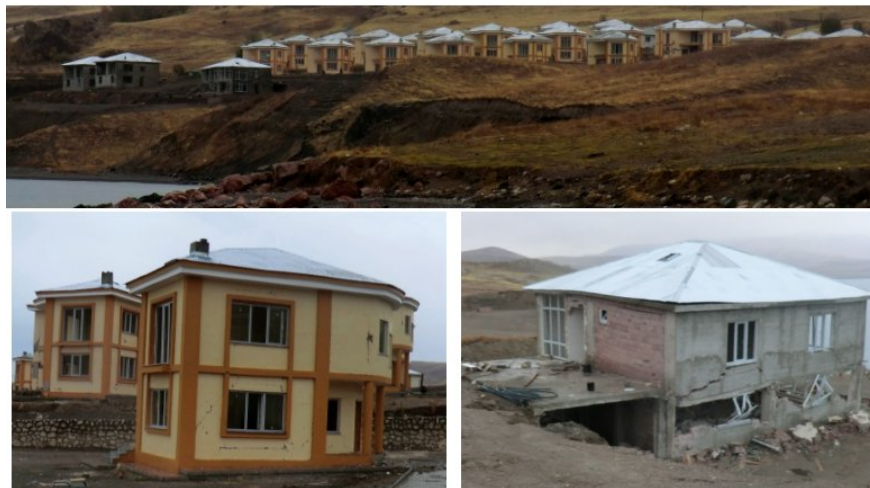
Photo 9 Damaged buildings due to permanent deformation of sloping ground
