COMPARING LIQUEFACTION PHENOMENA OBSERVED DURING THE 2010 MAULE, CHILE EARTHQUAKE AND 2011 GREAT EAST JAPAN EARTHQUAKE

Ramón VERDUGO¹

¹ Principal, CMGI Ltda. Santiago, Chile
rverdugo@cmgi.cl

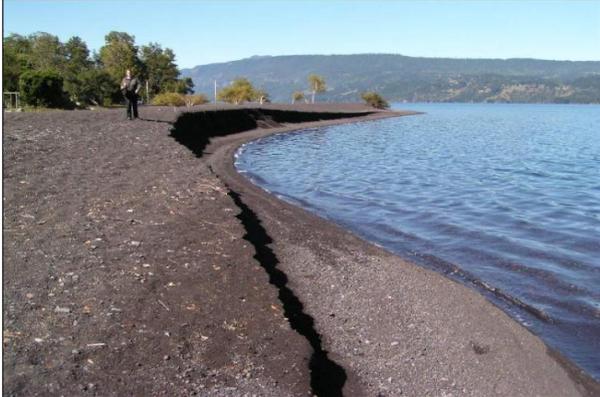
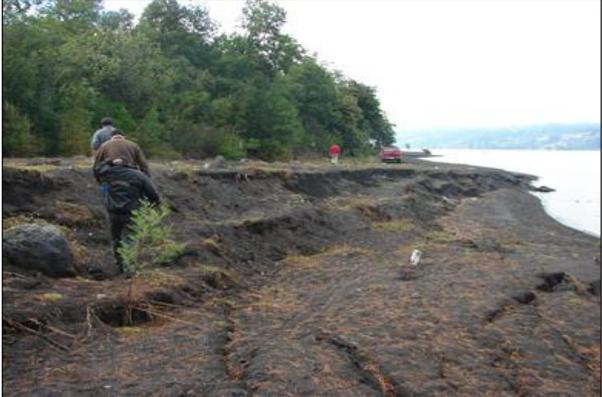
It is remarkable the fact that liquefied sites were observed in areas where the intensity was less than V. For example, the lateral spreading that involved banks of Lake Calafquén in the south (Fig. 10). The description of witnesses at Pucura sector (kilometer 10 of route Coñaripe - Lican Ray) states: "We had a family of gypsies who were camping on the site when the shaking started, they shouted calling us, a once we got over there the water come out of the earth as a hose stream "(website of the Panguipulli City Hall). This necessarily implies that the intensity of the quake, which correlates directly with structural damages, is not completely associated with the occurrence of liquefaction. Although this confirms the well-known dependence of the liquefaction strength on both level of cyclic stresses and number of cycles, it also shows the actual impact of the earthquake duration on the liquefaction strength.

Fig. 10.- Lateral Spreading observed in an area of low intensity: Pocura and Calafquen (source: Sernageomin and Municipalidad of Panguipulli)

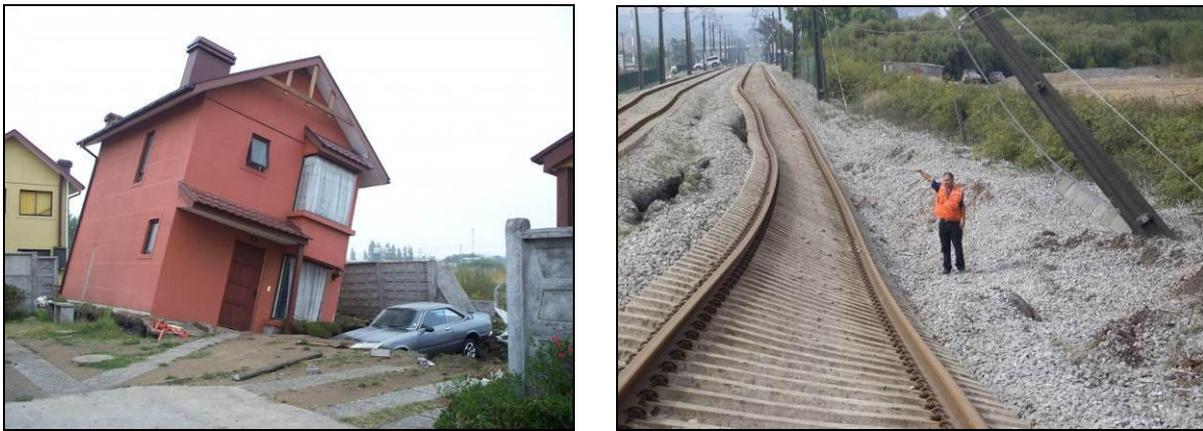
One example is the case of Brisas del Sol Condominium, located in Talcahuano, where 5 houses located in front of a wetland (similar to a swamp) suffered lateral displacement up to 2 meters. One of the houses is shown in Fig. 11. Another case occurred near the City of Concepcion, where the railway collapsed in several places due to liquefaction and subsequent settlements, as shown Fig. 11.

Fig. 11.- Liquefaction of flat areas. Condominium Brisas del Sol and railway near Concepción (EFE)

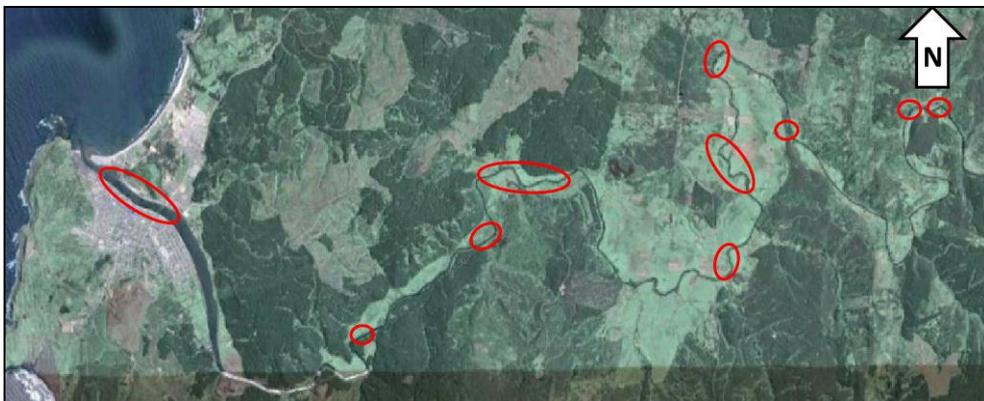
Fig. 12.- Lateral spreading observed along the Lebu River. Maule 2010 Chile Earthquake

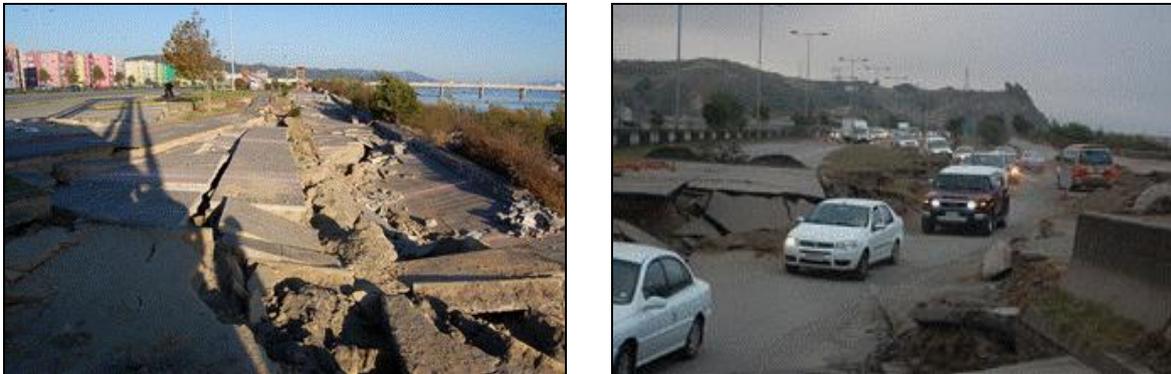
From Fig. 13, it is possible to quantify the potential effect of lateral displacements and settlements. In this case, different sites along the northern bank of Bio Bio River collapsed deforming toward the river.

Fig. 13.- Cracks and settlements on right side of BioBio River caused by lateral spreading

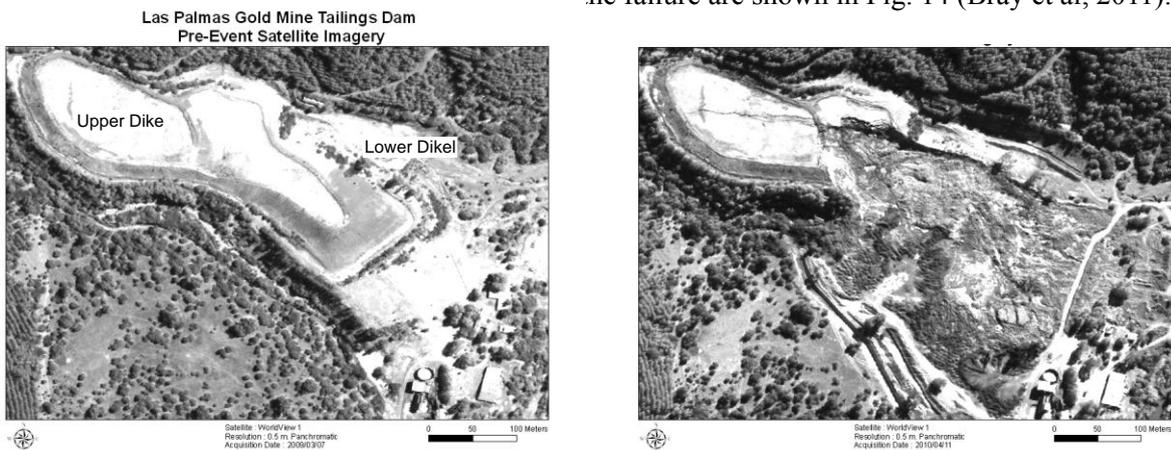
After the 2010 Chile earthquake five tailings dams constructed by the upstream method were reported with different levels of seismic failure: Chancón, Bellavista Dike No. 1, Veta del Agua Dike No. 5, Alhué and Las Palmas (Ramirez, 2010). Bellavista Dike No.1 collapsed, and a significant volume of tailings flowed into the Dike No. 2, which worked as a buffer, stopping the tailings flow. Dike No. 5 of Veta del Agua experienced a limited seismic failure; the toe of the dike moved down for a distance of 100 m, reaching El Sauce creek. Las Palmas experienced a catastrophic failure triggered by the 2010 Chile earthquake. The geometries before and after the failure are shown in Fig. 14 (Bray et al, 2011).

Fig. 14.- Pre-earthquake and post-earthquake satellite images of Las Palmas tailings dam

The tailings liquefied, flowing for a distance of about 0.5 km, killing four people who lived in a house that was buried under 4 m of tailings. The tailings dam consisted of two dikes (a lower one and an upper one), constructed in stages using the upstream construction method. This dam was operating until 1997, when the mining activity finished. From field observations it has been deduced that the bottom of this tailings dam was saturated, triggering a flow failure.

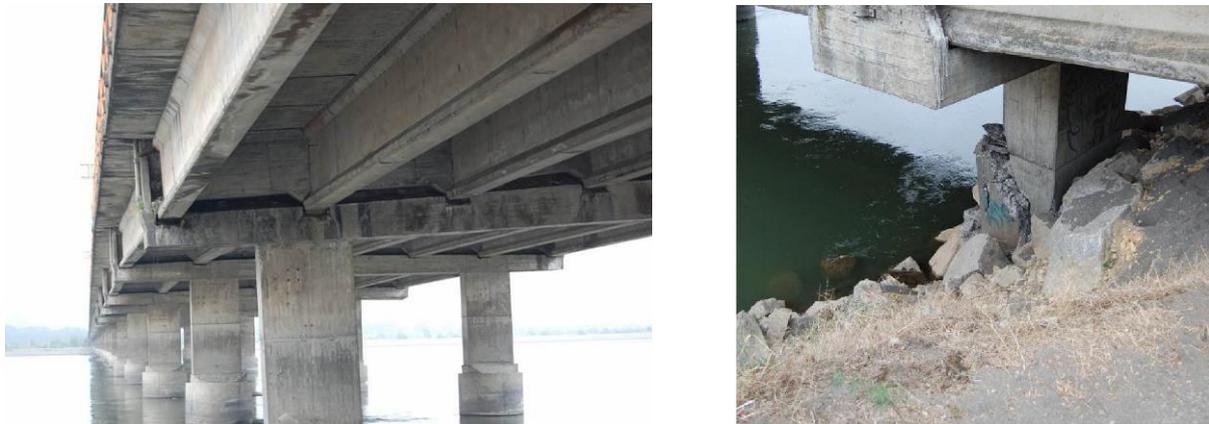
The bridge Juan Pablo II, located at the BioBio River, was the most seriously affected by the phenomenon of liquefaction. After the quake significant differential settlement showed up along the deck and the first pier (Concepcion abutment) collapsed due to the loads generated by lateral spreading (Fig. 17).

Fig. 17.- Settlement caused by liquefaction, and failure due to lateral spreading. Juan Pablo II Bridge affected by 2010 Chile Earthquake

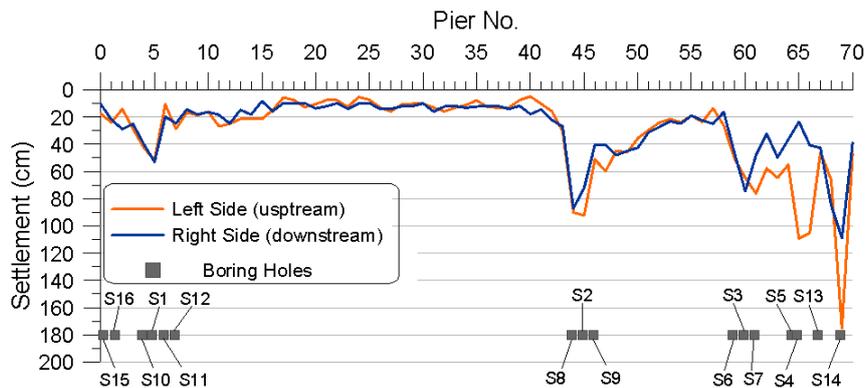
The topographic information obtained along both lines of the bridge allowed the assessment of the vertical deformation developed along the bridge. The result is presented in Fig. 18; around 15 piers developed settlements higher than 50 cm. In general, supports of the left longitudinal axis (upstream)

developed greater settlements than those observed in the right longitudinal axis. Larger settlements are concentrated at the Concepción abutment bank. The largest settlement is approximately 1.8 m, followed by settlements of 1.1 m and 0.9 m.

Fig. 18- Post-seismic settlements, Juan Pablo II Bridge

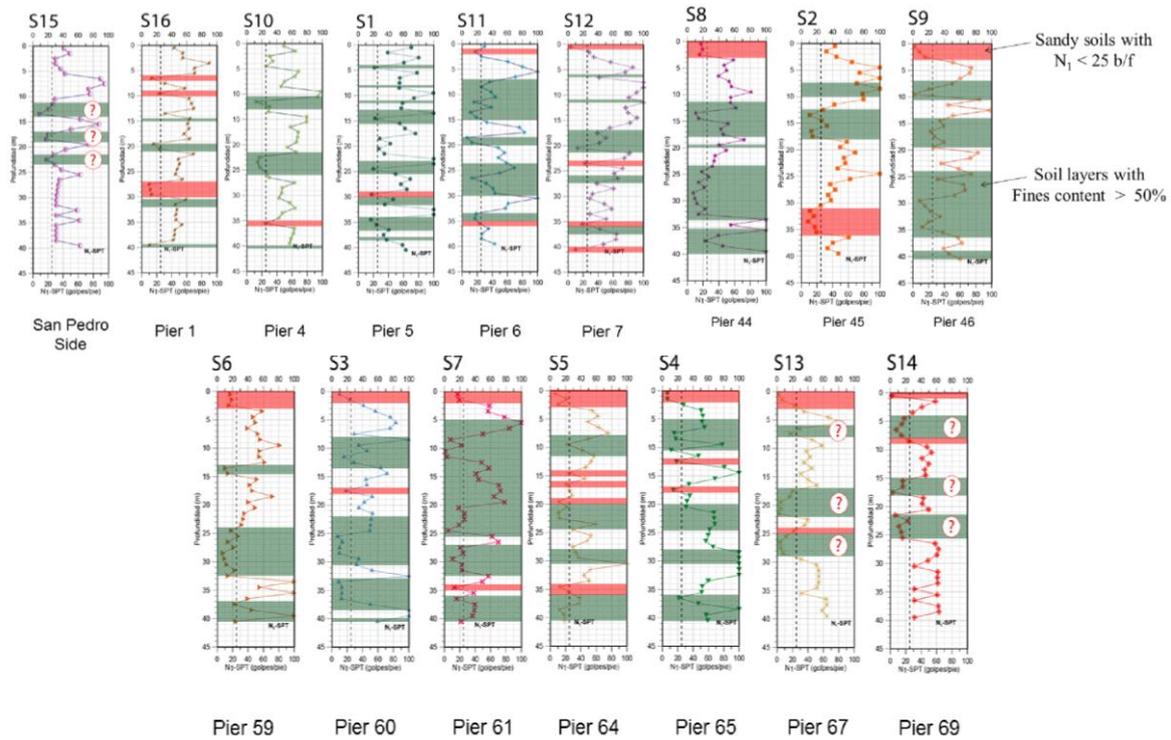
Because of the large differential settlements suffered by the piers, Juan Pablo Bridge was closed, and a series of 16 boreholes with N-SPT measurements was carried out by the Ministry of Public Works. Additionally, a limited number of classification tests were performed. The results are shown in Fig. 19, in terms of the normalized N_1 -SPT (normalized to 1 kg/cm²) and the fines content.

The most interesting aspect of this case is associated with the fact that only vertical permanent displacements were developed. The absence of lateral displacements necessarily implies that there are layers of non-liquefiable soils that were able to develop sufficient lateral stiffness to stabilize the structure. The N_1 -SPT confirms the existence of a highly stratified ground deposit, consisting of loose to dense sands and soft sandy silts. It is estimated that values of standard penetration tests (N_1)₆₀, exceeding 30 blows/foot are associated with layers of dense soil that should be responsible for the existence of enough lateral stiffness to prevent horizontal displacement.

It is important to indicate that, due to geological and tectonic issues, in Chile it is possible the occurrence of highly stratified soil deposits, where may coexist loose and dense sandy soils, with soft silts. As a consequence of this, the strength and deformability may be significantly different in both vertical and horizontal direction. This is the case of the ground that supports Juan Pablo II Bridge.

Fig. 19.- N_1 -SPT, results obtained in Juan Pablo II Bridge

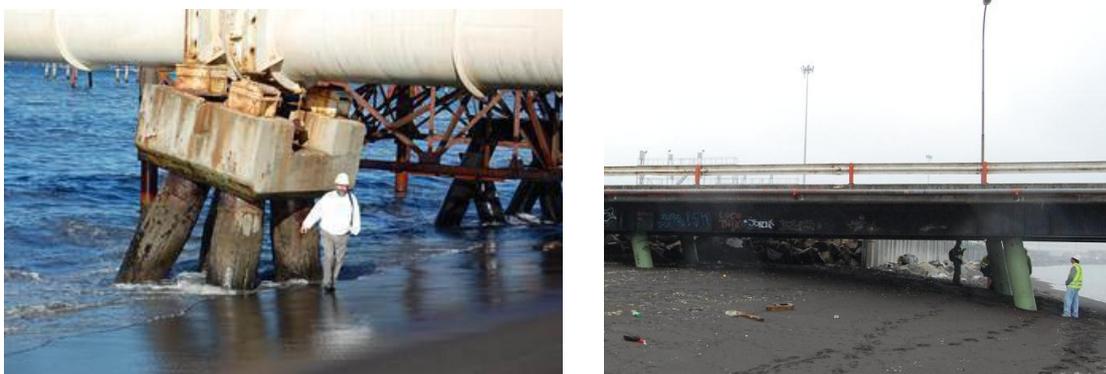
Ports and quays were also affected by liquefaction of the coastline and the seabed. The most severe cases of failure occurred between Talcahuano and Lota, specifically in the La Poza (Talcahuano), Lo Rojas (Coronel), Lota Bajo (Lota) and the Port of Coronel areas. In addition, some industrial facilities located in Coronel also suffered the effects of liquefaction. Part of the damages observed in these coastal structures is shown in Fig. 20.

The liquefaction of the line shore soil, in addition to the inclination of the ground toward the sea, generated a lateral flow which dragged the piles. However, the end part of the docks was supported by non-liquefiable soils that prevented any horizontal displacement. Thus the piles kept the head in place, fixed by the supra-structure, but their bottoms moved toward the sea following the direction of the flow of the liquefied soil.

Fig. 20.- Damages observed in private infrastructure and Port of Coronel
