LESSONS FOR CONCRETE WALL DESIGN FROM THE 2010 MAULE CHILE EARTHQUAKE

Key Words: 2010 Maule Chile Earthquake, concrete wall, boundary element, buckling, crushing, shear, configuration

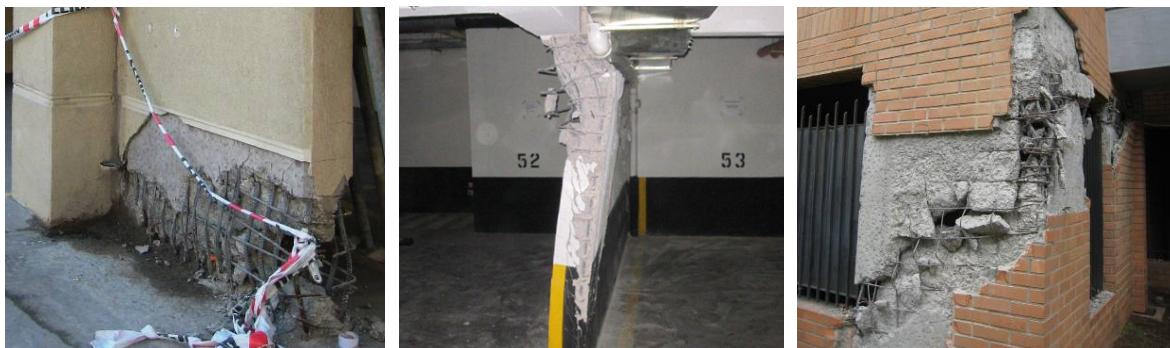
Damage to wall boundary elements, including concrete crushing and/or buckling of longitudinal reinforcing bars (Figs. 2a, 3a)

These phenomena result from flexural compression and/or cyclic tension and compression. They can be undesirable failure modes because they can lead to strength degradation and irreparable damage. To improve performance, potential modifications to design practice could include providing transverse reinforcement ties at a close spacing and/or providing an increased area of transverse reinforcement in wall boundary elements. Wall sections could also be designed to be governed by tension yielding.

Overall wall buckling (Figs. 2b, 3b)

This phenomenon consists of buckling of the wall section (as opposed to individual reinforcing bars) out-of-plane, resulting from flexural compression and/or cyclic tension and compression. Prior to the 2010 Chile earthquake this behavior mode had been observed in experimental tests but had not been reported in an actual earthquake. This behavior was also observed in the 2011 Christchurch, New Zealand, Earthquake. It can be an undesirable failure mode, particularly in regards to repairability of structures. To improve performance, potential modifications to design practice could include providing a minimum wall thickness at the compression boundary of a wall, as a function of the unsupported wall height in the region of potential plastic hinging. The thickness requirement could also depend on other variables such as unbraced wall length, axial load, neutral axis depth, or expected strain demand.

Damage resulting from building configuration issues (Fig. 2c)

Coupling from slabs, beams, spandrels, stairs, and other outrigger-type elements can cause damage to these elements and can also increase shear demand in walls. Potential improvements to design practice include accounting for these elements in the seismic analysis and design, or detailing them to minimize interaction with the designated seismic force-resisting elements.

Fig. 2 Damage from Chile Earthquake (a) Damage to a wall boundary element (b) Overall wall buckling (photo by Prof. Jack Moehle) (c) Damage at wall discontinuity

One of the key behaviors observed in the Chile earthquake is damage to multi-story walls near the base of the building, exhibiting buckled vertical reinforcement and crushed concrete concentrated over a relatively short height of wall. This type of failure was often not concentrated only at the boundaries, but was instead seen to propagate over much of the length of the wall as shown in Figs. 2a and 3a.

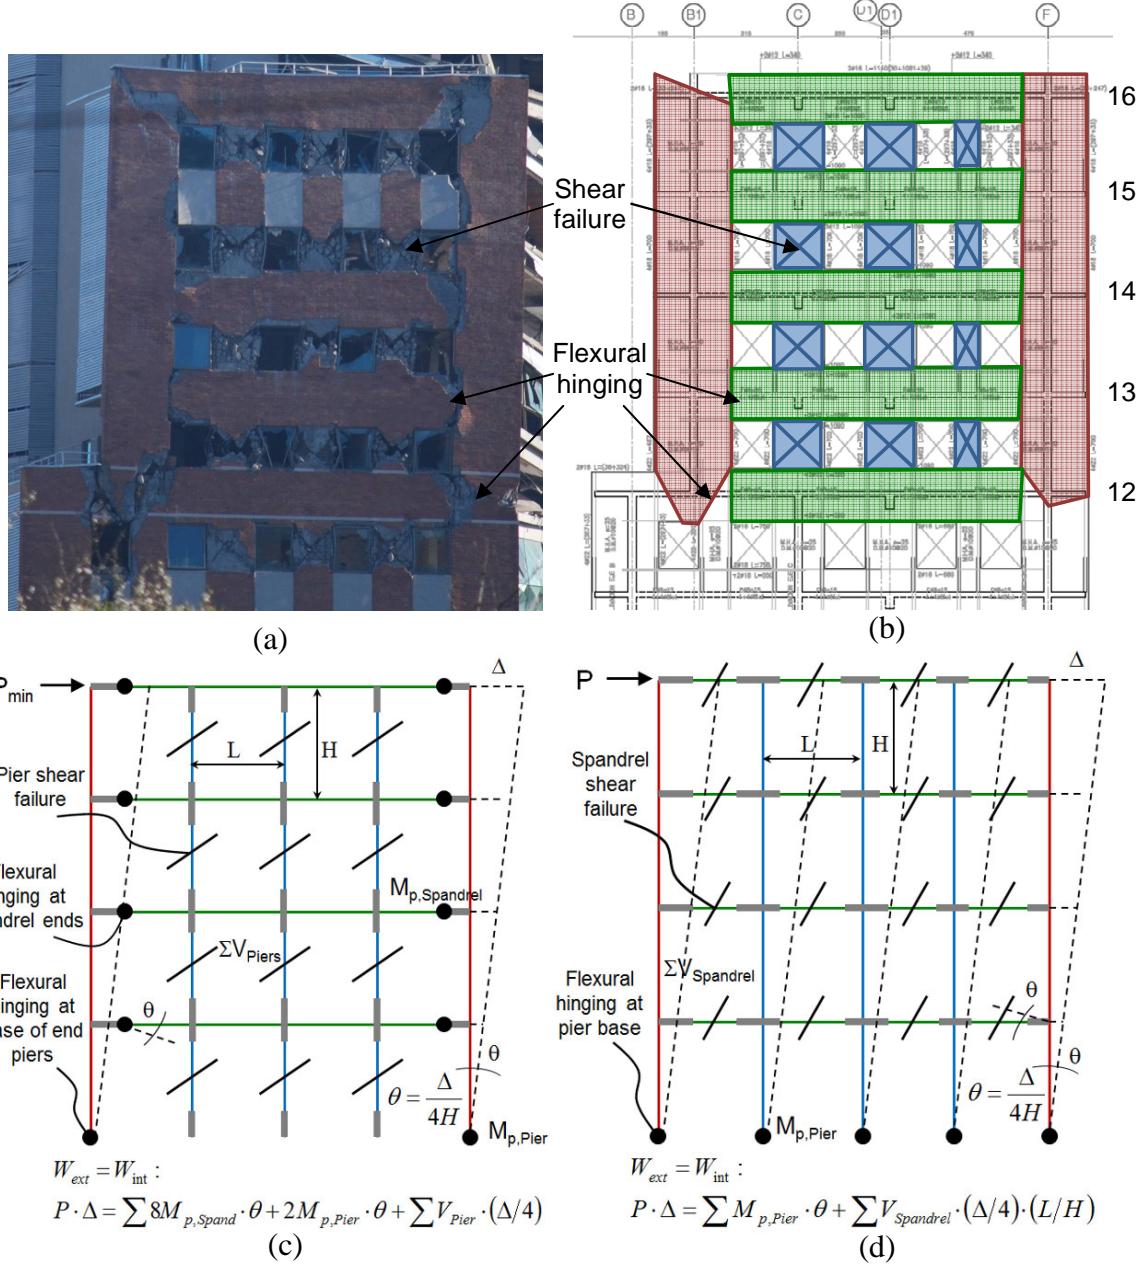
For example, the pier-spandrel system shown in Fig. 5a is a portion of a high rise building that suffered severe damage and partial collapse in the earthquake. Though not necessarily the cause of collapse, it is clear from the photo that wall piers suffered severe shear damage when constrained between deep spandrels, while the spandrels suffered flexural damage where they connect to heavier piers at the extreme bays. Based on this observation, engineering calculations of element strength should confirm that piers are shear-governed, and that the governing plastic mechanism for the system is as shown in Fig. 5c.

The structural behavior modes considered in this analysis for individual wall piers and spandrels were flexural yielding, sliding shear, and diagonal tension failure, computed based on strength equations from FEMA 306. FEMA 306 calculations for diagonal shear strength distinguish between the capacity corresponding to low and high displacement ductility demands on wall type elements. The geometry, reinforcement details, and specified material properties were obtained from available structural drawings for the building, while expected material properties for concrete and steel reinforcement were estimated based on PEER (2010). The axial load was calculated based on tributary area, self-weight, and typical dead and live uniform loads defined for a residential building by the NCh433Of.96 Chilean code (INN 1996). The resulting axial load ratio on the wall piers represents approximately 2% of their nominal axial capacity. Axial loads produced by seismic forces were disregarded in the simple hand calculations presented here. For each wall pier and spandrel beam, Table 2 presents the shear force corresponding to each of the behavior modes considered; the behavior mode with the lowest corresponding shear force is expected to govern the element's seismic response. These hand calculations confirm that the expected shear strength of individual piers is less than the shear that would correspond to flexural yielding.

For the plastic analysis of the four-story four-bay pier-spandrel system, several plastic mechanisms were considered, including shear failure of intermediate piers (Fig. 5c), spandrel shear failure between pier lines (Fig. 5d), and others. Virtual work principles and Lower Bound Theorem were applied to estimate the collapse load, assumed to be applied to the system at the top level of the subassembly. Indeed, the plastic mechanism shown in Fig. 5c corresponds to a lower plastic load than other possible mechanisms and is also consistent with the post-earthquake behavior observed.

Fig. 5 Pier-spandrel system: (a) observed damage (photo from EERI team) (b) idealized structural elements (c) plastic mechanism observed and validated by calculation (d) example of a plastic mechanism considered and shown by calculation not to govern.

Given that this behavior mode and mechanism are reasonably predictable by straightforward engineering calculations, the question could be considered whether design codes should require engineers to identify the governing behavior mode and mechanism, for example using capacity design principles. Currently US and Chilean codes make only a small distinction (via the strength reduction factor) in the assumed ductility capacity between shear versus flexural behavior. Shear failure of wall piers is generally less-desirable than flexural yielding because shear failure tends to exhibit less ductility and can be associated with a concentration of lateral deformation and damage.

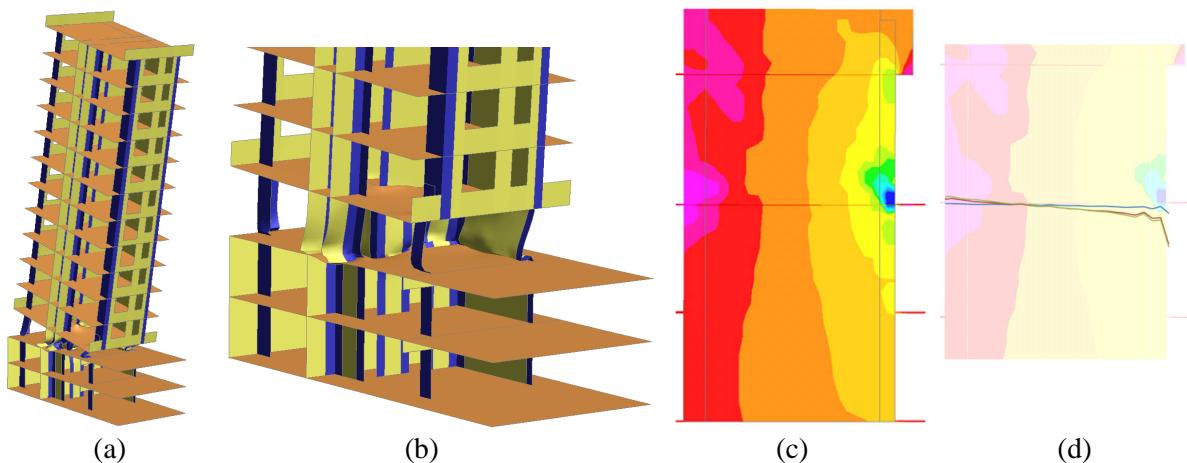
The ‘slice’ model (Fig. 6a) of the building was built based on the structural drawings. Few ‘engineering’ decisions and pre-calculations need to be made in assembling models of this type since all the walls, floors, reinforcement, openings, discontinuities etc. are represented explicitly. Almost all the concrete is unconfined since the reinforcement has few cross-ties and the bar spacings are large. The base of the model was subjected to the tri-directional motion time histories from the nearest recording station in Concepcion (Boroschek et al 2010).

Under seismic excitation this model predicts concrete crushing failure, initiated where

concentration of compression strain occurs in the extreme fiber of the wall at ground level. The compression failure zone does not spread vertically, but propagates across the width of the wall in successive cycles, during which the sway period of the building also elongates. Eventually, as vertical carrying capacity is lost at both ends of the wall the building topples under gravity (Figs. 6a and 6b). Fig. 6c shows a close-up of the lower stories of the wall at the initiation of collapse, with a concentration of vertical compression strain occurring at the first floor level. As shown in Fig. 6d, the strain distribution along this section of the wall is not linear in the compression zone; compression strains increase sharply near the extreme fiber. This preliminary analysis supports the hypothesis that compression failure in wall boundary elements can lead to collapse in certain cases.

Fig. 6 Analysis of wall with vertical discontinuity (a) model deformed shape at failure (b) close-up of lower stories (c) vertical strain concentration at ground floor (c) strain distribution on wall section
