REPORT ON 2012 VAN (TURKEY) EARTHQUAKES

ABSTRACT: An earthquake of Mw7.2 on 23 October 2011 occurred in the Van region of Eastern Turkey. The mainshock and long series aftershocks caused significant damage and claimed 644 lives. Particular features of the earthquake, damage, losses, rehabilitation and the lessons learned are covered.

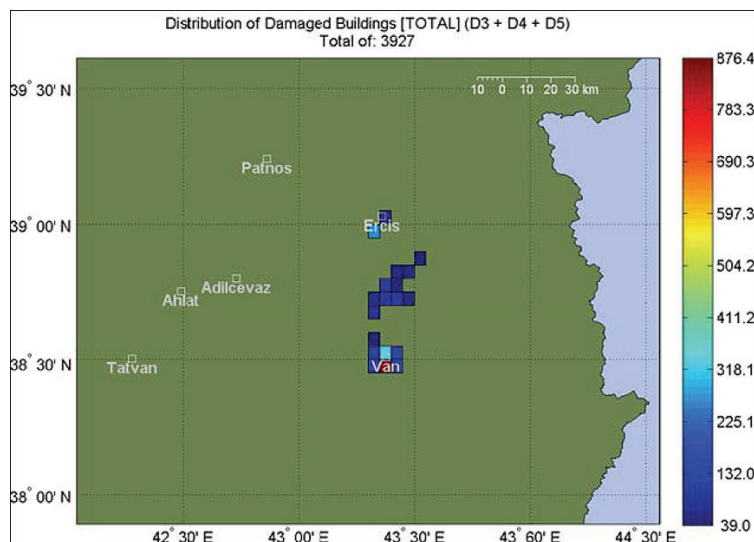
- Damaged beyond repair (EMS'98 damage states: D3+D4+D5) = 3,927 (Fig 6)
- Medium Damage (EMS'98 damage state D2) = 9,956
- Light Damage (EMS'98 damage state D1) = 24,582

Fig 6. Estimated Distribution of buildings damaged beyond repair (EQE-KOERI, 2011)

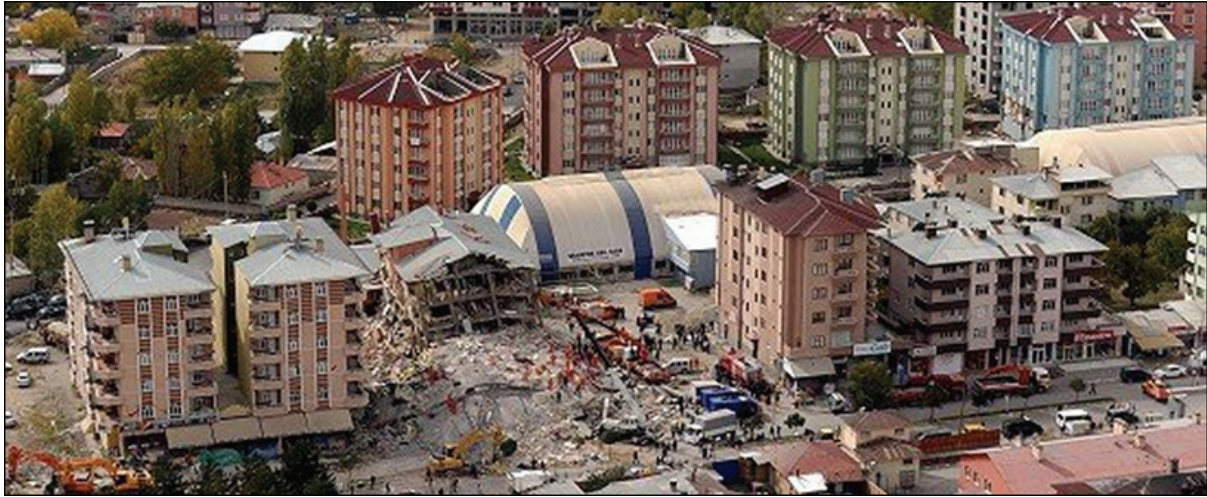
Fig 7. Damaged Reinforced Concrete buildings in Erciş (AA Press)

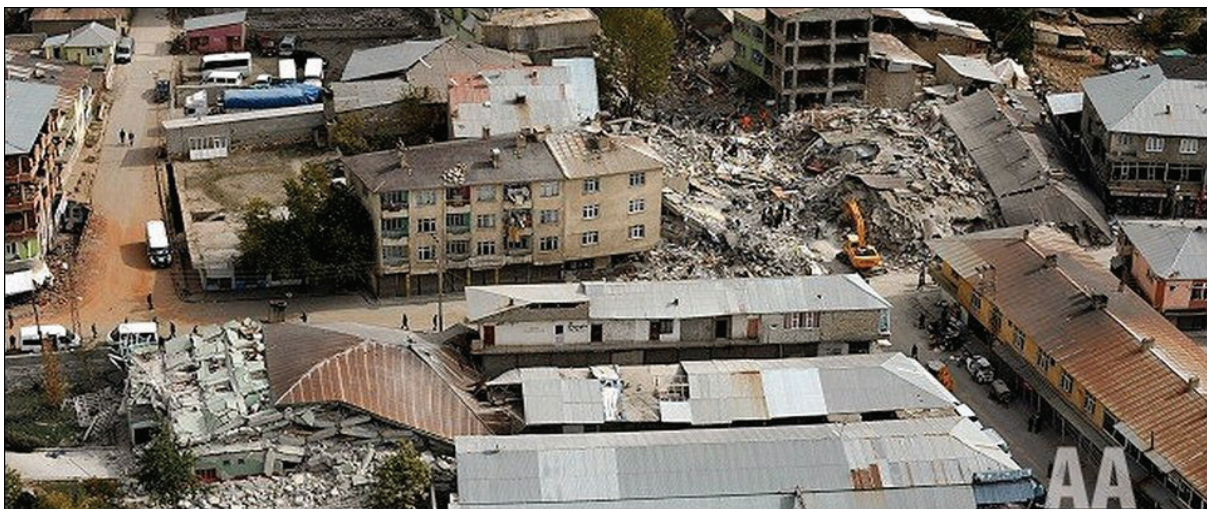
Fig 8. Damaged Reinforced Concrete buildings in Erciş (AA Press)

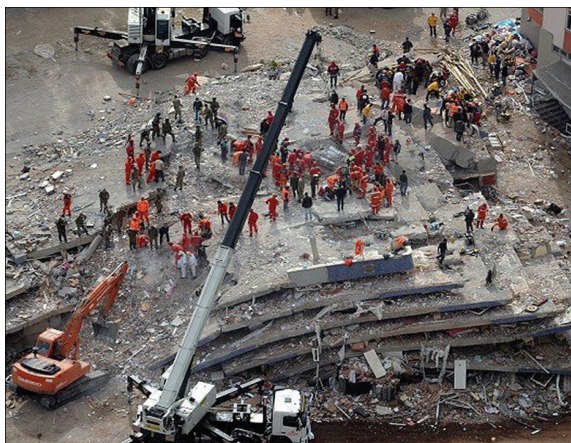
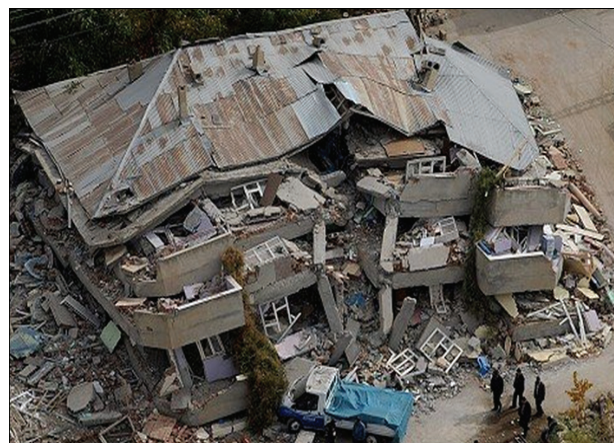
Fig 9. Damaged Reinforced Concrete buildings in Erciş (AA Press)

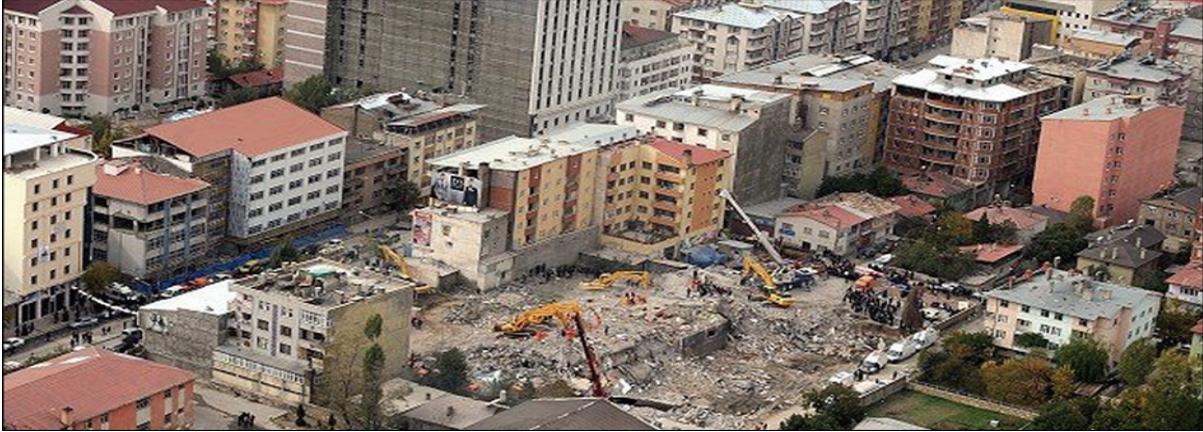
Fig 10. Damaged Reinforced Concrete buildings in Van (AA Press)

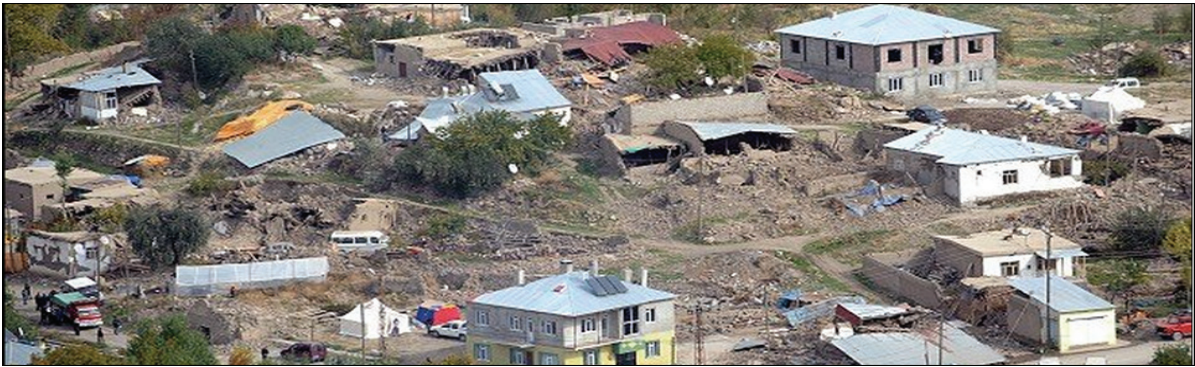
In villages, the dominant building type consists of adobe and stone masonry buildings minimally reinforced with timber lintel beams. The roofs are constructed mostly with galvanized steel sheets. Livestock shelters generally have heavy earthen roofs. Those buildings with heavy earth roof experienced heavy damage and collapse as it has also been experienced in previous rural earthquakes in Turkey.

Fig 8. Damaged rural buildings in Tevekli village (AA Press)
