SEISMIC DAMAGE OF A NINE-STORY RC RESIDENTIAL BUILDING IN SENDAI DESIGNED BY OLD SEISMIC CODES

ABSTRACT: Structural damage is reported for a nine-story reinforced concrete residential building which experienced the 2011 Tohoku-chiho Taiheiyo-oki Earthquake in Sendai. The structural system is moment resisting frames in longitudinal direction and coupled shear wall system in the transverse direction. The failure mode of beam-column joints are compared to the prediction by the current seismic design guidelines. The validity of their provisions on joint shear strength and the other specifications are discussed.

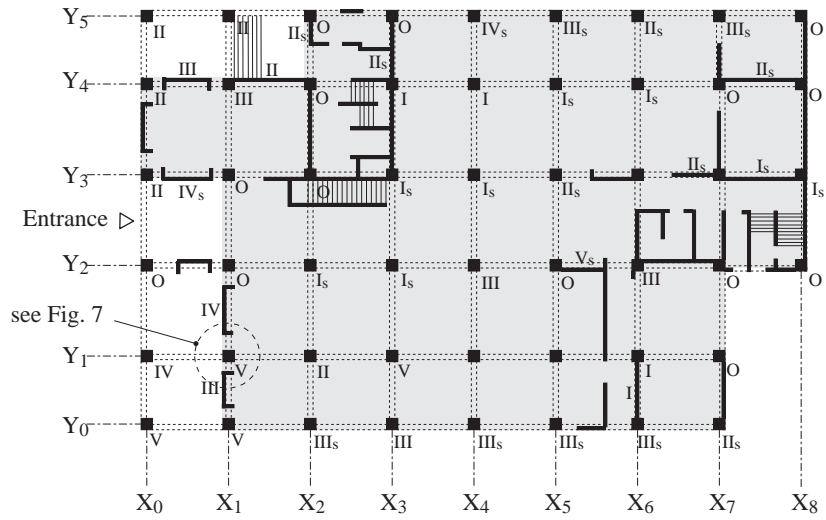
Fig. 2 Plan of 1st floor and damage grade of structural members

The evaluated grade of the columns and walls are shown in **Figs. 2** through **6**. The first story column at X_1 - Y_1 suffered the damage of the severest grade of V. The **Fig. 7** shows the photo of the column. Cover concrete spalled off at the bottom of the column and the longitudinal bars are buckled. Flexural yielding at the base occurred and high axial force variation due to rocking wall at the above level cause the severe damage. Possibility of this problem had been already pointed out by the vulnerability assessment done in 2011. Story drift at the first story seems to be the largest because the number of columns with grade III or severer were observed only for the first story. This interpretation may be endorsed by the fact that most of the gross fracture were observed only at the first story. The damage of columns at the second story is not significant.

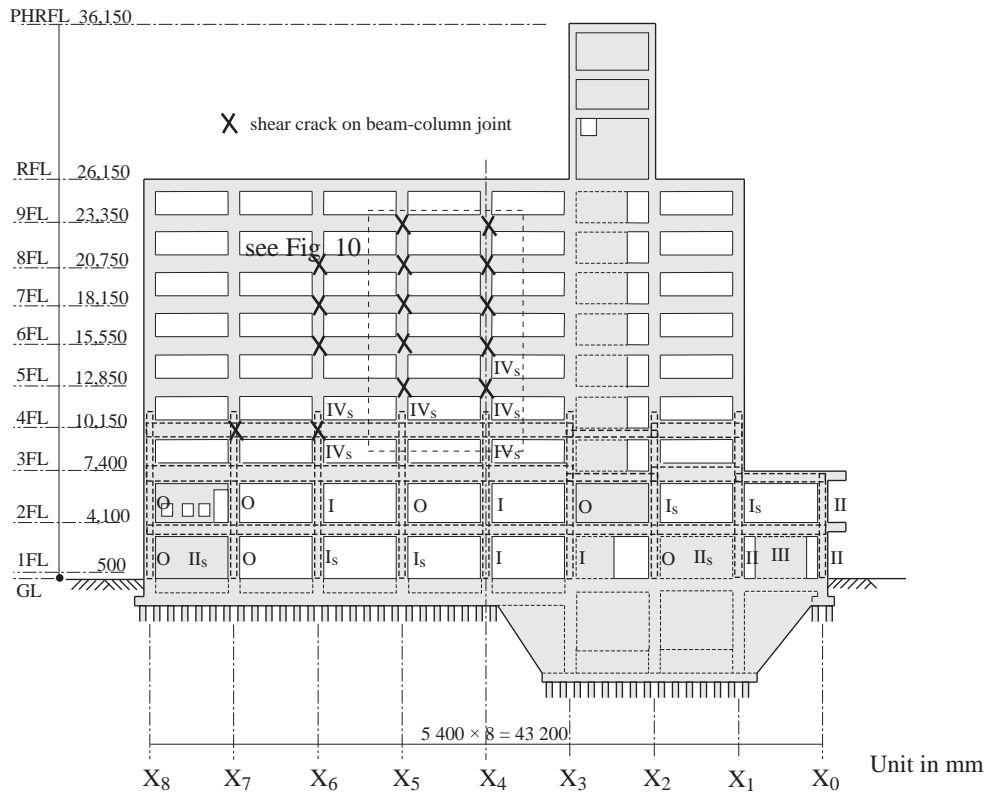
Fig. 5 Elevation of Y₄ Frame and damage grade of structural members

The seismic evaluation standard¹⁾ have no predefined equations to consider beam-column joints with poor performance. But as shown in **Fig. 5**, diagonal cracks were observed at many beam-column joints in the longitudinal frame of Y₄. So, the failure type is evaluated by the current seismic design.

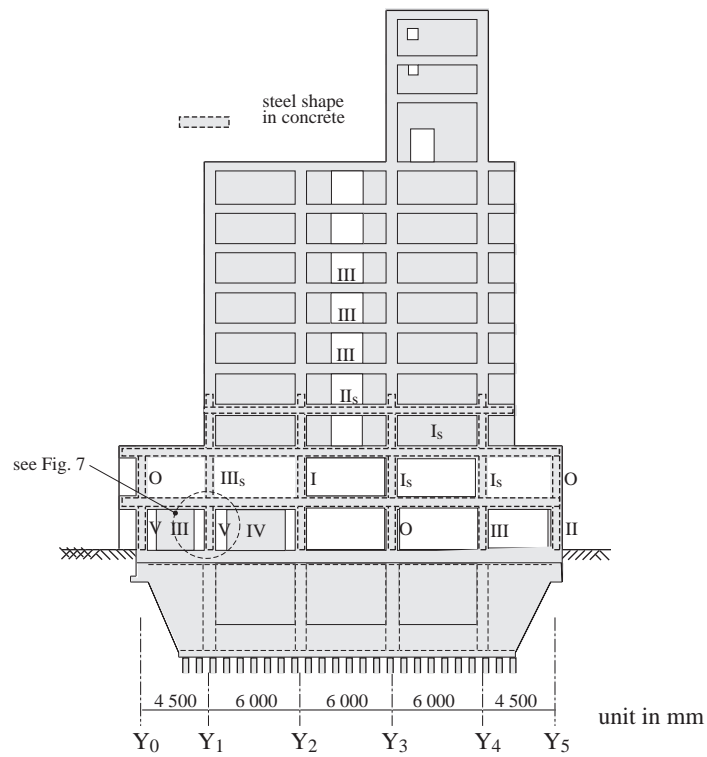
Fig. 6 Elevation of X₁ Frame and damage grade of structural members

The other severe damage was observed on the boundary beams which consist of coupled shear walls in transverse direction starting from the 4th floor level through the roof floor level. Damage grade of the beams were III from the fourth floor through seventh floor as shown in the elevation of X_1 Frame in **Fig. 6**. The section of the beams is 350mm wide and 600mm deep where the longitudinal reinforcements are 5-D22 bars for top and 3-D22 bars for bottom. The stirrups are 9mm diameter plain bar with spacing of 200mm. No shear failure was not observed but the stirrups were not sufficient for control the residual crack width less than 1.0mm.

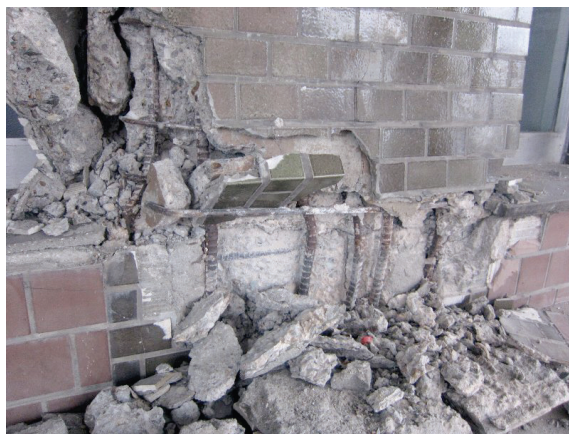
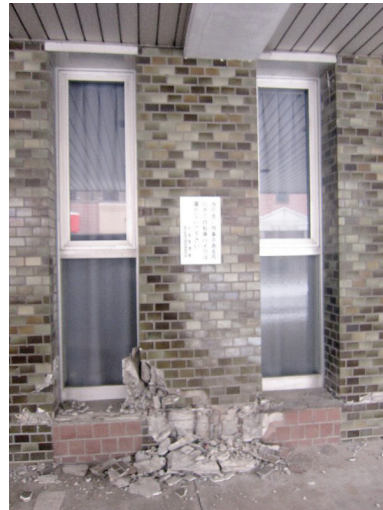
The first story SRC column subjected to bending and high axial tension by the rocking wall above showed the severest damaged in this building. It is due to the deficiency of steel lattice that is not continuous nor embedded into the foundation but just ends at the first floor level which allowed concentration of local deformation adjacent to the weak section at the bottom of the column.

Fig. 7 Column X_1-Y_1 at 1st floor with concrete crushing and rebar buckling

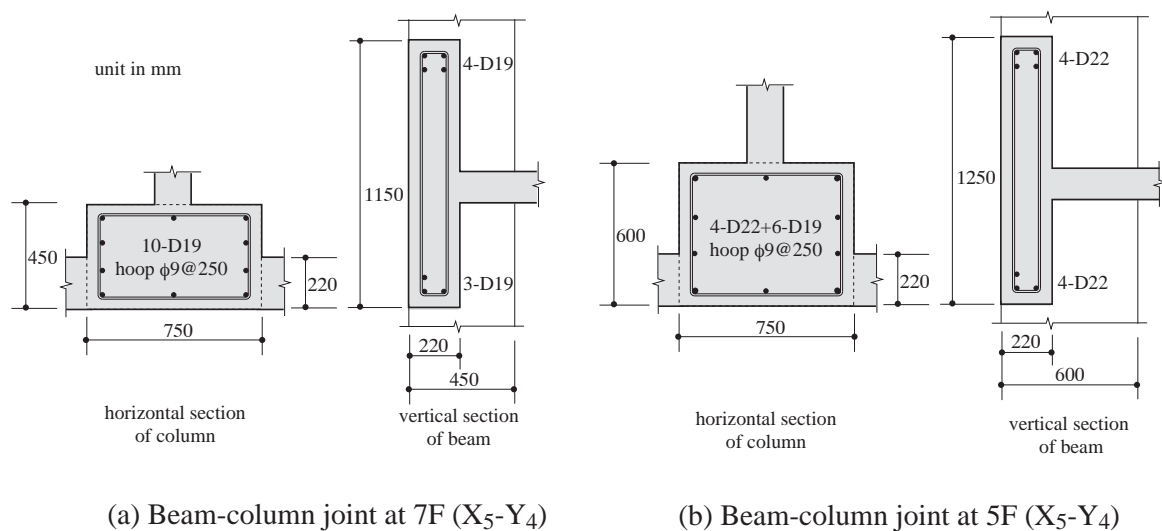
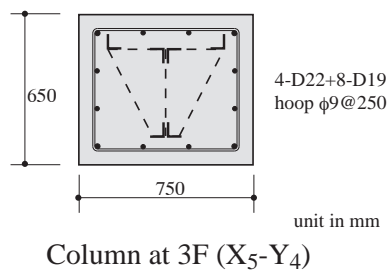
Fig. 8 Detail of a typical SRC section of columns in Frame Y_4

The sections of beam-column joints are shown in **Fig. 8** for the beam-column joint at fifth floor level and seventh floor level taken from the structural drawing. They are crucial beam-column joints provided with joint hoops with common spacing to the hoops in the column according to the structural drawing. The flexural strength, shear strength and joint shear strength are calculated based on the design strength of material and design equations as follows,

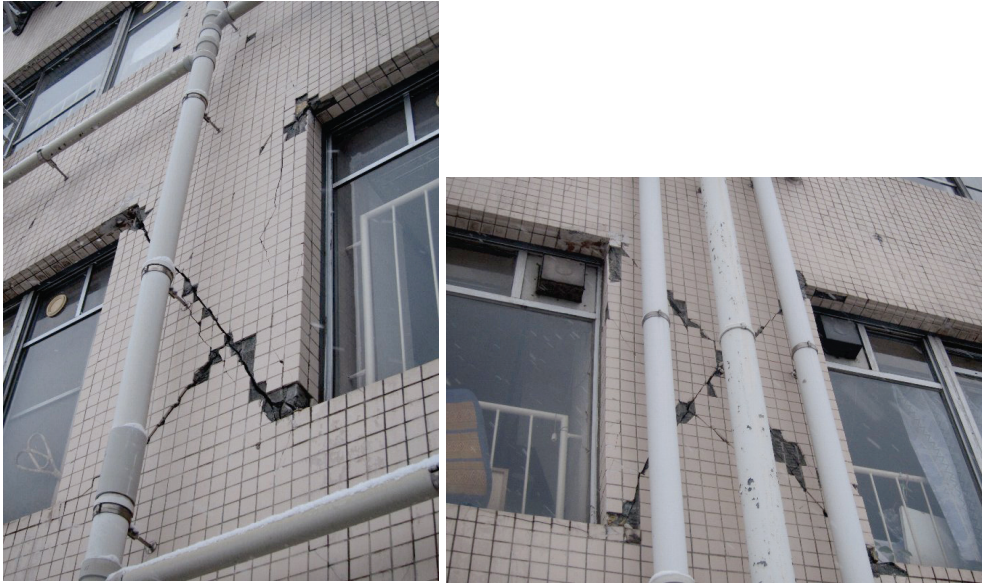
Some of the exterior RC/SRC columns in Y_4 frames suffered a shear failure at the third, fourth and fifth story with damage grade of IV. **Fig. 9** shows the shear cracks on the columns.

Fig. 9 Shear failure of exterior column in Y₄ frame

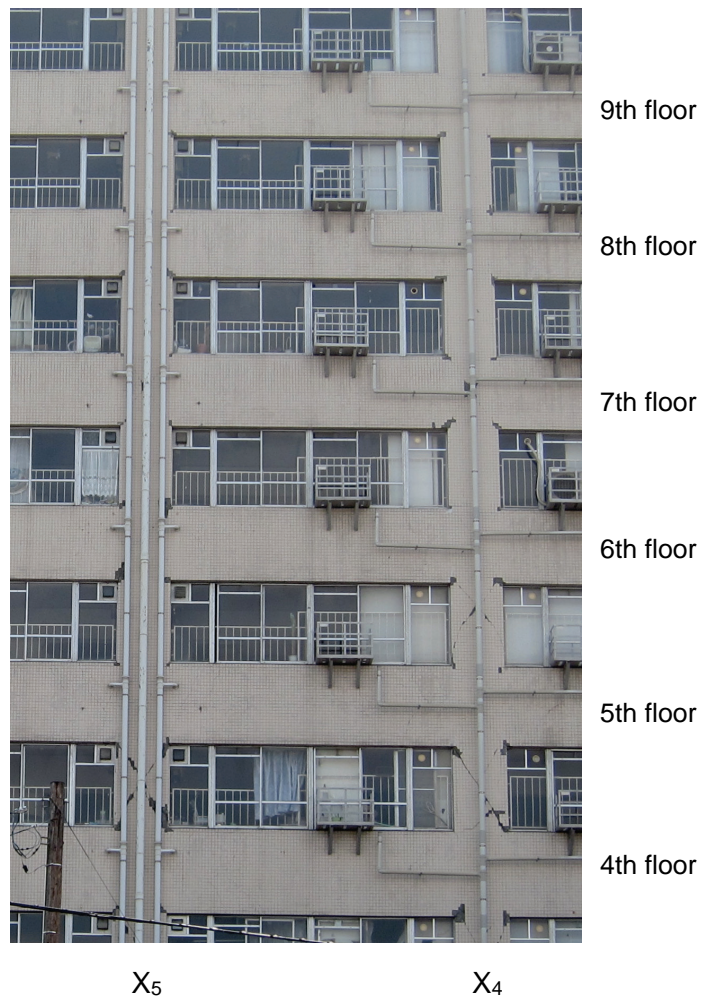
By the image on the photo of the exterior side of Y_4 frames shown in **Fig. 10**, it is revealed that some beam-column joints have significantly cracked and concrete crushing was also found. The cracks originated from the corner of the window opening and proceeded into the center of joint. Crushing of concrete as well as tile peeled off at the crossing point of diagonal cracks were evident. It is presumed that longitudinal direction was imposed very large story drift, because the non-structural RC partitions along the corridors in the longitudinal direction between Y_2 frame and Y_3 frame had been significantly failed in shear.

Fig. 10 Joint shear failure of beam-column joints
