PERFORMANCE OF BURIED HIGH VOLTAGE POWER CABLES DUE TO LIQUEFACTION

John M. EIDINGER¹

ABSTRACT: Buried high voltage power cables failed in many locations in the February 22, 2011 M 6.3 Christchurch earthquake, due to liquefaction. The empirical evidence of these failures is presented. The original design of the cables is considered, and what made the cables so vulnerable. Nonlinear analyses of buried cables are presented to see how they "theoretically" should perform due to liquefaction. Full scale tests are conducted for unreinforced and reinforced buried cable duct banks to examine their relative capability to absorb the effects of liquefaction. Recommendations are made for the design of new buried cables in liquefaction zones.

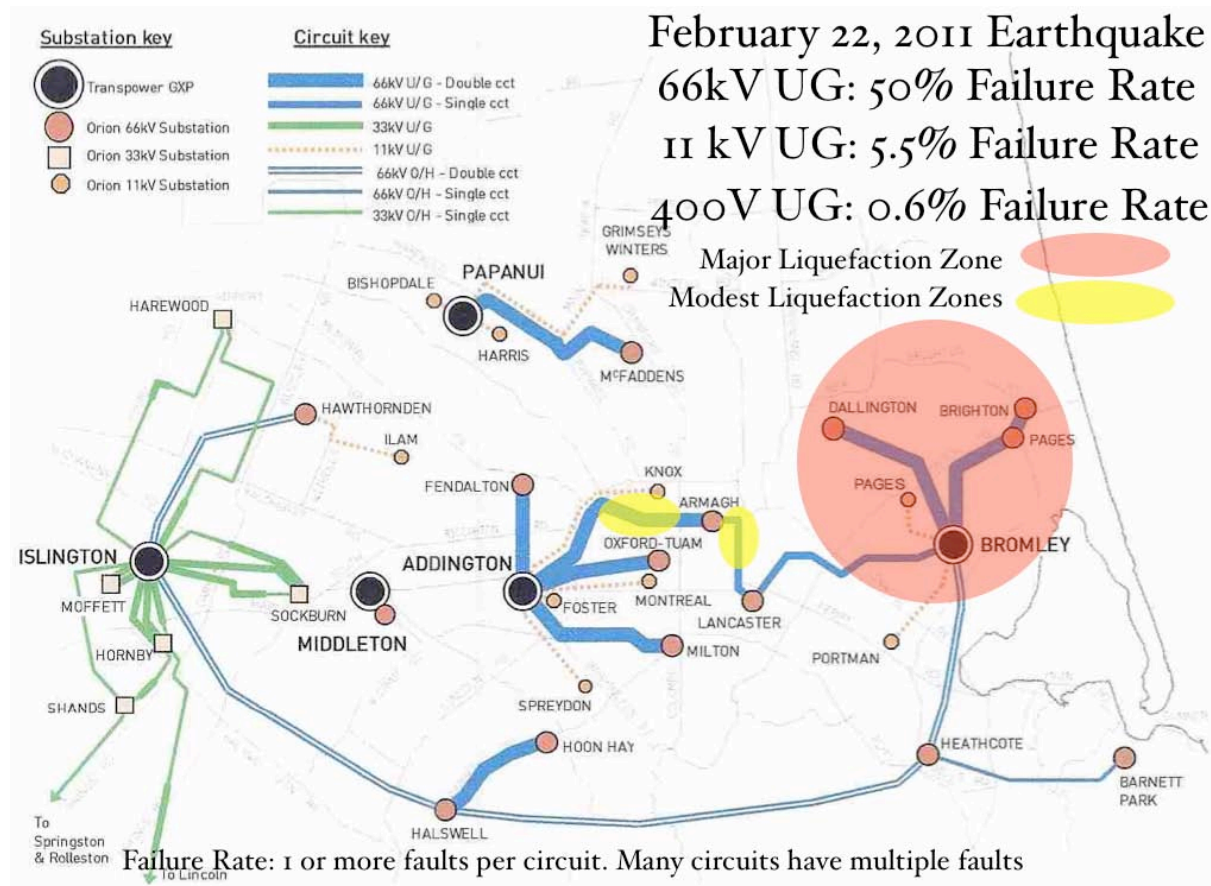
Figure 1. Location of Orion 33 kV to 66 kV Distribution System and Liquefaction Zones (Feb 22 2011)

This paper examines just one aspect of the overall power system damage, namely the failure of buried 66 kV power cables in the Orion system. Figure 1 shows a map of the Orion power system, highlighting the liquefaction zones in red (major liquefaction, settlements often 5 to 10 cm, with lateral spreads locally up to 1 meter) and yellow (moderate liquefaction, with settlements commonly 2 to 5 cm).

In Figure 1, the red zone in the eastern part of the city suffered the most widespread concentration of liquefaction, and the worst impact to buried power cables. The eastern part of the city is primarily residential. From the Bromley 220 kV – 66 kV substation, there are 5 underground (UG) 66 kV circuits that branch out to 66 kV substations: all these circuits had more than 1 faults; short term emergency repair was to deploy emergency generators at low voltage substations; moderate term repair was to re-energize substations with temporary above-ground cables; the long term permanent strategy (2012 and beyond) is to install new end-to-end 66 kV buried cables, with some seismic design provision. Exactly what will constitute the seismic design for the new buried cables remains to be determined.

In Figure 1, the two yellow zones are drawn over the single Lancaster-to-Armagh 66 kV XLPE-type circuit and the double Addington-to-Armagh 66 kV oil-type circuits. These failed at six locations, were repaired with new splices at those six locations, and put back into service.

In Figure 1, the statistics for the February 22, 2011 earthquake are presented. If one counts by circuit, including all of Orion's system, then 50% of 66 kV underground cables had one-or-more

faults; 5.5% of 11 kV and 0.6% of 400 Volt. If one counts only those circuits located within liquefaction zones, essentially all the 66 kV buried cables failed.

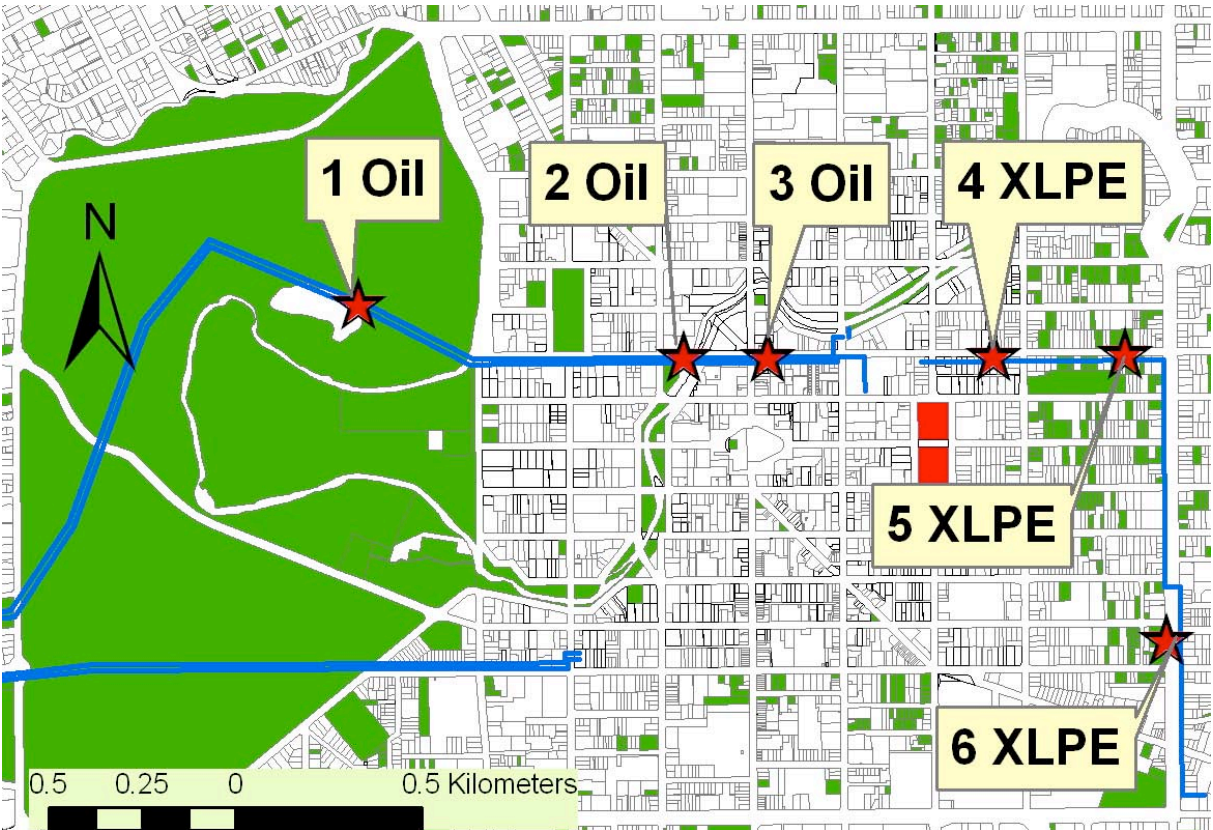
Figure 2. Location of 66 kV Buried Circuit Faults, Central Business District, Christchurch (Feb 22 2011)

Figure 2 shows the alignment of 66 kV buried circuits in and around the central business district (CBD) of Christchurch, New Zealand. The red stars show the locations where the circuits failed. The blue lines show the circuit alignments. Green areas are parks. The meandering Avon River is highlighted by green parks along either bank. The six circuit failure locations are noted "1, 2, 3, 4, 5, 6". The type of cable at each faulted location is listed as either Oil, or XLPE. Each blue line represents a three-phase circuit. Oil-type cables have all three phases within pipe. XLPE-type cables have three separate cables.

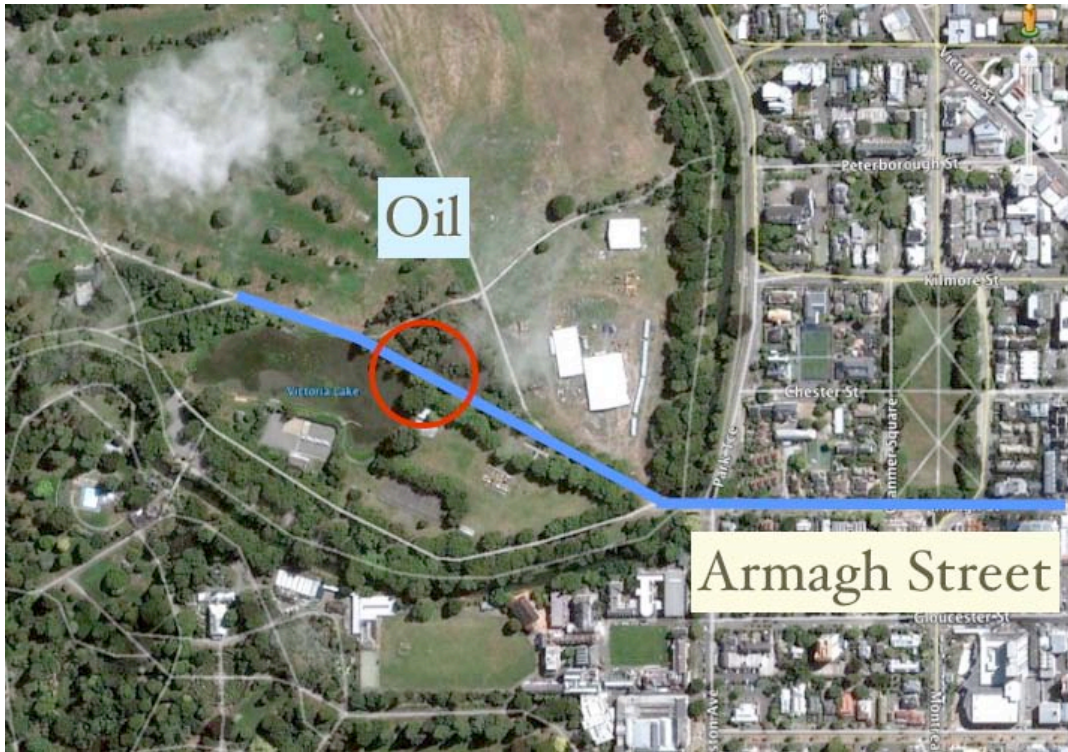
Figure 3. Location 1 – 66 kV Oil-filled Cable

Figure 3 shows failure Location 1. Figure 4 shows the cross section of the trench design used at Location 1, same as used at Locations 2 and 3. In the field, we observed the actual "230 mm cement-bound sand" and "80 mm red concrete cap" to have the consistency of a moderate strength concrete. Native soil in the top 3 meters, surrounding the cables, are typically moderate strength clays / silts, able to withstand a vertical-cut trench wall. Figure 5 Shows the buckled cables, as crews dig them up after the earthquake. Figure 6 shows the cable cross section, comprised of three aluminum phases (300 mm²), paper wrapped, with three oil-ducts; all housed within a corrugated aluminum pipe and then with protective plastic outer sheath.

Post-earthquake inspection at Location 1 revealed that the cable alignment was parallel and about 6 meters from the edge of Lake Victoria. Liquefaction occurred under the lake, inducing some settlements, and possibly a very slight lateral spread, as indicated by damage to the retaining wall at the edge of the lake. One buried storm culverts goes under power cable, another over the power cable one installed likely before, and one after, the cable installation. Surface level ground deformations in the zone where the cable failed show sudden "knife edge" settlements on the order of 2 cm, gradual lateral soil movements of perhaps 3 cm.

The damage pattern of the cable shows a classic "nonlinear beam on nonlinear soil" pattern, expressed mostly of vertical settlement. The actual damage to the cable occurred due to high curvature on the exterior aluminum pipe, leading to local wrinkling of the corrugations, pushing inward on the oil tubes / paper wrap. The aluminum pipe tore, releasing the oil and allowing air into the cable. The actual aluminum cores did not appear worse-for-wear.

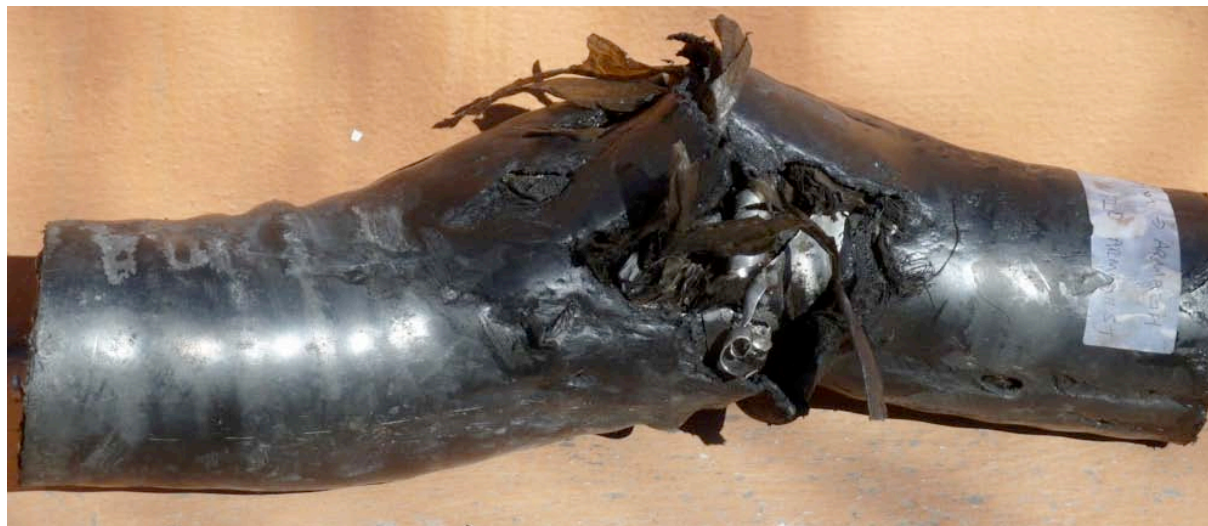
Figure 7. Oil-Type Cable (Location 3)

Figure 7 shows the cut-out section of a oil-type cable, from Location 3. The final deformed shape shows that the cable tried to deform in sharp double curvature, to accommodate a shear across the cracked thermal concrete cross section. The high curvature lead to high strain in the aluminum pipe, tearing it. Post-earthquake inspection of the roadway surface at Location 3 showed street-level knife-edge type vertical settlements on the order of 2 cm; no lateral spreads.

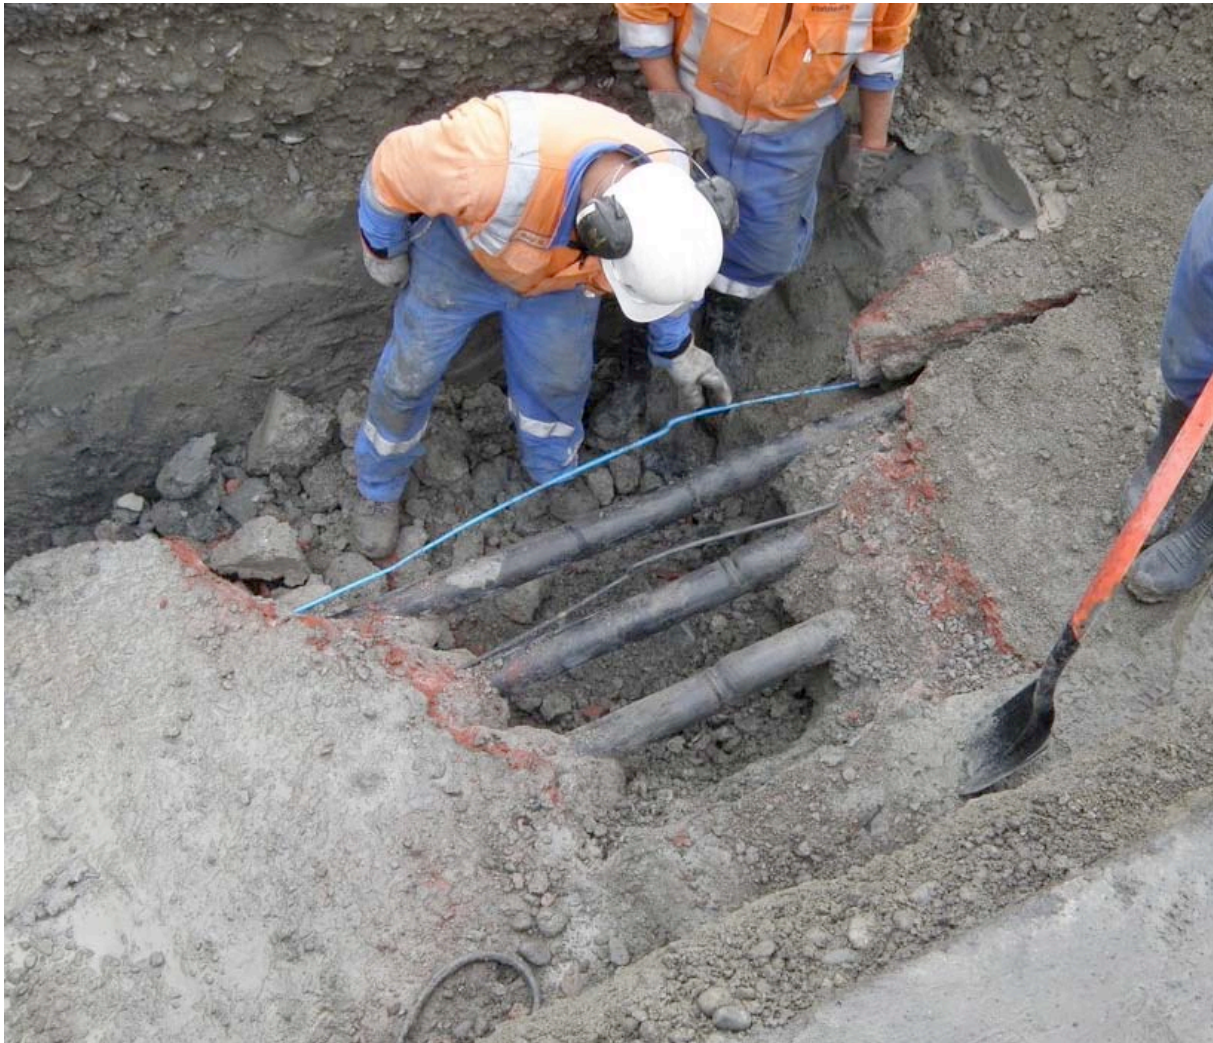
Figure 10. Exposing the Damaged XLPE-Type Cables, Location 6

Figure 10 shows work crews exposing the fault cable at Location 6.

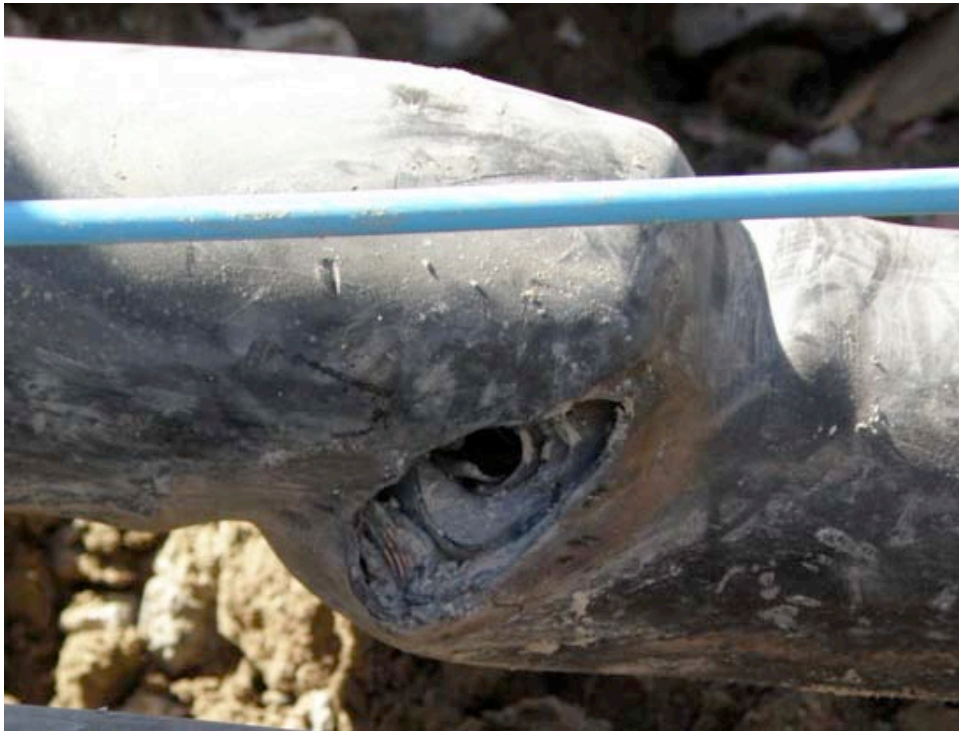
Figure 11. Failed XLPE-Type Cable, Location 4

Figure 11 shows the tell-tale reverse-curvature bend in the XLPE cable from Location 4, with a blow-out hole caused when the cable faulted. Each of the three cables had similar reverse curvature at this location. Figure 12 shows this cable after the outer HDPE coating is removed. The high reverse curvature has caused the XLPE insulation around the copper core to wrinkle outwards, tearing the outer copper sheath.

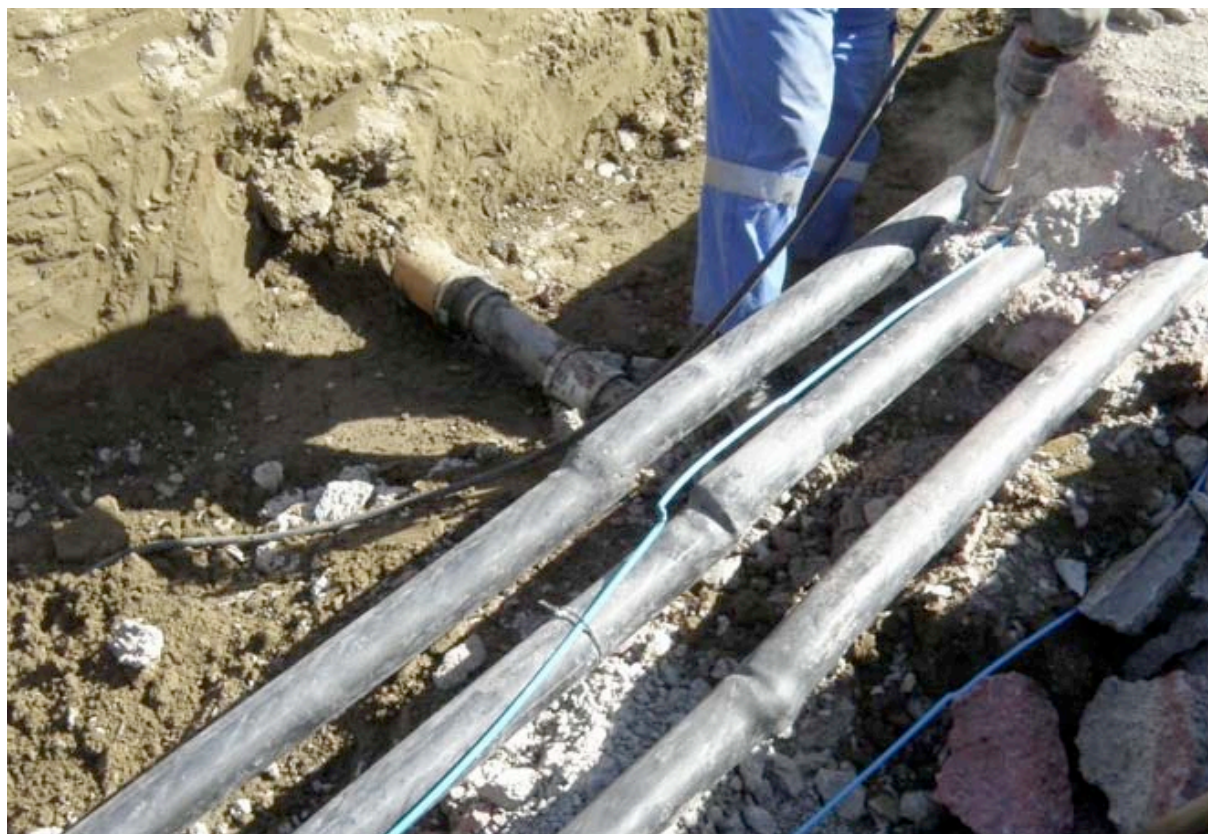
Figure 13. Failed XLPE-Type Cable, Location 5

Figure 13 shows the buckling of the XLPE-type cables at Location 5.

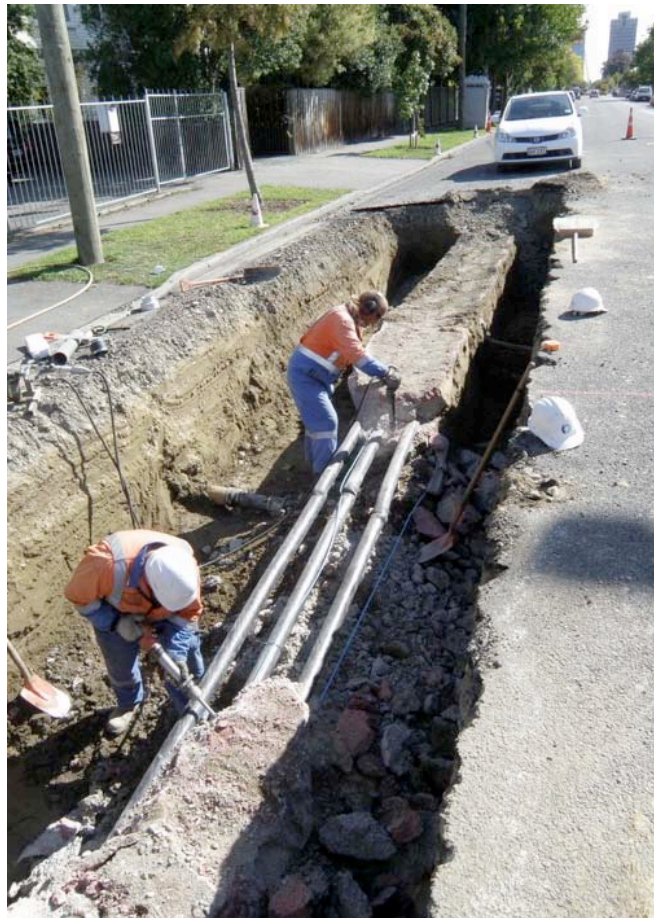
Figure 14. Street at Location 5

In discussions with Orion, it was observed that multiple people who looked at the damage locations could not discern any particular reason why the cables broke at those specific locations. Figure 14 shows the street in the vicinity of Location 5: no major ground deformations are observed.
