DAMAGES OF WOODEN HOUSES CAUSED BY 2011 GREAT EAST JAPAN EARTHQUAKE AND TSUNAMI

Mikio KOSHIHARA¹, Naohito KAWAI², Hiroshi ISODA³ and Takahiro TSUCHIMOTO⁴

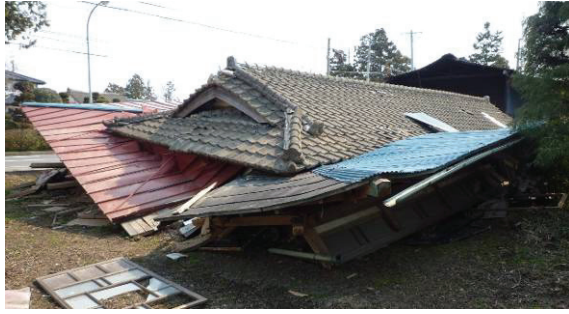
Fig.2 Collapse of wooden house in Osaki

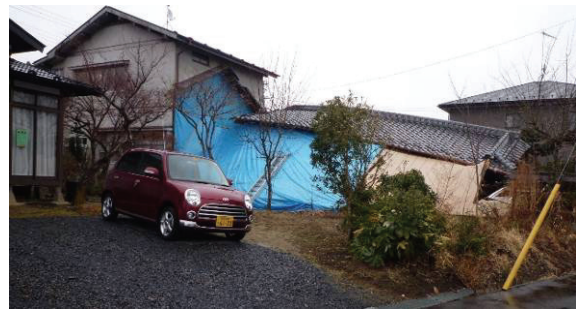
Fig.3 Partial collapse of wooden house in Kurihara

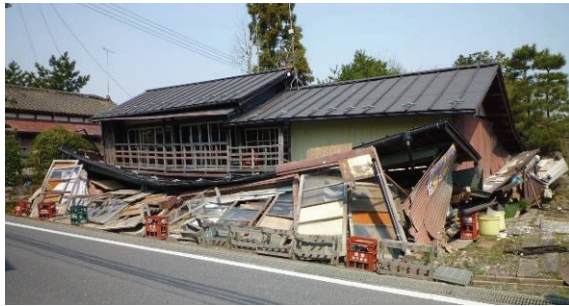
Fig.4 Collapse of wooden house with store attached in Misato

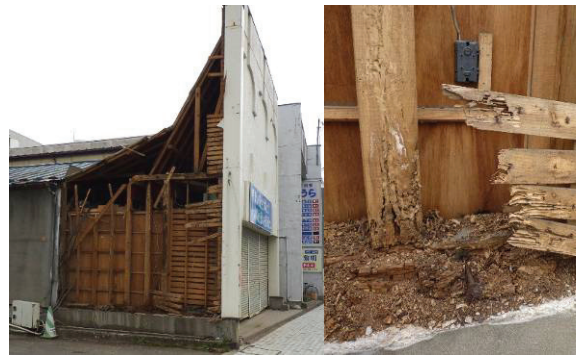
Fig.5 Severe damage of wooden house with store in Osaki

building members in Fig. 5 showed extensive termite damage.

The wooden houses typically have large openings facing the street, which is inadequate for earthquake resistance. Exterior walls often showed chipped mortar and glass as well as ants in the wood sheathing, which sometimes spread into the structural members. Therefore, the damage of most dwellings was amplified due to the termite damage.

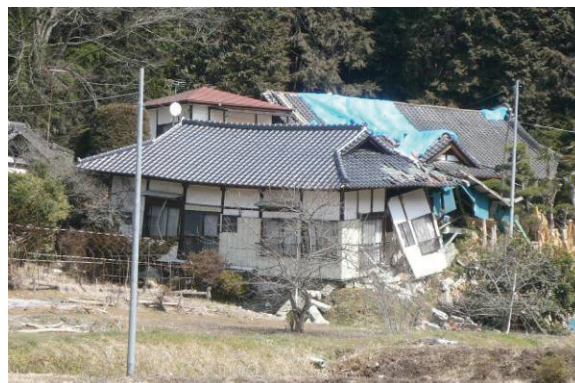
In contrast, one distinct example of vibration damage is found in Fig. 6, which shows the partial collapse of the high stone foundation near the city of Nasu Karasuyama and the town of Ichigai in Tochigi Prefecture. This vibrational failure of the foundation was often found and would lead to the collapse of the wooden structure above.

Fig. 6 Collapse of wooden house with high stone foundation

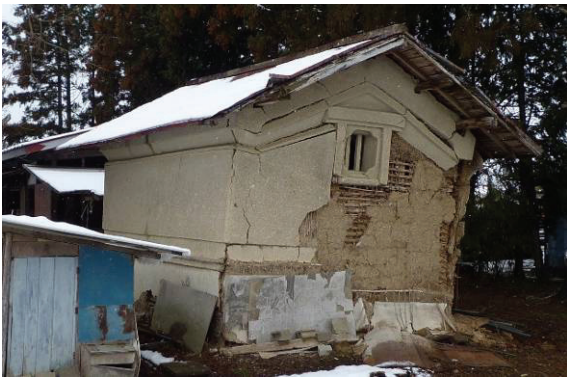
The primary type of damage was in the form of fallen roof tiles or chipped exterior wall coatings. Major damage, demonstrated in Fig. 7, was evident in the form of permanent inclination of the building. The group of store-houses in Osaki, as seen in Fig. 8, was over 200 years old and had obvious structural deficiencies. Although there is no deformation to the columns and other structural members, the termite decay is extensive within the members and would be difficult to repair. Fig. 9 shows a building on the same property as the warehouses. A retrofit was performed on the interior wooden bearing walls and reinforced concrete masonry foundation inside. The structural timbers were still intact but the roof collapsed.

Fig.7 Permanent inclination of a storehouse

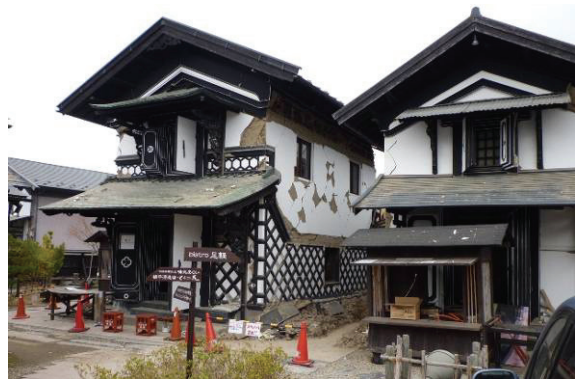
Fig.8 Damage of older storehouses in Osaki

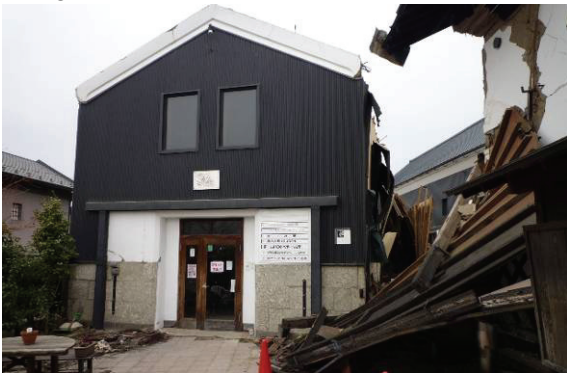
Fig.9 Retrofitted storehouse in Osaki

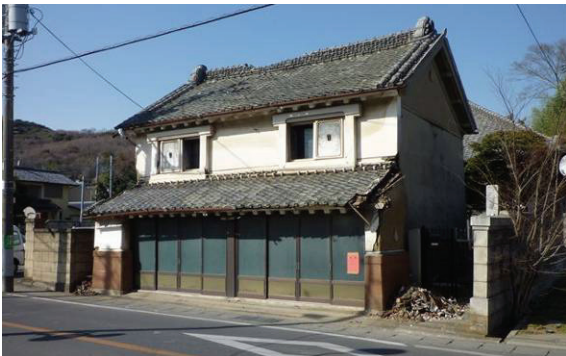
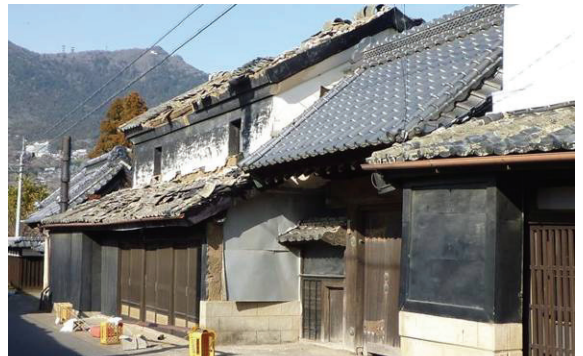
Fig.10 Damage of storehouse with heavy mud walls in Tsukuba

Fig.11 Damage of three storehouses with heavy mud walls

Fig. 10 and Fig. 11 show the damage of residential storehouses. Residual deformations were small and the damage was primarily in the form of cracks and spalling of the mud wall as well as falling roof tiles.

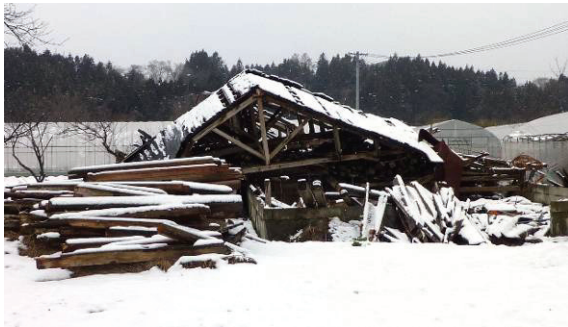
In residential areas, many structures such as barns and small storage buildings collapsed. These structures did not have adequate seismic considerations. Examples of such damage are in Fig. 12 and Fig. 13.

Fig. 12 Collapse of shed in Kurihara

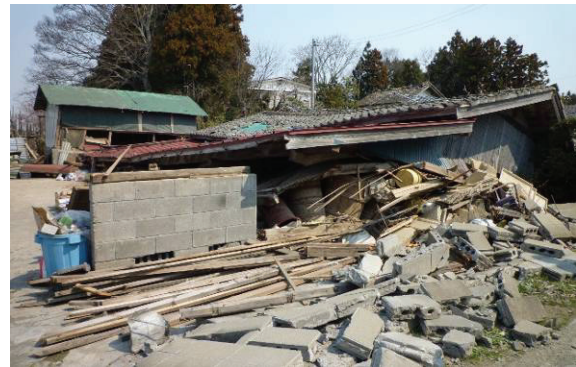
Fig.13 Collapse of shed in Kurihara

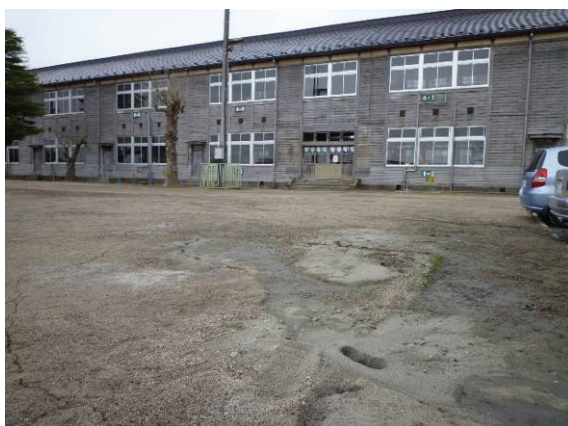
School buildings were a mixture of old timber construction methods and new laminated timber structures. A schoolhouse using older timber construction was reported to have a partial second floor collapse and large deformations in Osaki city as well as traces of sand boiling in the schoolyard, caused by liquefaction of the sandy ground. Fig. 14 shows the markings indicating sand boiling. In Iwaki timber schoolhouses are heavily damaged as shown in Fig. 15.

Fig.14 Damage of school building and markings of sand boiling in Osaki

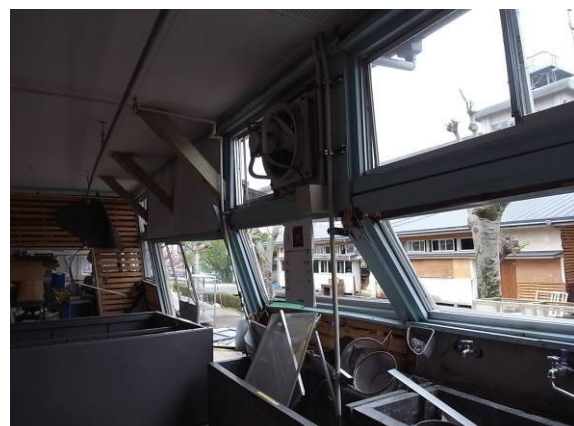
Fig.15 Severe damage of school building in Iwaki

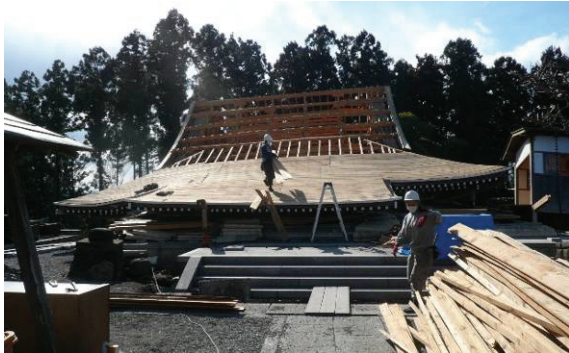
Damage to shrines are widely reported across the Northeast of Japan with a notable collapse of the main building of a temple in Takanezawa town, seen in Fig. 16.

Fig.16 Collapse of the main building of temple in Takanezawa

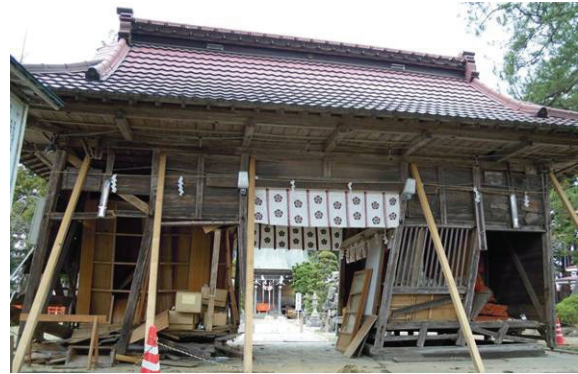
In addition, Fig. 17 shows the severe damage of the gate to a shrine in Osaki-city. Marks around the site seem to indicate sand boiling caused by the liquefaction of the sandy ground. These shrines used traditional wooden construction methods and were located on soft soils.

Fig.17 Severe damage to the gate of a shrine in Osaki

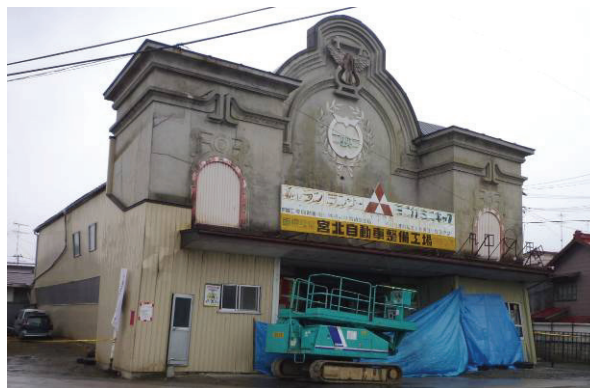
In addition to other building types discussed, a renovated theater in Kurihara-city experienced large residual deformation, evident in Figure 18.

Fig. 18 Severe damage of old cinema in Kurihara-city

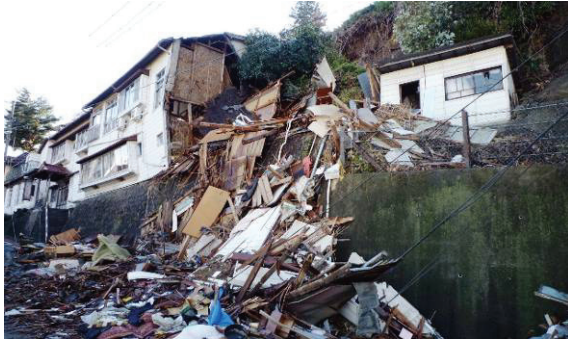
Fig. 19 Collapse of hotel due to landslide in Sendai-city

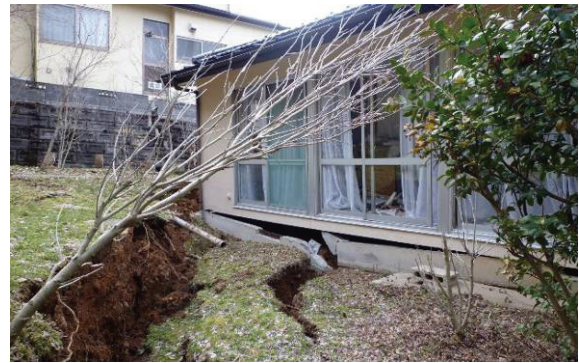
Fig. 20 Severe of a house due to landslide in Sendai-city

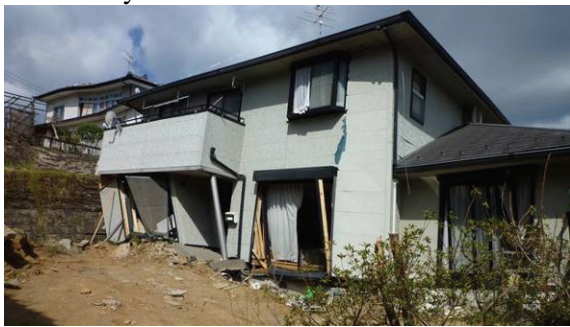
Fig. 21 Severe damage of a house due to landslide in Sendai-city

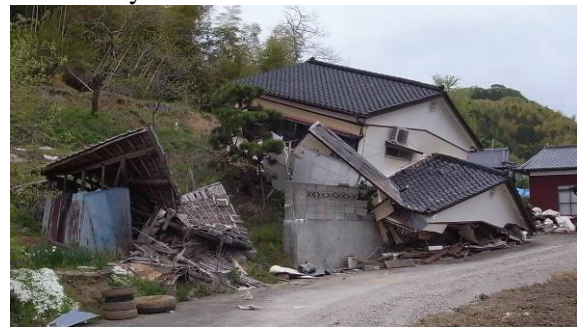
Fig. 22 Severe damage of a house due to landslide in Iwaki-city

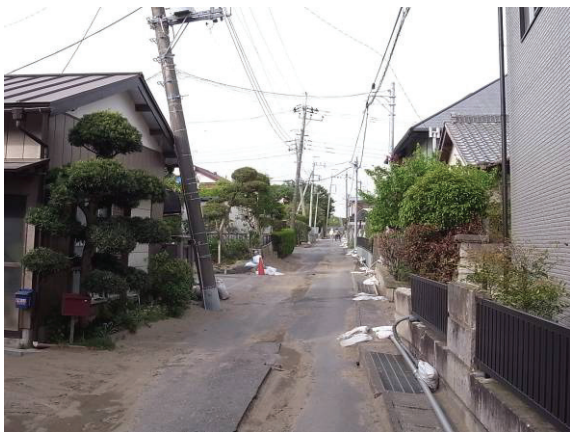
Fig.23 Damage due to liquefaction in Katori-city

Prefecture and Kuki city in Saitama Prefecture. The structural damage to the superstructure due to liquefaction was rather small if it used a reinforced concrete foundation. Damage was typically in the form of structural inclination and subsidence.

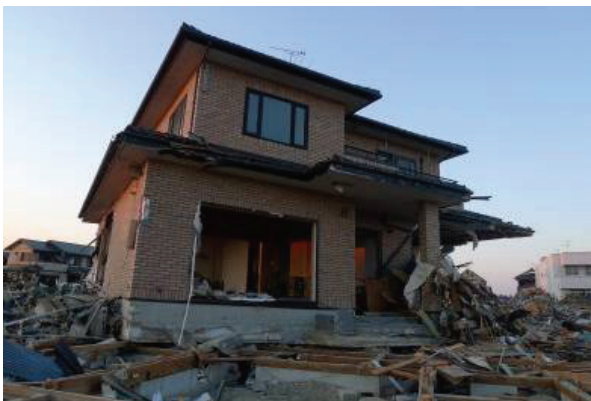
Initial investigation was conducted on the house in Fig. 28 at location (1) (Circled numbers in Fig.27 and so on), which had been carried away with the foundation attached. The junction of the foundation to the steel pile failed due to the force of the tsunami, leaving the steel pipe piles in the sand since in Fig. 29 at location (2). This would indicate that the tsunami wave was moving east to west-southwest.

Fig. 28 Wooden house that was carried away with foundation

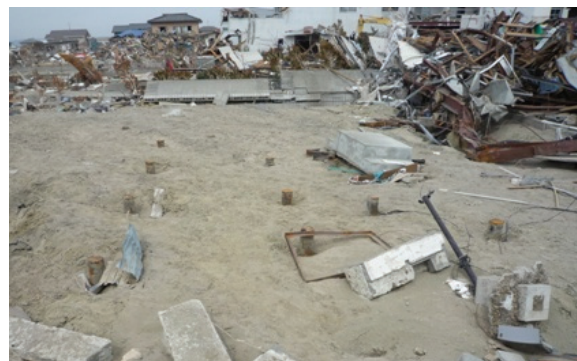
Fig. 29 Steel pile left at the original position of Figure 28

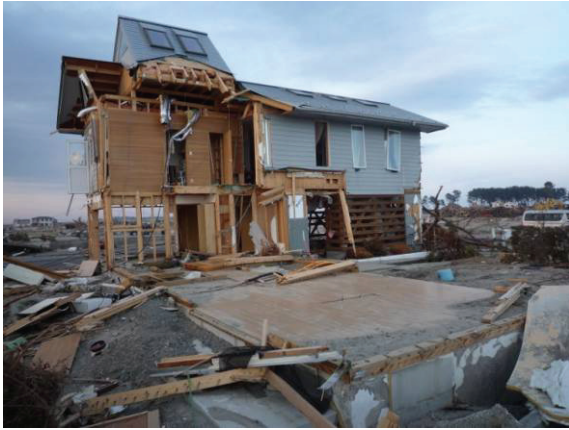
The extent of the severe damage was mostly on the eastern peninsular region. One wooden building, as pictured in Fig. 36, was previously “L” shaped in plan. The part of the house that had the largest amount of area exposed to the tsunami wave washed away while the shorter side remained. Judging from the connection in Fig. 37, the estimated date of construction was after 2000, revised building standard in Japan.

Fig. 36 A portion of a wood house that was washed away

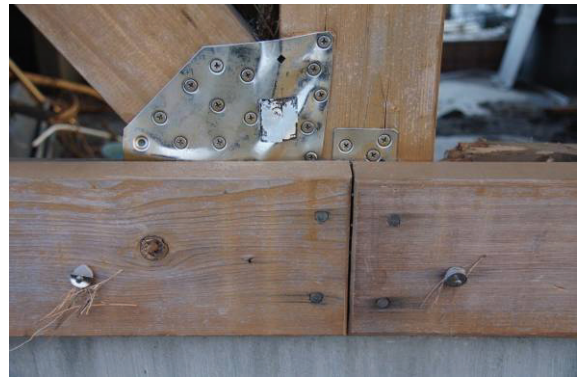
Fig. 37 Fastener of joint in the house of Fig. 36

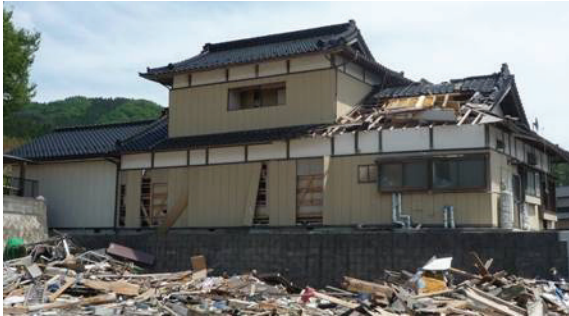
Fig. 45 shows a traditional Japanese wood house in location (5) that survived the inundation depth of about 5-6 meters and it was located 1.5 meters above the road level. Although the walls were destroyed the structure was intact, and there seemed to be little residual deformation in the house. Fig. 46 in location (6) was about 2 meters above the road level. The house was spared despite floodwater levels reaching 6 meters, damaging parts of the roof as well as the house. A relatively new house to the northeast was washed away. This house was equipped with significant tie-down hardware and large partial corrosive pores were observed. This indicates that the tie-down hardware was not sufficient to fix the house to the foundation.

Fig. 46 Wooden house that avoided being carried away even with flood damage up to the 1st floor roof

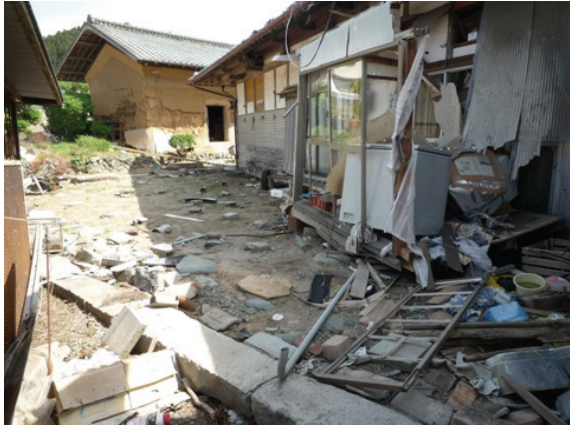
was con-firmed to have one brace with nailed joints and anchor bolts into the foundation. In addition, despite a 3.8-meter inundation depth, a dilapidated warehouse in location (11) remained standing (Fig. 48). Just to the East in location (12), old houses were rotated about 30 degrees clockwise (Fig. 49). The fact that some of these older buildings withstood these floodwaters suggests that the slope reduced the force of the tsunami in contrast to the lowlands.

Fig. 49 Survived old house which was rotated
