# LIQUEFACTION IMPACTS IN RESIDENTIAL AREAS IN THE 2010-2011 CHRISTCHURCH EARTHQUAKES

Misko CUBRINOVSKI<sup>1</sup>, Duncan HENDERSON<sup>2</sup> and Brendon BRADLEY<sup>3</sup>

**ABSTRACT:** In 2010 and 2011, the city of Christchurch (New Zealand) was hit by a sequence of strong, local and devastating earthquakes. Widespread and very severe liquefaction affected many of the city suburbs and its central business district. This paper summarizes the characteristics of liquefaction and discusses its impacts on residential houses and buried pipe networks.

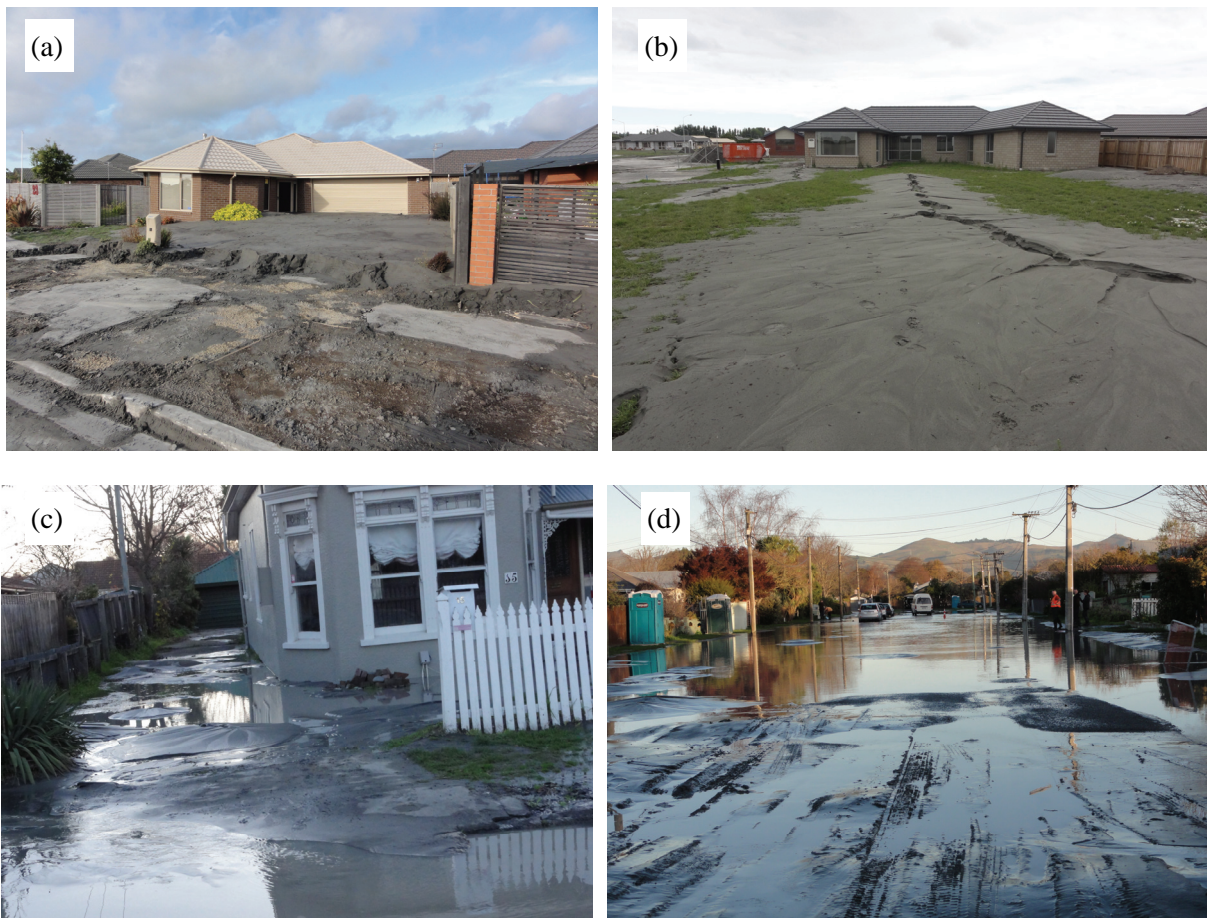
Figure 6 illustrates typical manifestation of severe liquefaction in the eastern suburbs of Christchurch. There was widespread and very large in volume (thickness) sand/silt ejecta covering the residential properties and streets in these suburbs. In numerous cases the entire area of the property was covered by 50-60 cm thick silt/sand ejecta (Figure 6a), and massive in size sand boils (Figure 6b) indicated very severe (and often extreme) liquefaction of loose to very loose soils highly susceptible to liquefaction. In the worst affected areas, extreme liquefaction with mud and water flooding entire streets and adjacent properties and even larger neighborhoods encompassing several streets within a suburb. Following the 22 February 2011 earthquake, over 400 000 t of silt/sand ejecta was removed in the clean up of streets and properties which indicates both the extreme severity and extent of the liquefaction. While the 22 February event caused in most cases the most severe liquefaction, a complete flooding of streets and very severe liquefaction occurred in these areas also during other earthquakes, as illustrated in Figures 6c and 6d where substantial sand boils and effects of liquefaction are seen in Avonside and Avondale after the 13 June earthquakes.

Fig. 6 Severe liquefaction in residential areas (suburbs along Avon River in the abandoned “red zone”)

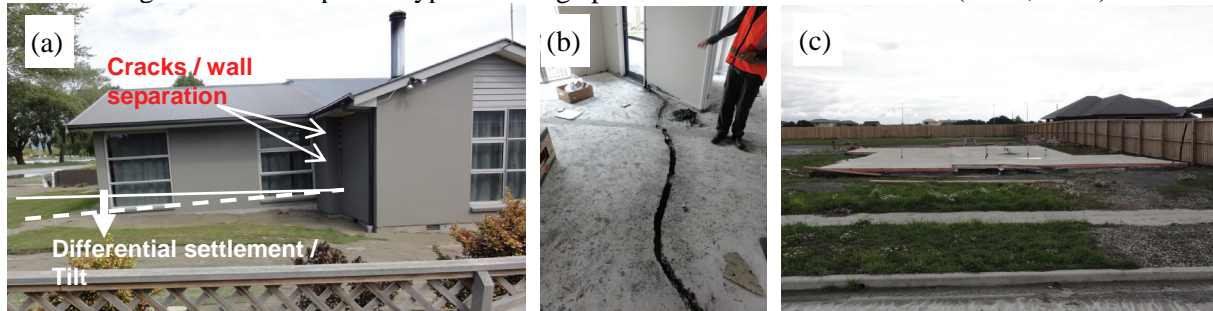
The liquefaction often led to large global and differential settlements. In the worst cases, the total (global) settlement exceeded 40-50 cm. Differential settlement resulting in permanent tilt of houses and often causing foundation and structural damage (Figure 9a) was the most common mode of deformation for both foundation types. Concrete slabs suffered serious damage including wide cracks (Figure 9b), and non-uniform deformation such as dishing (sagging) and hogging. Figure 9c shows a characteristic dishing of a newly constructed slab on grade which was affected by heavy liquefaction in the foundation soils. A number of different deformation modes could be identified for the perimeter

Fig. 9 Observed typical liquefaction-damage to house foundations: (a) differential settlement resulting in tilt and damage to house; (b) large crack in a concrete slab; (c) dishing of concrete slab on grade

footing foundations including humping of floors (often in individual rooms) due to larger settlement beneath the heavier walls, dishing caused by heavy brick chimneys founded on isolated footings in the interior of the floor plan, and racking/twisting of the superstructure caused by differential settlement/movement of corners/parts of the foundation due to its inadequate stiffness.

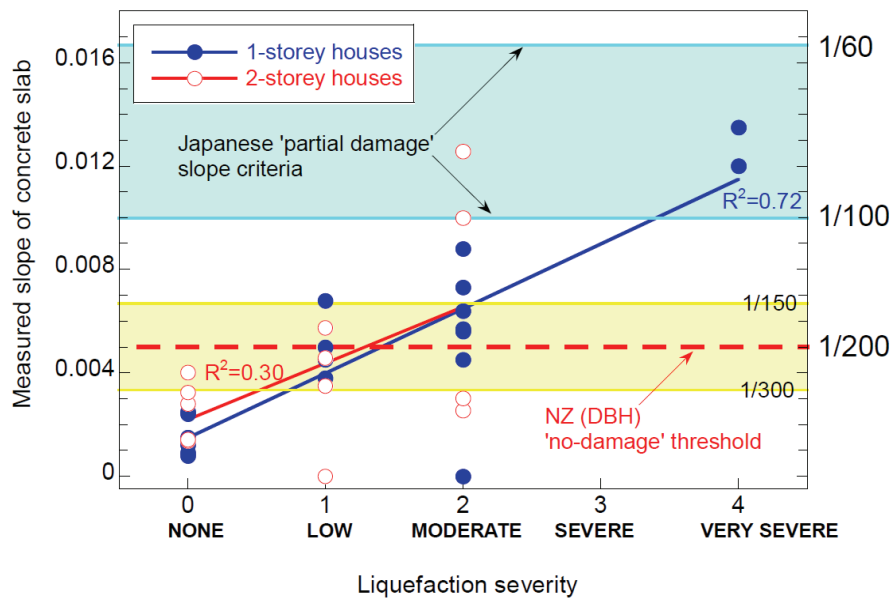
Correlation between the slope of concrete slab foundations (a proxy for the tilt as well) and liquefaction severity (0=none, 1=low, 2=moderate, 3=severe, 4=very severe, extreme liquefaction) is shown in Figure 10. Here, the maximum floor slope is shown based on approximately 15-20 floor elevation measurements across the footprint of the building. The plot also indicates several recently developed damage criteria in New Zealand (DBH, 2011) and Japanese practices (Yasuda et al., 2012) based on experiences from the 2010-2011 Christchurch earthquakes and 2011 Great East Japan earthquake respectively. The shaded (yellow) area (1/300 to 1/150 slope) indicate the typical range of slope found in newly constructed concrete floor slabs (the average slope between two points 2m apart), DBH, 2011). In the DBH guidelines for repairing and rebuilding of houses affected by the Christchurch earthquakes, differential settlement (floor slope) and cracks width have been adopted as criteria to evaluate whether the foundation damage requires repair or not, as summarized in Table 2. The 1/200 slope is also indicated in Figure 10, as a reference 'no-damage' threshold. It is interesting to note that the new Japanese evaluation criteria for damage to houses (Yasuda et al., 2012) are defined as: partial damage (1/100 to 1/60), substantial damage (1/60 to 1/20) and severe destruction (over 1/20 slope). It is apparent from Figure 10, that the measured slope of concrete slabs was clearly related to the severity of liquefaction. In general, in areas of no/low liquefaction, the measured slope was within the construction tolerance or allowable slope. In areas of moderate and particularly severe liquefaction, however, the slope was often above the allowable threshold slope of 1/200. In several cases, the slope exceeded the partial damage limit of 1/100 specified in the Japanese assessment criteria.

Fig. 10 Correlation between liquefaction severity and measured slope of concrete slab foundations for 32 houses in Christchurch with reference to recent New Zealand and Japanese damage criteria

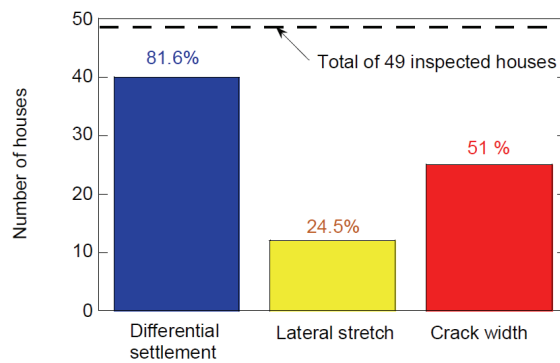
Fig. 11 Summary of damage to concrete perimeter foundations (49 inspected houses in Christchurch) indicating percentage of foundations exceeding the DBH no-damage criteria listed in Table 2

The 49 inspected perimeter footing foundations were scrutinized against the DBH damage criteria listed in Table 2. Since most of these foundations/houses were old (pre 1930, 1930-1959, 1960-1979) and of poor quality (often without any reinforcement), they suffered very high proportion of damage: 82% had tilts exceeding 1/200, 25% had total width of cracks exceeding 20mm and 51% max width of a single crack over 5mm. The damage for these foundations was poorly related to the liquefaction severity, and 8 foundations showed damage greater than at least one of the criteria listed in Table 2 despite being located in areas of no liquefaction.

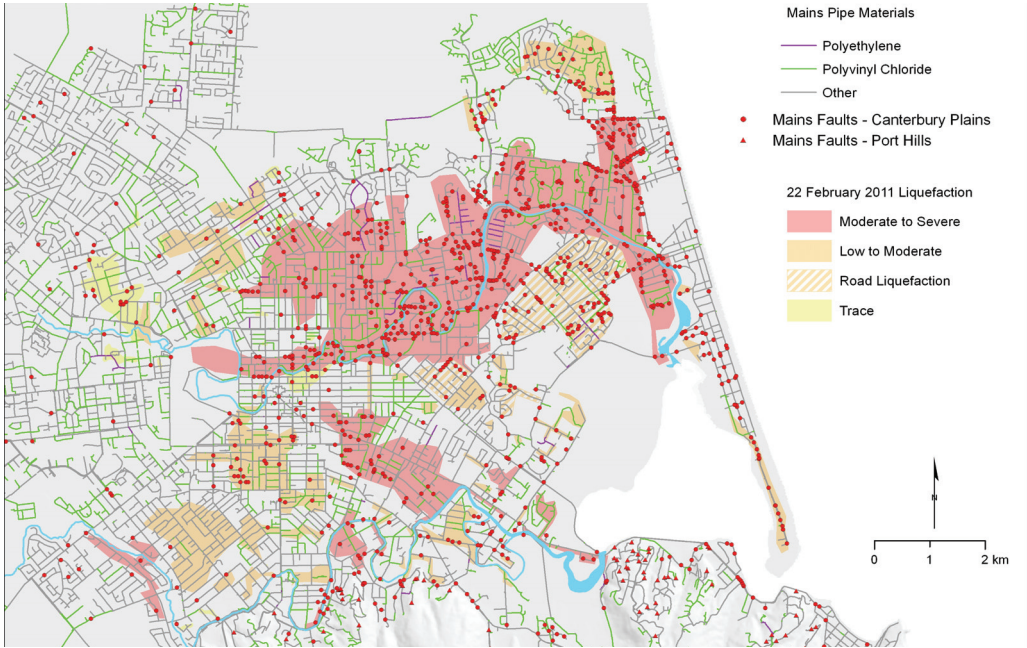
Figure 12 shows the location of repairs/faults on the watermains network (red symbols) following the 22 February 2011 earthquake. Superimposed in the background of the figure (with red, orange and yellow colours) is the liquefaction map (Cubrinovski and Taylor, 2011) indicating the severity of liquefaction (and associated land damage) induced by this earthquake. Preliminary GIS analyses (Cubrinovski et al., 2011) using the pipe network damage data and liquefaction observation maps show a clear link between the damage to the pipe network and liquefaction severity. Approximately 58% of the damaged pipes were in areas of moderate to severe liquefaction, 20.2% were in areas of low to moderate liquefaction, 2.5% in areas where traces of liquefaction were observed and 19.3% in areas where no signs of liquefaction were observed.

Fig. 12 Liquefaction map and locations of damage to the potable water network of mains (red symbols) of Christchurch due to the 22 February 2011 earthquake (Cubrinovski et al., 2011)

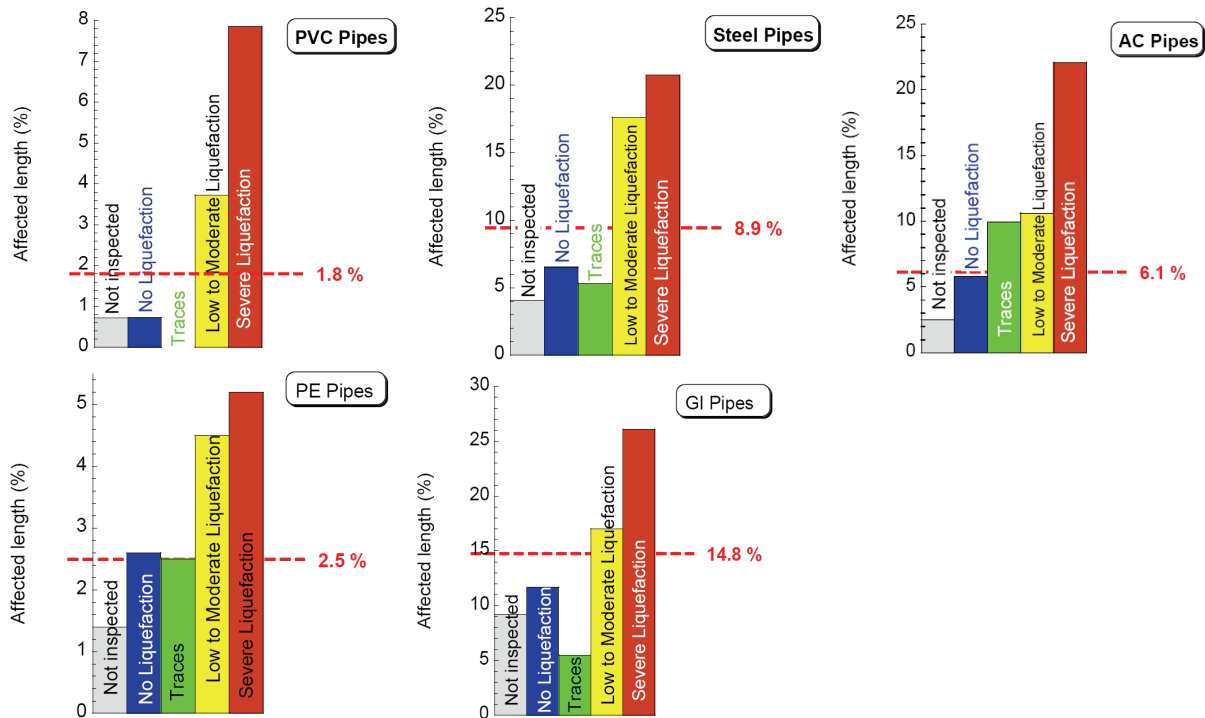
The analyses also revealed that PE pipes and PVC pipes suffered significantly less damage (three to five times less on average) than AC, steel, GI and other material pipes. Figure 13 summarizes the performance of different pipe materials (PVC, steel and AC pipes for the watermains; PE and GI pipes for the submains) and clearly indicates the difference in the performance of different pipe materials and the increase in the pipe network damage with increasing liquefaction severity.

Fig. 13 Summary of damage to water pipes due to the 22 February 2011 earthquake indicating performance of different materials in relation to liquefaction severity: Water mains: (a) PVC, (b) Steel, (c) Asbestos Cement pipes; Submains: (d) PE, (e) Galvanized Iron pipes
