QUICK REPORT OF 2011 VAN EARTHQUAKE

Key Words: 2011 Van earthquake, damage reconnaissance, R/C buildings, Masonry buildings, Damage classification

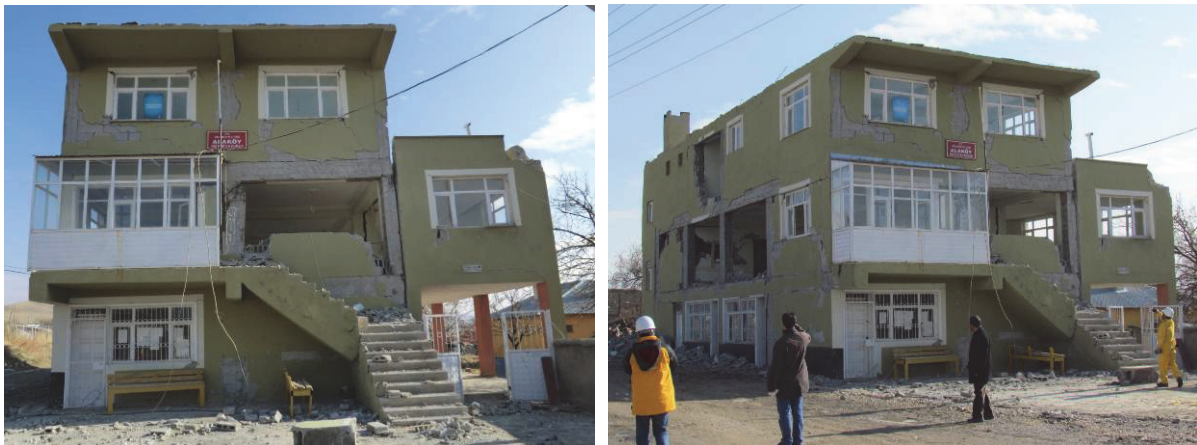
Photo 1 Overview of building

The school building shown in Photo 1 is located in Alakoy and consisted of structurally independent two reinforced concrete buildings stand side by side: three-story and two-story reinforced concrete buildings. The three-story building was severely damaged.

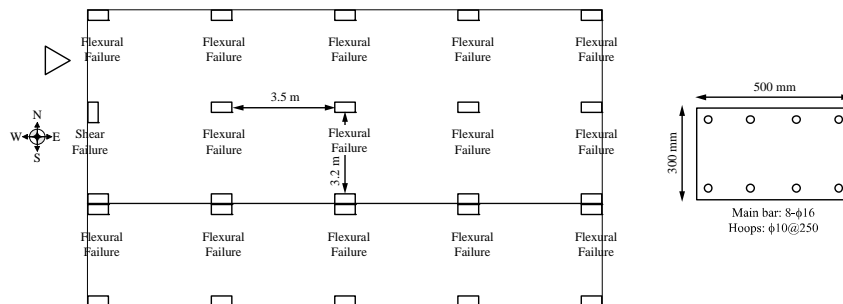
Fig. 2 Second floor plan and damage pattern of columns

The second floor plan of the buildings and damage patterns are shown in Fig. 2. The details of damage are written beneath the column depicted by rectangular in Fig. 2. The three-story building has four spans in the longitudinal direction and three bays in the transverse direction, and those of span lengths are shown in Fig. 2. The columns are arranged in the same direction, except the column on the west side, beside the entrance indicated as a triangle symbol. The typical geometry of cross section of the columns shown in Fig. 2 has eighteen $\phi 16$ plain bars, a $\phi 10$ plain bar hoop spaced at 250 mm approximately, and 20 mm of concrete cover. A clear height of 2.1 m at the second floor was assumed.

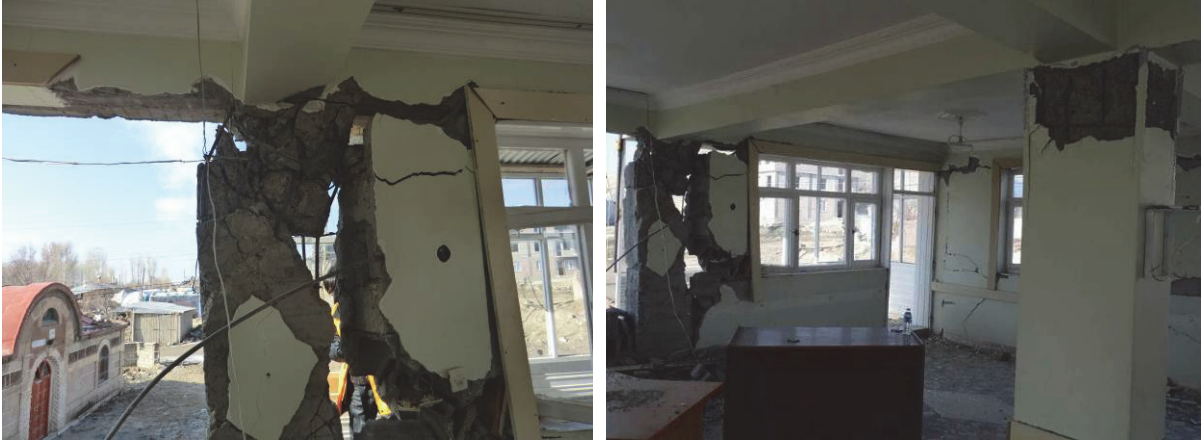
Photo 2(a) shows details of a west side column failed in shear. Concrete of the core was splitted off by the shear crack and the longitudinal reinforcement buckled. All the columns failed in flexure in north-south direction except the west side column as shown in Photo 2(b). Photo 3 shows the expansion joint between two buildings and approximately gap of 60 mm at the top of the second floor column observed. The unreinforced concrete masonry wall was damaged and had several shear cracks of non-structural components.

(a) West side column failing in shear (b) Column flexural yielding at the top
 Photo 2 Details of damaged columns

The calculated ultimate strengths of the columns are listed on Table 2. The story shear strength of the floor is calculated as 674.4 kN, and the base shear strength coefficient, C_B is calculated by using the floor weight of two floors (2,688 kN) as 0.25. The west side end column was judged as failing in flexure as shown in Table 2, hence material property or bar arrangement detail are need to be discussed.

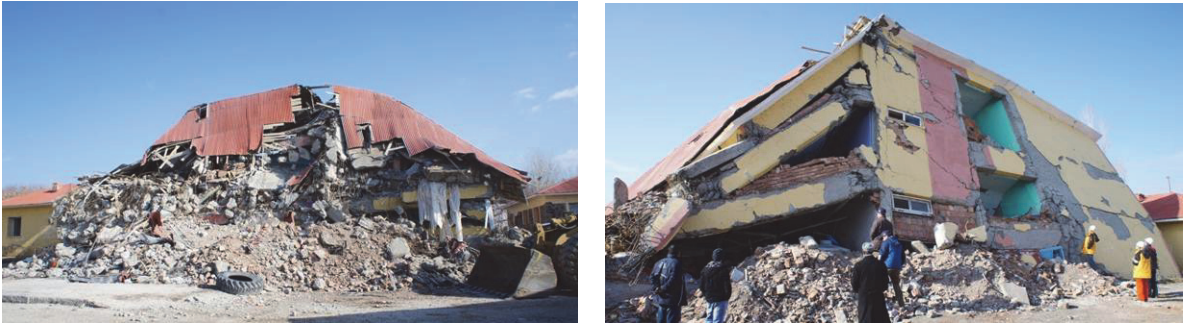
The building is three stories reinforced concrete building which is located at a village apart around 2 kilometers from the epicenter of the main-shock (October 23rd). The building was constructed in sometime from 1980 to 1990. All stories completely collapsed by the earthquake as shown in Photo 4. Fortunately no students and no teachers were killed, because the earthquake occurred on holiday. Since no structural and construction information is available, unquestionable reason of the collapse is unknown. Many beams and columns were observed to be separated at the joint as shown in Photo 5(a). The reasons of such premature failures at joints were because of short anchorage length of beam main rebar to column and lack of confinement in the joint, as shown in Photo 5(b). The photograph also shows the ineffective anchorage length in the bottom bars of beam, which demonstrates the structural design and/or detailing was conducted only for vertical load, not for seismic load. Thus, the building must have collapsed by separation of beams and columns at every joint one after another during the earthquake, without providing enough resistance of structural members.

(a) West side of view (b) East side of view
Photo 4 Overview of building

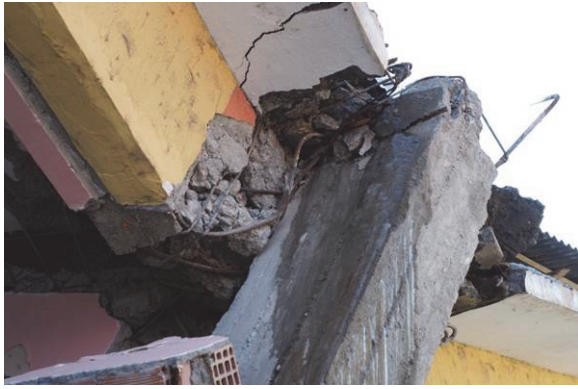
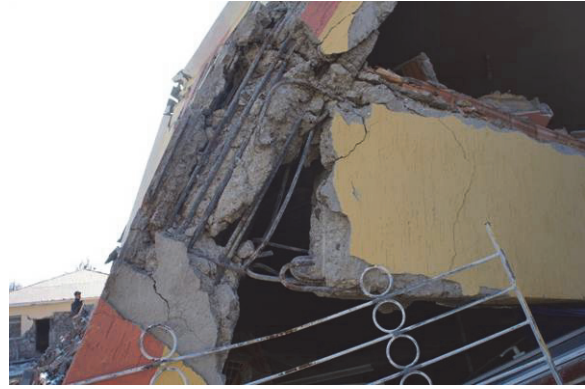
(a) Separation between beam and column (b) Anchorage failure of beam main rebar
 Photo 5 Details of damaged beam-column joint

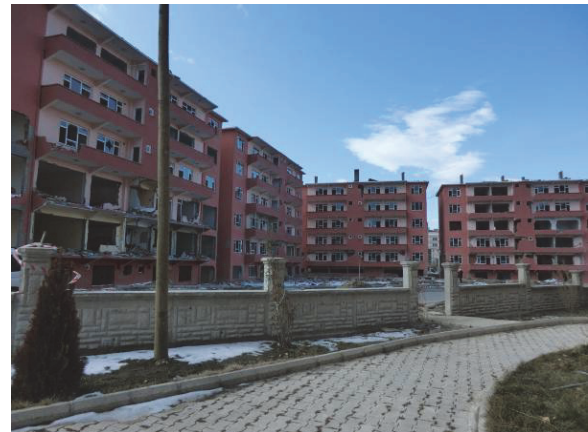
Photo 6 North-east side view of the buildings

Four apartment buildings as shown in Photo 6 were investigated. The buildings are six stories reinforced concrete buildings, and their layout is shown in Fig. 3. The first and second floor plan with the damage level in the longitudinal direction of structural members of Building A, B, C and D are shown in Fig. 4 to Fig. 7, respectively. Photo 7(a) shows details of shear failure at the top of a south side column. The beam-column joint failure was observed in the south-east corner of Building C as shown in Photo 7(b).

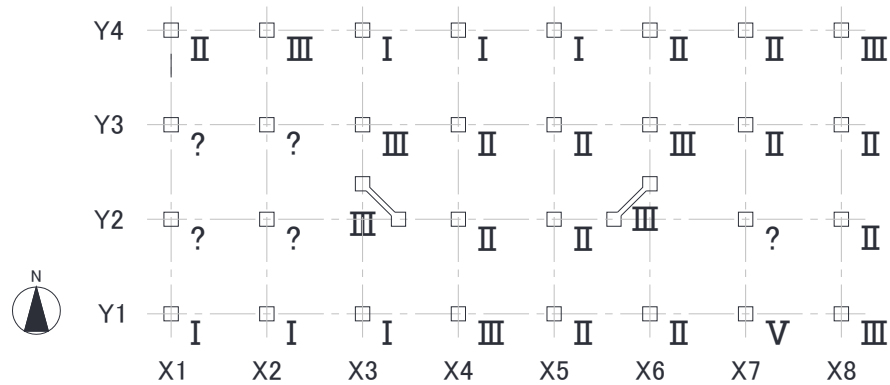
Fig. 4 Second floor plan and damage level of structural members (Building A)

Damage evaluation method	
	Method 1 (Flexural failure)	Method 2 (Shear failure)
Building A	Severe damage	Severe damage
Building B	Moderate damage	Severe damage
Building C	Moderate damage	Moderate damage
Building D	Minor damage	Moderate damage

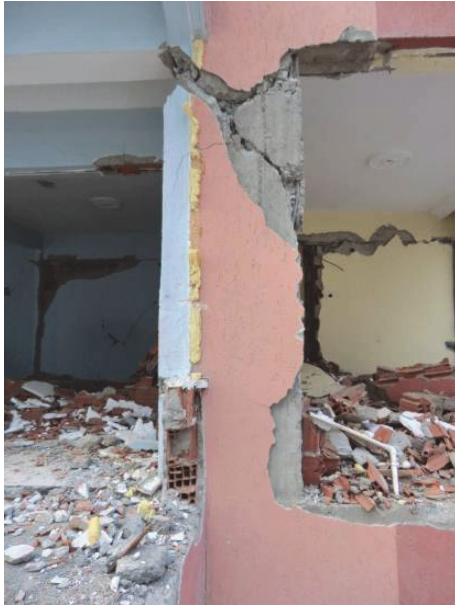
(a) shear failure of south side column of Building A (damage level V)

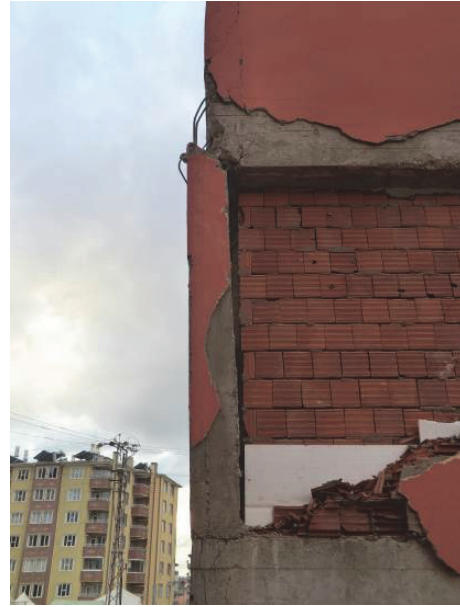
(b) beam-column joint failure (south-east corner of Building C)

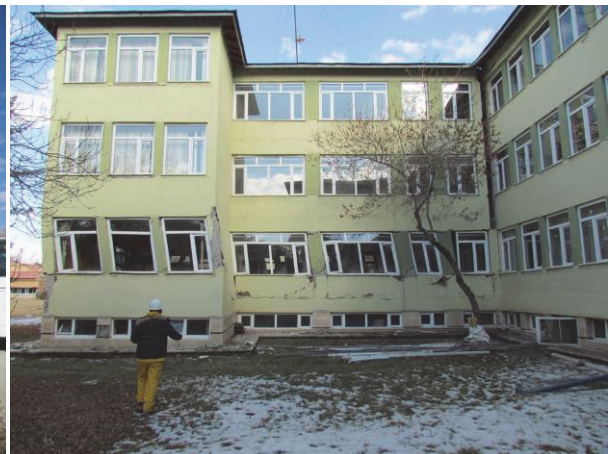
Photo 9 South side of Building C

Building C was severely damaged as shown in Photo 9. All columns yielded at the top and bottom ends of column and residual deformation was measured as about 7 degree. The residual gap between Building B and C at the second floor level is 30cm. Dimensions of all columns are the same, 200mm by 500mm. Bar arrangements in the columns were also investigated through cracks and with radar. There are four bars as main bar, of which diameter is 16mm, and diameter of hoop is 8mm with spacing of 200mm. The plan and column arrangement of building C is shown in Fig. 5. Clear heights of columns, story heights, standing wall heights, and total height of the building are also shown in the figure.

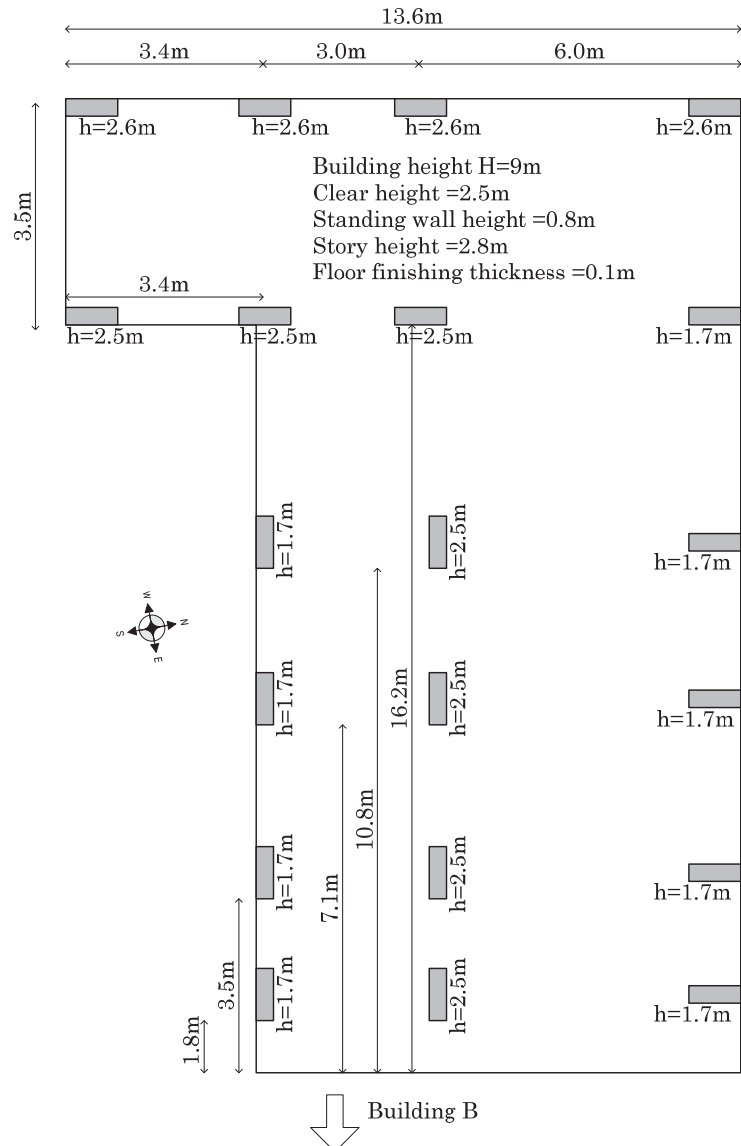
Fig. 5 Floor plan and column arrangement of building C

Table 4 shows the calculated strengths. Only the column with D of 500mm and h of 1700mm is evaluated to fail in shear, although it showed flexural failure. Material tests are needed to discuss the failure mode. Story shear strength is calculated as 1006.01kN, $C_B=0.14$.

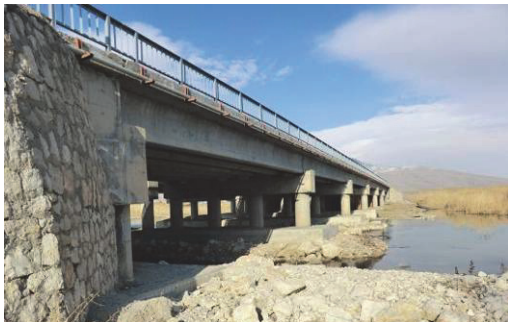
The type of bridges in damaged area was mainly simple concrete beam bridge (Photo 10(a)). Some bridges employed rubber bearings to have the effect of the seismic isolation as well as for consideration of thermal effects (Photo 10(b)). The use of airport terminal building was limited due to the damage of airport building. It should be mentioned the damage observed by our team was limited with the damages of non-structural members. On the other hand, the airplane service was completely recovered by utilization the new terminal building, which was taken into service right after the second earthquake (Nov.9th) (Photo 10(c)). The railway is normally used for international logistic service. The railway was available after the earthquake with no heavy damage (Photo 10(d)). The small scale industrial structures in the old industry zone were partially damaged. The structural systems of typical manufacturing structures were RC frames and infill wall of concrete blocks (Photo 11(a)). Photo 11(b) shows the total collapse of a manufacturing building. The adobe houses were also severely damaged (Photo 12(a)). The out of plane failure on the wall was observed (Photo 12(b)).

(a) Bridge with no significant damage

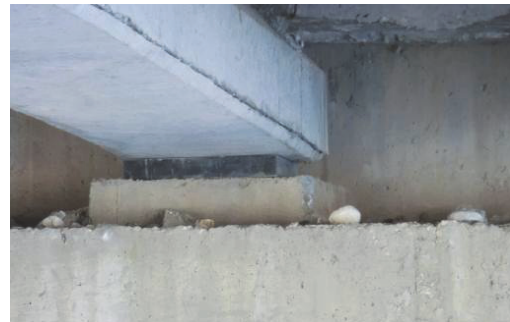
(b) Rubber bearing of photo(a)

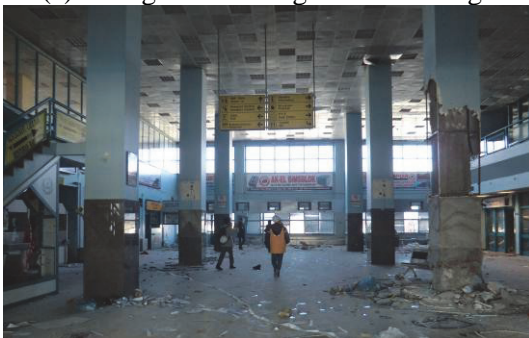
(c) Damage of airport

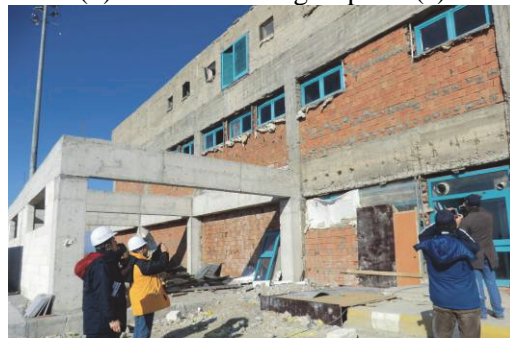
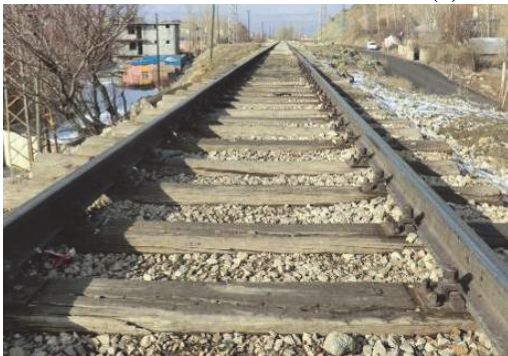
(d) Railway with no significant damage
Photo 10 Damage of infrastructures

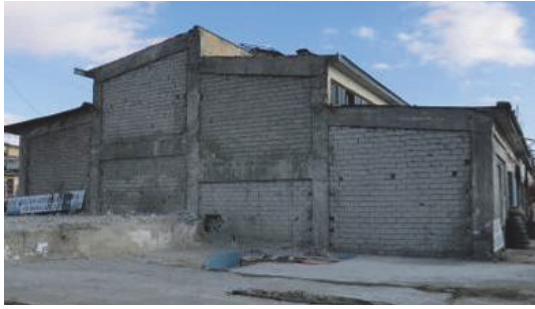
(a) Typical industrial structure

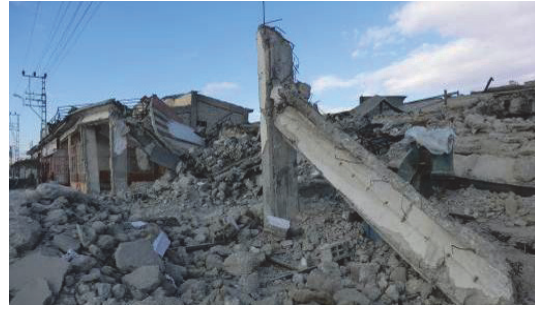
(b) Collapse of an industrial building

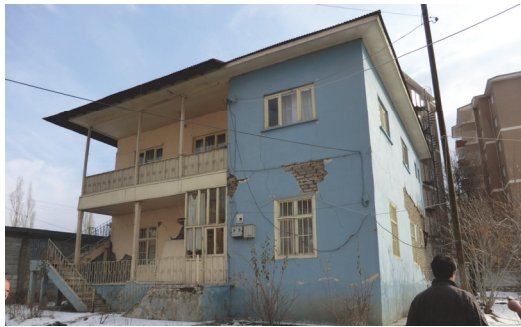
(a) Damage of adobe house

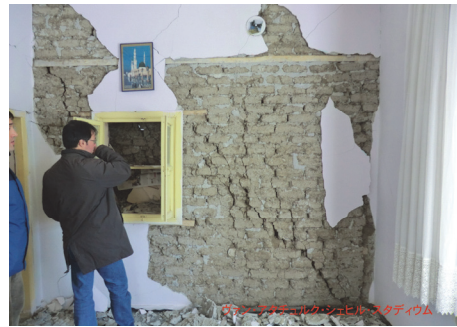
(b) Out of plane failure
