STRUCTURAL ASSESSMENT OF A REPAIRED CABLE BRIDGE DAMAGED IN 1999 CHI-CHI EARTHQUAKE

ABSTRACT: The Chi-Lu cable-stayed bridge was damaged during Chi-Chi Earthquake just before completion of its construction. Urgent repairs were made following the earthquake without having made a detailed assessment of the damaged structure. To assess the structural safety, a series of field tests were implemented, including load tests, ambient vibration test and forced vibration test. This paper presents the assessments on the structural safety of the bridge by field tests before the official re-opening, and the health monitoring of this bridge since its reopening to general traffic conditions.

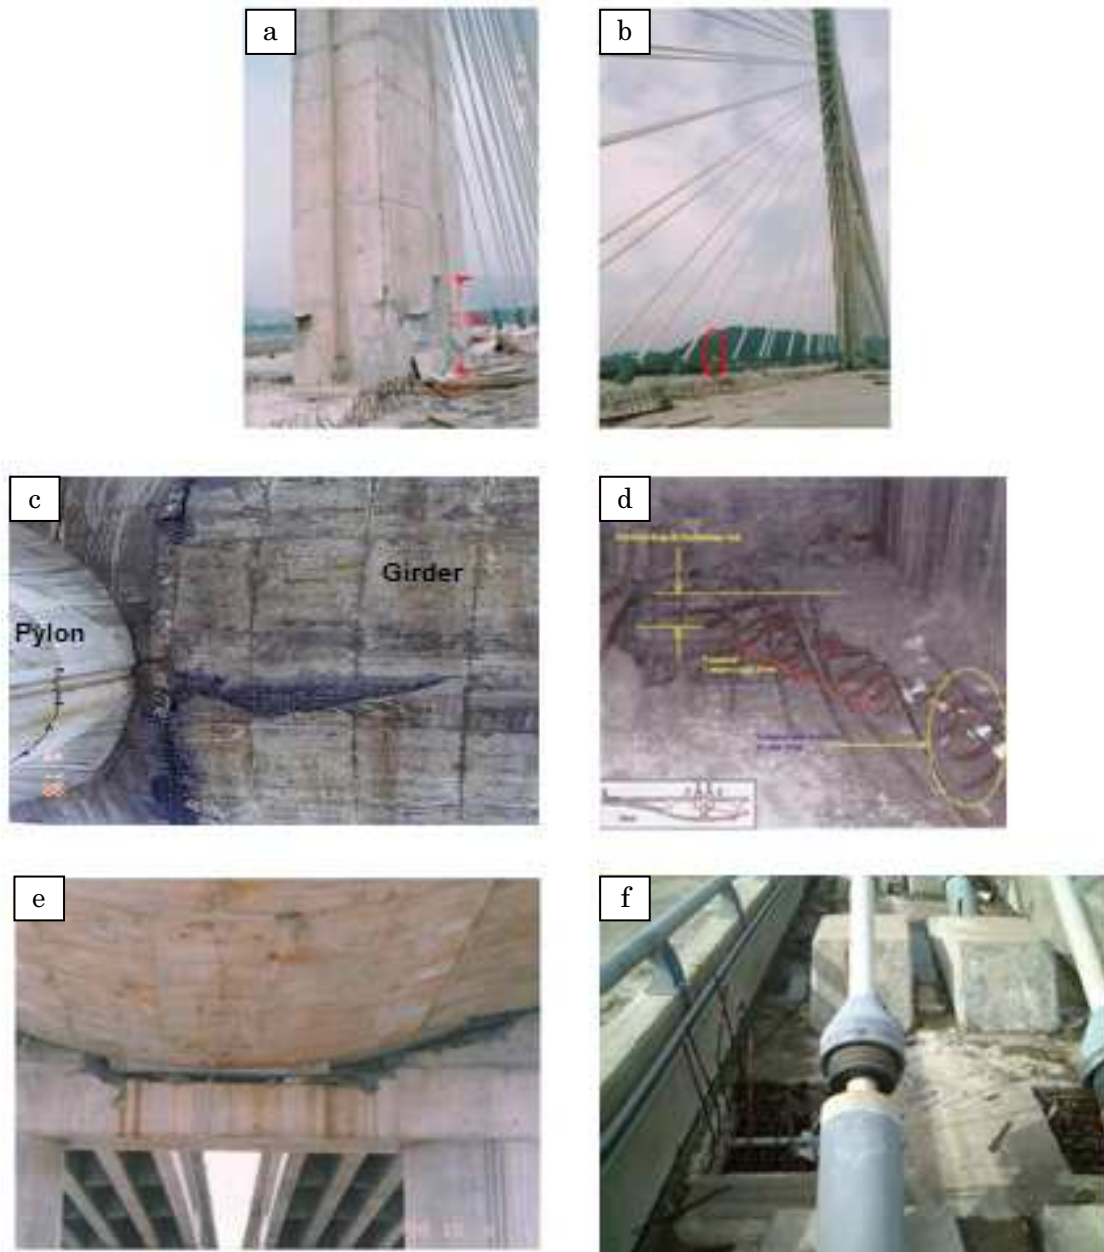
Shaken by Chi-Chi Earthquake, the Chi-Lu Cable-Stayed Bridge was known as the first damaged modern prestressed-concrete cable-stayed bridge. The observed damage is as follows. The protective concrete cover of the pylon spalled (Fig.3a); one cable fell onto the deck (Fig.3b); the soffit of the girder at the juncture with the pylon cracked (Fig.3c); the rebar in the transverse direction of the girder buckled in compression (Fig.3d); the cap beams of the two bents were damaged by the vertical and lateral pounding forces (Fig.3e); the eccentric device of the guide pipes come off (Fig.3f); and the elevation profile of the deck was lower than that of the design profile (Fig.4). For preventing further damage from more earthquakes, 18 supporting frames were set up (Fig.5) before completion of the repair.

Fig. 3 Chi-Lu Cable-Stayed Bridge damage after Chi-Chi Earthquake

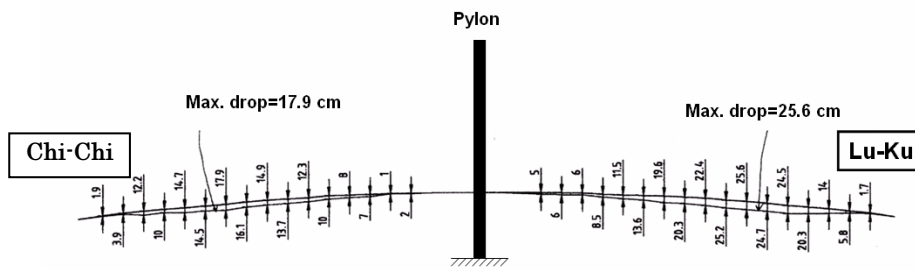
Fig. 4 Elevation profile of the deck after the earthquake

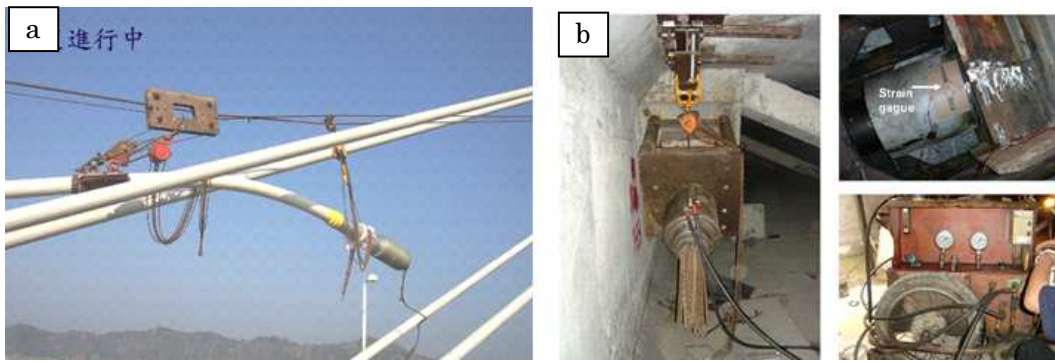
To verify the analyzed cable sag value, two surveyors measured the sag. From the survey, the sag is 50.0 cm, which is close to 49.0 cm. To verify the identified cable force 1.66E6 N, the hydraulic jack in Fig.8b read the cable force 1.69E6 N, which is also closed to the identified cable force 1.66E6 N. Without applying formulas, and not knowing the sag and the moment inertia in advance, the identified results yield good agreements with the surveyed sags as well as those measured cable forces. With the identified sag and the identified moment inertia, and the measured frequencies, by practical formulas (Zui H. et al. 1996), one can check on the cable force.

Fig.8 Repair of the cable system : (a) a cable with new anchor was hanged to the pylon, (b) the cable force was measured and tensioned inside the girder

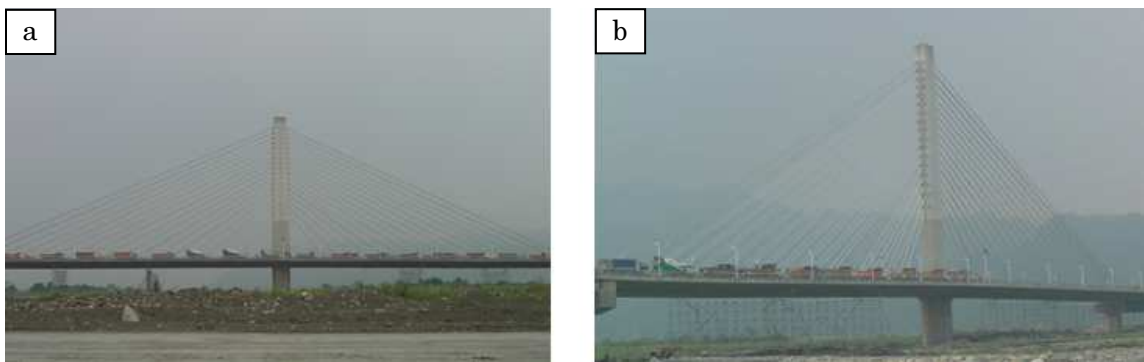
After Repair Stage 2, the bridge owner entrusted NCREE for the 2nd truck loading test. After the 2nd loading test, as shown in Fig.10, Chi-Lu Bridge was officially opened to the general traffic. During the 2nd loading test, to measure the response of the girder and pylon, both LVDT and tilt meter were deployed as shown in Fig.11. The LVDT were installed on the top of the scaffoldings, setup above the riverbed. Two critical loading patterns were applied on the deck. One is the two-span loading, and the other is single-span loading, as shown in Fig.10a and Fig.10b, respectively. Table 1 lists both the experimental results and the numerical results by the FEM model used the original design. In the two-span loading pattern, the displacement response is close to that of the design value; in the single-span loading pattern, the displacement response is more conservative than the design value. After the loading test that ensured the safety of the bridge, Chi-Lu Bridge then was officially opened to the general traffic.

Fig.10 The 2nd loading test after Repair Stage 2

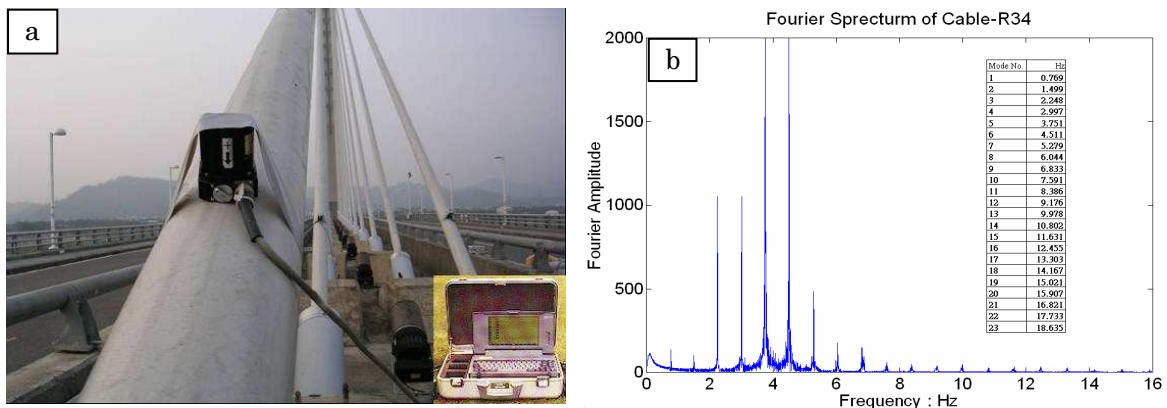
Consider the example of Cable R33, one of the four longest cables of this bridge. Fig.12b shows the measured velocity spectrum with 23 characteristic frequencies. On the other hand in the FEM analysis, a beam model subjected to gravity and geometry-nonlinearity was adopted. The parameters to be determined are the cable force and the moment inertia. After the optimization process, the identified cable force is 1.66E6 N, and the moment inertia is 5.0E-6 m⁴. Table 2 compares the characteristic frequencies from the measured and those from the analysis. The analyzed cable sag, shown in Fig.13, is 49.0 cm.

Fig.12 Cable vibration measurement and its signal spectrum

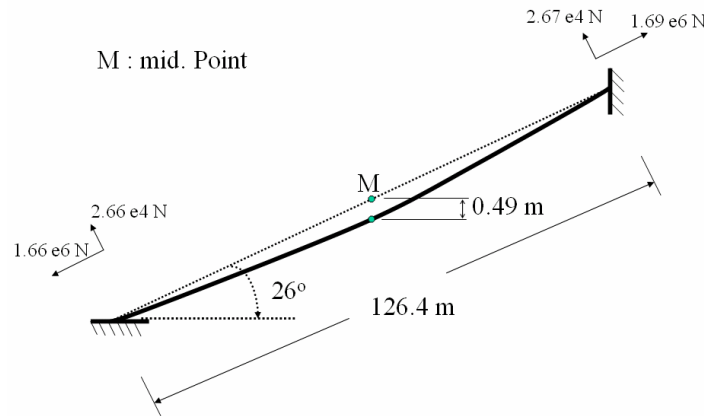
Fig.13 The identified cable configuration with sag 49 cm

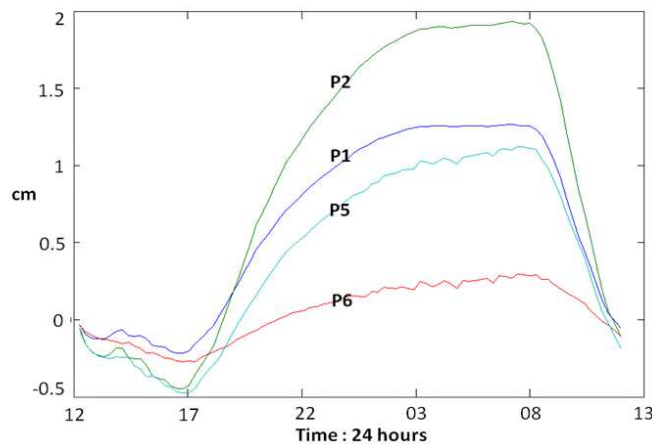
The level sensors were placed inside the girder, shown in Fig.15, where P3 and P4 were immediately beside the pylon and serve as reference points. Beginning at noon one day, and ending at noon the next day, the girder elevation was continually monitored for 24 hours in Fig.16. At 5:00 pm, the bridge temperature peaked, the steel cables lengthened, and P2 and P5 elevations decreased, whereas between 3:00 am and 8:00 am, the bridge temperature was the lowest, the steel cables contracted, and P2 and P5 elevation increased.

Fig.16 Monitoring the level change for 24 hours

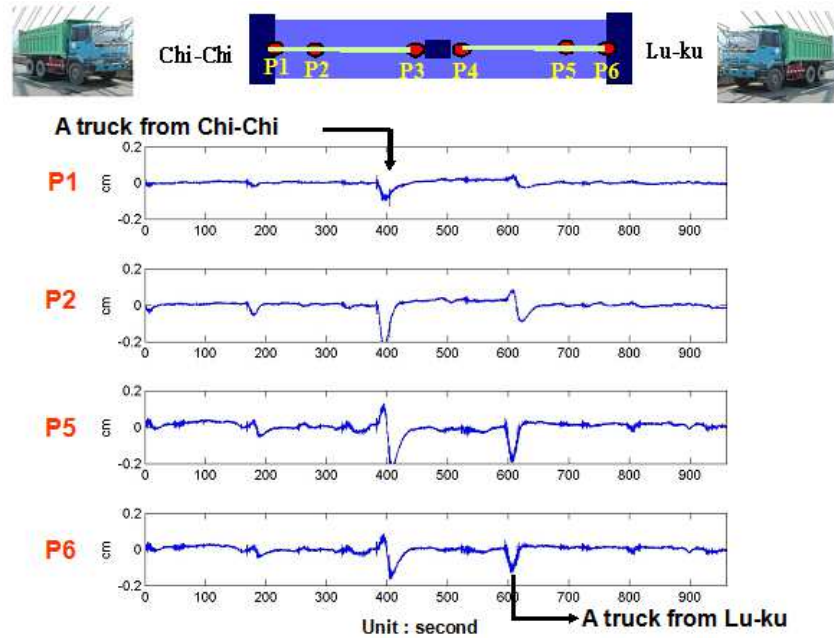
Furthermore, to observe the elevation change induced by traffic, the quasi-static signal in Fig.16 could be filtered out. As shown in Fig. 17, two trucks drove onto the deck at different time. The truck that first arrived had driven from Chi-Chi; thus, P1 and P2 simultaneously dropped and P5 and P6 simultaneously rose. When the truck passed the pylon and crossed over onto the Lu-Ku end, P1 and P2 increased to their original positions and P5 and P6 dropped simultaneously. When the truck left the bridge, the girder returned to its original stable level. About 200 s later, the second truck drove over the bridge from Lu-Ku. The change in the girder's elevation was similar to that under the first truck, only the order and timing of the dropping and rising was reversed. It is demonstrated that the FBG-based level sensors can trace the girder level influenced by temperature change and traffic loading. From the regular observation, the girder level is stable without obvious settlement since the bridge's opening to the general traffic.

Fig.17 Vertical response to two trucks

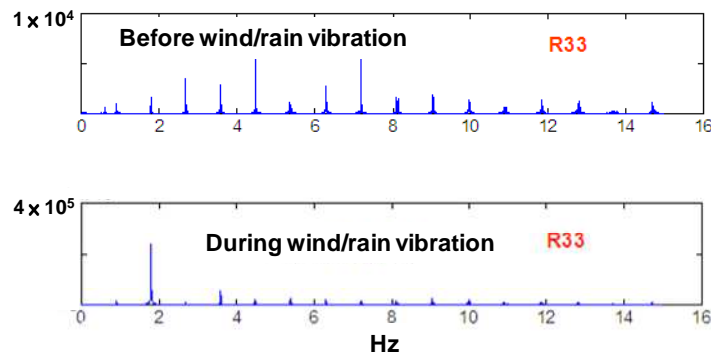
On July 28, 2008, Fung-Wong Typhoon went across Taiwan. Fig.19 shows the vibration spectrum of Cable R33 before and during the wind/rain vibration. From Fig.19, the vibration spectrum before the wind/rain vibration was distributed along each mode, but was more concentrated and stronger on the second mode during the wind/rain vibration. Besides, the strong cable vibration was also video-taped. The field observation demonstrates that some cables of Chi-Lu Cable-Stayed Bridge may behave in wind/rain instability.

Fig.19 Spectrum comparison before and during wind/rain vibration

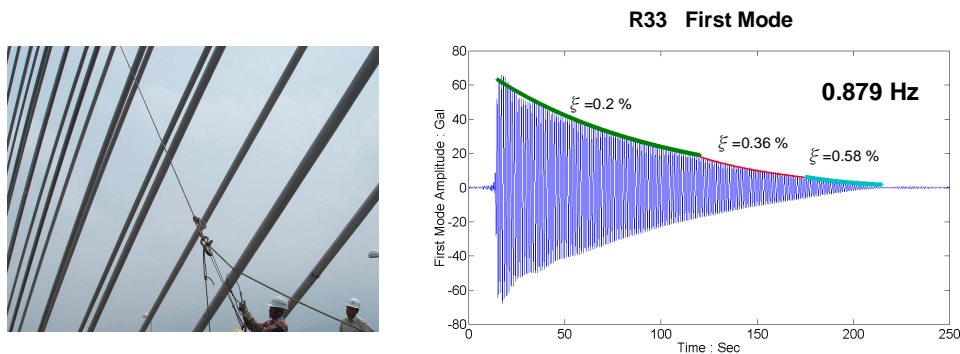
To further study the inherent cable damping (Pacheco, B. et al. 1993), a pull-and-release experiment, as shown in Fig. 20, was carried out to determine the damping ratio and the Scruton Number:

Where m is the mass per unit length, ξ is the damping ratio, ρ is the air density, and D is the cable diameter. Table 3 lists the Scruton Number for three cables. According to PTI (1993), if the Scruton Number is less than 1.7, wind/rain induced vibration will readily occur. The measured wind/rain vibration signal, the taped video, and the pull-and-release experiment agree with the PTI recommendations.

Fig.20 The pull-and-release forced vibration and the damping analysis
