# **EARTHQUAKE AND TSUNAMI DAMAGE ON STEEL BUILDINGS CAUSED BY THE 2011 TOHOKU JAPAN EARTHQUAKE**

**ABSTRACT:** The 2011 Tohoku Japan earthquake and tsunami caused extensive damage to steel building structures. Large slippage over a large inter-plate fault produced very high tsunami waves that attacked the east coast of Japan. The Committee of Steel Structures of the Architectural Institute of Japan carried out earthquake damage reconnaissance over cities where severe ground shaking was recorded among the prefectures of Miyagi and Fukushima. Tsunami damage reconnaissance was also conducted along the coastlines of Iwate, Miyagi, and Fukushima.

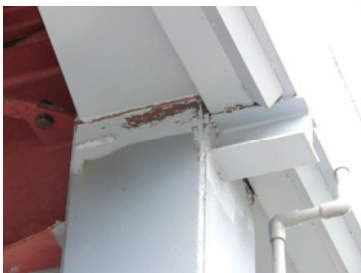
Brittle fracture of beam-to-column connections, which was observed widely after the 1995 Kobe earthquake, has not been reported from the Tohoku event. Photo 1 shows damage observed in an older structure that employed built-up HSS (hollow structural steel) columns made up of a light W-shape and a pair of cover plates. Such sections were commonly used before cold-formed HSS sections became available.

Photo 1 Yielding of an older built-up column (Koriyama)

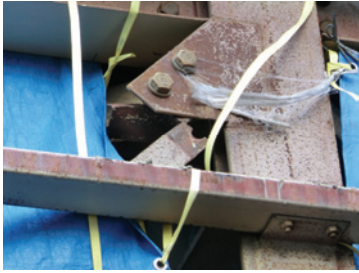
Photo 4 Net section fracture of single-angle brace (Miyagino, Sendai)

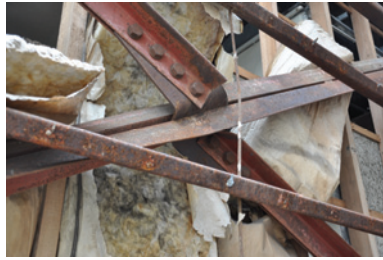
Photo 5 Bending of middle gusset plate in an X-brace (Miyagino, Sendai)

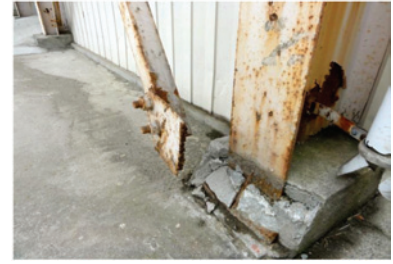
Photo 6 Fracture of gusset plate-to-column weld and spalling of concrete covering an exposed base plate (Ishinomaki)

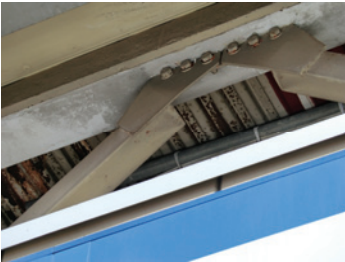
Photo 7 Out-of-plane deformation of gusset plate (Miyagino, Sendai)

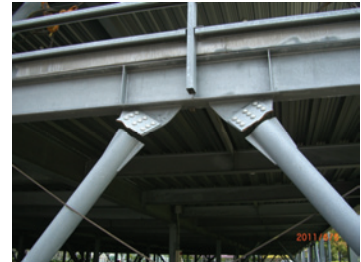
Photo 9 Out-of-plane deformation and fracture of gusset plates (Miyagino, Sendai)

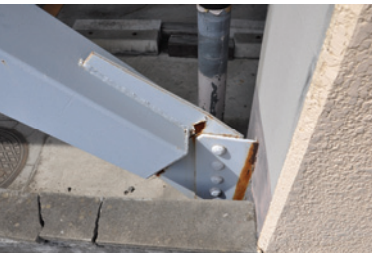
Photo 10 Out-of-plane deformation of gusset plate caused by compression (Miyagino, Sendai)

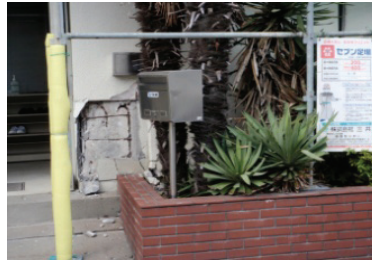
Photo 11 Spalling of reinforced concrete encasing a steel column base (Wakabayashi, Sendai)

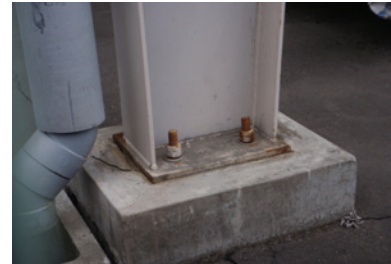
Photo 12 Elongation of anchor bolts in an exposed base plate (Miyagino, Sendai)

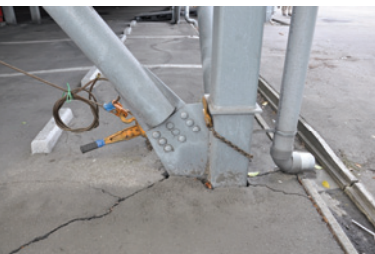
Photo 13 Cracking of asphalt covering a column base (Miyagino, Sendai)

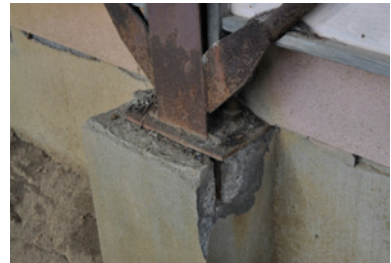
Photo 15 Spalling of reinforced concrete foundation supporting a column base (Koriyama)

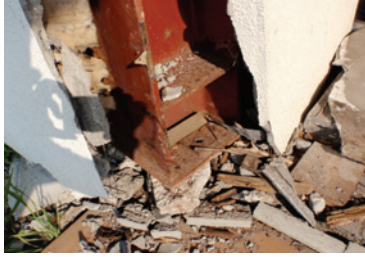
Photo 16 Fracture of anchor bolts (Miyagino, Sendai)

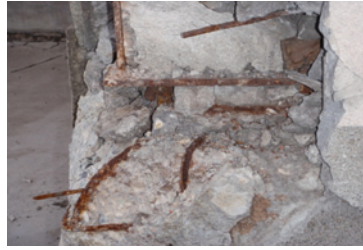
Photo 17 Fracture of anchor bolts, spalling of concrete covering a column base (Miyagino, Sendai)

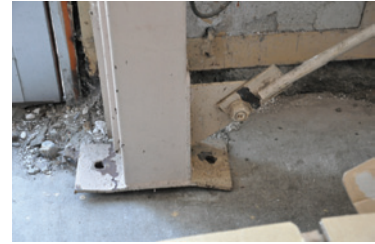
Photo 18 Fracture of anchor bolts, out-of-plane deformation of base plate (Miyagino, Sendai)

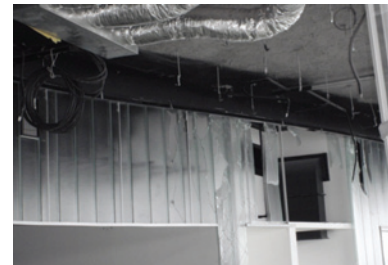
Photo 21 Fallen ceiling, partitions damaged by impact (Aoba, Sendai)

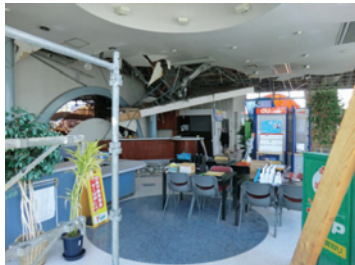
Photo 22 Partly fallen ceiling (Koriyama)

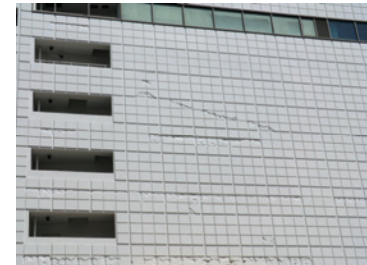
Photo 24 Cracking of external finish (Aoba, Sendai)

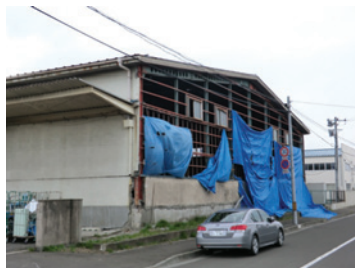
Photo 25 Failure of metal lath-and-mortar cladding (Miyagino, Sendai)

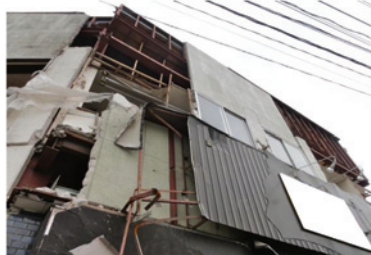
Photo 26 Fallen cladding (Ishinomaki)

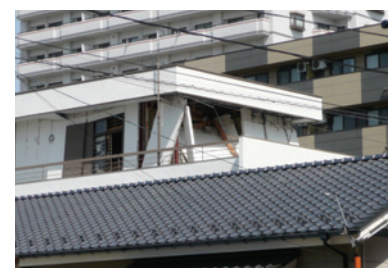
Photo 27 Fallen and twisted cladding (Koriyama)

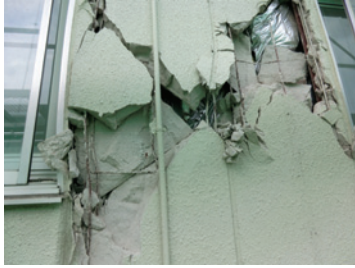
Photo 28 Damage to cladding covering a column (Wakabayashi, Sendai)

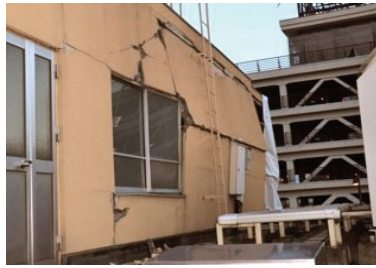
Photo 29 Damaged cladding in a mechanical penthouse (Koriyama)

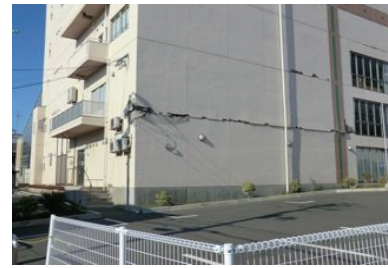
Photo 30 Damaged cladding (Sukagawa)

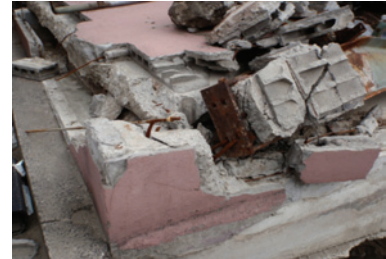
Observations: Two spans closest to the shore collapsed. Fracture of anchor bolt

Photo 39 Port facility B: fractured anchor bolt.

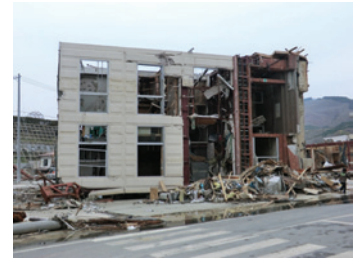
Observations: Building dislocated about 15 meters and lain sideways after all piles failed due to pullout.

Photo 42 Building B: building collapsed towards left.

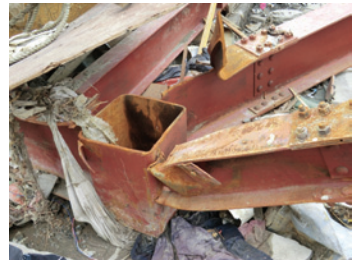
Observations: Collapsed after extensive connection failure.

Photo 45 Building C: failed connection.

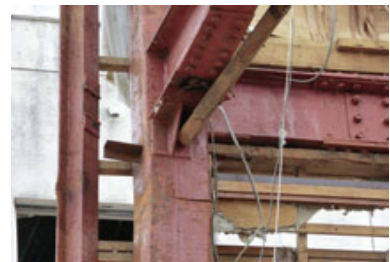
Photo 48 Building D: beam-to-column connections at corner

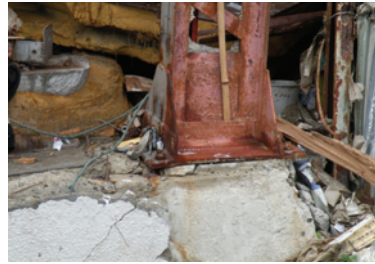
Observations: Residual drift exceeding 1/20. East frame collapsed.

Photo 53 Warehouse A:  
damage to column base.

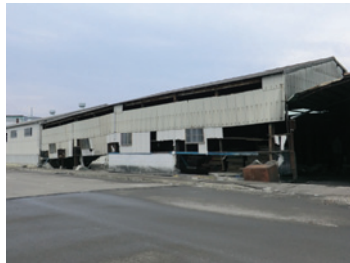
Observations: Foundation subsided due to tsunami and liquefaction.

Photo 55 Warehouse B: external  
view; right end subsided.

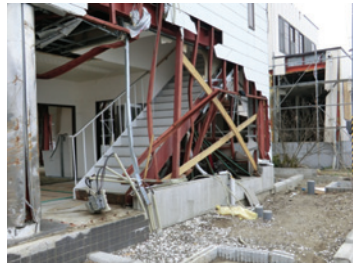
Photo 58 Office building C:  
severe damage to cladding.

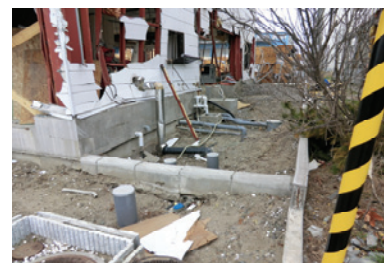
Columns: square HSS's, Beams: W-shapes, Column bases: exposed type  
Observations: Underground piping exposed after scouring.

Photo 59 Office building C:  
under-ground piping exposed  
after scouring.

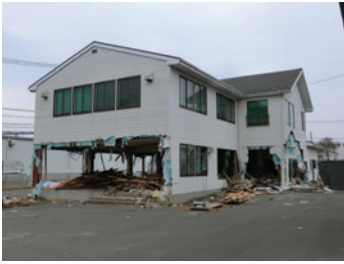
Columns: Square HSS's, Beams: W-shapes, Column bases: exposed type  
Observations: First floor cladding washed away. No structural damage.

Photo 60 Office building D: cladding washed away in first story; minimal structural damage.

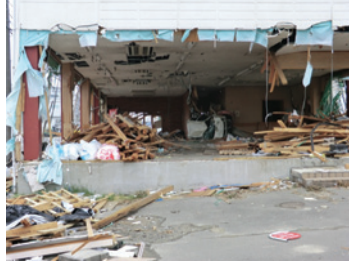
Photo 61 Office building D: nonstructural damage in first story.

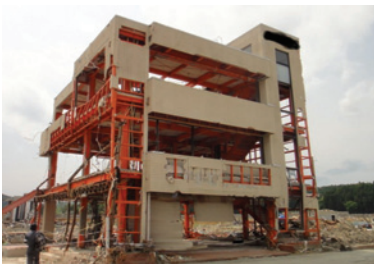
Photo 62 Office building E: majority of nonstructural elements washed away; minor structural damage.

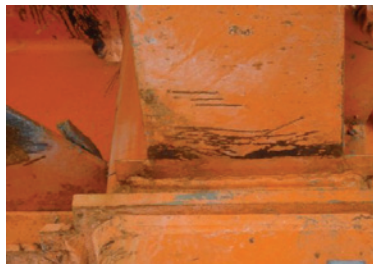
Observations: Evidence of beam yielding. No residual drift.

Photo 63 Office building E: yielding of beam near beam-to-column connection.

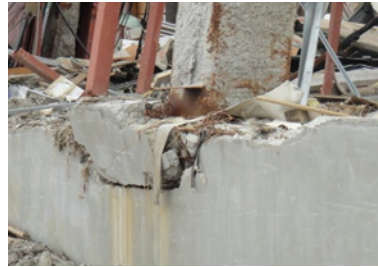
Observations: Wall closest to shore line was pulled toward the shore. Roof truss buckled and collapsed. Anchor bolts in column base fractured. Bolts joining roof truss members fractured. Adjacent 3-story R/C school building completely subsided during tsunami attack.

Photo 69 Elementary school gymnasium A: damaged column base.

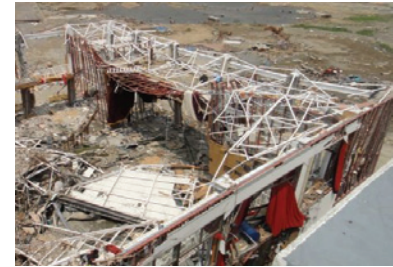
Photo 70 Elementary school gymnasium A: severely damaged roof.

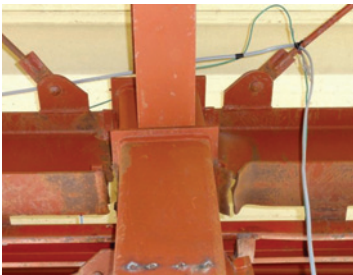
X-dir.: moment frame, Y-dir.: moment frame  
 Observations: Severe damage caused by impact of debris. Damage concentrated in single-story segment. (Residual drift of 1/160 in Y-direction. Anchor bolts fractured. Fracture in beam-to-column connections. Ceiling braces fractured.) No damage in two-story segment.

Photo 74 Store B: fractured beam-to-column

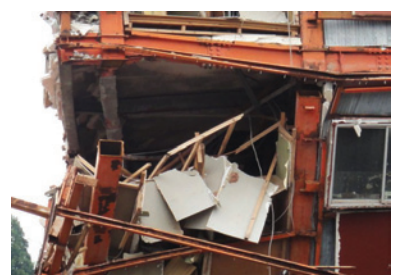
X-dir.: moment frame, Y-dir.: moment frame  
 Observations: Second story collapsed after weld fracture between through-diaphragm plate and column.

Photo 76 Traditional hotel A: close-up view of collapsed second story.

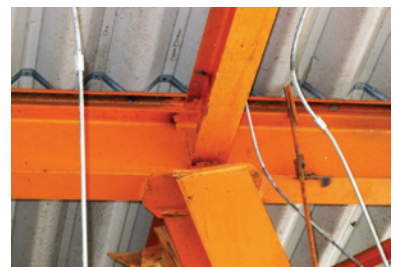
Single story  
 X-dir.: moment frame, Y-dir.: moment frame  
 Observations: Plastic hinging and fracture at top and bottom of column. Residual drift of 1/5 in Y-direction.

Photo 79 Store C: plastic deformation at top of first-story column.

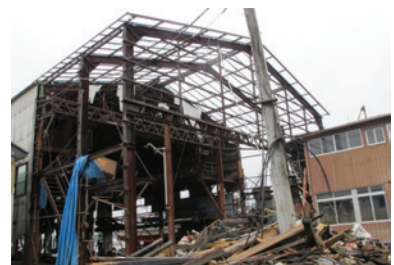
Photo 82 Factory C: external view.

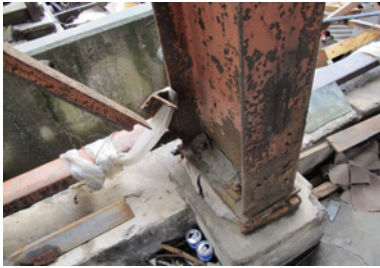
X-dir.: inverted V-braced frame, Y-dir.: moment frame  
 Observations: Buckling and fracture of braces, bending of column base plates.

Photo 83 Factory C: net section fracture of a single-angle brace at the column base.

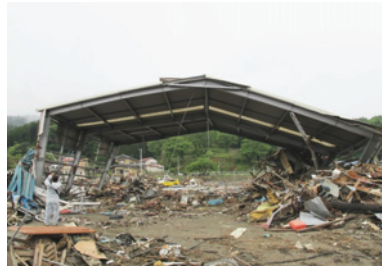
Observations: Collapsed in Y-direction. Yielding in column bases and panel zones and gable frame beams

Photo 84 Factory D: building leaning towards right.

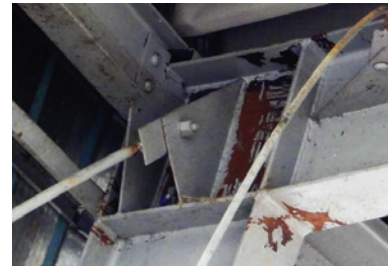
Photo 85 Factory D: yielding of joint region.

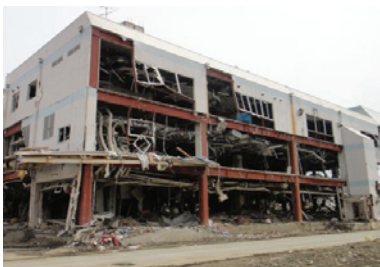
Photo 86 Store D: damage to cladding.

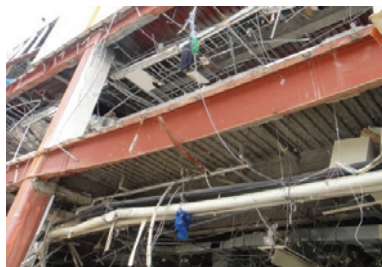
Observations: No residual drift. Torsional deformation of beams in frame facing the shore line.

Photo 87 Store D: torsional deformation of beam.

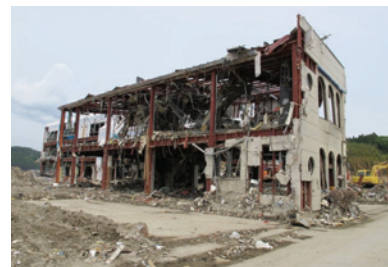
Photo 88 Store E: damage to cladding.

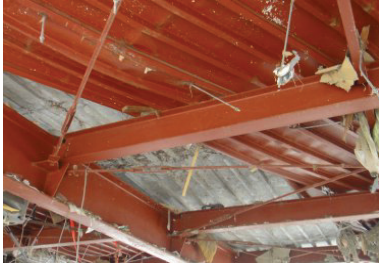
Observations: Residual drift of 1/200. Damage to second-floor concrete slab. Suspected cause is lifting force produced by air pocket in the first story.

Photo 89 Store E: deformed metal floor slab.

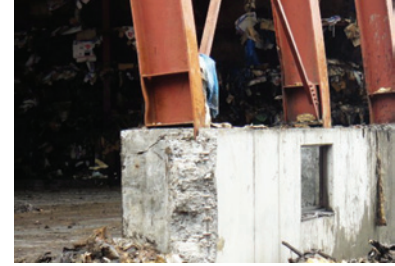
Observations: Lateral-torsional buckling of beam. Yielding of column base. Severe deformation of column panel zones.

Photo 91 Factory E: local flange buckling of column near base.

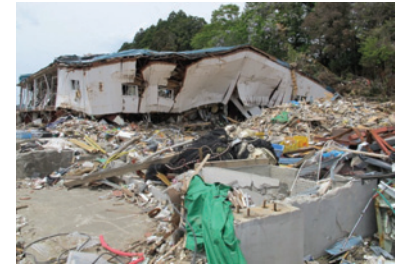
Observations: First story collapsed in X-direction. Building displaced in X-direction by 20 m.

Photo 94 High-school gymnasium B: building displaced by 20 m.

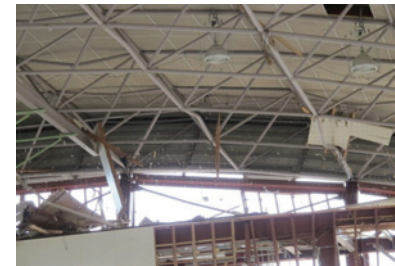
Observations: Severe deformation of frame facing the shore line. Buckling of X-braces. Buckling of chord members in roof truss.

Photo 97 Gymnasium C: distorted roof trusses.

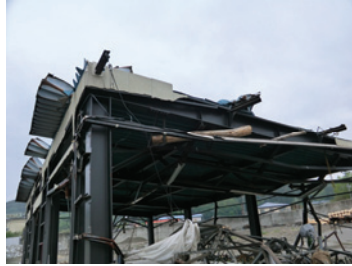
Photo 99 Warehouse D: minimal structural damage; no residual drift.

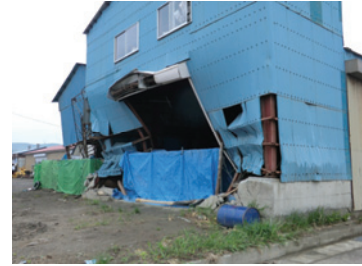
Photo 100 Factory F: cladding remained.

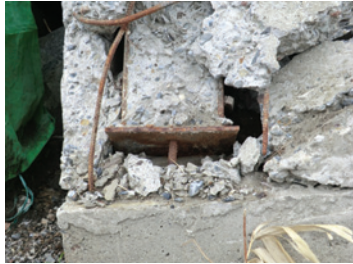
Photo 101 Factory F: damage to concrete encasing column base.

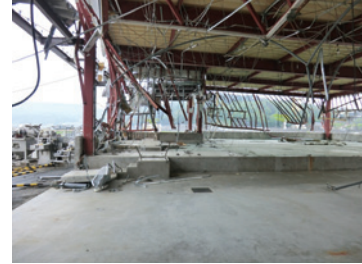
Photo 103 Factory G: little structural damage.

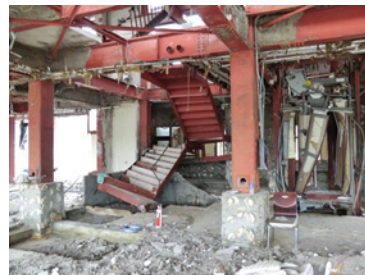
Photo 105 Hotel B: interior damage seen at first story.

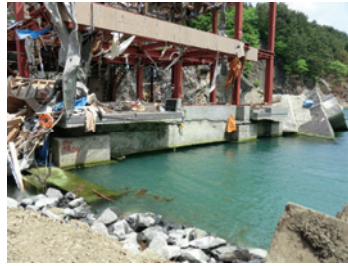
Observations: Internal and external finishes washed away. Little residual drift. Foundation exposed after scouring.

Photo 108 Office building F: foundation exposed after scouring.

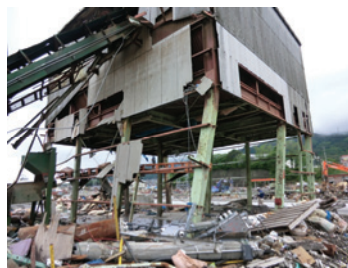
Observations: Internal and external finishes washed away. First story deformed towards shoreline. Round bar braces fractured.

Photo 110 Factory H: first story leaning towards inland.

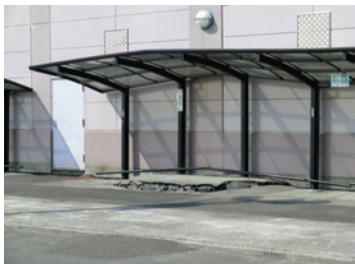
Photo 111 Shopping complex: ground subsided near footing foundation. (Rifu)

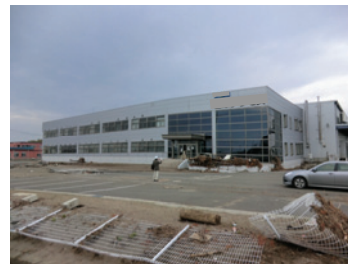
Photo 112 Office building: Two right-end spans subsided due to liquefaction. (Iwanuma)
