CHRISTCHURCH CITY LIFELINES – ASSESSMENT AND REPAIR OF CONCRETE POTABLE WATER RESERVOIRS FOLLOWING THE FEBRUARY AND JUNE 2011 CHRISTCHURCH EARTHQUAKES.

Ian BILLINGS¹ and Nicholas CHARMAN²

Key Words: Christchurch City New Zealand, 22 February and 13 June 2011 earthquakes, concrete reservoirs, performance, assessment and repair

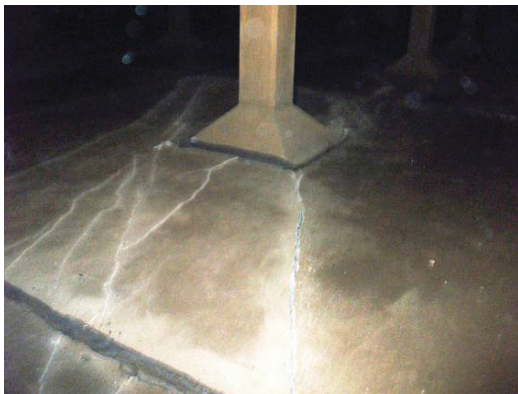
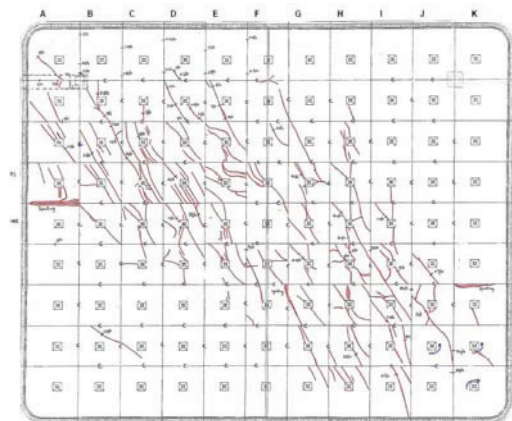
The main structural damage was cracking of the base-slabs with crack widths of up to 35mm measured and movement of slabs both horizontally and vertically by up to 50mm (the internal areas of base-slab comprise a double slab constructed in offset individual slabs). This cracking, as indicated in Figure 1, had a distinctive pattern extending diagonally across the reservoir and over a zone of some 20 m width. A similar pattern of cracking was also observed in the roof. Discrete localised cracking was observed in the walls, along with opening of some vertical construction joints, and the central, low height, dividing wall was severely damaged at one location coincident with the base-slab diagonal cracking pattern. The adjoining pump station was also significantly damaged plus the main 600 mm diameter inlet / outlet pipe. Further mapping of the base-slab following the 13 June 2011 earthquakes and other significant aftershocks identified additional cracking and also continued movement of slabs horizontally and vertically.

Fig. 1: Huntsbury No.1 Reservoir – base-slab cracking (22 February 2011 damage mapping).

Investigations as to where 32,000 m³ of water drained to have been inconclusive but it appears likely that a significant volume drained through the construction joints and cracks in the base-slab (and into the underlying fractured basalt) and, some drained through the mains pipes as the seismic actuated shut-off valves take time to close.

The distribution and orientation of cracking observed within the reservoirs structure and in the tunnel is indicative of a zone of shear movement, extending diagonally across the reservoir footprint, along planes of weaknesses in the underlying rock. This has been confirmed by the inclined boreholes and trenching carried out inside the reservoir. The 22 February 2011 earthquake has reactivated an underlying ancient shear zone and resulted in movement on planes of weakness in the rock. As further movement could occur in future similar events, and in view of the increased seismicity, it was assessed that the reservoir should not be reinstated over the shear zone.

A detailed structural seismic assessment was completed for the reservoir. Based on current design requirements it indicated vulnerabilities with the roof and wall construction joints for in-plane loading and that the walls were marginal for out of plane bending. However the cause of the damage is considered primarily attributable to movement in the underlying shear zone.

As noted above, a reservoir reinstated or constructed over the shear zone was not considered a viable option. However, as the Huntsbury site remained critical in CCCs immediate and long term network water storage requirements a range of structural options were developed that considered the shear zone location and its risks. The final configuration adopted for reconstruction of the site is two significantly smaller reservoirs constructed in the corners of the current reservoir footprint as shown in Figure 2. These new reservoirs utilise lengths of the existing reservoir's walls and columns with additional new walls plus base-slab and roof overlays. Construction and commissioning of the Stage 1 6,200 m³ first replacement reservoir was completed mid December 2011. Construction of the second replacement reservoir is anticipated to be completed in mid-2012. The estimated total storage volume at the completion of reconstruction is 13,600m³, providing just under 40% of the reservoir's original capacity. A replacement pump house has been constructed remote from the reservoirs.

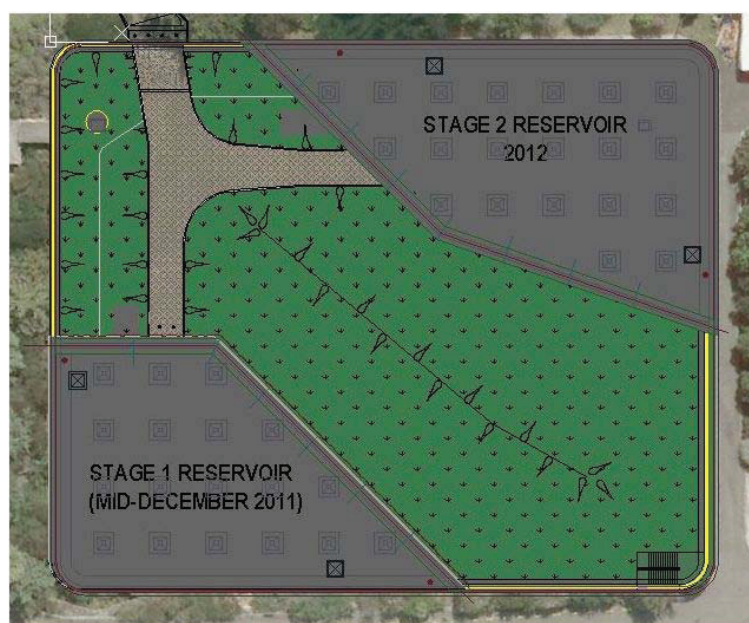
Fig. 2: Huntsbury No.1 Reservoir – proposed site reinstatement.

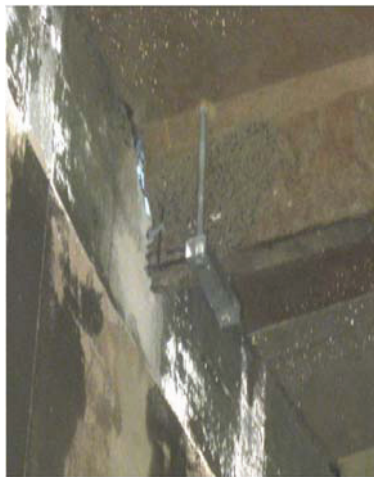
Damage noted to Reservoir No.2 includes; cracking in base-slabs, spalling and cracking around the wall foundation ring-beam, vertical and horizontal movement of wall relative to foundation ring beam, cracking or opening of wall construction joints, damage to roof-wall connections and minor internal column concrete spalling. Damage noted to Reservoir No.1 is very similar to No.2 but its roof is more severely damaged due to extensive failure of roof-wall dowel connections, and water appears to be leaking from the circumferential post-tensioning tendon anchorages. The resultant roof movement, once the dowels have failed, has smashed the overhanging roof nib, resulted in precast roof tee units engaging the wall and punching out wall concrete, and damaged webs in the tee units. The pump house between the two reservoirs also has structural damage including spalled concrete and cracking of wall and slab concrete. Refer Figures 3 and 4 for indicative reservoir structural damage observed.

Fig. 3: No.1 Reservoir – significant roof damage.

Structural repair and retrofit requirements are extensive and costly including; construction of a full base-slab overlay and internal ring beam to tie the wall in to the base-slab and to provide a direct seismic shear transfer mechanism, a ring beam around the top of the wall (No.2 reservoir) and bandaging of all wall vertical construction joints full height. Reservoir No.1 repairs are still being developed at the time of writing but expected to be similar.

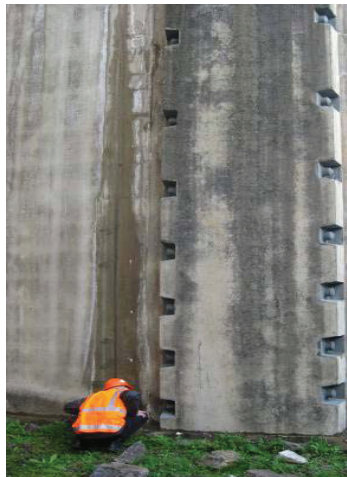
Fig. 4: No.1 Reservoir – leaking vertical wall joints.

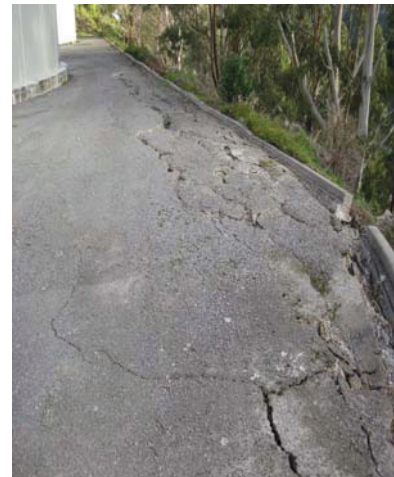
Fig. 5: Access road – cracking and slumping.

The access road to the reservoirs has suffered significant cracking, settlement of up to 500mm and has slumped towards the slope below the reservoirs, refer Figure 5. The stacked basalt block gravity wall supporting this road partially collapsed resulting in rockfall hazards to the road and residents below (emergency temporary rockfall fences were installed to mitigate short term rockfall risks). The original construction platform for the reservoirs was cut into rock and there is a near vertical face of up to approximately 21 m height behind the reservoirs. The 22 February and 13 June 2011 earthquakes caused significant loosening and dislodgement of material from the rock face. Rock and material has piled up behind the reservoirs and some rocks have likely impacted the reservoir wall.

Geotechnical repairs at the site are also extensive and will continue till late 2012. A permanent piled replacement retaining wall is currently proposed to retain the edge of the access road. A grid of rock anchors and soil nails installed over the cut face behind the reservoirs is also currently proposed.

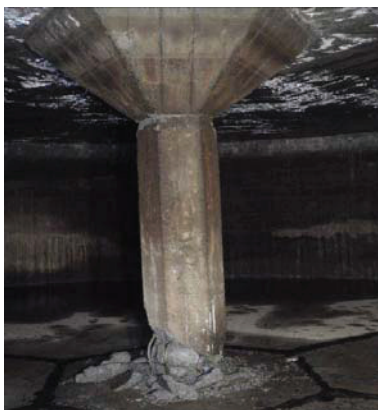
Fig. 6: Clifton 3 – internal column failure.

Damage noted included failure of the internal column (Figure 6), sagging of the roof and shearing of the roof overhang at the roof-wall joint (Figure 7). Under horizontal earthquake loading the roof has impacted the top of the wall and resulted in its overhanging nib shearing off. Excessive translation of the roof subsequently occurred and resulted in the column failing due to only limited shear and flexural capacity. Simple repair of the roof nib was completed following the 22 February earthquake but this failed during the 13 June event.

Repair and retrofit included break-out and reconstruction of the damaged top and bottom of the column, jacking of the roof vertically and fitting of a reinforced concrete ring beam at the top of the wall to restrain the roof against lateral earthquake movement. A kerb has been constructed at the base of the column to provide additional restraint. Minor repairs to floor sealants and wall cracking were also required. The reservoir was returned to service late December 2011.

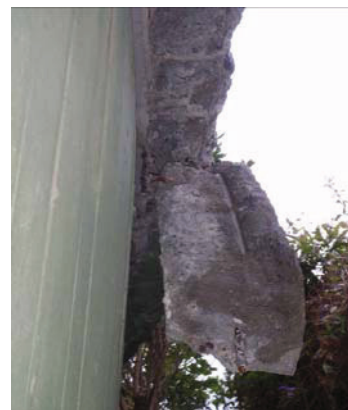
Fig. 7: Failure of roof overhanging nib.

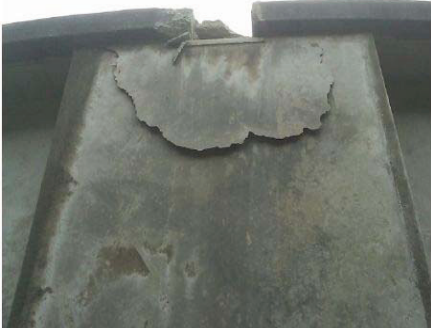
Fig. 8: Upper Balmoral – concrete shear failure at pilaster locations due to roof beam impact.

The roof comprises precast roof beams that slot into the reservoir wall and pilasters. Under horizontal earthquake loading the roof beams have impacted the wall and resulted in major cracking and damage to the top of the wall (Figure 8) and to the beams. At pilaster locations, the beams have punched off the wall concrete at the ends of the beams (Figure 9). Excessive roof movement has also resulted in damage to the top of the internal column.

Simple repair of the damaged wall sections that support the roof was completed following the 22 February 2011 earthquake but subsequently failed during the 13 June event. Engineered repair and retrofit included fitting of a reinforced concrete ring beam at the top of the wall (tied to the roof beams), break-out and reconstruction of the damaged top of the column plus wall and beam repairs. An internal ring beam has been constructed to tie the wall into the base-slab and to provide a more direct seismic shear transfer mechanism. The reservoir was returned to service late December 2011.

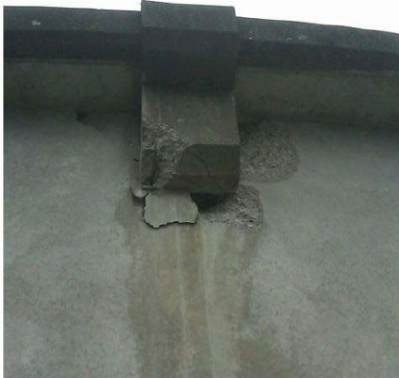
Fig. 9: Upper Balmoral – concrete damage at roof beam wall support.
