SEVERAL FEATURES OF LIQUEFACTION-INDUCED DAMAGE TO HOUSES AND BURIED LIFELINES DURING THE 2011 GREAT EAST JAPAN EARTHQUAKE

Susumu YASUDA¹ and Keisuke ISHIKAWA²

ABSTRACT: The 2011 Great East Japan earthquake caused severe liquefaction in Tohoku and Kanto districts. About 27,000 timber houses, a lot of buried sewage pipes and roads were damaged due to liquefaction. In Tokyo Bay area, the very long duration of the main shock and an aftershock 29 minutes later probably induced the severe liquefaction. Sidewalks and alleys buckled at several sites, probably due to a kind of sloshing of liquefied ground. Moreover, much sand boiled from the ground and the ground subsided significantly because the liquefied soils were very fine.

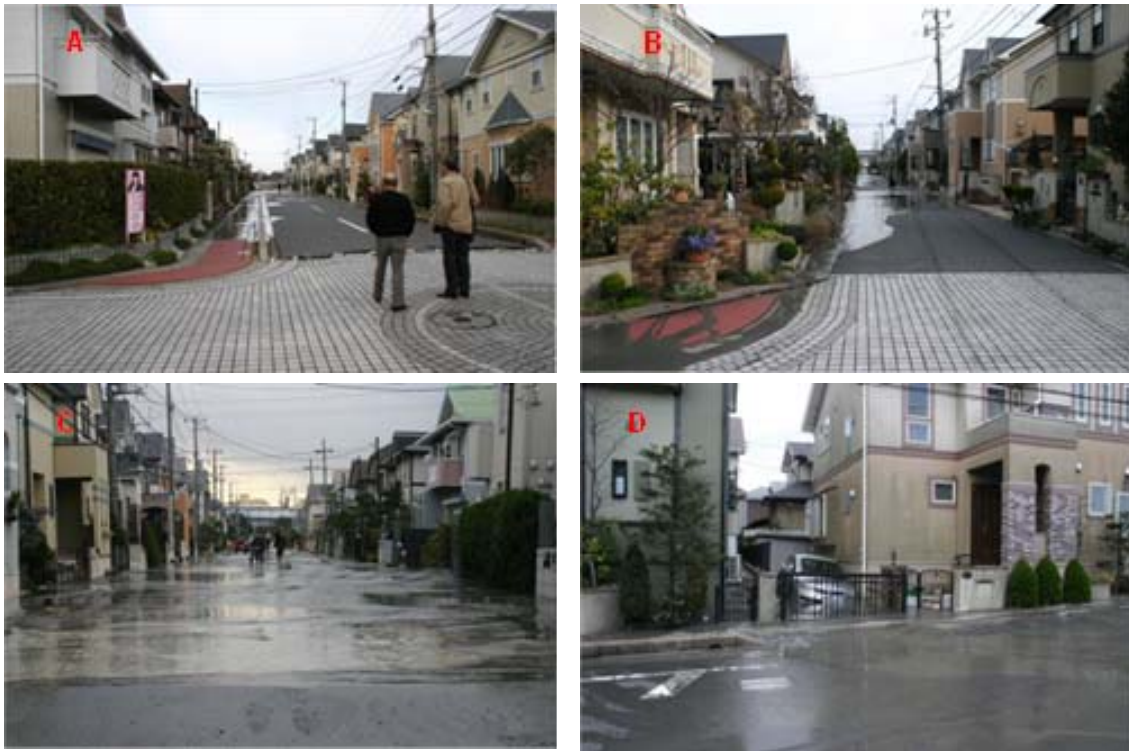
Photo 1 Sequential photos taken by Mr. K. Ogawa

As the earthquake occurred at 14:46 in the afternoon on Friday, many important photos and movies were taken at many sites along Tokyo Bay to study the process and mechanism of liquefaction. Among them a series of photos taken by Mr. Katsunori Ogawa just after the earthquake at Maihama 3-chome in Urayasu City is introduced in Photos 1 (1) to 1 (4):

A <14:56>: Spew out of muddy water started in northeast direction. It took several minutes to start the boiling after the settle of the main shock.

B <15:01>: Boiled muddy water gradually spread and covered the road.

C <15:21>: The southwest road covered completely with muddy water. Water pipes look like to break.

D <15:22>: Many houses settled and tilted and cars submerged in the boiled muddy water.

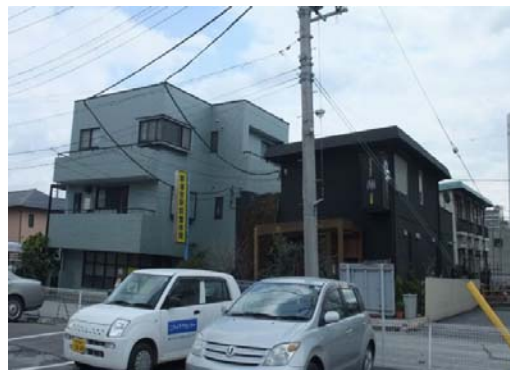
(1) Outside of the tilted house

According to the result of totaling by the Ministry of Land, Infrastructure, Transport and Tourism, about 27,000 houses were damaged due to liquefaction as shown in Table 1. Photos 2 (1) and 1 (2) show a damaged house taken from outside and inside, respectively. The house settled and tilted about 40/1,000. In the heavily tilted houses, inhabitants feel giddy and nausea and difficult to live in their houses after the earthquake. However damaged houses due to liquefaction had been judged as partial collapse or injured only during past earthquakes because of no damage to walls and windows, though it has been desired both settlement and inclination must be considered in the judge.

Photo 2 Severely settled and tilted house in Urayasu City

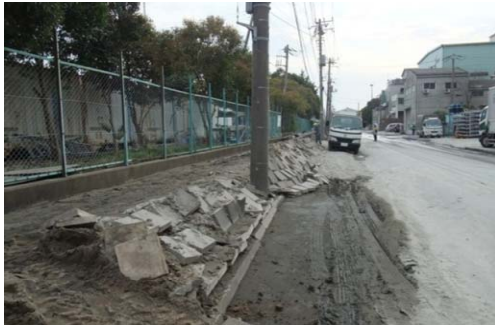
Miracle phenomena, heaving, buckling or thrust were observed at several footways and alleys as shown in Photo 3 at many sites in Tokyo Bay area. Some thrust might occur at the boundaries due to a kind of sloshing of liquefied ground as schematically shown in Figure 15 (1), because shaking continued for long time after the occurrence of liquefaction. Figure 16 shows heaved footways or alleys in Urayasu City together with contour lines of the thickness of the F layer under the ground water table. It may be said that the heaving occurred at the sites where the bottoms of the F layer, in other word liquefied layer,

Photo 3 Heaving of a footway at Takahama, Ichikawa City

are sloped. This implies that a kind of horizontal buckling of surface layer might occurred due to the concentration of horizontal compressive stress as schematically shown in Figure 15 (2). However, more studies are necessary on the mechanism of the buckling.

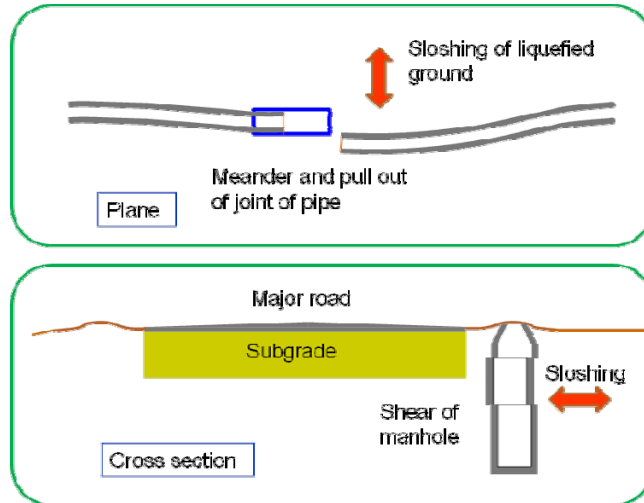
In sewage facilities, pipes were meander or broken, joints were pulled out and pipes were filled with muddy water. Many manholes were sheared in horizontal direction and filled with muddy water whereas few manholes uplifted. Though the mechanism of these unique damages is still studying, one authors' idea is illustrated in Figure 17. As mentioned above a kind of sloshing of liquefied ground might occur due to long duration of shaking and caused thrust of roads. By the same movement of the ground, pipes might meandered violently in horizontal direction, resulting pull out or break of joints, and eventually liquefied muddy water invaded into the pipes. Manholes might be sheared due to horizontal force and pressurized liquefied muddy water came into the manholes. Fortunately or unfortunately invaded muddy water into the sewage pipes and manholes might prevent uplift.

Figure 17 Unique damage to sewage manholes and pipes

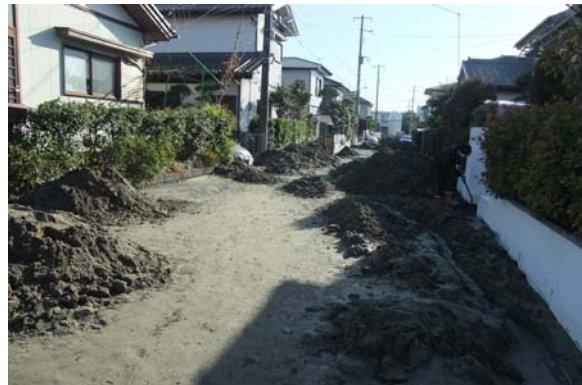
Photo 4 Thick boiled soil observed in Chiba City

Much eruption of sands and large ground subsidence occurred in the liquefied area. The maximum thickness of the erupted sand and the maximum ground subsidence observed by the authors were about 30 cm and 50 cm, respectively. This is the first experience for the authors to see such thick deposited boiled sand in Japan. However, one of the authors had seen similar much eruption and large subsidence in Christchurch during the main shock on September 2010 and aftershock on February 2011. Figure 18 compares grain size distribution curves of erupted soils in Christchurch during the main shock with those in Tokyo Bay during this earthquake. Fines contents for Christchurch and Tokyo Bay are similar. Then it is estimated that in the very fine sands, ejection of water continues for long time because of low permeability of liquefied soils in both area. Moreover fine soil particles are easy to uplift above the ground surface by the ejecting water. And the removal of the deposited soils by inhabitants accelerated the settlement of the ground surface.

Photo 4 shows an alley covered by boiled sands. It was difficult to run on the thick deposited wet sands by cars and bicycles. Moreover large settlement of the ground around buildings prevented to go out from parking spaces.
