FAULT RUPTURE AND ASSOCIATED GEO-HAZARDS OF FUKUSHIMA-PREFECTURE HAMADOORI EARTHQUAKE

Key Words: Hamadoori Earthquake, Idosawa and Yunotake Faults, landslide, gymnasium building, swimming pool, ground deformation

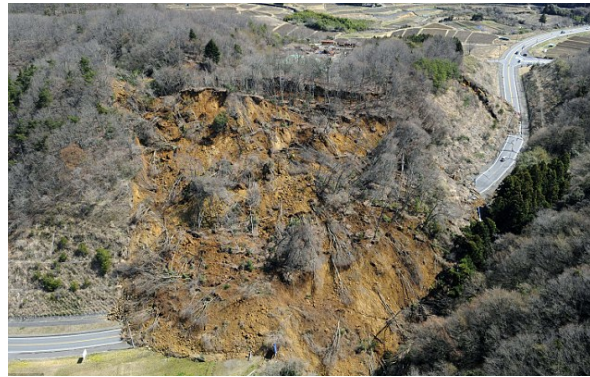
The landslide, mentioned above, was one of the most catastrophic failures caused by this earthquake. The soil mass moved coherently down the slope and blocked local Highway No. 14, which connects the area with a major freeway, the Joban Expressway. The landslide was triggered at the contact between highly weathered tuff and mudstone. Additionally, tall and steep road cuts were present adjacent to the landslide in (Figure 3, 4 and 5), which suggest that the road construction resulted in significant removal of lateral support. One person, whose vehicle happened to pass by, was found dead in the landslide mass.

Fig. 4 An aerial view of the landslide mass (Photo by Kyodo News). The coherent landslide mass flushed the road passing by its toe.

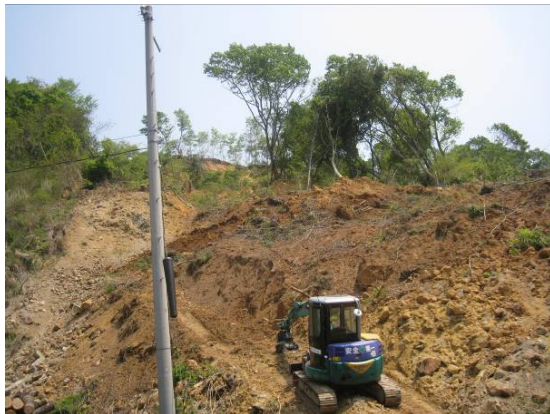
Fig.5 A closed view of the landslide mass (37°00'00.3", 140°47'14.5")

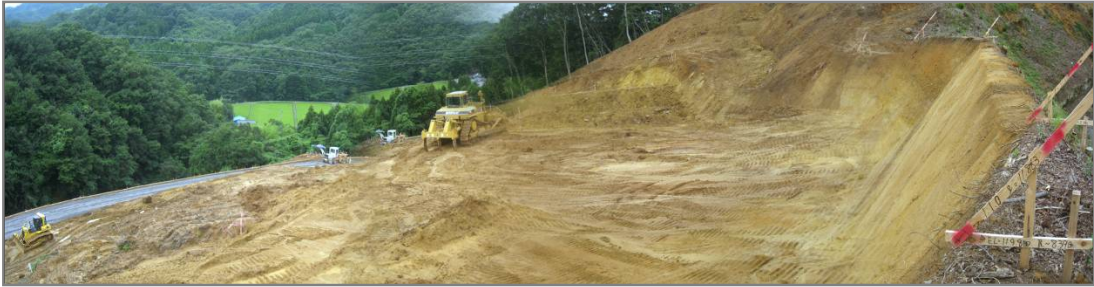
After the authors' LiDAR survey, the landscape was dramatically changed for the construction of temporary road (Figure 8). Earth cut and fill operations were done in such a way that the road would be constructed directly on the landslide mass without deeply cutting it, thus the greater toe part of the landslide mass would remain as it is for better stabilization of the soil mass. However, a careful and continuous eye is to be kept on it because of the disturbed landslide mass as well as the fill for the temporary road is not completely consolidated (Figure 9) and there surely exists a deep-seated slip surface, as can be seen from the presence of large tensional cracks along the top of landslide mass (Figure 10).

Fig. 8 Panoramic view of the landslide mass, re-profiled to an apparent stable configuration for the purpose of road construction.

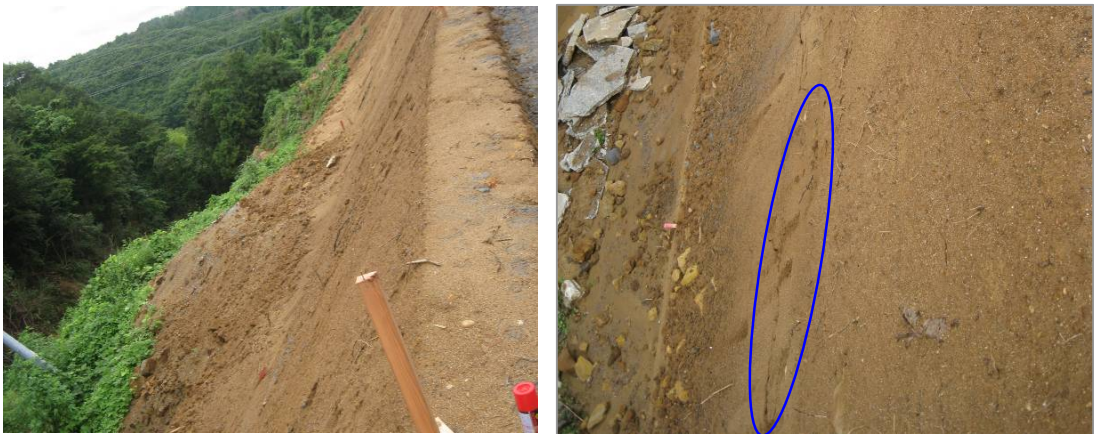
Fig. 9 Embankment of the road constructed on the landslide mass (left photo). Small scale cracks were observed near the base of embankment even during construction (right photo).

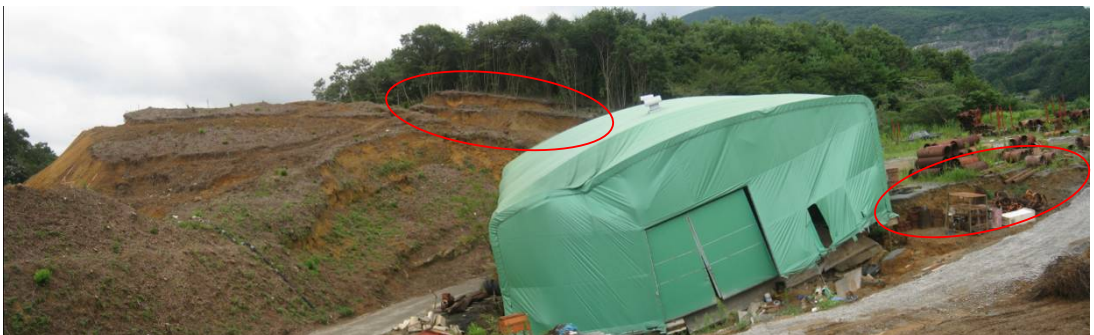
Fig. 10 Huge tension cracks present along the top of the landslide, showing the presence of deep seated slip planes.

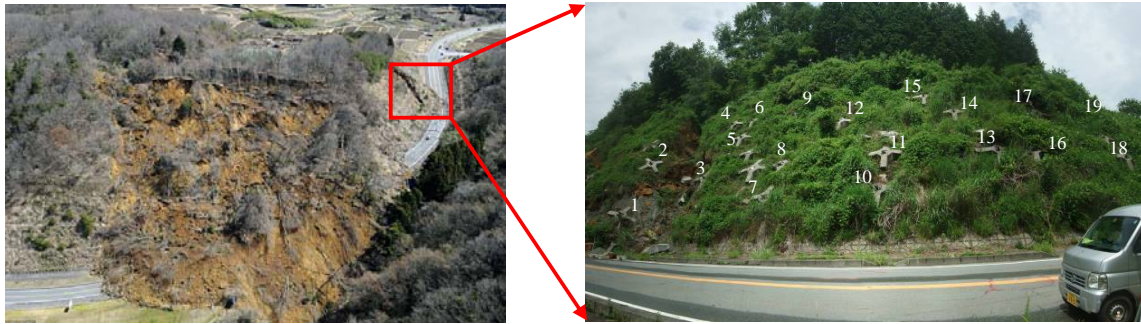
A natural slope immediately right to the current landslide reportedly started to move slowly immediately after the road was constructed across this area. Therefore the slope was intensively tied back with pre-stressed anchors. During the above mentioned earthquake, this slope was also disturbed significantly, being dragged by the adjacent major landslide mass. During the last survey on June 23, the positions of ground anchors were also measured to monitor gradual slippage of this slope (Figure 11).

Fig. 11 A disturbed natural slope adjacent to the coherent landslide mass. The numbers for the ground anchors were marked for the reference to be used in future.

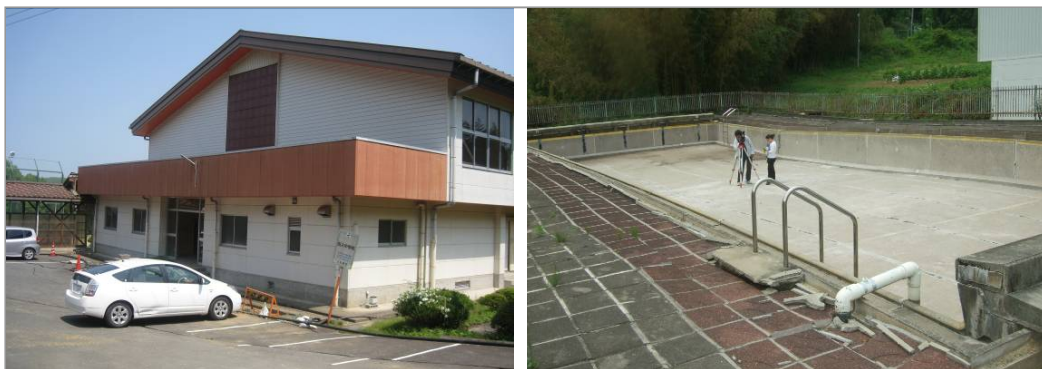
On the southern extension of Idosawa Fault, there is Tabito Junior High School whose gymnasium building and swimming pool, immediately next to each other, were located exactly above Idosawa Fault. As shown in Figure 12, the structures were deformed and tilted, about 3° westward, to unserviceable condition and large scale open cracks were observed along their peripheries. Though the damage to these structures had nothing to do with major landslides along Idosawa Fault, temporal monitoring of their deformed shape can give an idea of a possible continuous deformation buildup in soils near the fault.

Fig. 12 Idosawa Fault passing under the gymnasium building (left photo) and swimming pool (right photo) of Tabito Junior High School, tilting and deforming the structures ($36^{\circ}57'52.2''$, $140^{\circ}42'10.0''$)

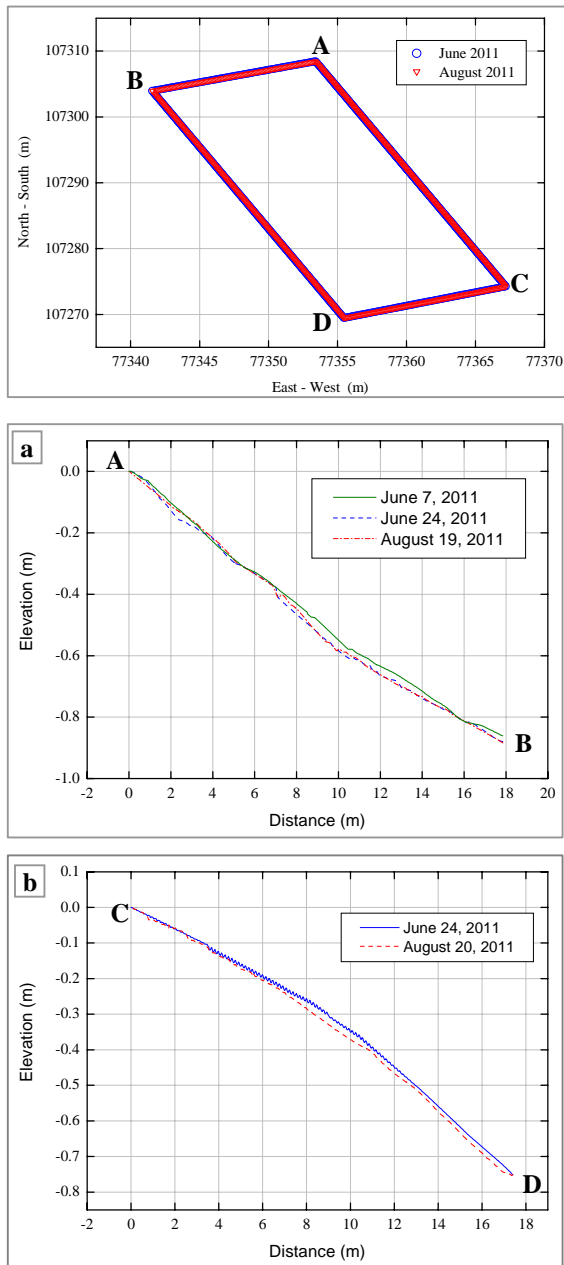
Assuming that the hanging wall has not moved, elevations of all other points are determined setting the hanging wall elevation as a reference. On June 7th, only front face of the gymnasium building was measured. While comparing it with that measured on June 24th, it is found that the footwall side has sunk down by about 3~4cm (Figure 13a).

Fig. 13 Continual deformation of the ground supporting gymnasium building of Tabito Junior High School from June 2011 to August 2011 a) face AB b) face CD

Similarly, comparing the measurements of June 24th and August 20th, the front face does not show any change but the rear face shows that foot wall area has deformed by 2~3cm (Figure 13a and b). This suggests that ground had been undergoing a continuous/continual deformation; as one of teachers at this junior high school noticed that some cracks were getting wider slowly but steadily.

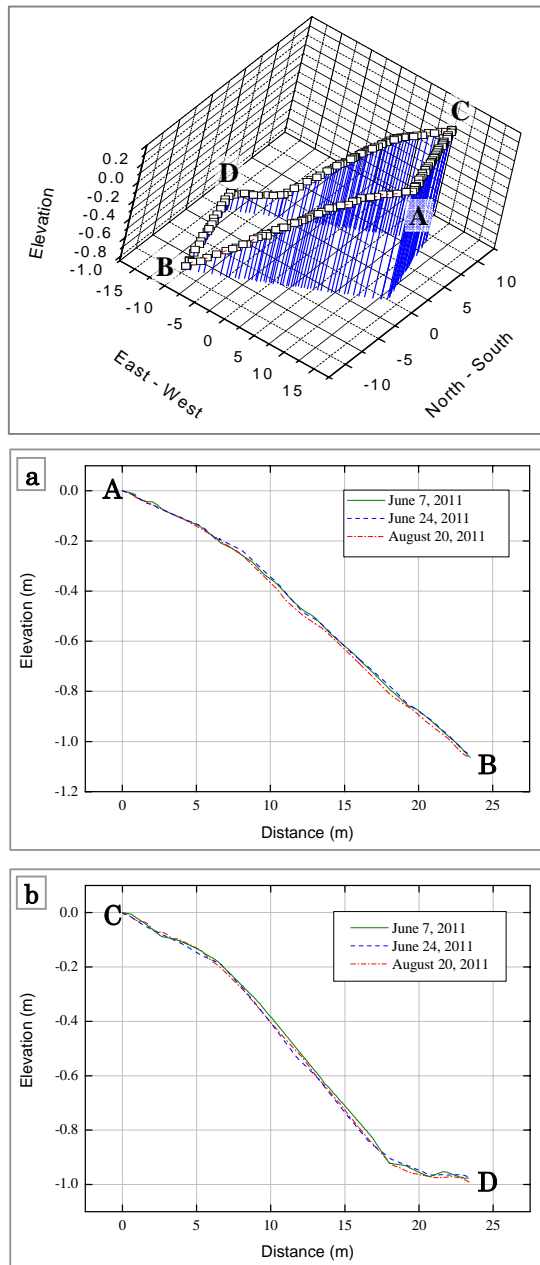
Fig. 14 Continual deformation of the ground supporting swimming pool of Tabito Junior High School from June 2011 to August 2011 a) face AB b) face CD

The swimming pool was deformed considerably by the fault dislocation (Figure 14). Following the same way as for the gymnasium building, change in elevation of the faces perpendicular to the fault line (face AB and CD, marked in Figure 14) was determined. It is quite clear from Figure 14 that the football side has sunk down by almost the same amount as it was observed for gymnasium building.
