DAMAGE TO WATER SUPPLY SYSTEM INDUCED BY THE 2011 GREAT EAST JAPAN EARTHQUAKE

Masakatsu MIYAJIMA

Professor, School of Environmental Design, Kanazawa University,
Kanazawa, Japan, miyajima@t.kanazawa-u.ac.jp

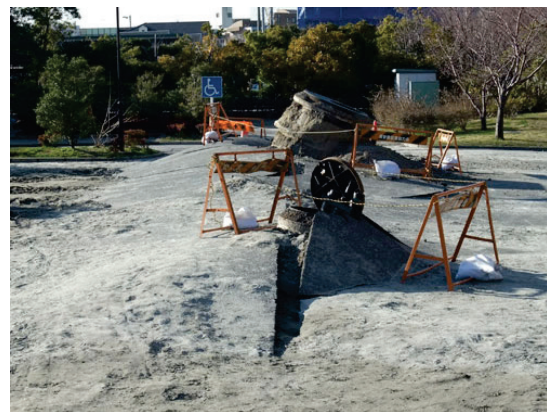
The damage caused by the earthquake and tsunami seems to be classified into five categories. Firstly the causes of damage are divided by earthquake and tsunami. Causes of damage by earthquake are classified into ground shaking itself and ground failure such as liquefaction, slope failure and etc. Photo 1 shows damage to expansion joint of steel pipe with 2400mm diameter. This damage seems to be caused by ground shaking and/or ground deformation. Photo 2 shows an uplift of underground water tank induced by liquefaction.

Photo 2 Uplift of underground water tank (Chiba Pref.)²⁾.

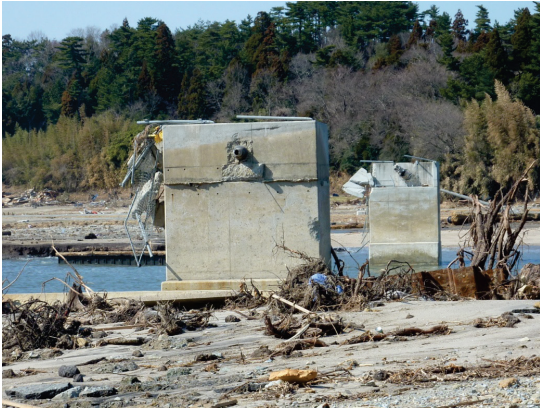
Causes of damage by tsunami are classified into three categories; inundation, washing away and scouring of surface ground. Some intake facilities were inundated by tsunami and became malfunction for long time because of high density of calcium chloride in water. Photo 3 shows damage to a water pipe bridge by tsunami. The water pipe bridge was completely washed away. Photo 4 shows damage to a buried pipeline. The pipeline appeared above ground after tsunami because of scouring caused by tsunami. The mechanism of damage to pipeline, that is, how much force acts on a pipeline is not sure. The mechanism of this kind of damage must be clarified in future.

Photo 3 Damage to water pipe bridge (Miyagi Pref.) .

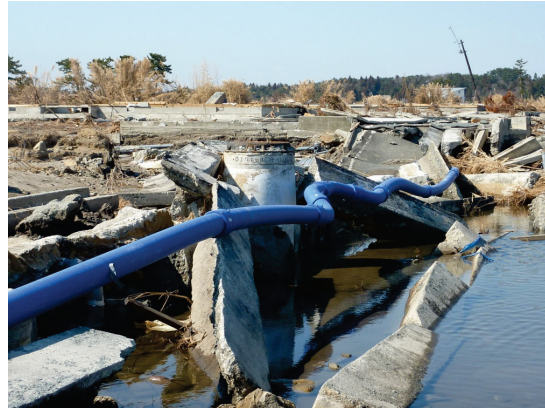
Photo 4 Damage to pipe by scouring of tsunami (Miyagi Pref.) .

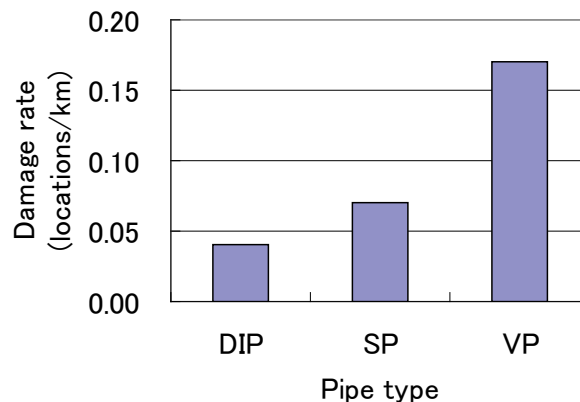
The total number of damage to transmission main, distribution main and branch pipelines was 264 except the flooded areas, and the piping length is 3,761km. The damage rate of transmission main, distribution main and branch pipelines was, therefore, 0.07 (locations/km) The damage rate in relation to pipe type and pipe diameter is shown in Fig. 1 and 2, respectively. Fig. 1 indicates that the damage rate of polyvinyl chloride pipe (VP) is high. Fig. 2 reveals that the smaller the pipe diameter is, the higher the damage rate.

Fig. 1 Damage rate related to pipe type.

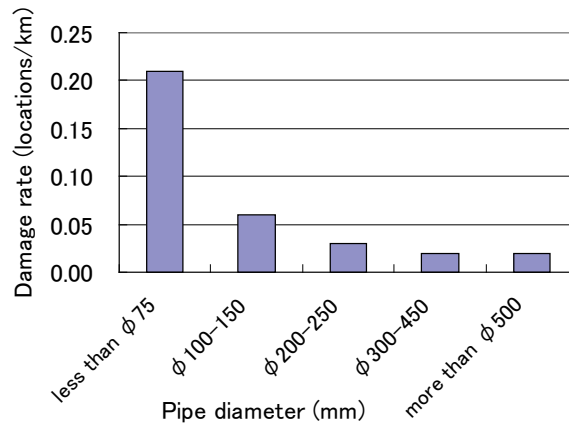
Fig. 2 Damage rate related to pipe diameter.

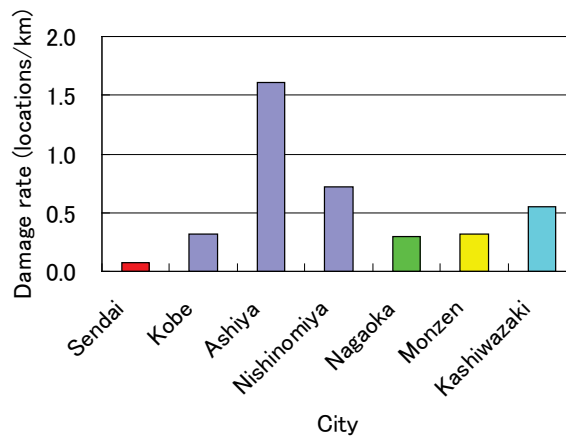
Fig. 3 Comparison of damage rate.

Fig. 3 illustrates a comparison of damage rate of Sendai City with those of other cities suffered damage to pipeline in the past earthquakes. Kobe, Ashiya and Nishinomiya Cities suffered damage to water supply pipeline in the 1995 Hyogo-ken Nambu Earthquake, Nagaoka City in the 2004 Niigata-ken Chuetsu Earthquake, Monzen Town in the 2007 Noto-hanto Earthquake and Kashiwazaki City in the 2007 Niigata-ken Chuetsu-oki Earthquake, respectively. This figure reveals that the damage rate of Sendai City was very low in comparison with another cities. Magnitude of earthquake and seismic intensity in each city were different. PGA of K-NET Sendai observation station was, however, not small; 1,808 (cm/s/s). This value is higher than most of cities listed in Fig. 3. One of reasons of low damage rate in Sendai City seems to be high earthquake-proofing rate. The earthquake-proofing rate is defined as the piping length of ductile cast iron pipe with earthquake resistant joint and welded steel pipe divided by the total piping length. The earthquake-proofing rate of Sendai City is 51.2%.

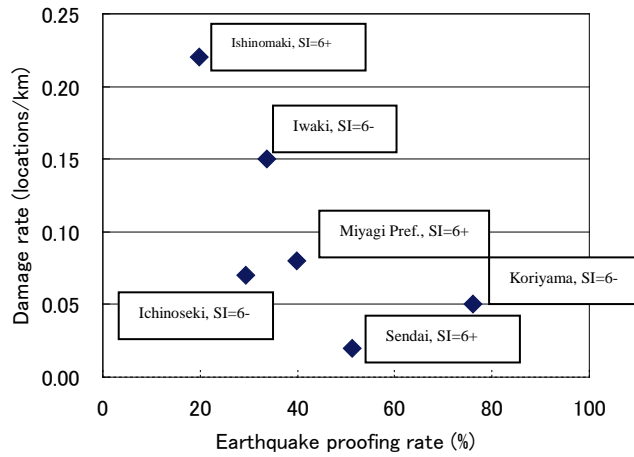
Fig. 4 illustrates the relation between the earthquake-proofing rate and damage rate suffered damage in the 2011 great east Japan earthquake. The damage rate shown in this figure is calculated by using the damage to transmission and distribution main pipeline, that is, distribution branch pipeline is not included. This figure indicates that the higher the earthquake-proofing rate, the lower the damage rate is. There was no damage to the ductile cast iron pipe with earthquake resistant joint. Effect of earthquake-proofing pipe was, therefore, verified by the earthquake.

Fig. 4 Relation between earthquake proofing rate and damage rate.

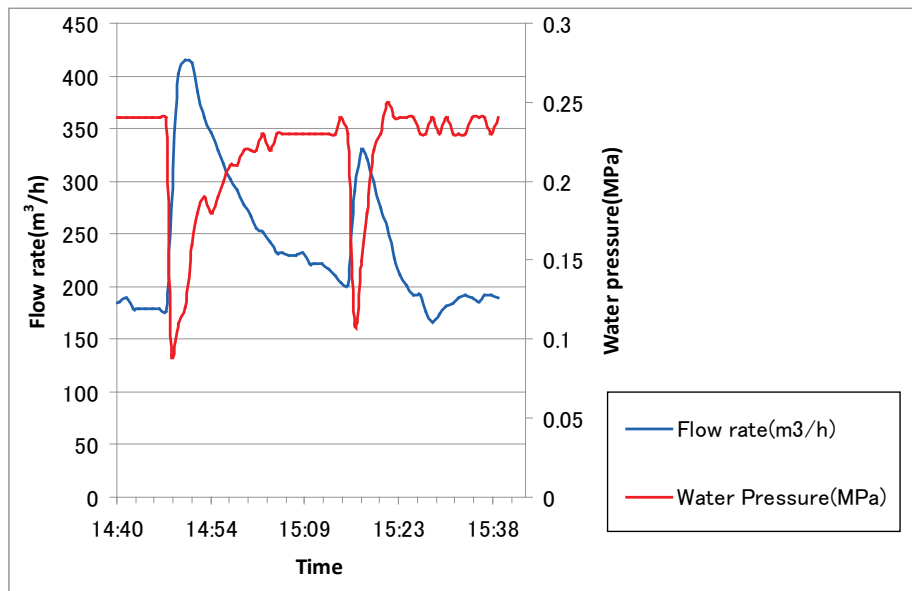
Unusual phenomena such as an abrupt increase in flow rate and a decrease in water pressure of water distribution system in spite of no damage to pipeline was occurred in several cities during the great east Japan earthquake. Fig. 5 shows time histories of the flow rate and water pressure at a water distribution plant of the Bureau of Waterworks Tokyo Metropolitan Government. The flow rate increased and water pressure decreased rapidly just after the earthquake. The higher flow rate and lower water pressure were recovered after about 20 minutes. The similar phenomena were occurred again by the aftershock.

Fig. 5 Time histories of the flow rate and water pressure at a water distribution plant of Tokyo.

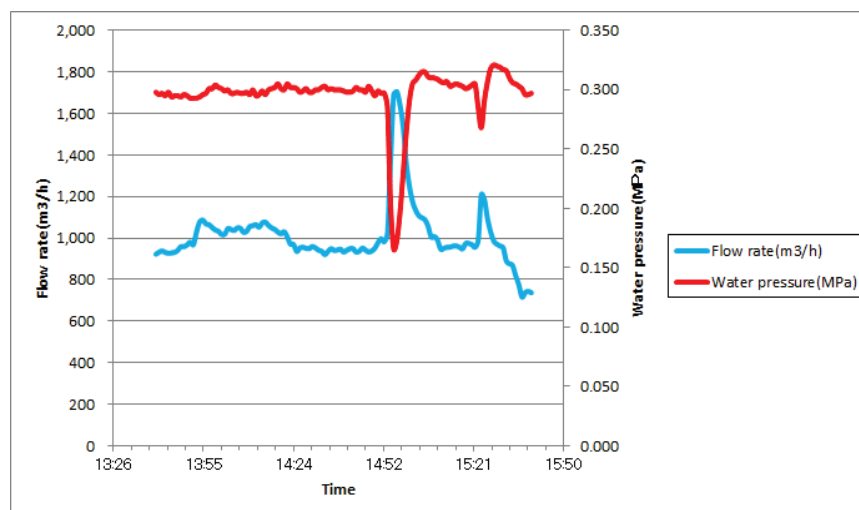
Fig. 6 Time histories of the flow rate and water pressure at a water distribution plant of Osaka.

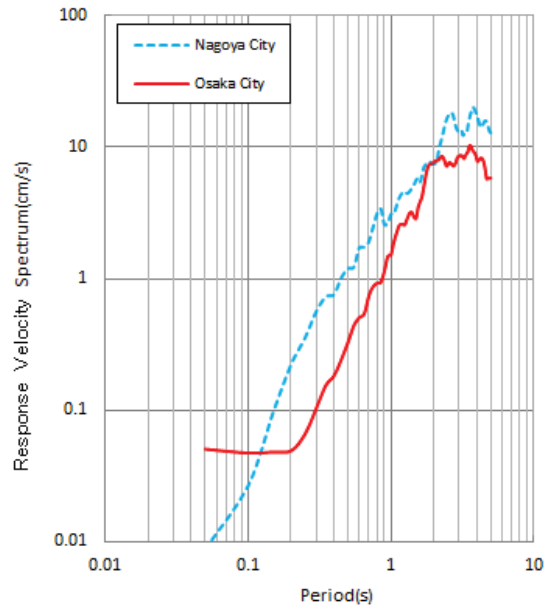
Fig. 7 Response velocity spectra of recorded waveform at Nagoya City (K-NET AIC004) and Osaka City (K-NET OSK005).

Fig. 7 illustrates response velocity spectra of recorded waveforms of the great east Japan earthquake at Nagoya City (K-NET AIC004) and Osaka City (K-NET OSK005). This figure indicates that the predominant periods are more than one second.

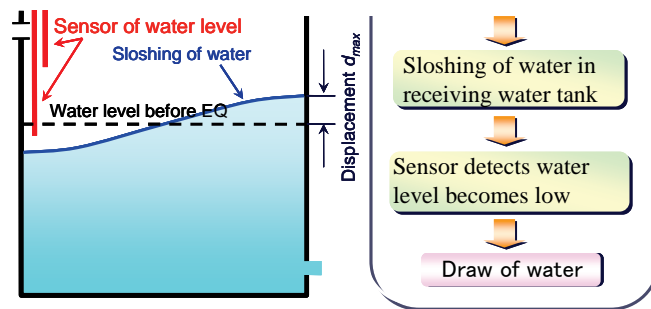
Fig. 8 Mechanism of draw of water from distribution pipe to receiving tank by sloshing during earthquake.

Murata and Miyajima³⁾ have considered that one of causes of the unusual phenomena seems to be sloshing of water in receiving water tank. If sloshing of water in receiving water tank is occurred by an earthquake, draw of water to receiving water tank starts by error of a sensor of water level in the receiving water tank as shown in Fig. 8. If sloshing of water in many receiving water tanks occurred simultaneously, an abrupt increase in flow rate and a decrease in water pressure may be occurred. Occurrence of sloshing of water in receiving water tank depends on the dimensions of receiving water tank and the height of water in the tank. Murata and Miyajima³⁾ have investigated dimensions of receiving water tank in a water distribution block of Osaka City and estimated the natural period of sloshing of the water. Fig. 9 shows cumulative percentage of natural period of water in receiving water tank in case that the height of water is $\frac{3}{4}$ and $\frac{1}{2}$ of the height of water tank. The height of water is variable and depends on use of water. The natural period of sloshing is more than 1.0 second

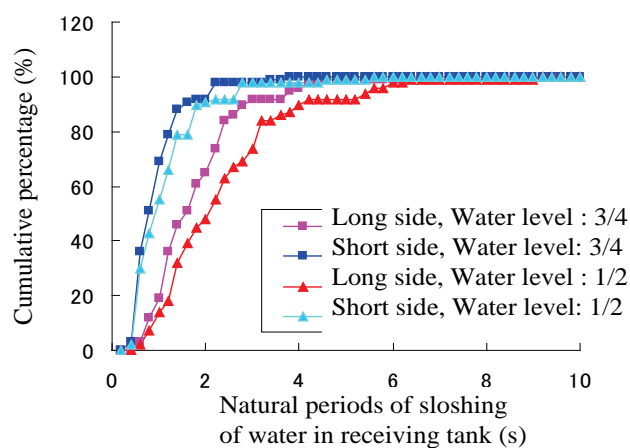
Fig. 9 Cumulative percentage of natural period of water in receiving water tank

of more than 80% of the water tank in the direction of long side in the water distribution block in Osaka City. This is one example, but long period ground motion more than one second can be caused sloshing of water in receiving water tank. However, the further study is needed to clarify the cause of an abrupt increase in flow rate and a decrease in water pressure of water distribution system in spite of no damage to pipeline and its effects to emergence response just after large scale disaster.
