THE DAMAGE OF SEWAGE TREATMENT SYSTEMS CAUSED BY THE GREAT EAST JAPAN EARTHQUAKE

Manabu MATSUHASHI¹, Wataru FUKATANI², Toshihiro YOKOTA³, Masaaki OZAKI⁴, and Nobuyuki HORIE⁵

¹Research Engineer, Department of Water Quality Control, National Institute for Land and Infrastructure Management, (NILIM), Ministry of Land, Infrastructure, Transport and Tourism (MLIT), Tsukuba, Japan, matsuhashi-m92ta@nilim.go.jp

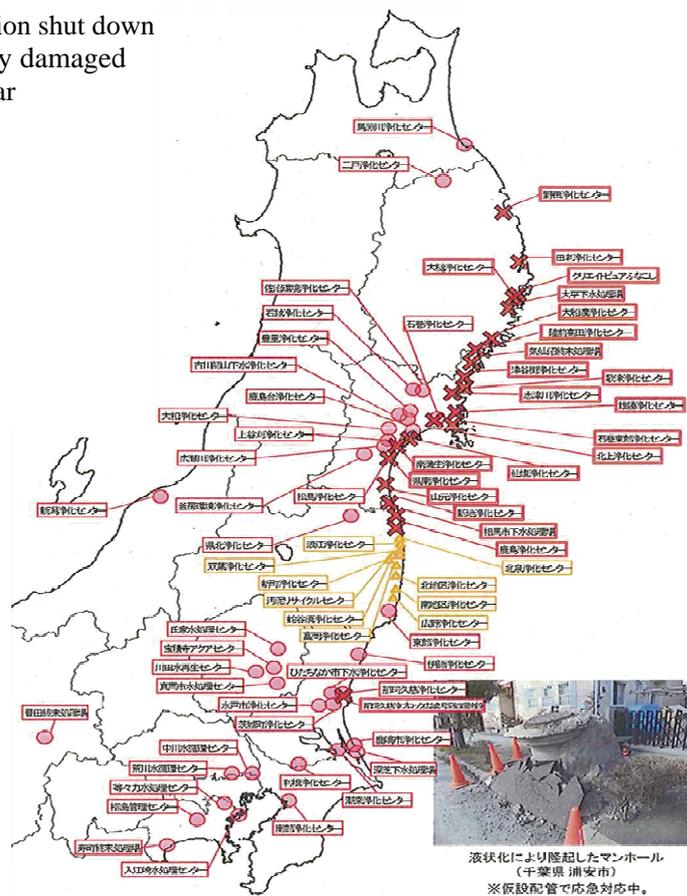
As shown in Figure 1, damage has been confirmed over a wide area ranging from Iwate Prefecture to Kanagawa Prefecture, with sewage treatment plants along the coastlines of the prefectures of Iwate,

Miyagi, and Fukushima suffering particularly severe tsunami damage, while even at inland sewage treatment plants which were spared tsunami damage, the earthquake motion either damaged or dislodged sludge scrapers.

Figure 1. Damage to Sewage Treatment Systems by the Great East Japan Earthquake

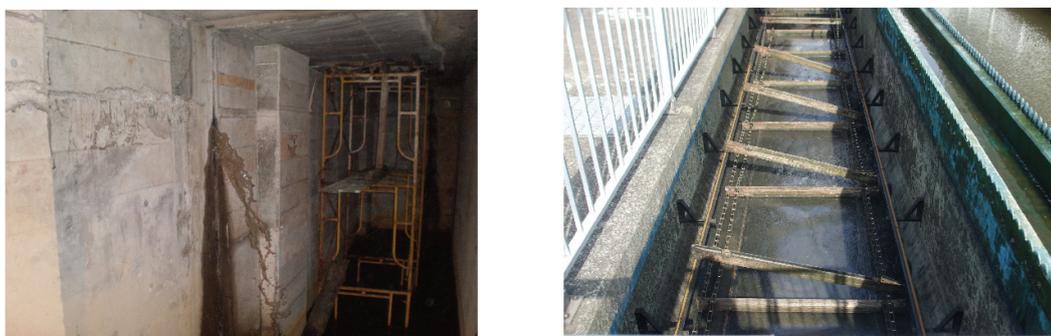
Damage to sewage treatment systems caused by earthquake motion included derailment or breakage of flight chains and breakage of flight plates of sludge scrapers, or leakage caused by displacement of expansion joints of interior pipes, etc. (Fig. 3). But these kinds of damage were also caused by past earthquakes, and at the same time, at many damaged sewage treatment plants, countermeasures hypothesized on level 2 earthquake motion have not yet been taken, so it is predicted that similar damage will gradually decline in severity as earthquake resistance measures progress.

Figure 3. Earthquake Motion Damage to Sewage Treatment Plants (Leaks, flight panel displacement)

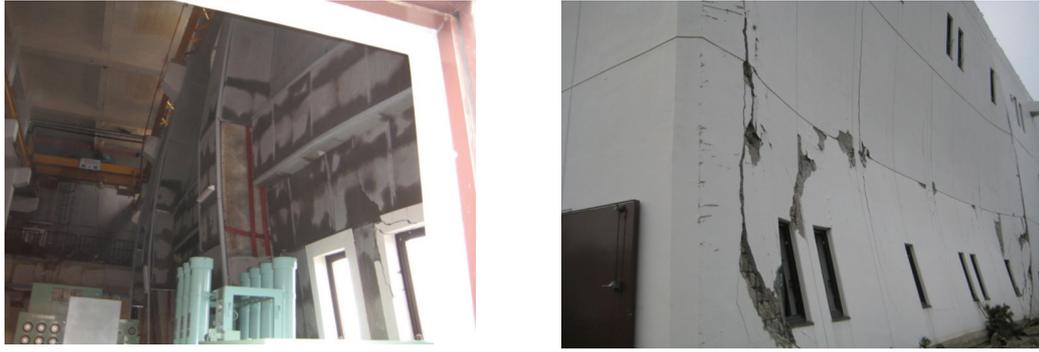
It is reported that damage caused by the wave force of tsunami varied in its degree according to the distance from the coast and according to the layout of structures between the coast and the damaged facility *¹, but as shown in Figure 4 and Figure 5, on civil engineering structures and buildings inside treatment plants at locations without structures acting as barriers, damage such as the destruction of gates, windows, walls, or columns occurred often.

Figure 4. State of Damage to Walls and Columns of Structures by Wave Force

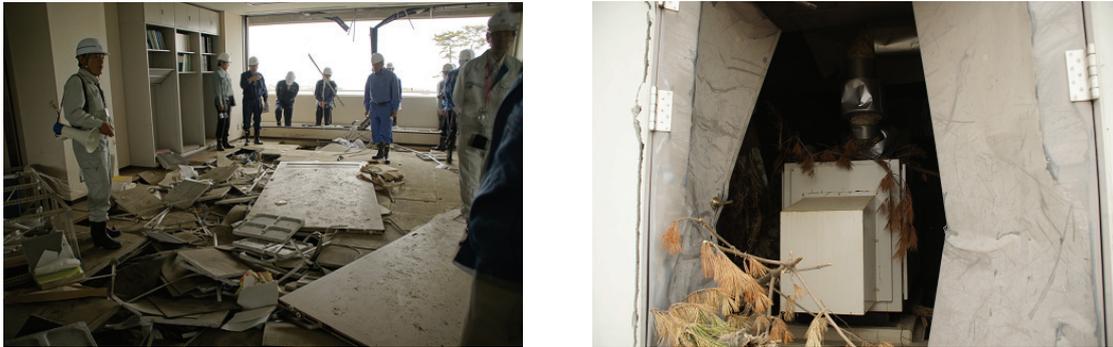
Figure 5. Damage to Doors and Windows by Wave Force

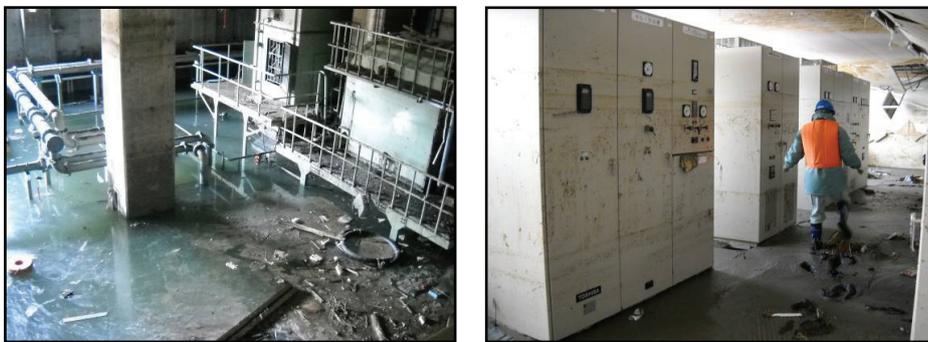
Submersion damage caused by tsunami occurred throughout the prefectures of Iwate, Miyagi, Fukushima, and Ibaraki. According to the results of the questionnaire survey, at some treatment plants, respondents answered that the maximum submersion depth (maximum traces of maximum submersion on each facility) was 10m or more, making this the most common cause of damage to sewage treatment plants by the Great East Japan Earthquake. Specific damage by submersion was, as shown by Figure 6, shutting down functions of electrical equipment and machines, deterioration of insulation, power failures or short-circuits, and the partial or complete halting of sewage treatment functions. In addition, large quantities of floating debris (rubble, automobiles, etc.) flowed into reaction tanks, creating conditions obstructing restoration.

Figure 6. Damage to Electrical and Mechanical Equipment by Submersion

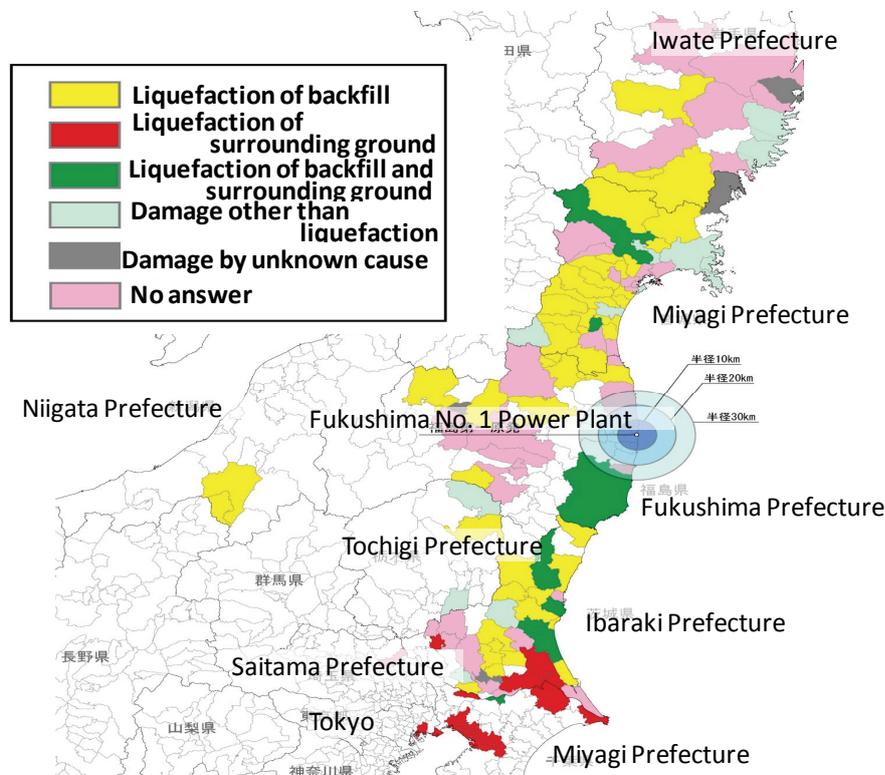
It shows that damage to backfill by liquefaction was seen relatively often in the Tohoku Region, which includes the prefectures of Iwate, Miyagi, and Fukushima, and damage caused by liquefaction of all the surrounding ground was seen in Tokyo, Chiba Prefecture, Ibaraki Prefecture and other regions centered on the Kanto, which are far from the hypocenter and where the earthquake motion was smaller than in Tohoku.

Figure 9. Distribution of Damage to Sewer Pipes

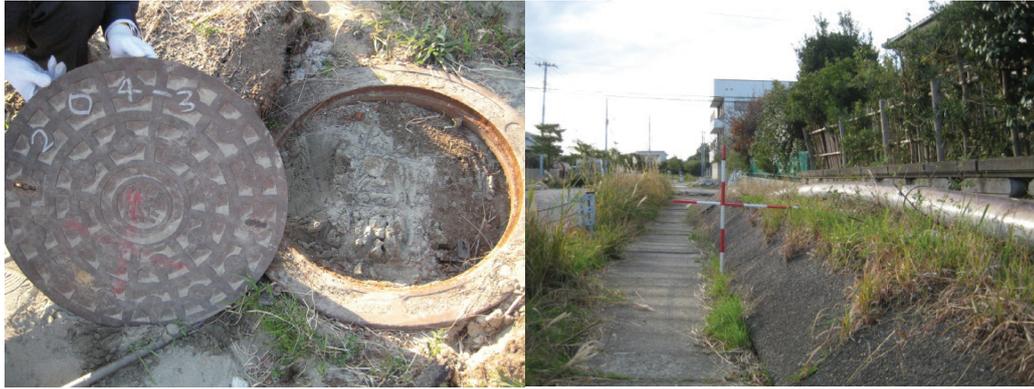
Figure 11. Blanket Liquefaction Damage of Surrounding Ground (Sand plugging, sewer pipe exposure)
