EVALUATION OF DESIGN AND CONSTRUCTION PRACTICES

-- A LESSON LEARNT FROM KASHMIR EARTHQUAKE --

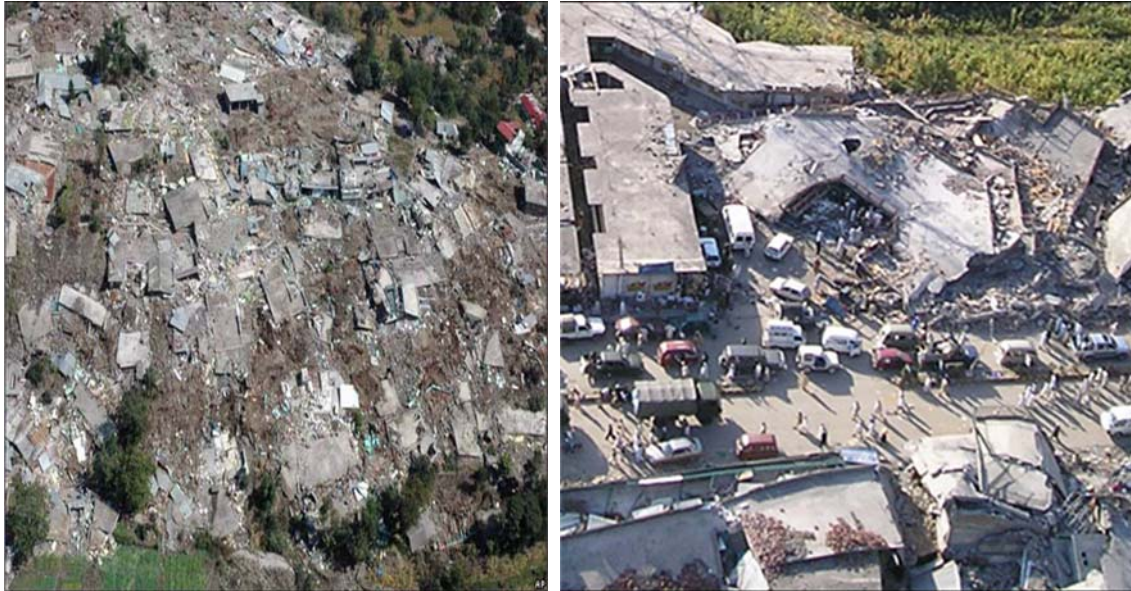
This earthquake was resulted from reactivation of northwest-striking fault, later defined as the Balakot–Bagh fault (Figure 1). The surface expression of the causative fault extends between Bagh and Balakot through Muzaffarabad (Geological Survey of Pakistan (GSP), 2006). The fault has reverse separation with northeast side moved up which has been verified by high crustal deformation from satellite data and fault modeling. The earthquake caused a widespread destruction in a wide belt along the total length of the fault. The area is characterized by its rugged mountainous terrain with limited communication structures connecting the sparse settlements. The devastated area is also recognized by the severe environmental conditions (especially very cold winter) and the residential structures were constructed with heavy roofs and thick walls to ensure the survival in these extreme environmental conditions. Due to the poor economical conditions, settlements in the mountainous ranges are the first choice for common people as compared to the flat land, which is more expensive. Moreover, the important/official structures were not designed properly for such an intense shake while the common residential dwellings were constructed without any design provisions. The earthquake was severe enough to destroy these structures. The city of Muzaffarabad and Balakot town were the nearest settlements to the epicenter, and they were the most heavily damaged (Figure 2).

Fig. 2 Devastation caused by Kashmir Earthquake in Muzaffarabad and Balakot cities

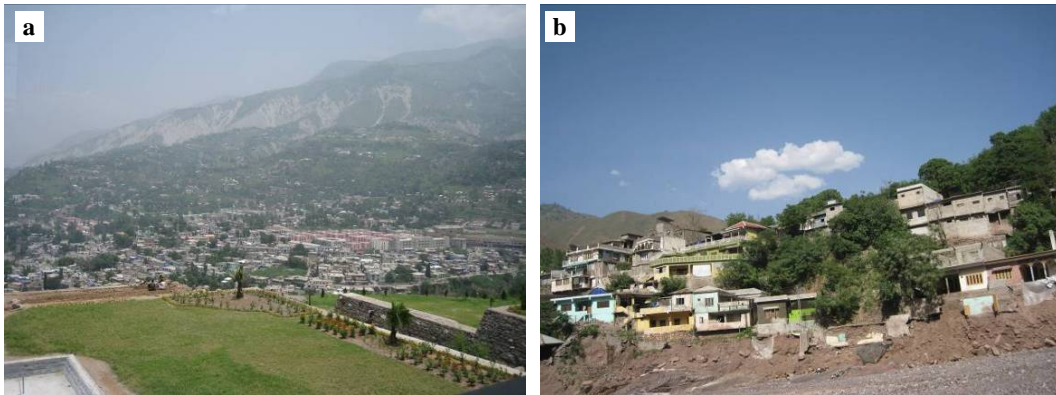
As is discussed, the devastated area has a rugged mountainous terrain with very limited flat terraces. These flat terraces are well congested and the land price is beyond the approach of majority. Therefore, a fair number of population lives along the hill slopes (Figure 3a), building their dwelling against the

natural slopes (Figure 3b) or on the soft deposits. These sites are vulnerable and have the tendency to magnify the earthquake effects. A large number of houses, with their back walls against the hill slopes, have been damaged during the earthquake due to increased pressure from the soil behind (Figure 4).

Fig. 3 a) A view of the Muzaffarabad city showing that a considerable number of population is living along the hill slopes behind flat terraces b) A typical example of the poor site selection, a common construction approach along the hillside (Photos by Kazmi, 2007)

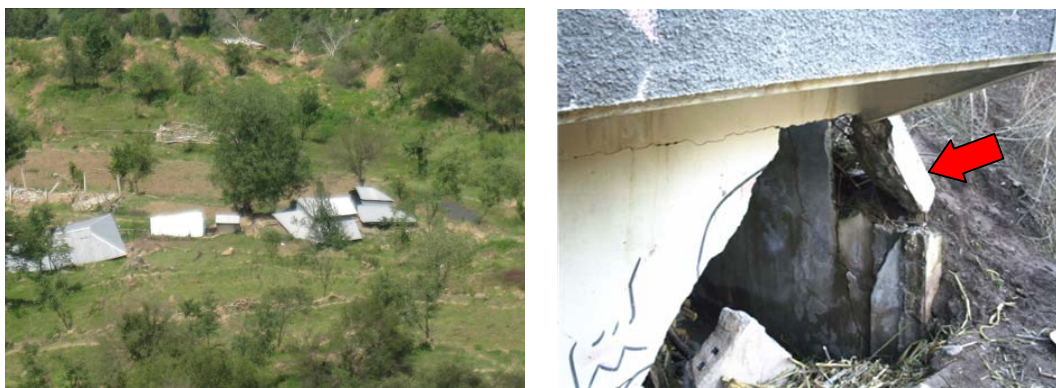
Fig. 4 Houses collapsed during the Kashmir earthquake with their rear walls damaged by increased earth pressure from the hill slope.

In hilly areas, back wall of house is mostly adjacent to the slope of mountain. By Earthquake rehabilitations authorities, it was particularly emphasized through the technical brochures and other mediums to avoid construction against the slope if back wall is not designed as a retaining wall.

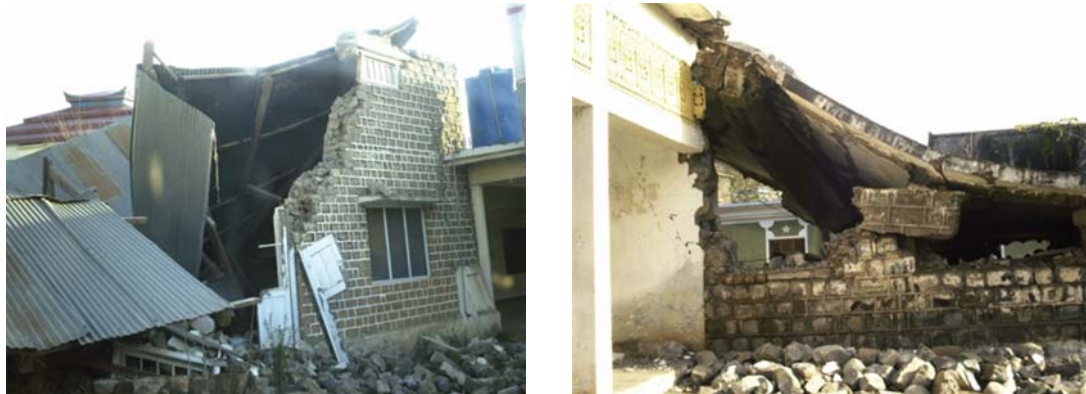
In addition to the poor site selection, lack of seismic considerations in design and construction was a prime reason for this massive devastation and death toll. Use of locally available stone and concrete blocks in construction is a state-of-the-art approach for construction of houses. Majority of the residential houses were made of stone or hollow concrete block masonry with corrugated iron roofs resting on timber trusses. The primary load bearing members were the masonry walls. Complete structural collapse was observed due to failure of such walls in out-of-plane bending and in-plane shear. Majority of the public structures (schools, colleges, hospitals etc.), which are supposed to be designed for a higher level of service and importance factor, also had similar structural systems as that of the residential houses. The ground shaking was large enough to partially or fully collapse all such constructions (Figure 5). A death toll of more than 15000 school children witnesses the extent of damage to school and colleges.

Fig. 5 Girls Degree College Rawalakot (left photo) and Boys Degree College Hajira (right photo) were totally collapsed during the earthquake. The structural system for both the buildings was load bearing stone masonry walls with different roofing system (Photo by Kazmi, 2006)

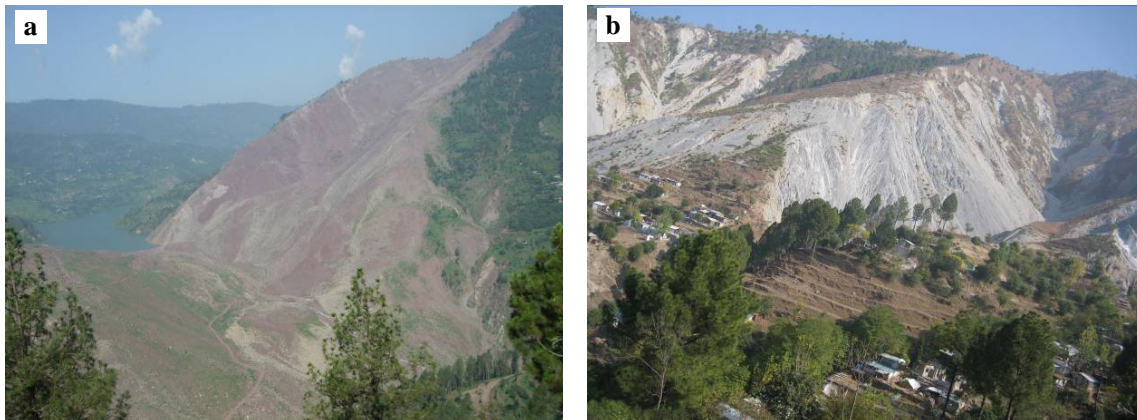
example is the Hattain Bala landslide (Figure 6a), an 85 million m³ soil mass (Dunning et al., 2007) that moved down the slope flushing the whole village settled on it and killing almost 200 people. The soil mass blocked two tributaries of Jhelum River and created a huge landslide dam, which later breached in 2010 and caused flooding to its downstream. In addition to such huge landslides, surficial slope failure appeared in wide belt along the total stretch of Balakot-Bagh fault (Figure 6b). This slope failure created a huge amount of debris material which moved down the creeks during the heavy rains of monsoon and hit the inhabitants along the valleys.

Fig. 6 Landslides and slope failures caused by Kashmir Earthquake a) Hattain Bala landslide b) surficial slope failure along Balakot-Bagh fault (Photos by Kazmi, 2008)

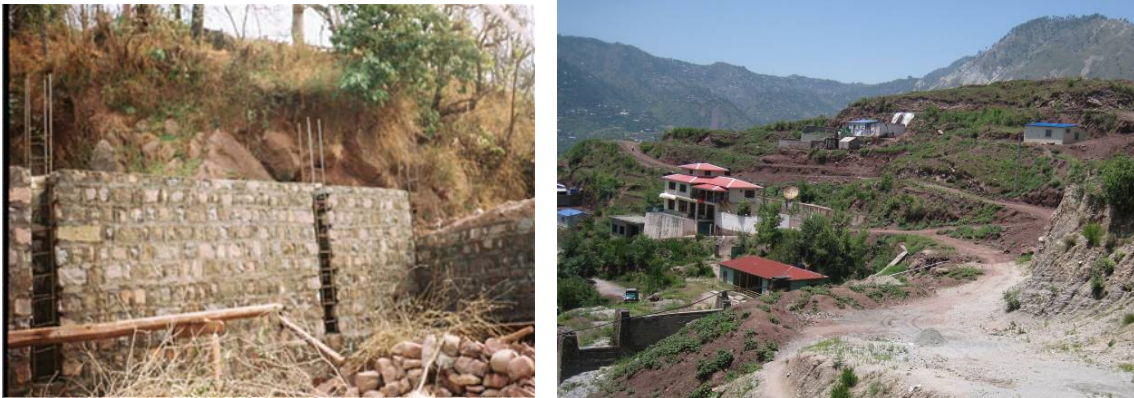
When a disaster strikes our fragile world and causes some serious devastation, it interrupts our senses for some period of time. But as the time passes by, we easily forget all that. Similarly, forgetting all what happened during Kashmir Earthquake, people are still constructing their houses against the hill slopes (Figure 7) by cutting the toes of natural slopes.

Fig. 7 Construction of the new house with their back wall facing the natural slope (Photo by Kazmi, 2008)

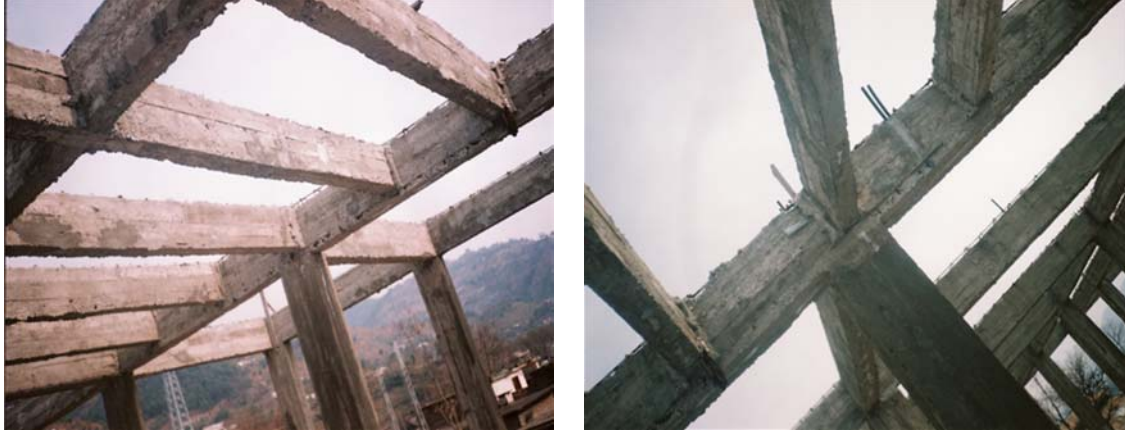
Figure 8 shows construction of government hospital at Hajira, a typical example of post earthquake construction. Both the photos in Figure 8 witness poor quality of design and construction. According to the revised seismic zoning, the building is located in zone-4 but the reinforcement detailing and structural members are not concordant with that. Spacing for the shear ties was larger than the maximum limit specified by the revised design code even at the locations of concentrated loads from the bracing beams. Sizes of many of the beams and columns were also violating the code specifications. Roof slab was not monolithically cast with the supporting beams and shear ties and negative reinforcement of the beams was exposed to the atmosphere. In addition to the inappropriate design/detailing, poor quality of construction was also observed. As can be seen from Figure 8, the whole construction was presenting concrete segregation and honeycombing while the reinforcement was exposed to the surfaces. While surveying the devastated area to evaluate the reconstruction, a

large number of similar cases were observed. Any future seismic activity may repeat the history with such a poor quality of design and construction. Although there are many socio-economic issues, people might have learnt from this recent incident to ensure safety for their lives.

Fig. 8 A typical example of reconstruction for concrete frame structure (Photos by Kazmi, 2007).

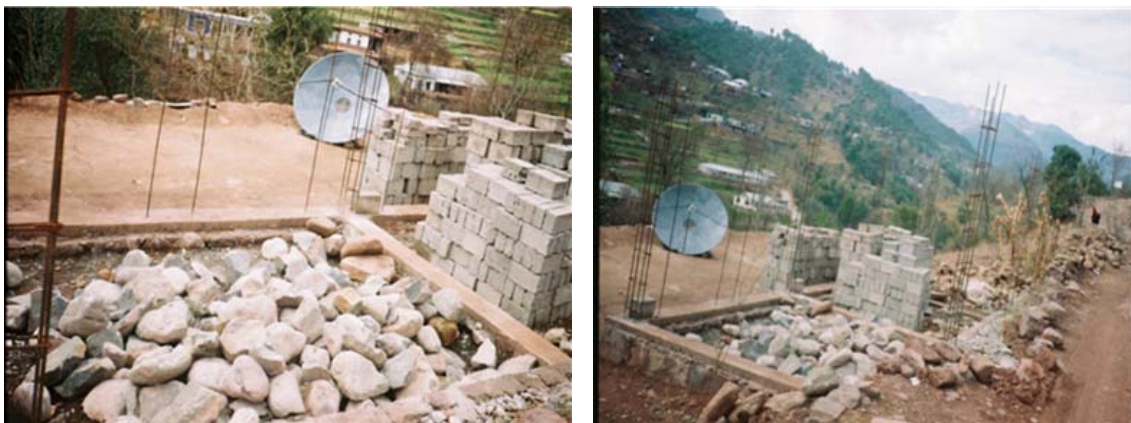
Despite of the effort made by ERRA and other authorities to communicate the recommendations for adobe houses to local society, local houses have been constructed on the older fashion with slight modification. Figure 9 shows a typical example of reconstruction for masonry houses. Very thin columns (equal to the width of concrete block, 150mm) were provided on corners and a single bar around the wall openings. 150mm wide hollow blocks were used for the in filled masonry. The adopted construction methodology can neither be cauterized as frame structure nor a masonry structure and are vulnerable to any extreme condition. Recommendations made to make the masonry houses seismic resistant (application of PP band etc.) were not observed in practical.

Fig. 9 A typical example of reconstruction for masonry houses (Photo by Kazmi, 2007)
