# OVERVIEW OF THE 1995 HYOGO-KEN NANBU EARTHQUAKE AND PROPOSALS FOR EARTHQUAKE MITIGATION MEASURES

Yoshikazu KITAGAWA<sup>1</sup> and Hisahiro HIRAISHI<sup>2</sup>

**Key Words:** 1995 Hyogo-Ken Nanbu Earthquake, Ground Motions, Soil Conditions, Structural Damages, Buildings, Civil Engineering Structures

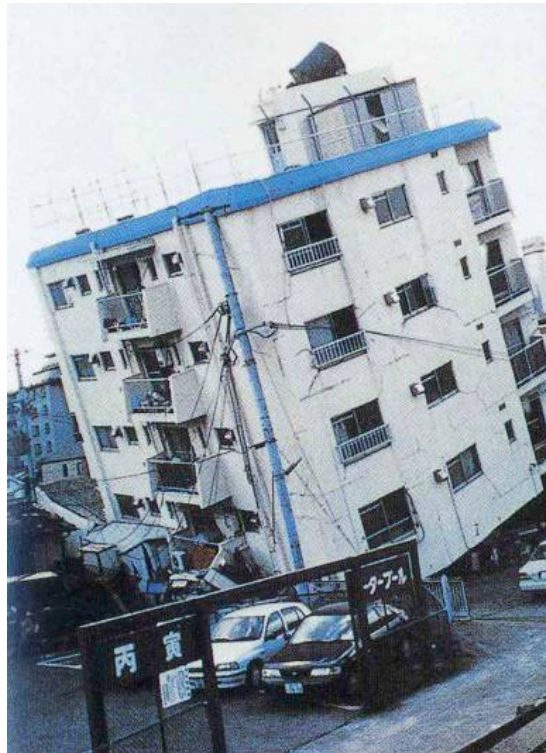
Photo 1 Building collapse at soft 1st story

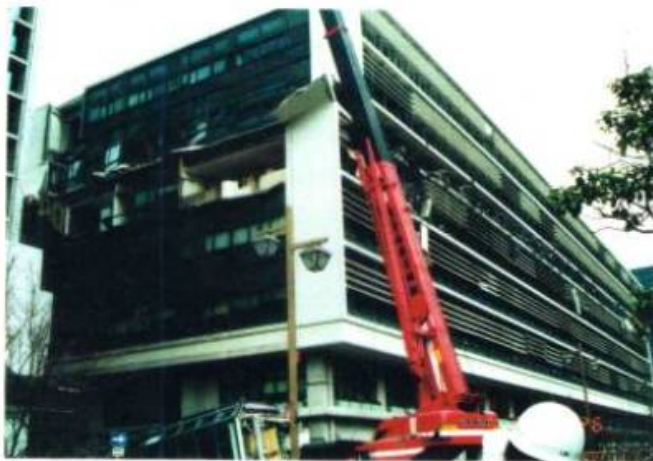
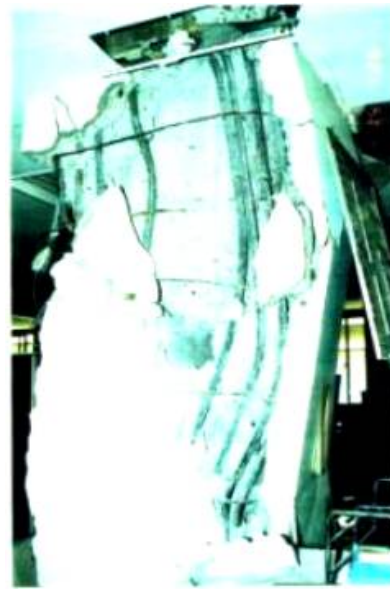
(a) Story collapse

(b) Column failure

Photo 2 Story collapse at 6<sup>th</sup> floor and column failure at 5<sup>th</sup> floor inside of the building

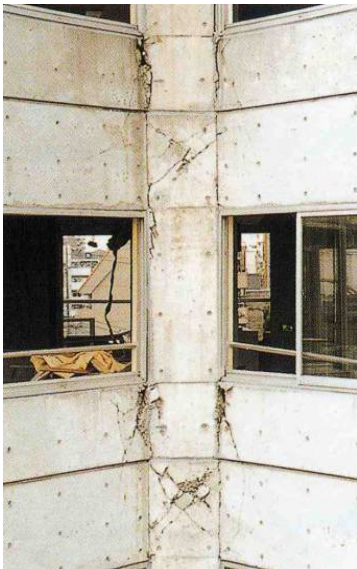
- 3) Beam-column joints: Shear cracks and spalling of cover concrete were observed in beam-column joints. Photo 3 shows shear cracking of an exterior beam-column joint , as an example.

Photo 3 Shear cracking of exterior beam-column joint

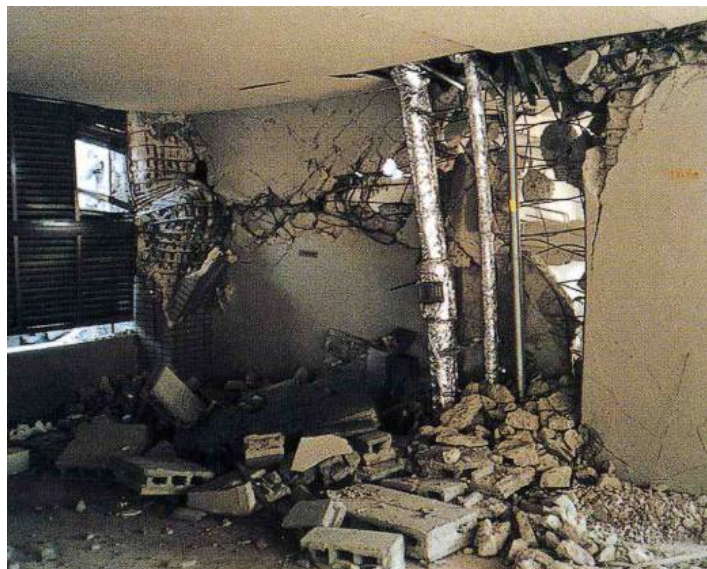
- 4) Shear walls: Typical failure patterns in shear walls were brittle shear failure in the web, sliding shear failure at construction joints, and shear compression failure at corners of the web. Photo 4 shows an example of sliding shear failure of a wall at mid-height.

Photo 4 Sliding shear failure of wall at mid-height

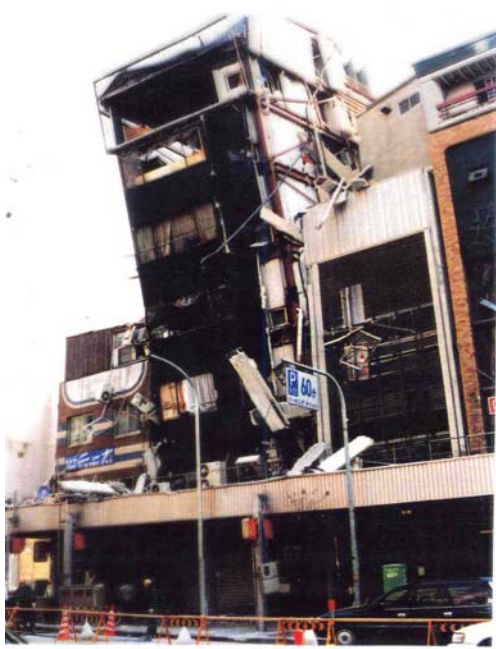
Photo 5 Steel-frame building with fracture of bracing members

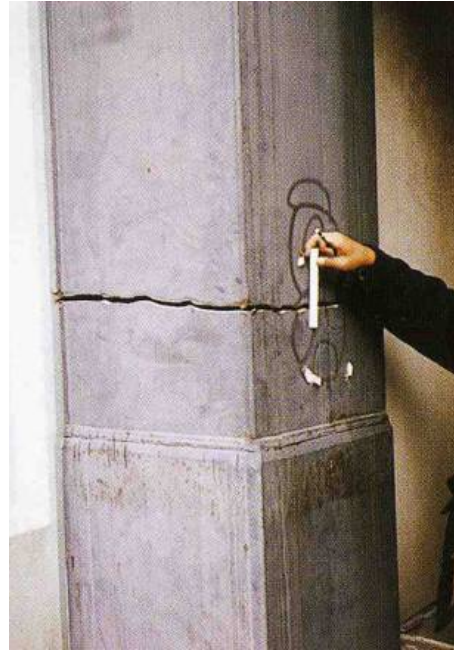
Photo 6 Brittle fracture of base metal in 1<sup>st</sup> column of steel high-rise building

steel was also disclosed in many instances. Early urban development areas have a high density of such old steel buildings, which tend to have serious lack of seismic capacity. Photo 5 shows an example of a steel-frame building with fracture of bracing members, and Photo 6 shows an example of brittle fracture of base metal in the first-story column of a steel high-rise building.

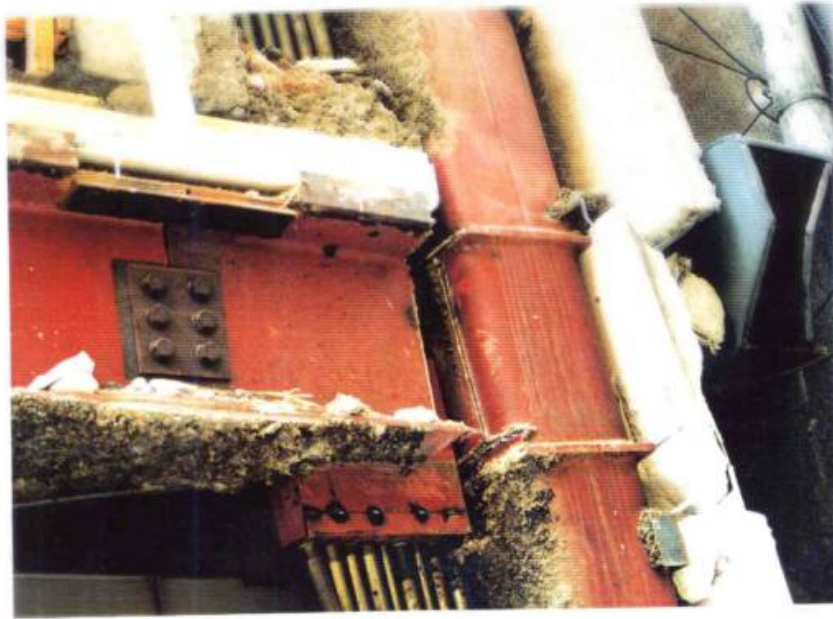
Damage to cover plates was observed at welds along the cover plates and beam ends. Most of the damaged connections had fillet welding and had inadequate strength to enhance the strength capacity of the beams. Photo 7 shows an example of damage to the column-to-beam connection.

Photo 7 Damage to column-to-beam connection

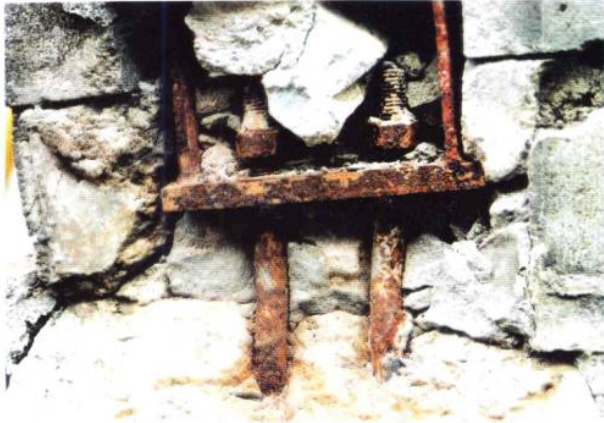
Photo 8 Pull-out of anchor bolts at column-to-base connection

- 5) Column bases: Among the 993 damaged buildings surveyed, 219 had damaged column bases. Such damage was structurally fatal in the overall damage to buildings. Photo 8 shows an example of pull-out of anchor bolts at a column-to-base connection.

Four types of failure were observed in base-plate connections: (i) fracture and pull out of anchor bolts, (ii) flexural deformation of base plates, (iii) fracture of fillet welds at column bases, and (iv) failure of concrete under the base plates. Four types of failure were also observed in concrete-encased column bases: (i) failure of the concrete that encased the column, (ii) failure of reinforcing bars, (iii) fracture and pull out of anchor bolts, and (iv) fracture of fillet welds at the column bases.

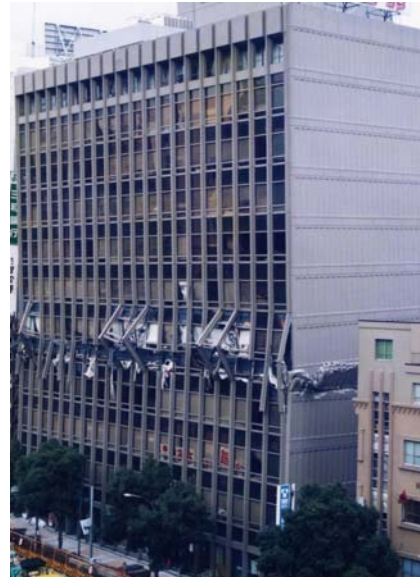
Photo 9 Story collapse at 5<sup>th</sup> floor

Composite encased-steel and concrete structures have been called SRC buildings. The Earthquake was the first time that a large number of SRC building were subjected to severe structural damage. The distinctive feature of collapsed SRC buildings was story failure at an upper floor level. In collapsed buildings with mid-height failure, most of the building was constructed of either SRC structures or mixed structures with SRC members in lower stories and RC members in the upper stories. Photo 9 shows an example of story collapse at the 5<sup>th</sup> floor.

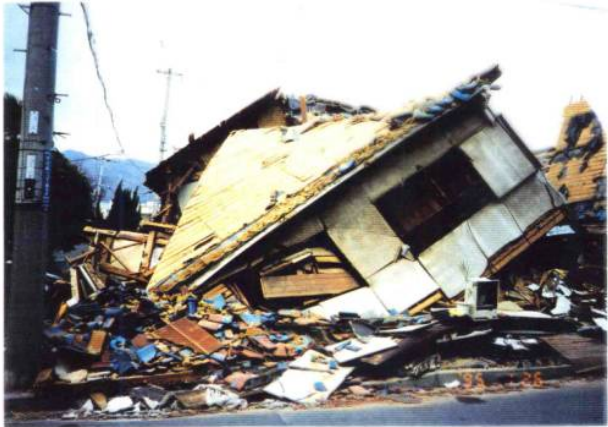
collapse of such houses. Typical damage to collapsed houses was the collapse of the first story where shear walls were insufficient or eccentrically placed. In some wooden houses that had an RC garage in the first story, the second story collapsed due to lack of lateral resistance and to the subsequent concentration of horizontal displacement in the second story. A number of narrow houses were heavily damaged due to inappropriate application of shear walls. In general, well-designed and well-constructed three-story wooden houses had almost no damage. Photos 10 and 11 show examples of the collapse of an old wooden house and new wooden house with a garage, respectively.

Photo 10 Collapse of old wooden house

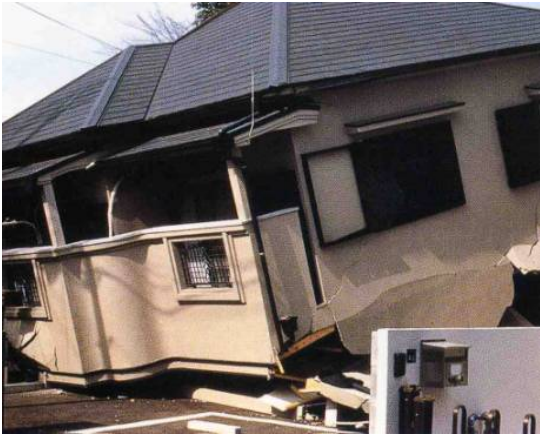
Photo 11 Collapse of new wooden house with garage

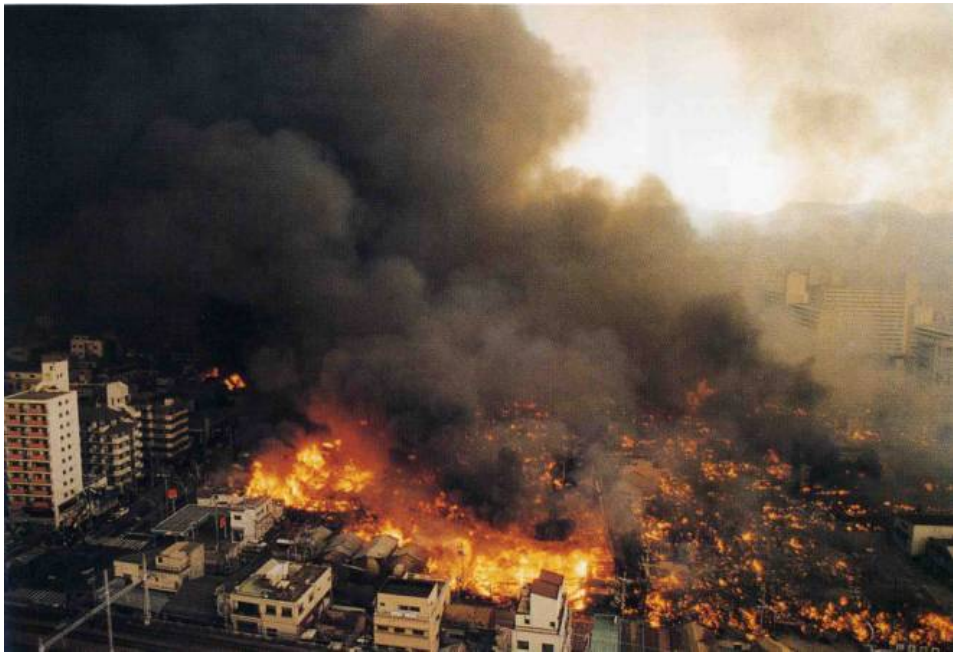
Photo 12 Extent of fire in Minatogawa-cho (contributed by Sankei Shimbun)

Fire damage was characterized as follows: (1) fires occurred immediately after the Earthquake, (2) many fires involved in electricity, (3) widespread urban-area fires occurred, (4) the speed that the fire spread was slow, (5) the outbreak and spread of fire in fire-resistant buildings were marked, (6) flying sparks and re-igniting occurred, (7) obstacles such as infrastructures and lifelines hindered fire fighting, (8) damage to disaster-prevention and fire-fighting facilities were marked, (9) fire fighting by citizens was widespread, and (10) streets and parks were helpful in preventing fire from spreading. Photo 12 shows the extent of fire in Minatogawa-cho (contributed by the Sankei Shimbun ).

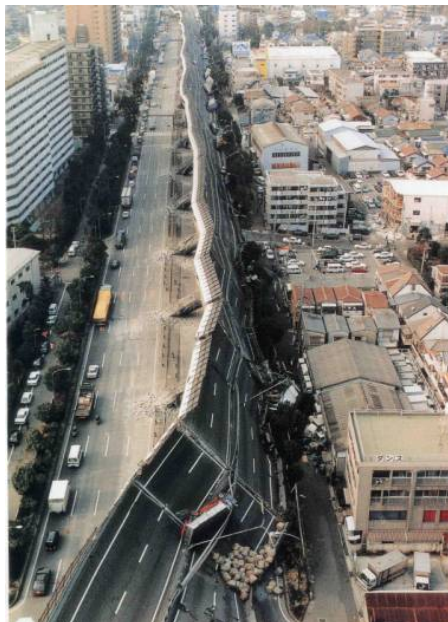
Photo 13 Damage to elevated urban highway (contributed by Yomiuri Shimbun)

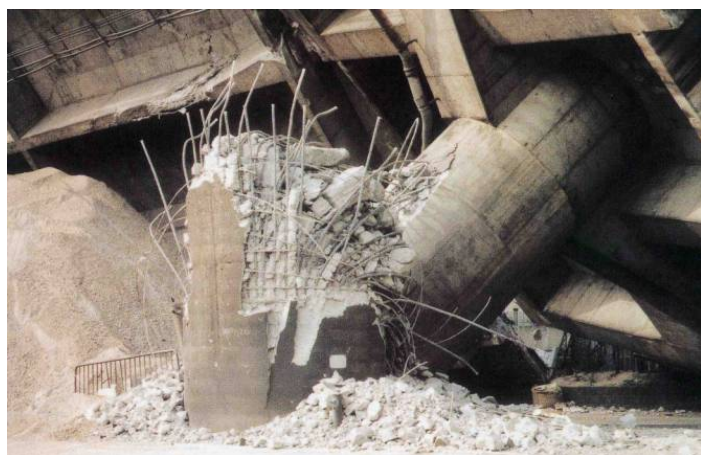
Photo 14 Shear failure of RC Pilz-type bridge

failure of RC bridge columns due to inadequate anchoring length of main reinforcements at cut-off points was significant in road bridges, and shear failure of columns of frame-type piers was significant in railway bridges. Photo 13 shows an example of damage to an elevated urban highway (contributed by the Yomiuri Shimbun ), and Photo 14 shows an example of shear failure of an RC Pilsz-typed bridge.

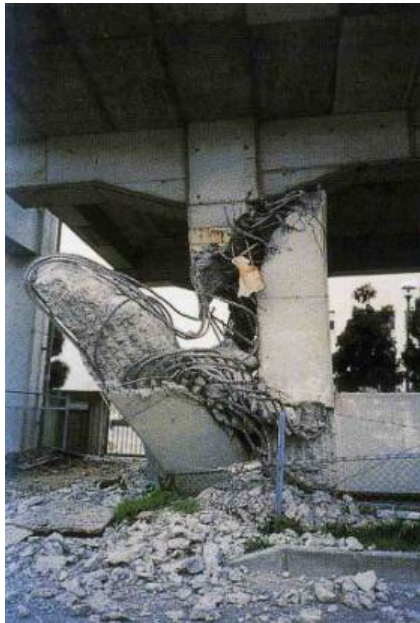
Damage to RC rigid-frame viaducts of railways (JR Shinkansen, Hankyu, Hanshin, Electric and Sanyo Electric Railways) in the epicentral region was extensive and very severe. Many of the RC viaducts completely collapsed due to shear failure in the columns. Most of the heavily damaged viaducts were constructed in either the 1960s or 1970s. At that time, the seismic design force used in the code was 0.2 G and structural details such as placement of hoop re-bard were inadequate to resist strong shaking. Collapse or heavy damage occurred mainly in the viaducts located in the region where the seismic intensity by JMA was VII. Photo 15 shows an example of shear failure of a railway RC-frame viaduct.

Photo 15 Shear failure of railway RC-frame

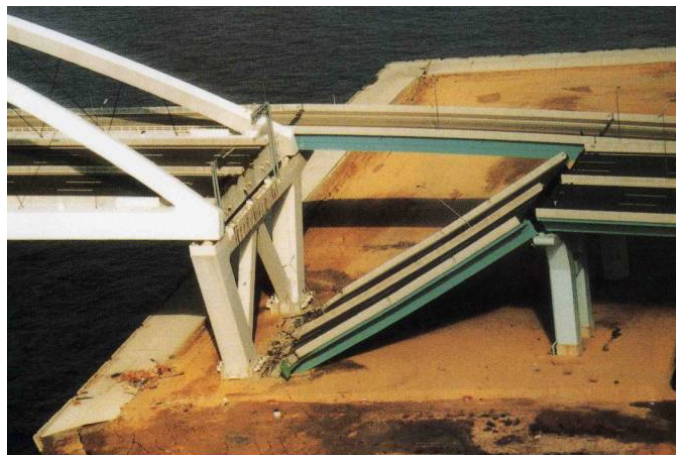
Photo 16 Fallen span in port bridge

large bridges cross the channels between reclaimed lands, and some of the foundations in these bridges were displaced due to the seismic-induced soil residual movement. In the Rokko Island Bridge (double deck, 215m span), the pivot shoes on the south side failed, thus causing the superstructure to fall from the shoes down to the frame pier with a transverse displacement of 3.1m. Some of the lateral beams connecting two plane-arch frames were buckled. In the Nishinomiya Port Bridge (8 spans totaling 252m), one of the upper shoes had severe brittle fracture and was completely split into pieces. The two steel-frame piers were displaced toward the sea by several centimeters and, partly due to this displacement, one adjacent steel simple girder fell to the ground. In the Kobe Bridge (continuous 3 spans totaling 322m), one of the foundation caissons was inclined by 80 cm at the top, and some of the bearings were fractured, resulting in longitudinal displacement of the arch structure. The Nada Bridge (Nielsen-type, 2 spans) suffered minor damage; its expansion joint was damaged by large transverse motion of the adjacent girder. In the Portpia Bridge, the bridge pier was inclined due to soil liquefaction, causing damage to bearings and seismic restrainers. In the Hagoromo Bridge (RC, 12m span, construction completed in 1929), partial compressive failure occurred in both the abutment and arch top. Photo 16 shows an example of a fallen span in a port bridge.

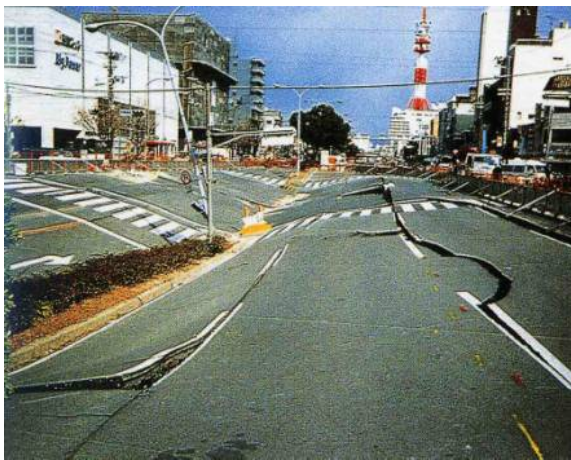
Photo 17 Settlement of national road over a subway station

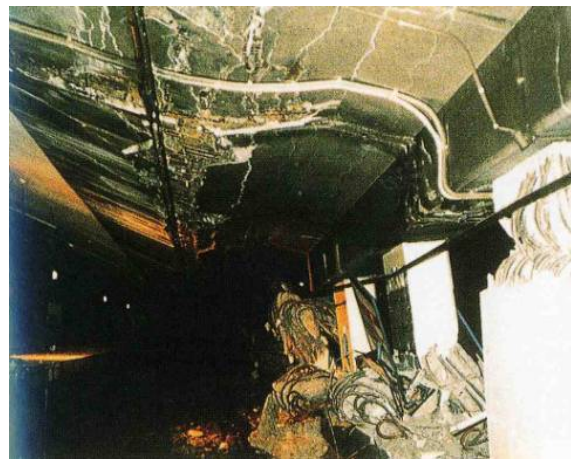
- 1) The subway structures in Kobe, such as Daikai Stations and Kamisawa Stations, suffered severe damage. The major damage occurred at RC intermediate columns, and many diagonal cracks occurred along the walls in the transverse direction. Judging from the damage pattern, strong dynamic horizontal forces (earth pressure and shearing force) and shear deformations were applied to the structures by the surrounding ground due to the strong horizontal motion. Most of the damaged structures failed due to a lack of load-carrying capacity against shear in the center column. Photos 17 and 18 show settlement on the national road over the subway station and collapsed center pillar subsided upper floor slab of the subway station.

Photo 18 Collapsed center pillar and subsided upper floor slab of
