# INVESTIGATION OF NATURAL FREQUENCY REDUCTION MECHANISM OF A HISTORIC MASONRY BUILDING IN PATAN FOLLOWING THE 2015 GORKHA EARTHQUAKE IN NEPAL

**ABSTRACT:** On April 25, 2015, Gorkha earthquake occurred about 80 km northwest of Kathmandu. In Patan, masonry structures collapsed in Durbar Square. The two-story masonry building that is the subject of this study, is about a 5-minute walk from Durbar Square. Although the building did not collapse, cracks were confirmed in several places. Microtremor measurements performed before and after the earthquake revealed that the natural frequencies of the building decreased. This study examined the factors that decrease the natural frequencies of buildings by seismic response analysis using ground motion estimated by the H/V spectrum ratio as input.

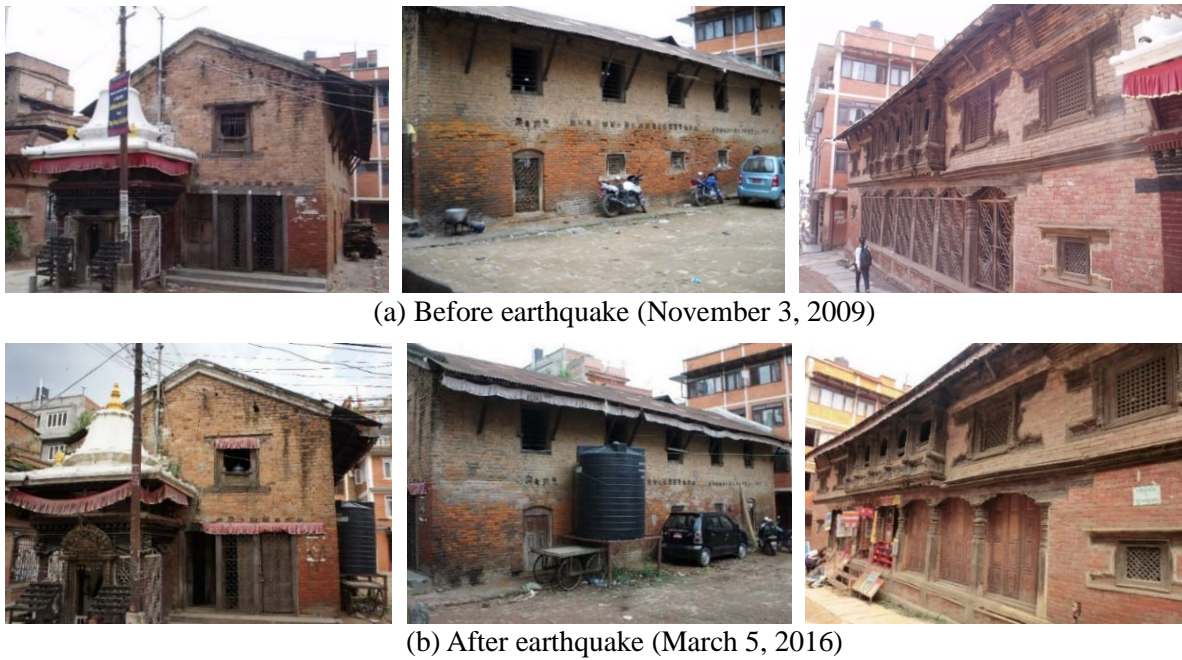
Fig. 1 Appearance of building before and after the 2015 Gorkha earthquake (Left: South side, Middle: East side, Right: West side)

Figure 1(a) and (b) respectively show the appearance of the building from the outside before and after the earthquake. It was difficult to find new cracks from outside the building. Figure 2 shows the locations where cracks were found inside the building by visual inspection after the earthquake. The left is the north and the top is the east. Since no comparable photographs were taken prior to the earthquake, it is difficult to judge whether the cracks found inside the buildings existed before the earthquake or were generated due to the earthquake, but those cracks appeared to be new. For example, the photograph of cracks found at D1 is shown in Fig. 3(a). A similar crack was found at D2. We considered that the cracks were generated at D1 and D2 due to the earthquake since the thin wall between D1 and D2 resisted the out-of-plane deformation of the longitudinal wall. We also found cracks at the boundary between the thin wall and the ceiling. In the same manner, the building has a thin wall (the wall between green circles ●) in the western part of the first floor (the lower part of Fig. 2(a)). Unfortunately, we were not allowed to enter the western part of the first floor, and the visual inspection could not be conducted in this part. But we assume that cracks similar to D1 and D2 were generated at the intersection part shown by green circles ● since we found a crack at D3 as shown in Fig. 3(b) in the small room in the north-eastern corner of the first floor.

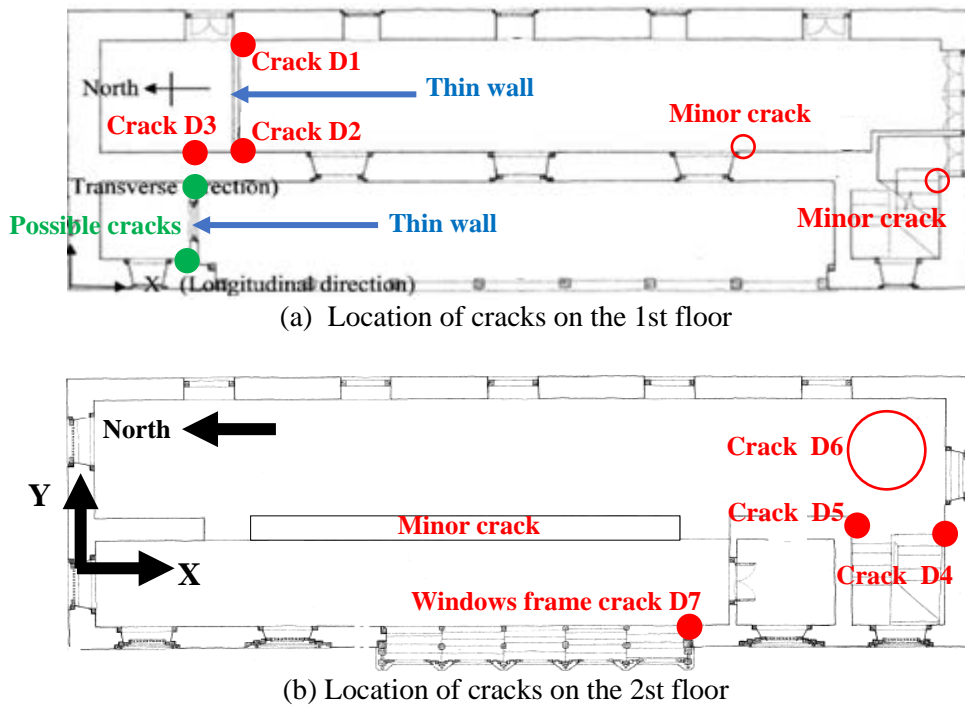
Fig. 2 Location of cracks found in the building after the 2015 Gorkha earthquake (The left is the north and the top is the east.)

which is used as a warehouse. The thin wall was modeled as 20 cm thick. Cracks have been identified at both ends of this thin wall (D1 and D2 in Fig. 2(a)). In the north-west side of the first floor, there is a thin wall connecting the inner wall and the western wall, and the thin wall was modeled as 20 cm thick (The thin wall is modeled with pink brick elements and the door frame is modeled with green and red timber elements.). A crack (D3 in Fig. 2(a)) is observed at the joints between the thin wall (light purple) and the inner wall (gray) as described before. As described later, the gray and yellowish green elements are color-coded to represent the crack of D3 generated at the boundary between the gray and yellowish green elements.

Based on the above, it was confirmed that the first-mode natural frequency after the earthquake can be roughly reproduced by assuming damage to the thin walls shown with D1 to D6 and the green circle in Fig. 2 where the damage was found or suspected by visual inspection.

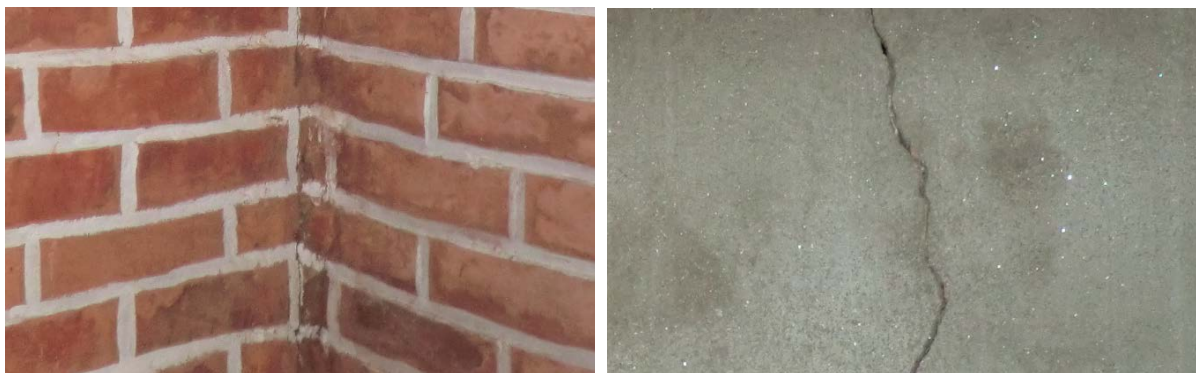
(a) Crack at D1

(b) Crack at D3

Fig. 3 Photographs of cracks found in the building after the 2015 Gorkha earthquake

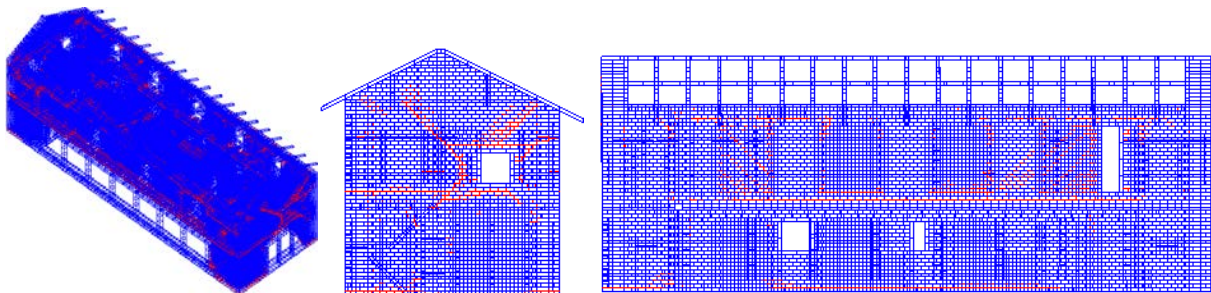
Figure 13 shows the cracking situation at the time when the estimated ground motion of Gorkha earthquake for 30 s was input to Analysis Model A. The outline of the element is shown in blue, and the location where the tensile failure occurs is indicated by the red line. In the narrow wall on the south side, diagonal cracks can be seen mainly on the second floor. In the longitudinal wall on the east side, diagonal cracks are observed mainly on the second floor, and horizontal cracks can be confirmed at the bottom of the first and second floor walls. From the occurrence of cracks, it can be inferred that the deformation in the Y-direction is outstanding.

Next, the natural frequencies after the earthquake were obtained from the Fourier transform of the displacement response from 33 s to 38 s. Table 6 shows a comparison of the natural frequencies before and after the earthquake between the microtremor and the analysis model. In the numerical analysis after the earthquake, only one outstanding mode in the X- and Y-directions was obtained, so only the comparison between the first mode (first mode in the Y-direction) and the third mode (first mode in the X-direction) is shown. In Analysis Model A, the first-mode natural frequencies in the X- and Y-directions after the earthquake are significantly lower than those before the earthquake and are much lower than those obtained by microtremor measurement after the earthquake. This also corresponds to the fact that the area of tensile failure that occurred in Analysis Model A was wider than the crack occurrence area confirmed by visual inspection on site, and the result of Analysis Model A was an overestimation of the actual damage. From the above, it is considered that the tensile strength of the actual buildings may be larger than the 0.1 MPa assumed in this study.

(a) View from the southwest (b) View from the south (c) View from the east  
Fig. 13 Failure occurrence after 30 s of ground motion input (Analysis Model A)

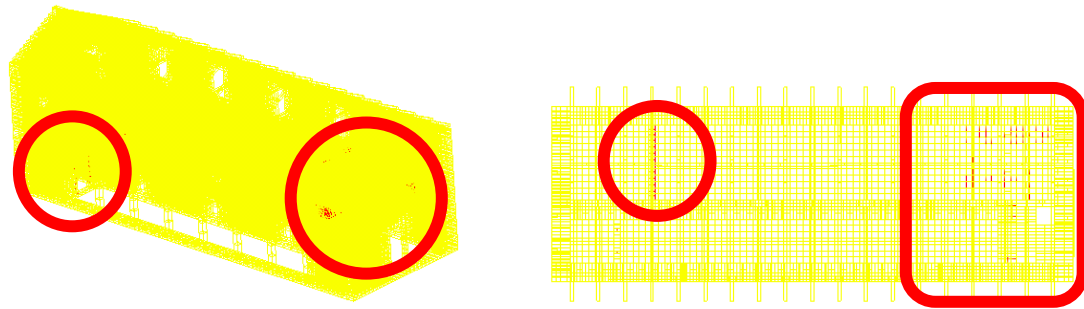
Fig. 14 Failure situation after 30 s of ground motion input (Analysis Model B)

In Analysis Model B, the failure was only allowed to occur at the locations where cracks were confirmed by visual inspection. Figure 14 shows the cracking situation when the estimated ground motion of Gorkha earthquake with a duration of 30 s was input to Analysis Model B. The outline of the element is shown in yellow, and the location where tensile failure occurred is indicated by the red line. Although it is difficult to discriminate from Fig. 14, it was confirmed that a tensile failure occurred at the locations where damage occurrence is allowed as shown in Fig. 12, and the failure occurred as expected.
