EMBANKMENT MATERIAL CHARACTERISTICS AT AGRICULTURAL RESERVOIR DAMAGED BY THE 1983 MIDDLE JAPAN SEA EARTHQUAKE IN AOMORI PREFECTURE

Hiroshi MORI¹ and Toshiki ASAKURA²

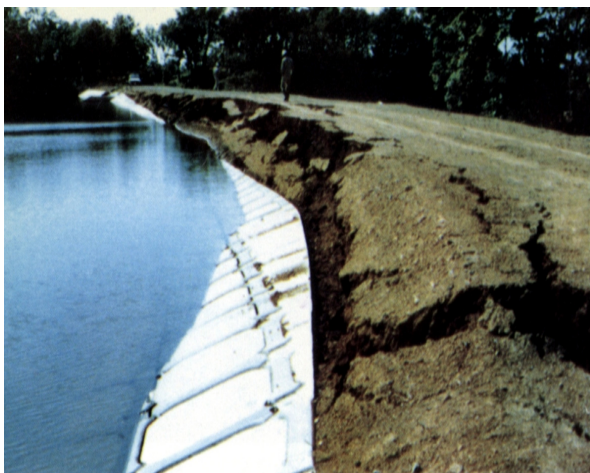
Photo 1 shows the example of an agricultural reservoir damaged by the 1983 Middle Japan Sea Earthquake at location (A) indicated in Fig. 3⁹⁾. Because the cracks on the embankment occurred and the sticking block slid down, it was assumed that the ground surface geological feature was in the area where grain particles were large as sandstone in (semi) solidified sediment.

Photo 1 Cracks on the embankment and sliding of the sticking block [Reference 9)]

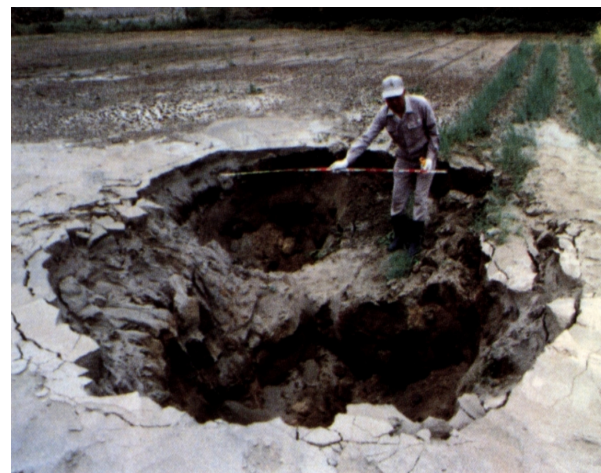
Photo 2 shows the example of a large sand boil in a paddy field damaged by the 1983 Middle Japan Sea Earthquake at location (B) indicated in Fig. 3⁹⁾. Damage done by sand boil was reported around this area where the ground surface geological feature was sand-fill. We inferred that a main factor of damaged agricultural reservoir was liquefaction of the foundation ground.

Photo 2 Large sand boil [Reference 9)]

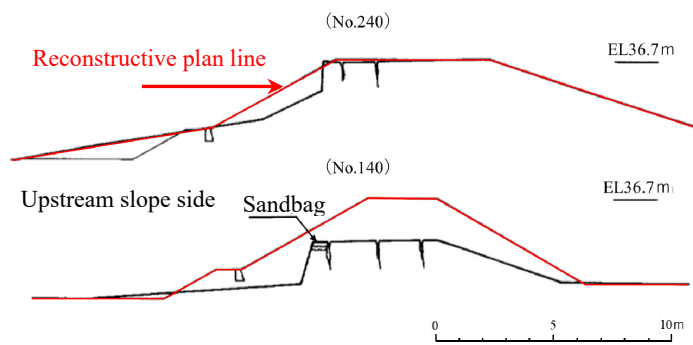
Fig. 4 Cross section of damaged Kasube-numa Reservoir [Reference 8) with partial revision]

Figure 4 shows a cross section of Kasube-numa Reservoir damaged by the 1983 Middle Japan Sea Earthquake at location (B) indicated in Fig. 3⁸⁾. Under this damage condition, as the settlement of upstream side of embankment and 2 – 3 axial cracks on crest occurred, about 1.5m of crest settlement was reported⁸⁾. From the soil boring log shown in Fig. 5, because this reservoir had both the embankment material and foundation ground material of sandy soil, we inferred liquefaction once more as the main cause of damage.

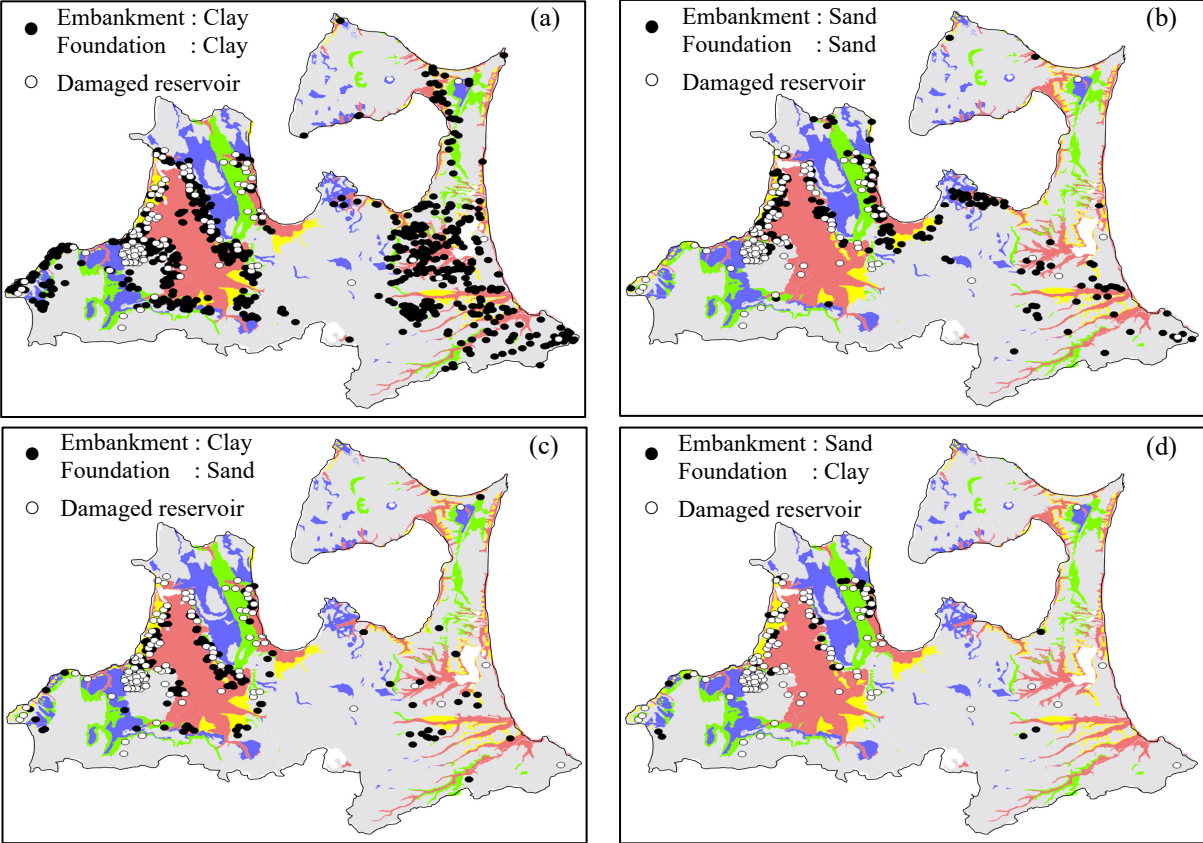
Fig. 12 Damaged agricultural reservoirs and the existing agricultural reservoirs with respective material combination [Reference 6) with partial revision]

Figure 12 shows the agricultural reservoirs (○) damaged in the 1983 Middle Japan Sea Earthquake and existing agricultural reservoirs (●) with the respective material combinations indicated in Fig. 10. In Fig. 12(a) indicating the clay–clay material combination of embankment material and foundation ground, although existing reservoirs with the combination in Fig. 12(a) agree with damaged reservoirs in the eastern area of the Tsugaru Plain, they tend to have a low degree of agreement at those in the sand-hill area around concentrating particularly on the western area of the

Tsugaru Plain and sandstone around facing Mutsu Bay. In Fig. 12(b) indicating the sand–sand material combination of embankment material and foundation ground, the existing reservoirs by the combination in Fig. 12(b) agree with damaged reservoirs in eastern and western area of the Tsugaru Plain and sandstone around facing Mutsu Bay, and they do also with the damage reports^{4), 5), 8), 9)} in the those days when both the embankment material and foundation ground material were sandy soil. In Fig. 12(c) indicating the clay–sand material combination of embankment material and foundation ground, although the existing reservoirs by the combination in Fig. 12(c) agree with damaged reservoirs in eastern and western areas of the Tsugaru Plain, they do not agree with those at the northern edge area of the Tsugaru Plain and sandstone around facing Mutsu Bay. Detailed investigations seem necessary for future studies because the possibility exists that Fine Fraction Content (F_c) value of an embankment material authorized as a clay soil by location was high¹²⁾. In Fig. 12(d) indicating the sand–clay material combination of embankment material and foundation ground, although it is difficult to estimate these values because existing reservoirs with that combination in Fig. 12(d) are few, the continuous verification by GIS is necessary because the possibility exists that including great damage by a pore water pressure rise in the embankment constructed by a sand material.

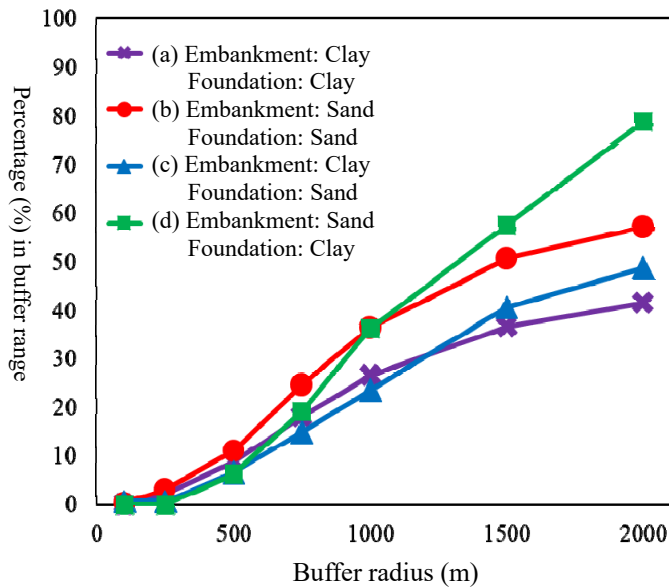
Fig. 13 Percentage in buffer range of damaged reservoir with each material combination

Figure 13 shows relations between the buffer radius and buffer range with each material combination when a buffer range is set up at some distance [R (buffer radius) = 100, 250, 500, 750, 1000, 1500, 2000 m] from the center of damage to a reservoir (refer to Fig. 14) for quantitative consideration of the degree of agreement with relations between the agricultural reservoir portions damaged in the 1983 Middle Japan Sea Earthquake and the existing agricultural reservoir portions for each material combination indicated in Fig. 12. These percentages in the buffer range with sandy soil

embankment material [(b), (d)] tended to be larger than those with clay soil embankment material [(a), (c)]. The percentage in the buffer range for cases with the sand–sand (b) and clay–sand (d) foundation ground material on bound of $R = 1000$ m and the percentage in the buffer range for cases with the clay–clay (a) and sand–clay (c) on bound of $R = 1250$ m, tended to reverse. On carrying out the detailed future investigations of foundation ground material, the impact statement precision can be improved by using the buffer radius (R). We could suppose the damage in the past and the factors such as wide or narrow areas.
