Quick damage survey after the 2011 off the coast of  
Fukushima Earthquake (M 7.3)

Takashi KIYOTA, Masataka SHIGA  
Institute of Industrial Science, University of Tokyo

# Survey area (16<sup>th</sup> Feb., three days after the earthquake)

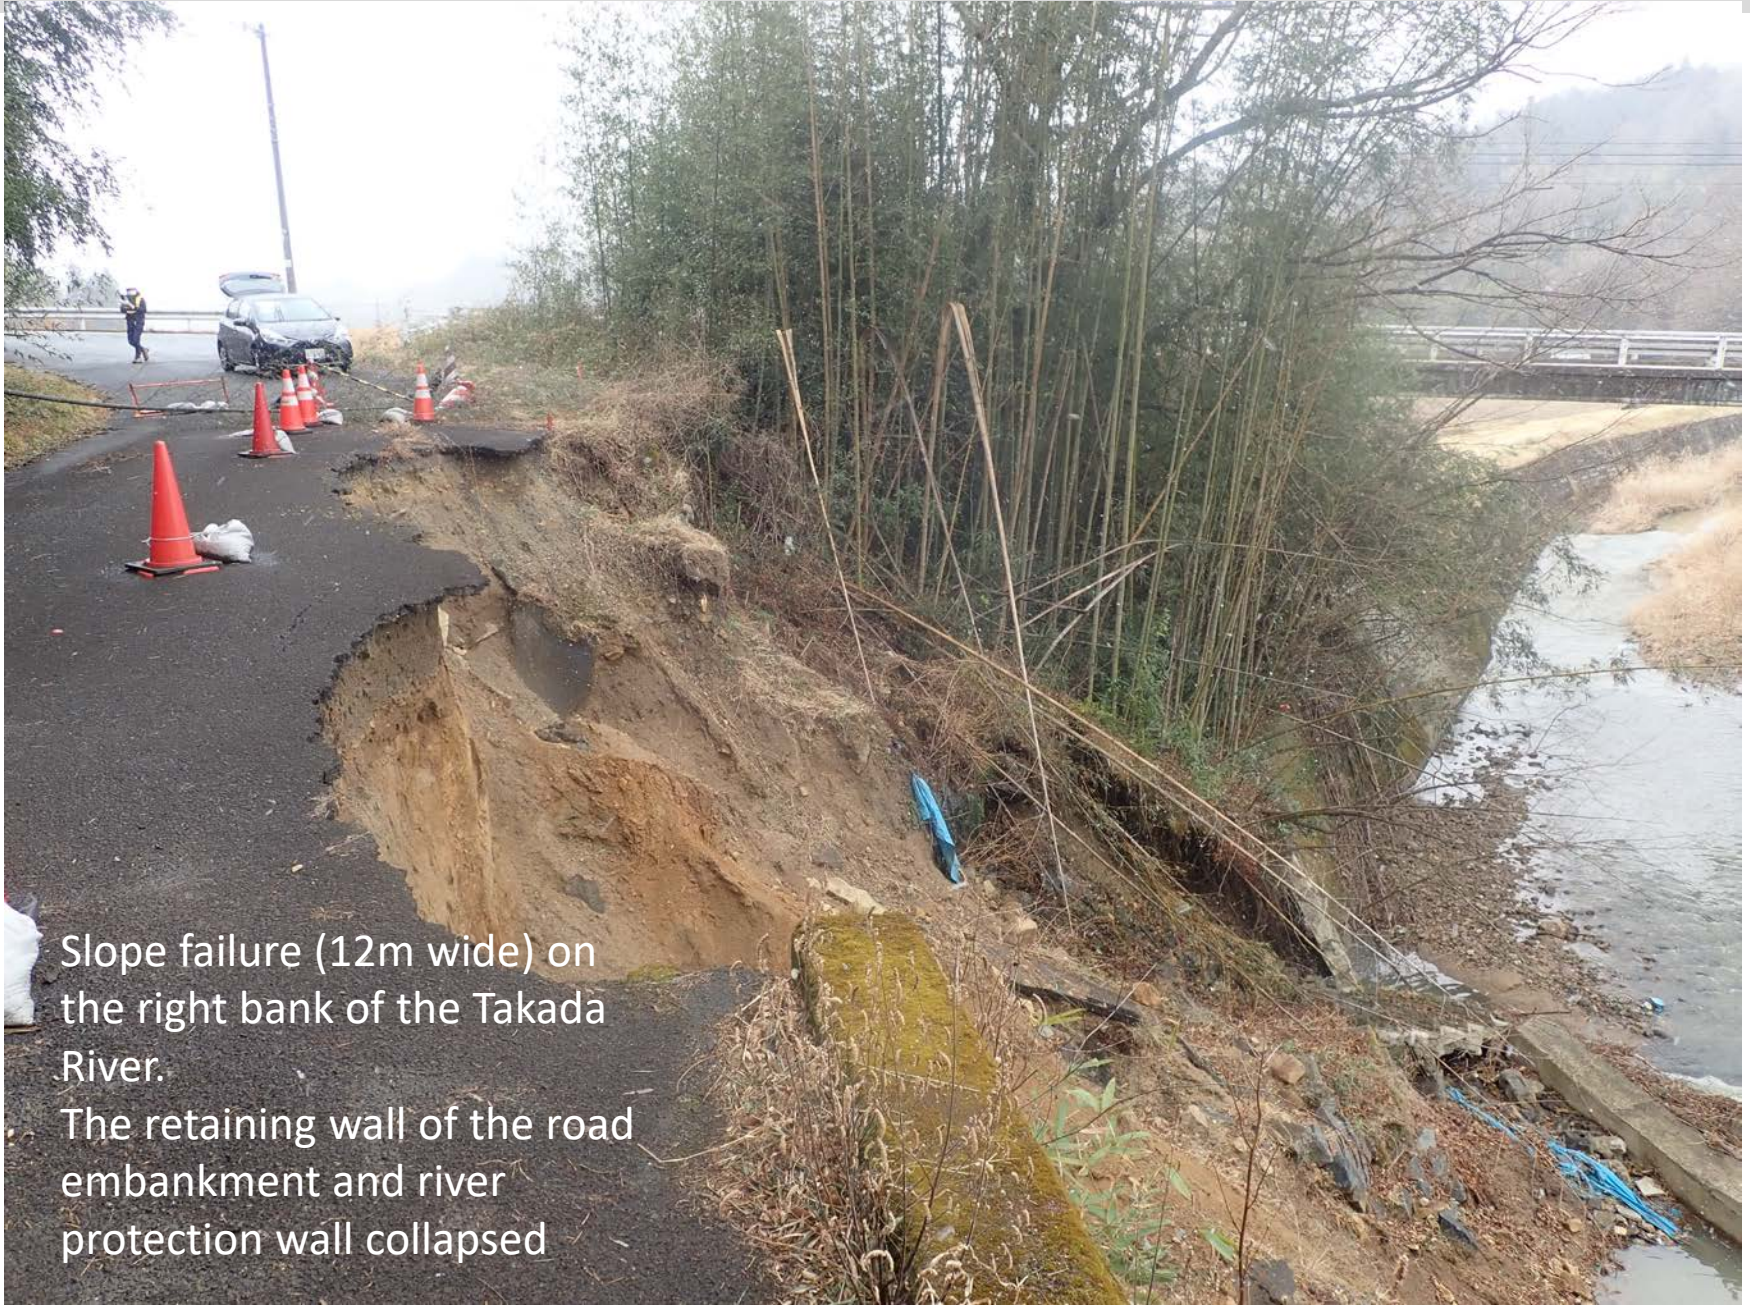
# Shirakawa-Inusotoba, Shiroishi City

Slope failure (12m wide) on the right bank of the Takada River.

The retaining wall of the road embankment and river protection wall collapsed

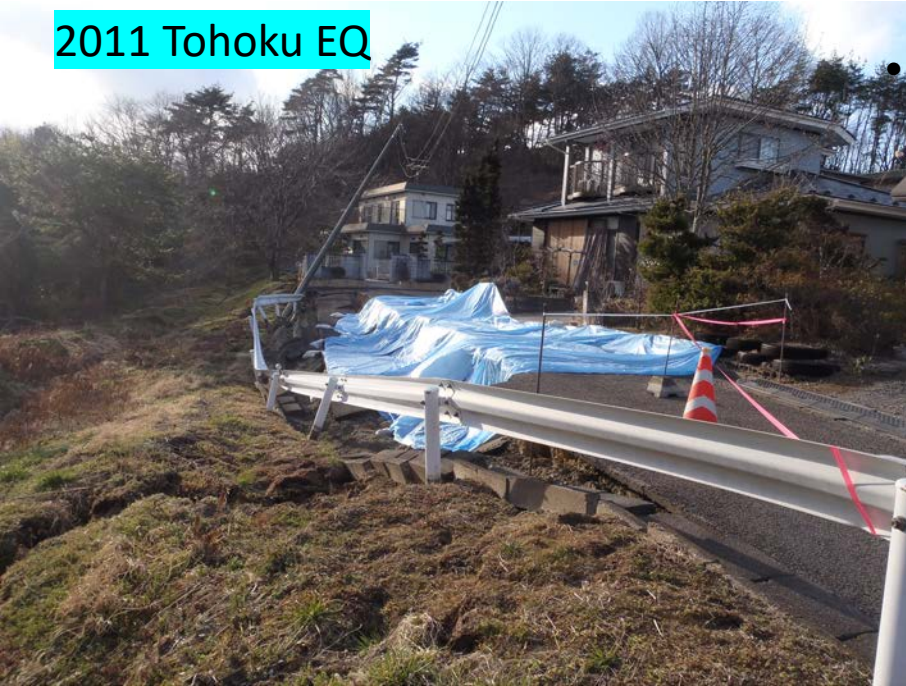
## 2011 Tohoku EQ

- A residential area developed by earth work. The area suffered from significant damage due to the 2011 Tohoku earthquake.

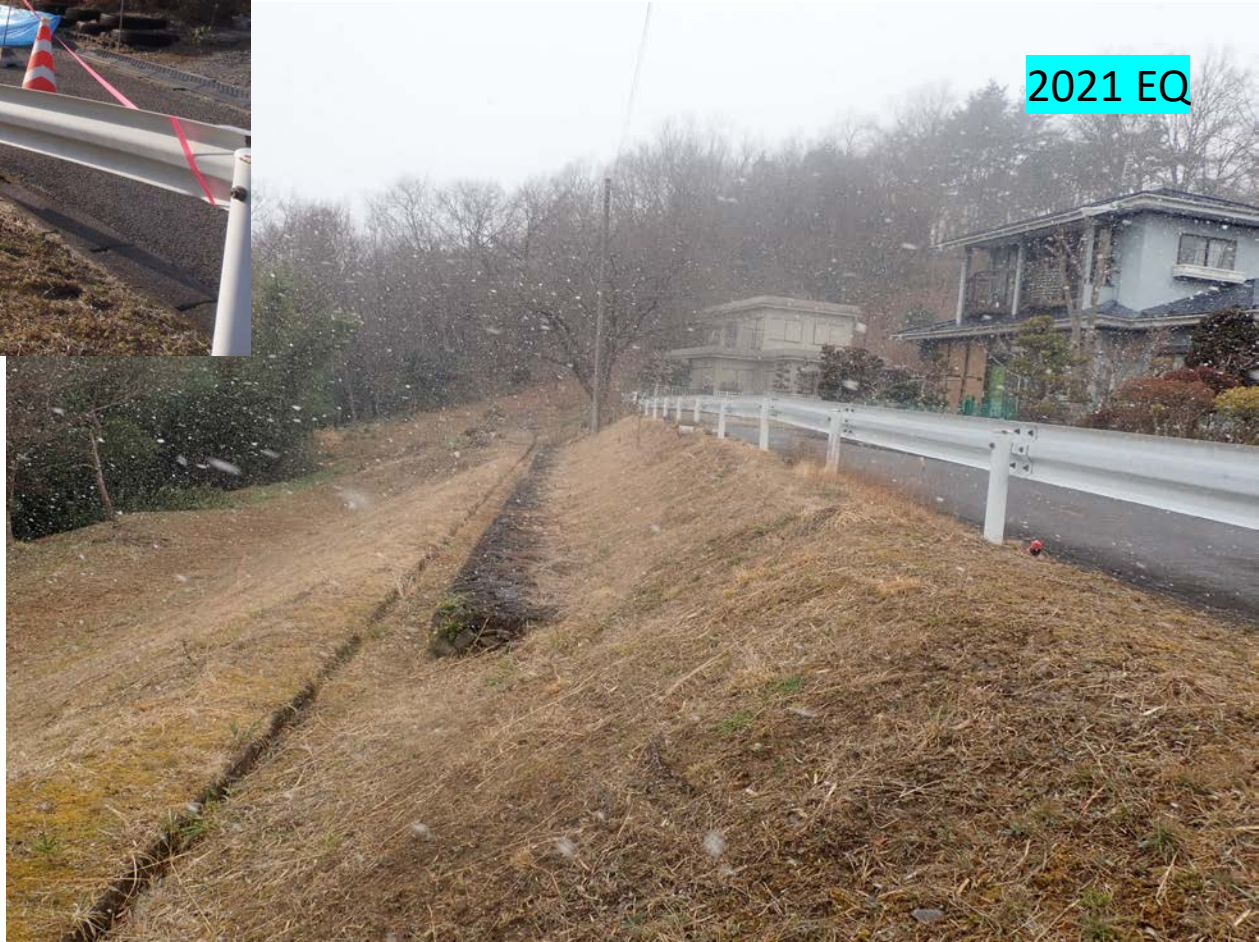
## 2021 EQ

No significant ground deformation or building damage was observed during the survey after the 2021 earthquake.

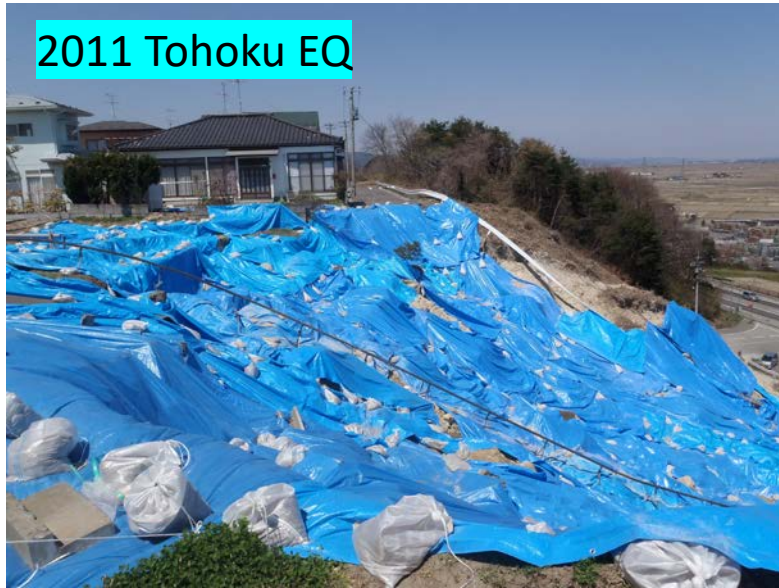
2011 Tohoku EQ

A residential area developed by earth work. The filled parts suffered from significant damage due to the 2011 Tohoku earthquake.

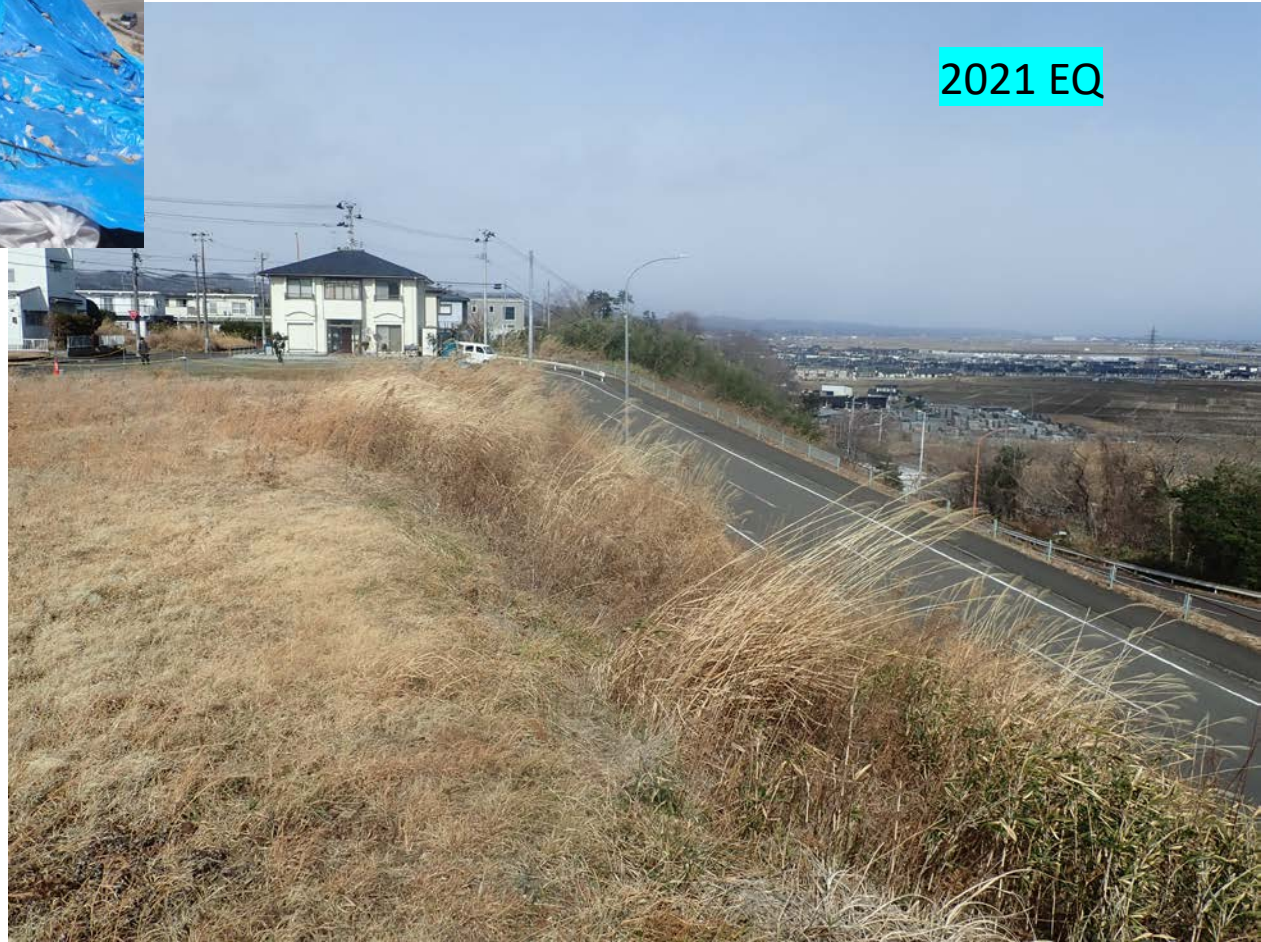
2021 EQ

Similar to Midorigaoka, no significant ground deformation or building damage occurred due to the 2021 earthquake.

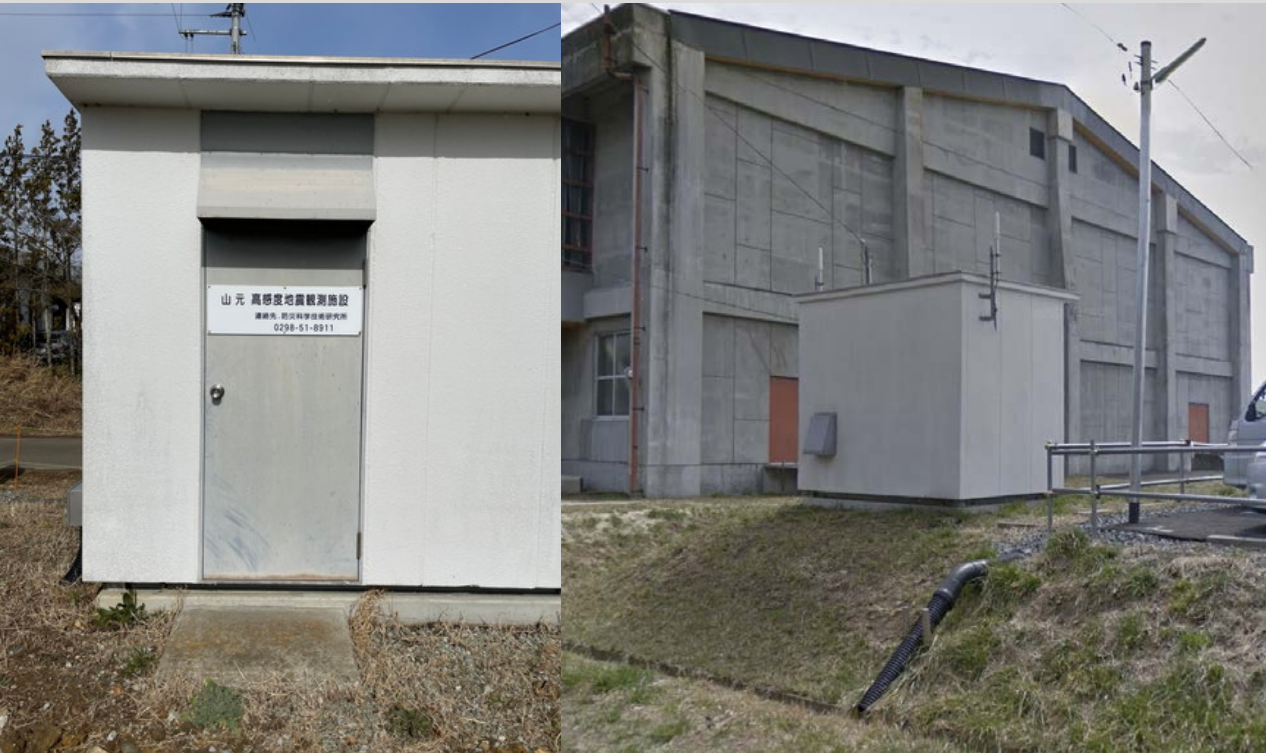
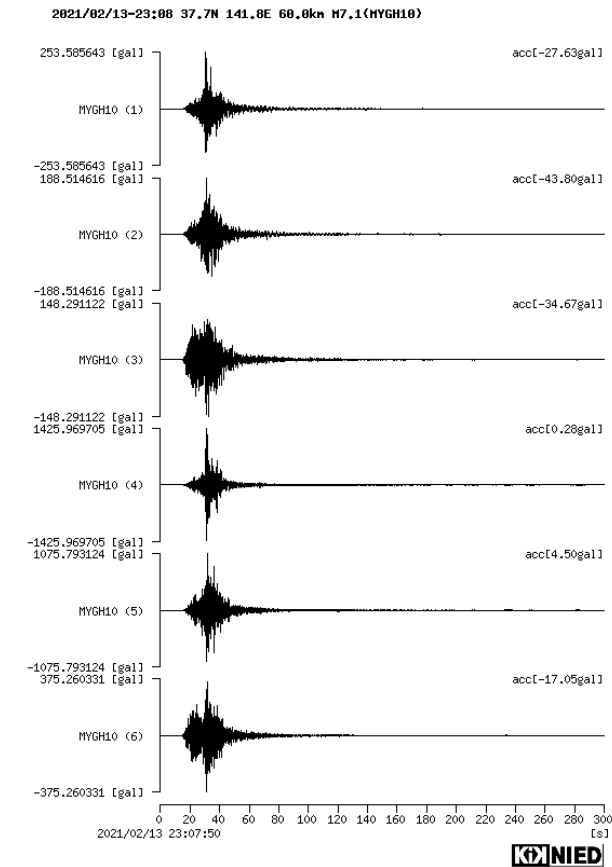
# Strong motion station, Yamamoto Town (NIED, MYGH10)

- An acceleration of 1,426 gal, the highest recorded value for this earthquake.
- The observation shed was set up on a 50cm embankment

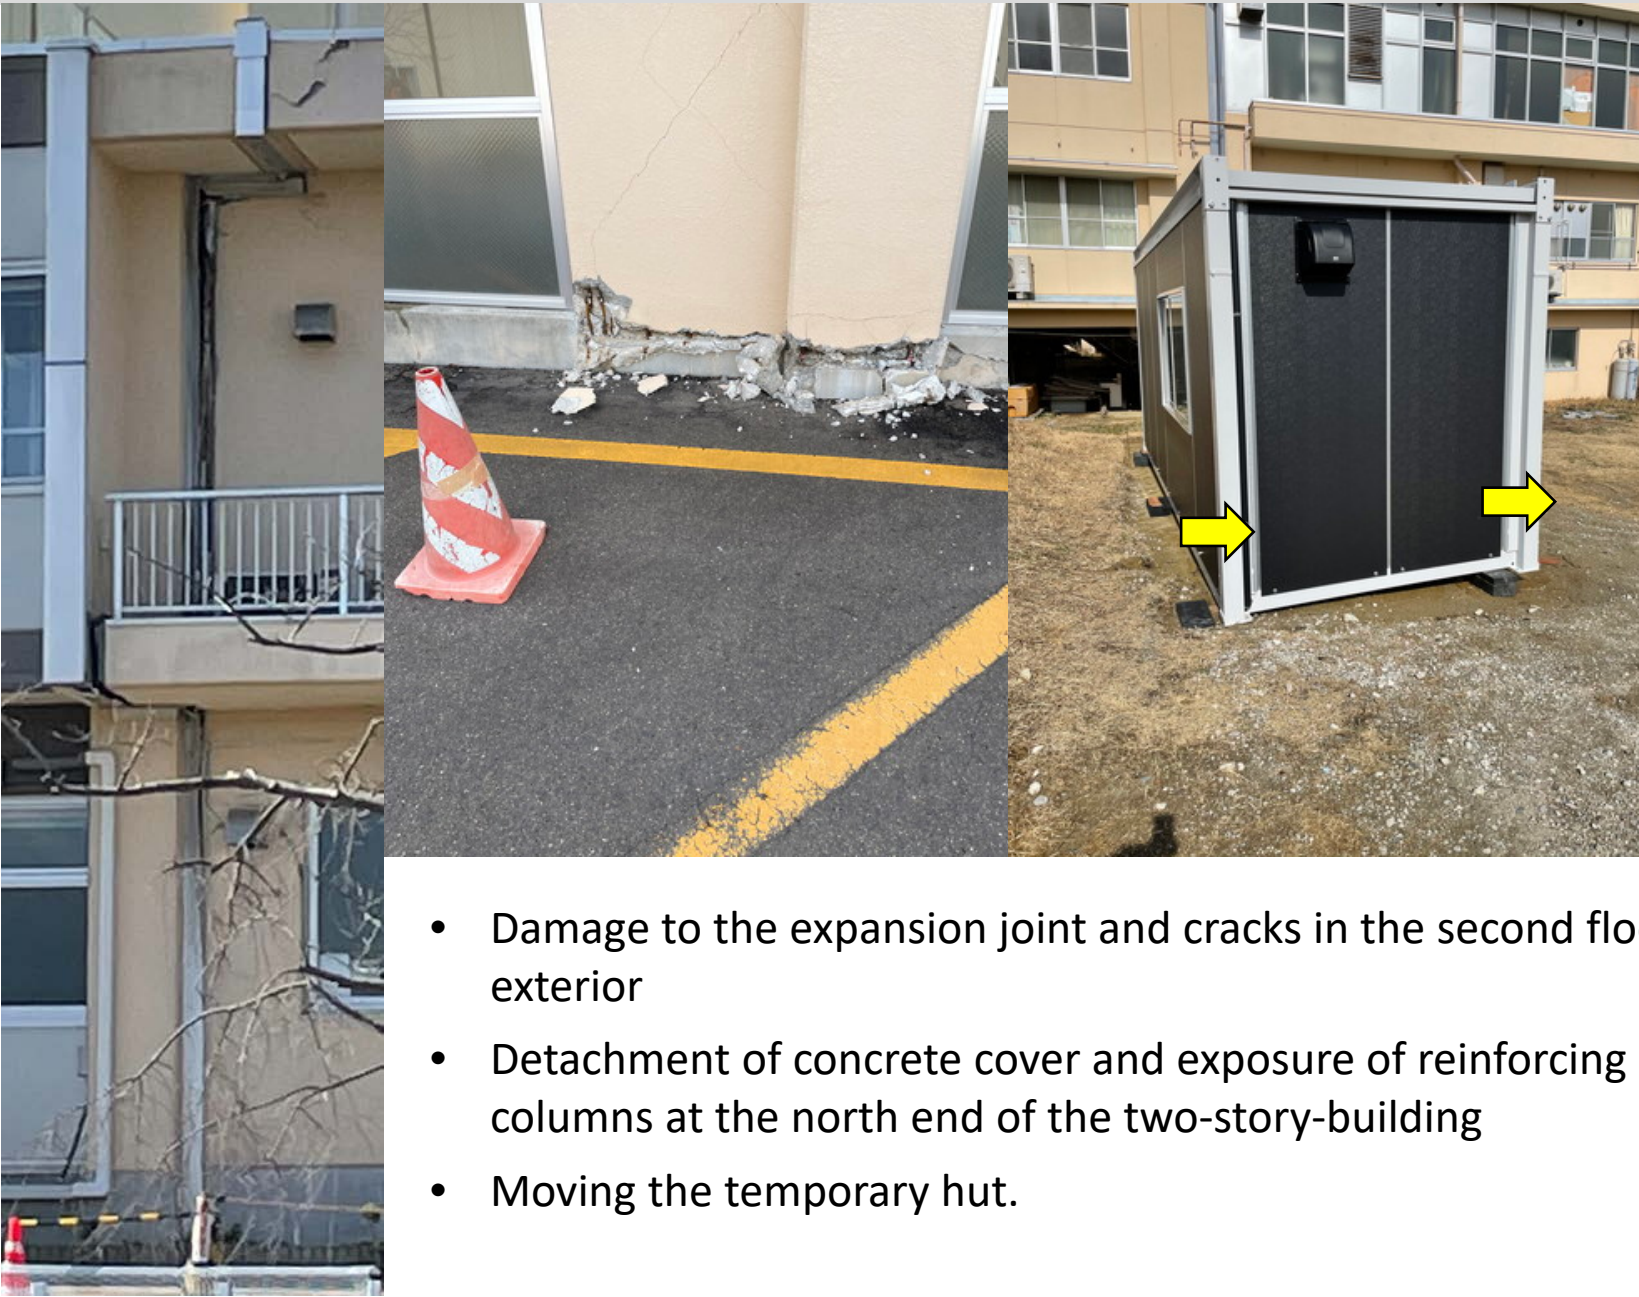
# Miyagi hospital, Yamamoto Town

- Damage to the expansion joint and cracks in the second floor exterior
- Detachment of concrete cover and exposure of reinforcing steel on columns at the north end of the two-story-building
- Moving the temporary hut.

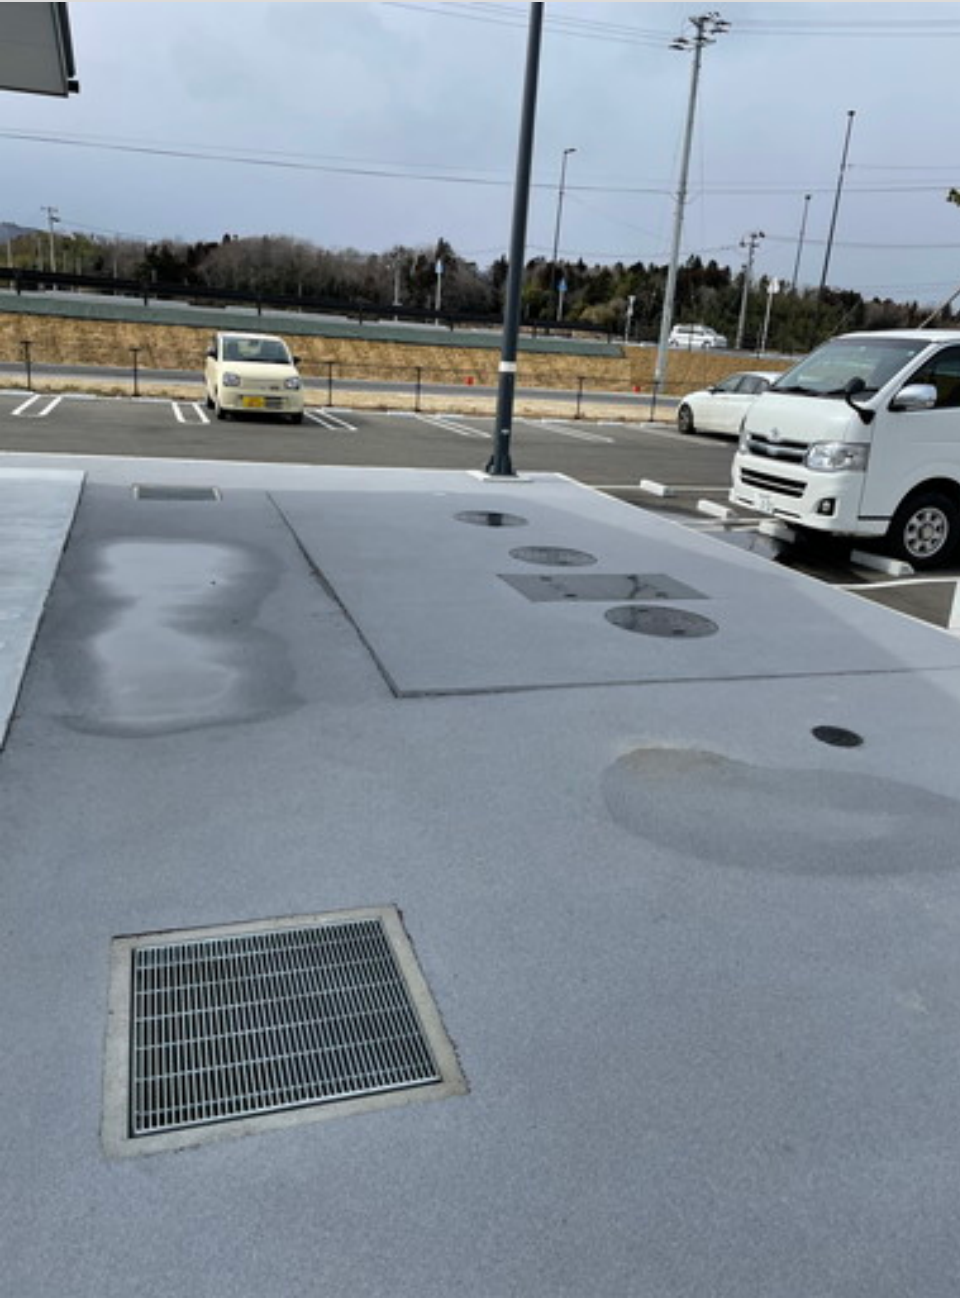
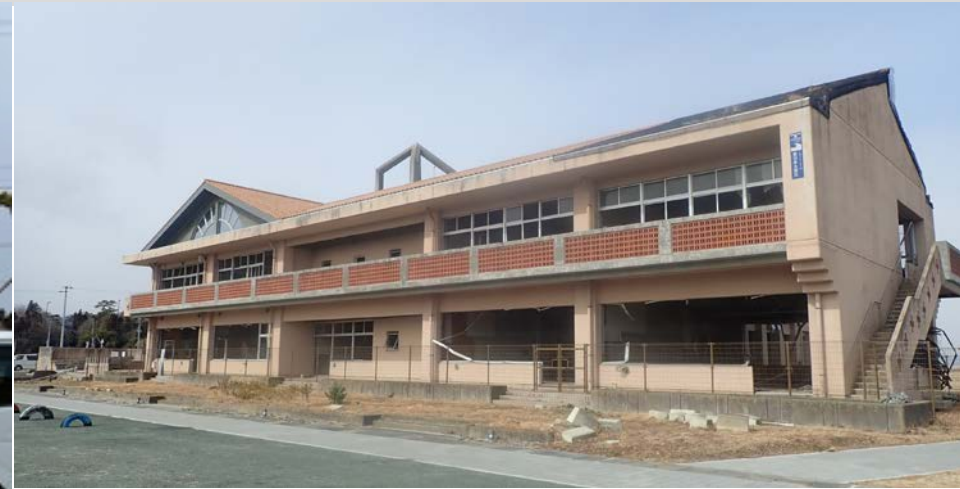
# Nakahama elementary school, ruin of the 2011 Tohoku earthquake

- No significant damage
- Uplift of buried tank (or settlement of surrounding ground) was observed.

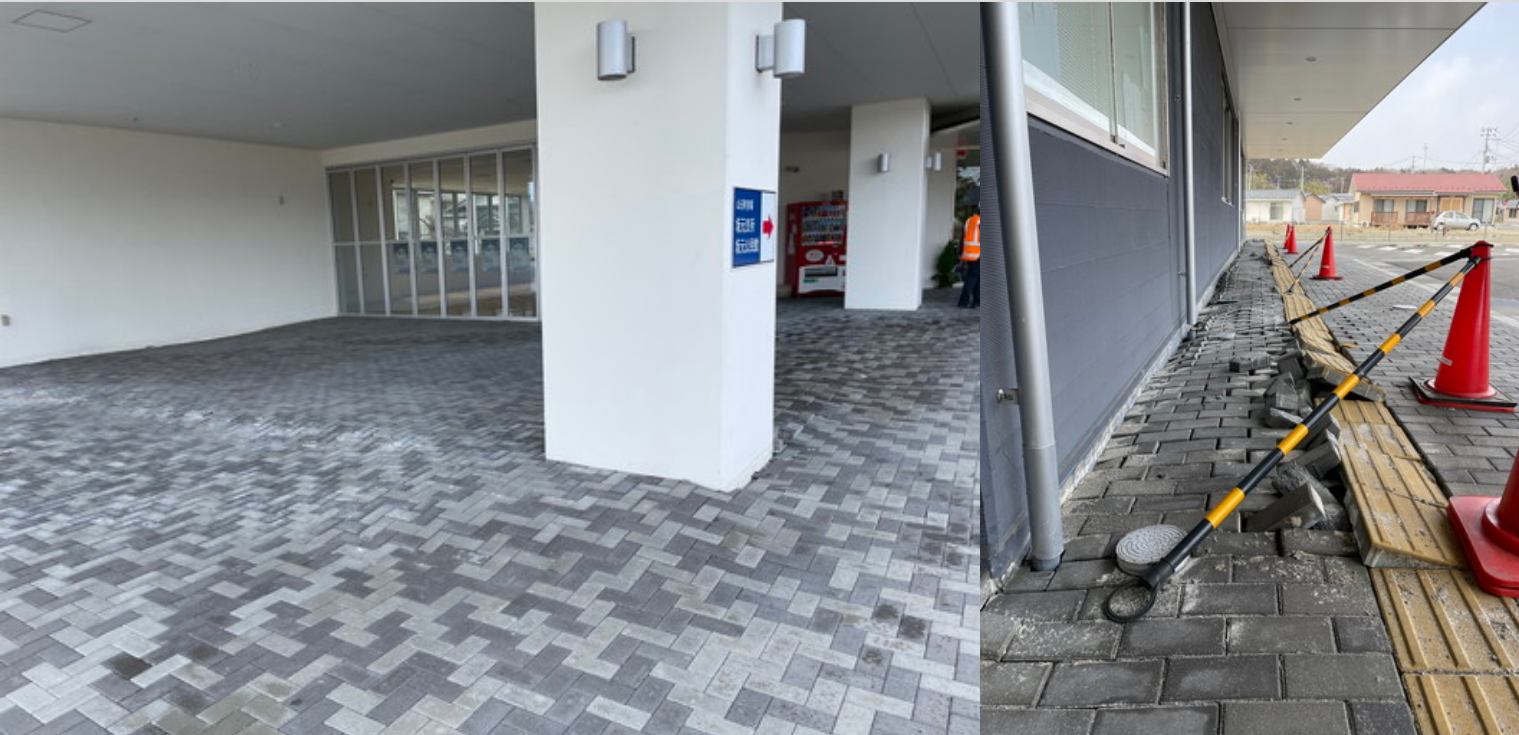
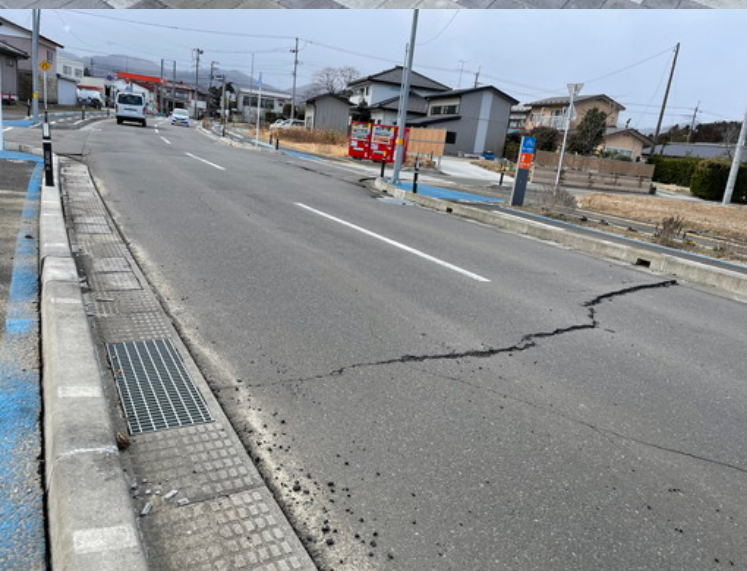
# Sakamoto branch office, Yamamoto Town

- The branch office opened in February 2015 and was built on reclaimed land that was once paddy field (see next page).
- Damage to block paving due to ground subsidence around the building. Liquefaction-induced sand ejecta was also confirmed.
- Cracks were found in the road and residential property in the reclaimed land.

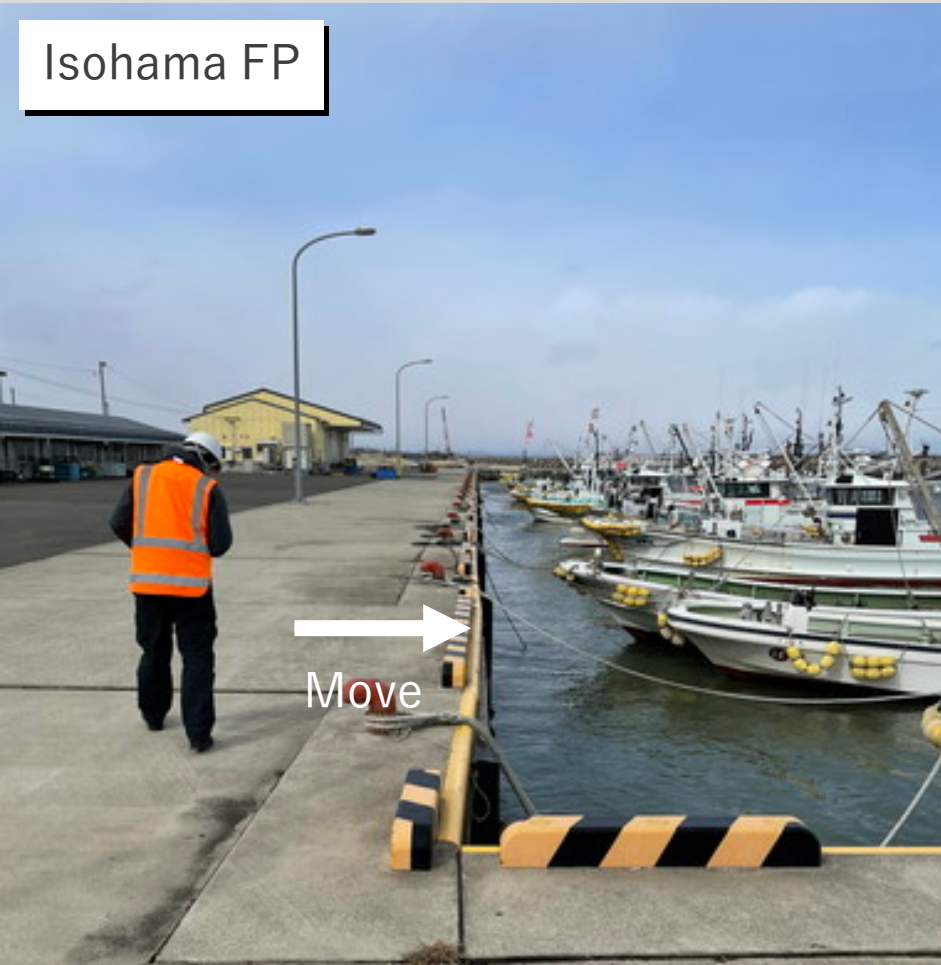
Isohama FP

- Overall, damage to fishing ports and coastal facilities was minor.
- Lateral movement of the quay was observed at Isohama fishing port.
- Gaps in the protective blocks due to the settlement of embankment slope (Sunakodagawa).

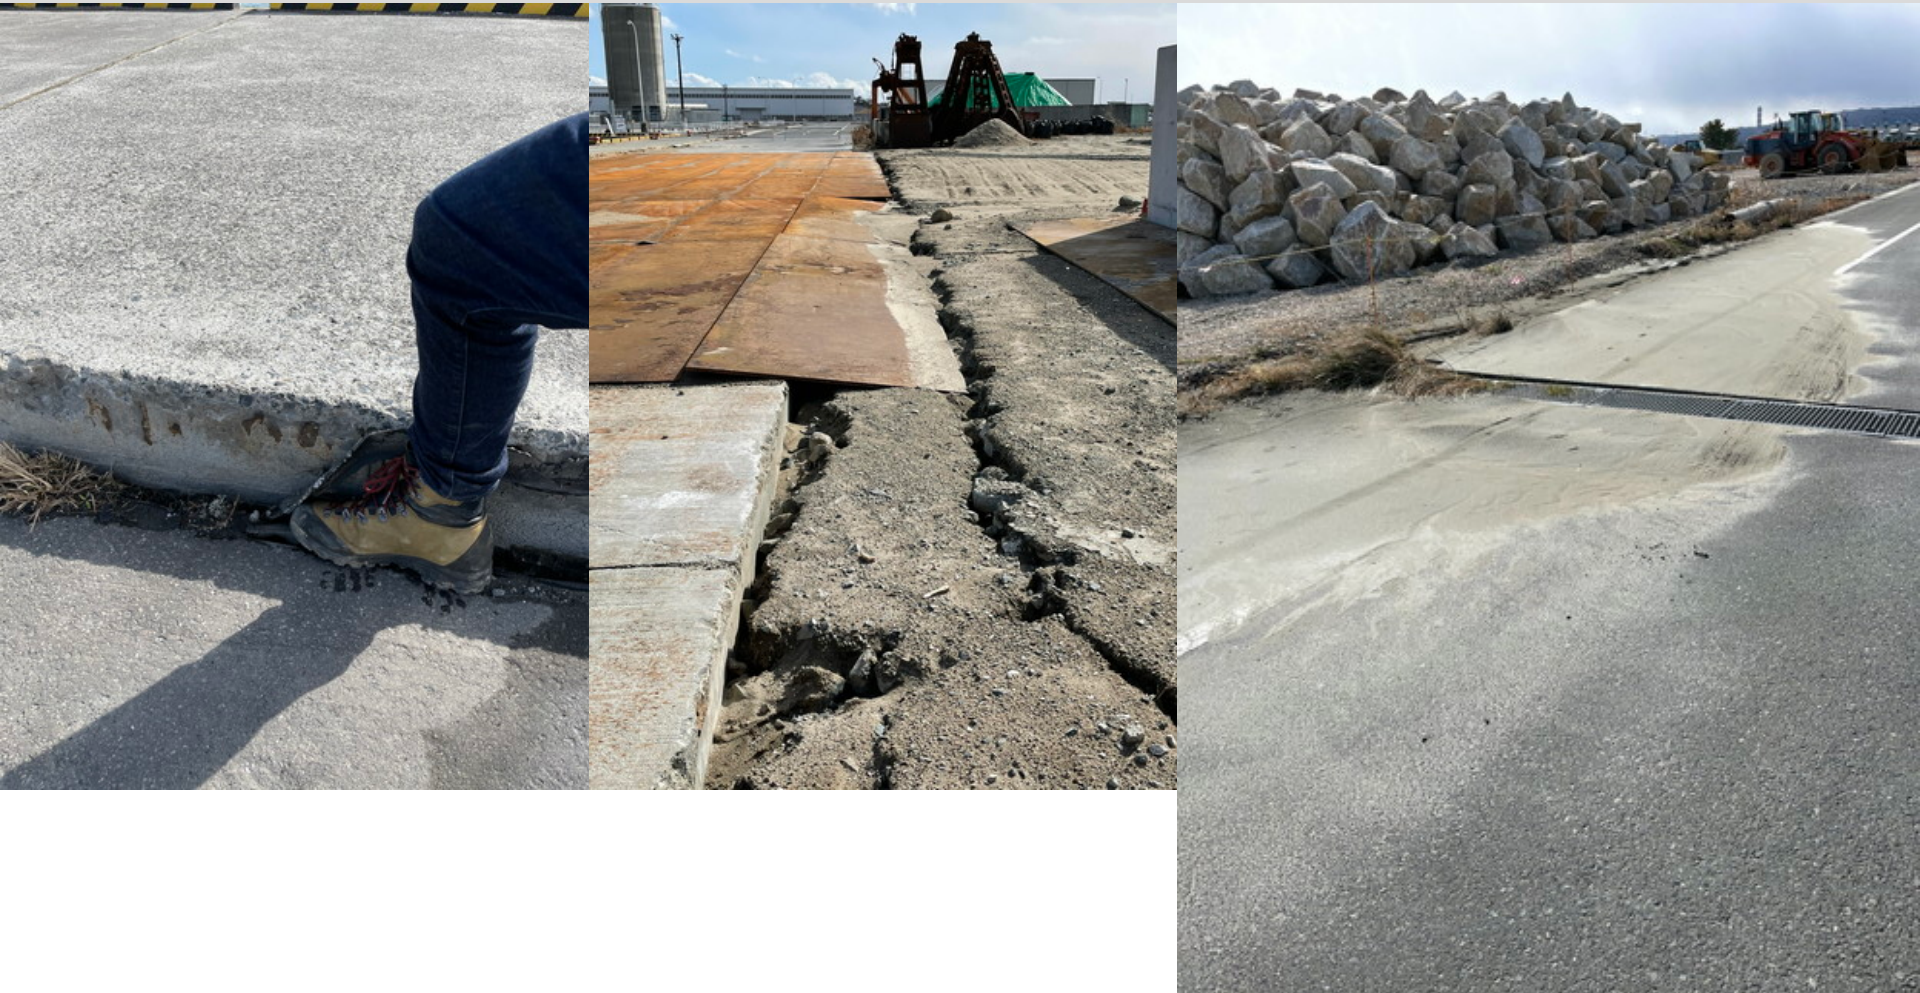
# Soma Port, Soma City

- At Soma Port, the quay walls were slightly inclined towards the sea.
- Subsidence and cracking of the ground behind the quay walls, as well as sand ejecta due to liquefaction, were observed.

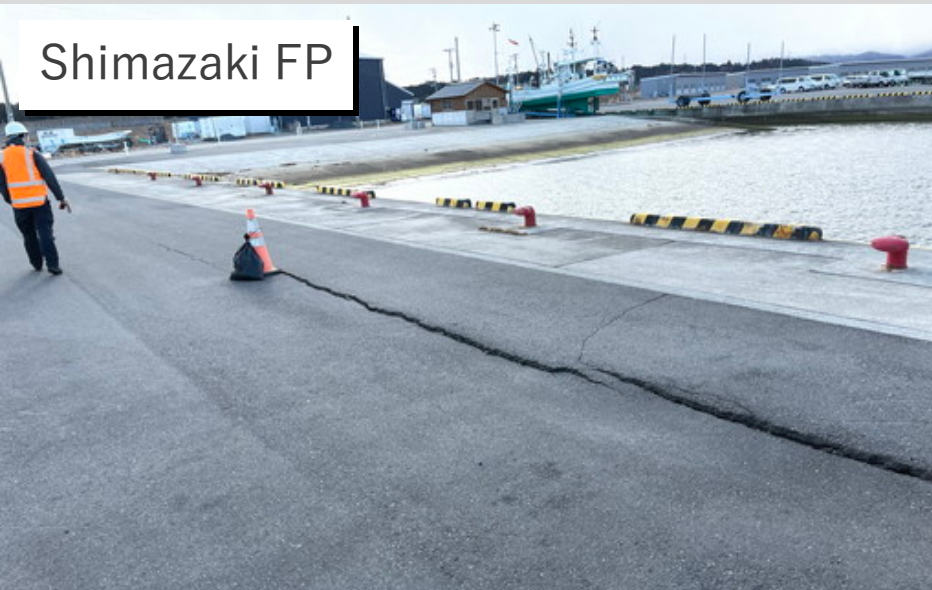
Shimazaki FP

- Minor damages to the fishing port facilities (crack on the pavement, small movement of quay walls and small settlement around the building).
