# LIQUEFACTION-INDUCED GROUND DISPLACEMENTS IN UCHINADA TOWN BY THE 2024 NOTO PENINSULA EARTHQUAKE

Akio SAKAMOTO<sup>1</sup> and Masanori HAMADA<sup>2</sup>

**ABSTRACT:** The 2024 Noto Peninsula Earthquake on January 1, 2024, caused extensive ground damage, including landslides and liquefaction. In Uchinada Town, Ishikawa Prefecture, which is located on the sand dunes, liquefaction caused large ground displacements with sand boils, fissures, subsidence and uplift. Roads, lifelines, buildings and houses were severely damaged. The authors measured the ground displacements by 3D survey using aerial photographs and discussed the effect of surface gradient on the displacements.

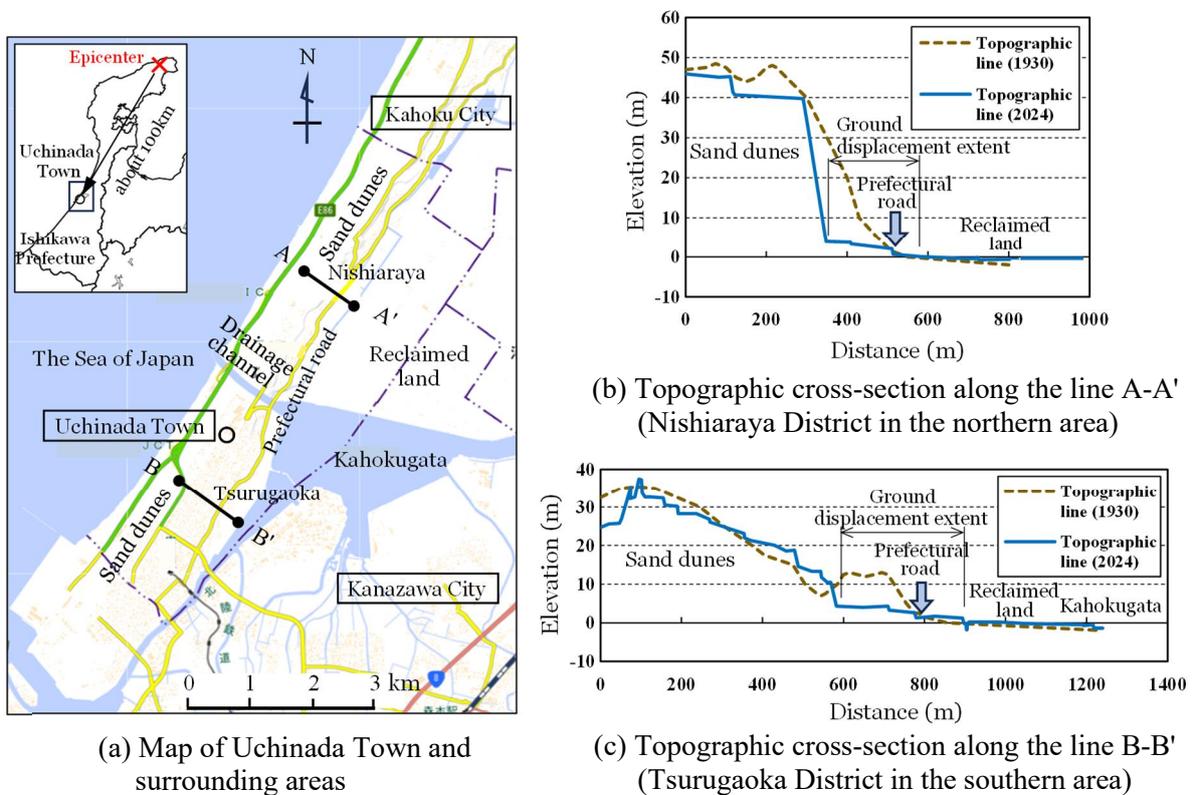
Fig. 1 Topography of Uchinada Town<sup>1)</sup>

Figure 1 shows the topography of Uchinada Town. Figure 1(a) is a map of the town including the surrounding areas. The town is located along the Sea of Japan, and the main part of the town is mostly situated on the Uchinada Sand Dunes<sup>5), 6)</sup>. The formation of the sand dunes began in the Jomon period, a prehistoric cultural era in Japan. Sediment discharged into the Sea of Japan by Tedoru River and other rivers was carried to the land area by strong sea breezes, forming sandbar-shaped sand dunes. As a result, the water area of Lake Kahokugata, a shallow lagoon, was left on the inland side<sup>7)</sup>. Due to the national reclamation project that began in the 1960s, the surface area of the lagoon is now 1/3 of its original area. Reclaimed land extends over the eastern side of the northern area of Uchinada Town. Figures 1(b) and 1(c) show cross-sectional views of the topographical changes in Uchinada Town.

In the northern area, lagoon was filled with soil excavated from the eastern slope of the dunes, resulting in steep slopes and excavation sites were formed. The excavation sites were later replaced by farmlands and residential areas. Figure 1(b) shows the topography of Nishiaraya District, which was particularly heavily damaged in the northern area. On the other hand, the southern area was developed for housing construction early on due to its nearby location to Kanazawa City. Figure 1(c) shows the topography of Tsurugaoka District, which showed relatively heavy damage in the southern area. This

area has residential zones extending from the top of the sand dunes to the reclaimed land facing Lake Kahokugata. As shown in Figs. 1(b) and 1(c), the cross section in 1930 is drawn based on a 1:25,000 topographic map<sup>8), 9)</sup>, and the cross section in 2024 is drawn based on post-earthquake aerial photogrammetric data, as described later.

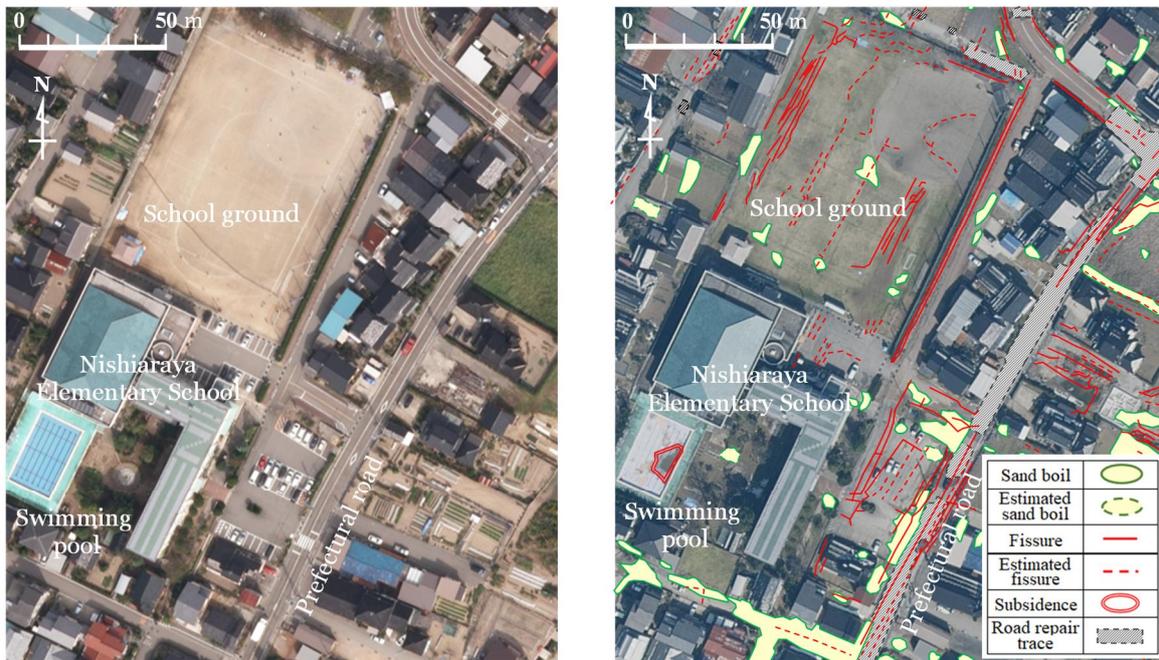
Fig. 3 Aerial photographs of the section around Nishiaraya Elementary School<sup>1)</sup>

Ground failures such as sand boils, fissures, subsidence, uplift and sinkholes were identified by comparing the pre-earthquake aerial photos shown in (2) or (3) with the post-earthquake aerial photos shown in (5) in Table 1. Figure 3 shows aerial photos of the section around Nishiaraya Elementary School pre- and post-earthquake. As shown in Fig. 3(b), post-earthquake, numerous fissures and sand boils can be seen on the school ground. However, the post-earthquake photos used for identification were taken 70 days after the earthquake, many of the failures on Ishikawa Prefectural Route No.8 (Matto-Unoke Line) and others had already been repaired before the survey. Therefore, identification of ground failure in this section was based on sand boils and fissures. In Fig. 3(b), a single sinkhole was identified at an elementary school pool, based on damage observed on part of the pool bottom. Next, the locations and extents of these ground failures were transferred onto the topographic maps of the Nishiaraya and Tsurugaoka Districts in (1) in Table 1 to create ground failure maps for each section.

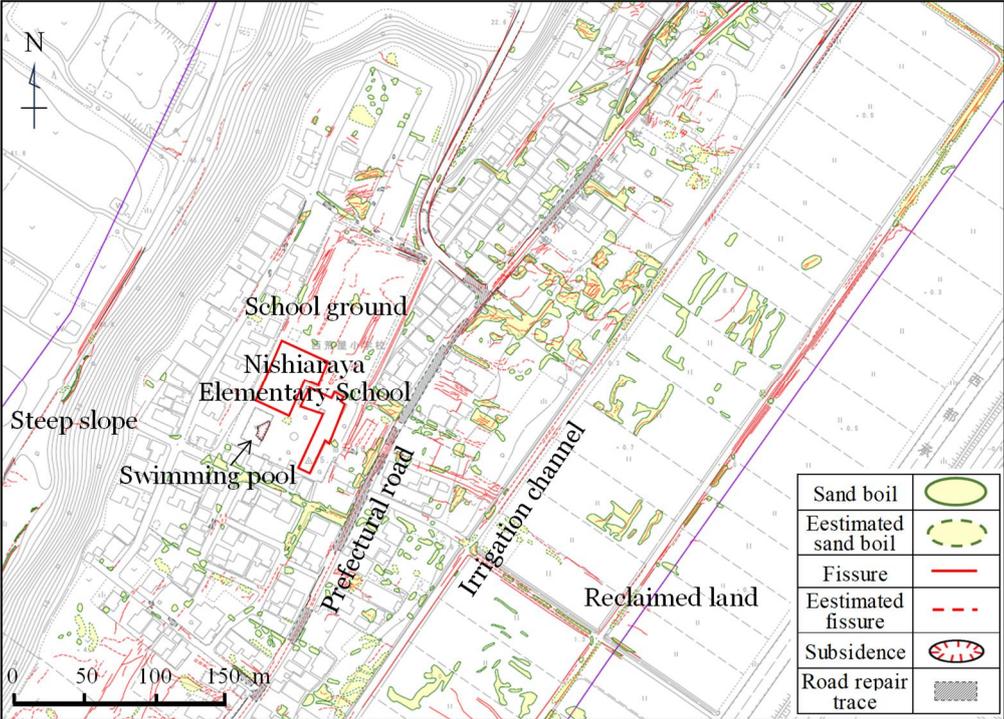
(a) Around Nishiaraya Elementary School

Figure 4(a) shows ground failures around Nishiaraya Elementary School. The section between steep slope and irrigation channel is gently sloping. The direction of the slope is perpendicular to the dune ridge lines and is also nearly perpendicular to the prefectural road and irrigation channel. The ground failures in Nishiaraya District occur mainly on the gently sloping section. There are several zones within the gently sloping section where ground failures are frequently observed, and among them, they are particularly concentrated around Nishiaraya Elementary School. As the general trend of ground failures is that more fissures occurred above the gently sloping section, and more sand boils occurred below the gently sloping section and in some reclaimed land. Numerous fissures are visible on the school ground of Nishiaraya Elementary School and the surrounding section, extending in the direction perpendicular to the slope. This suggests that tensile strains were caused by the ground moving along the slope.

A long series of fissures can be seen on the shoulder of the steep slope in the figure. These fissures were probably caused by a landslide due to seismic ground motion. A control point is located west of this position, but since it is about 300 m away, it was considered acceptable to treat it as fixed.

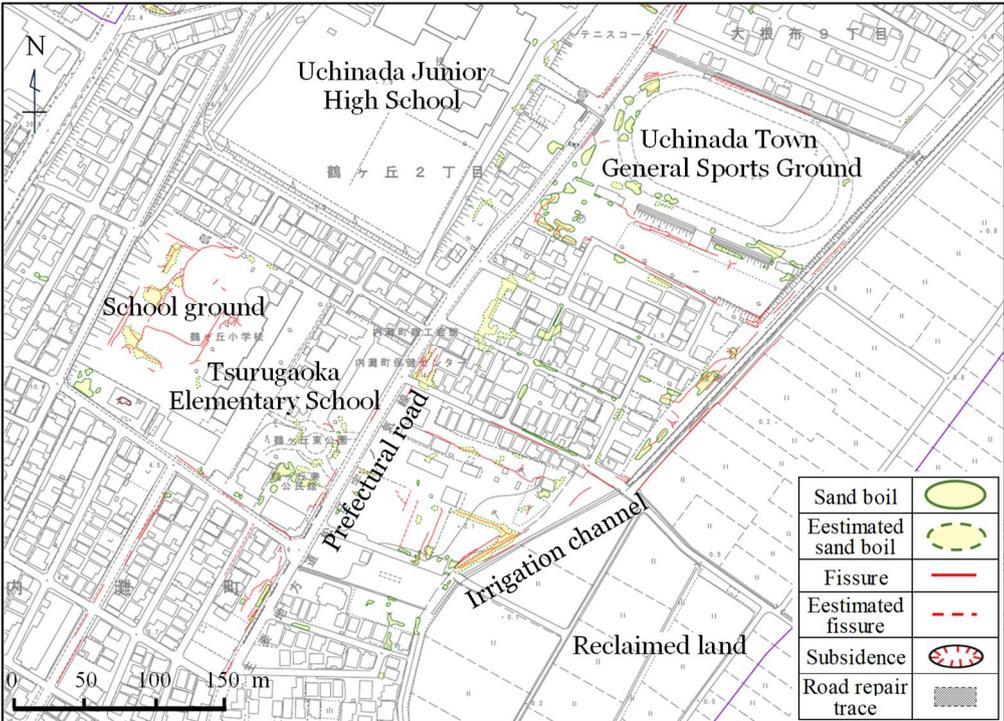
(b) Around Tsurugaoka Elementary School

Figure 4(b) shows ground failures around Tsurugaoka Elementary School, including Uchinada Junior High School and Uchinada Town General Sports Ground. This section is also gently sloping. As in Nishiaraya District, the direction of the slope is nearly perpendicular to the prefectural road. The figure shows that ground failures in Tsurugaoka District occur less than in Nishiaraya District. However, there are zones where ground failures are concentrated in residential sections east of the prefectural road and around the Uchinada Town General Sports Ground.

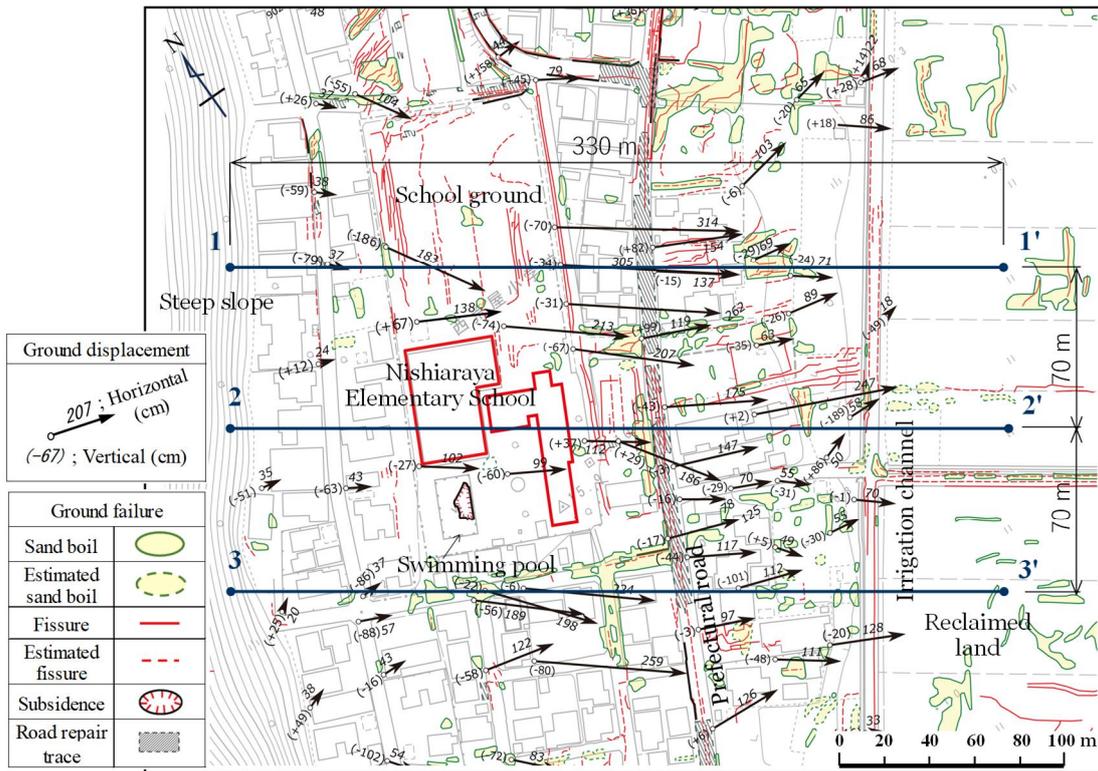
Fig. 5 Ground displacements and ground failures around Nishiaraya Elementary School<sup>1)</sup>

Figure 5 shows ground displacements and ground failures around Nishiaraya Elementary School. It is arranged so that the downward slope of the ground surface is on the right side of the figure. Horizontal displacement directions are shown as vectors, with their magnitudes indicated alongside. Vertical displacements are shown in parentheses. The unit of displacement is cm. Positive magnitude for vertical displacement shows uplift, and negative magnitude shows subsidence. The figure shows that horizontal displacements occur on the gently sloping section between steep slope and irrigation channel, where numerous fissures and sand boils are observed. The direction of horizontal displacements generally follows the direction of the ground surface gradient (right direction in the figure). The maximum horizontal displacement in the section shown in Fig.5 is 3.1 m. On the other hand, the horizontal displacements in Tsurugaoka District are generally small, corresponding to the lower frequency of ground failures. However, in the residential section east of the prefectural road, an observation point showed a displacement of 0.9 m, and the authors confirmed many houses suffered damage such as subsidence and inclination, through field surveys.

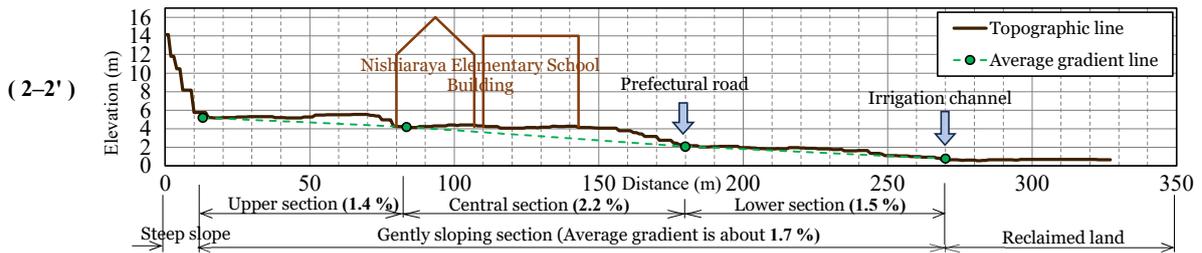
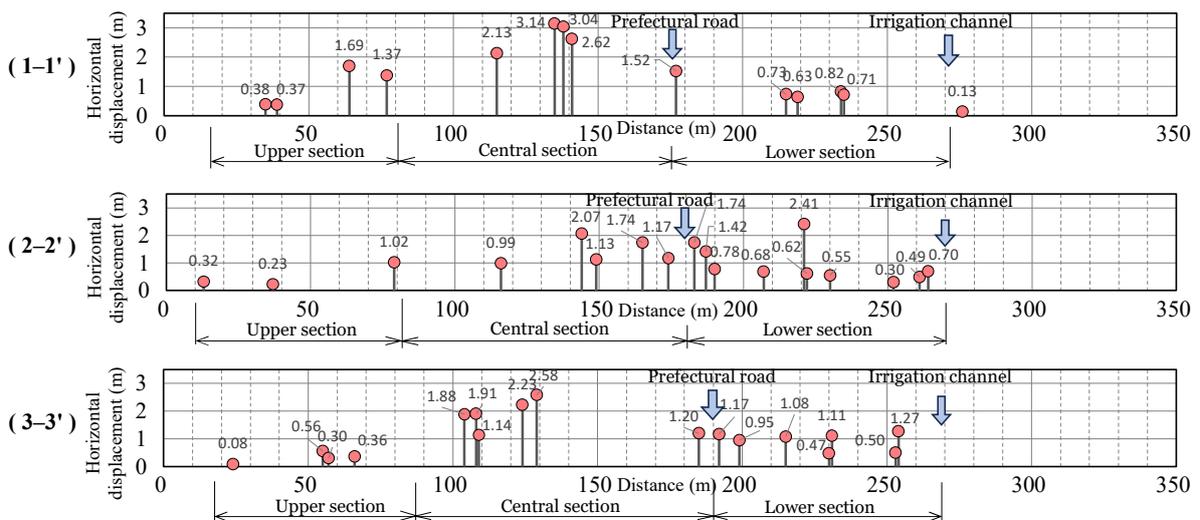
Fig. 6 Topography and horizontal displacements around Nishiaraya Elementary School

Figure 6 shows the horizontal displacement components in the direction of each line at observation points near the lines in Fig. 5, together with the topographic cross-section along the line 2–2'. The figure shows that horizontal displacements start at the foot of the steep slope, increase near the center of the gently sloping section, and slightly decrease around the prefectural road. These displacements also extend to the irrigation channel at the boundary of the flat reclaimed land, where these almost converge. As shown in Figs. 6(a) and 6(b), “Upper section” and “Lower section” are zones with relatively small displacement, and “Central section” are zones with relatively large displacement. Looking at the maximum displacement in the Central section of each line, it is 3.1 m from the line 1–1', 2.6 m from the line 3–3', while it is relatively small at 2.1 m from the line 2–2'. Because the line 2–2' crosses the elementary school building, it is considered that the ground displacements were controlled by the foundation piles of the building.

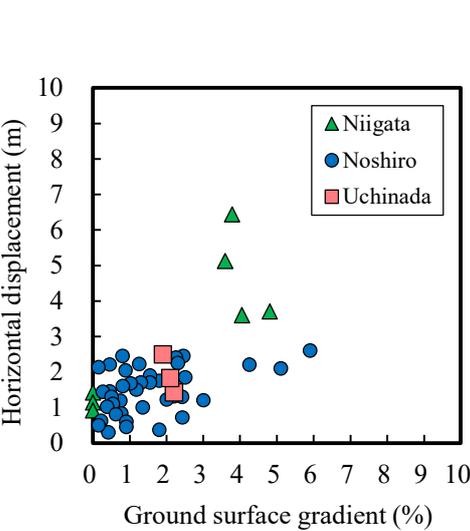
Fig. 7 Relationship between horizontal displacement and ground surface gradient<sup>1</sup>

Figure 7 shows the relationship between average horizontal displacement and average gradient for liquefied ground based on previous studies<sup>13), 14)</sup>, with the data from around Nishiaraya Elementary School (labeled as “Uchinada”) plotted on the same graph. Note that only the horizontal displacement data from the Central section were used, since the displacements in the Upper and Lower sections were small. The average horizontal displacement is the mean of the horizontal displacements within the Central section. The figure shows that the displacements in Uchinada Town were smaller than those of Niigata City, but were equivalent to those of Noshiro City.

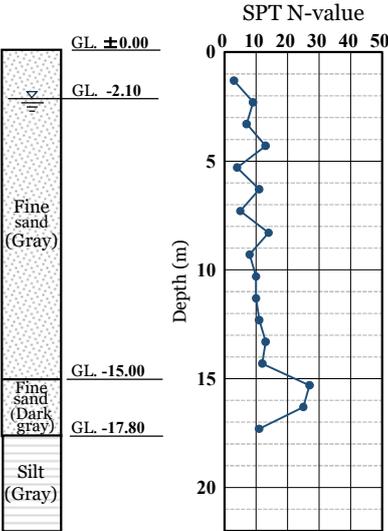
Fig. 8 Boring log at Nishiaraya Elementary School<sup>2</sup>

Figure 8 shows the boring log at Nishiaraya Elementary School. The groundwater level at this site is shallow as GL-2.1 m. The N-values of the layer from the ground surface to GL-15.0 m range from 3 to about 10 (loose to medium compaction), and the layer is composed of fine sand with nearly uniform grain size. Below GL-15.0 m, fine sand with uniform grain size is deposited, with N-values ranging from 11 to 27 (medium to dense compaction). Therefore, the ground in this section is liquefiable in conditions of groundwater level, degree of compaction, and grain size composition.
