DAMAGE BY THE 2011 EAST JAPAN EARTHQUAKE OF REINFORCED CONCRETE SCHOOL BUILDING IN TOCHIGI RETROFITTED BY STEEL-BRACED FRAME

ABSTRACT: A reinforced concrete three-story school building which was retrofitted by steel-braced frames suffered moderate damage such as column shear failure for the top story without any seismic retrofits under the 2011 East Japan Earthquake. Although the damaged story has possessed sufficient lateral-force resisting capacity to be required by the current seismic codes, irregular stiffness distribution over the height of the building, generated by the seismic retrofits except for the top story, caused the concentration of a large deformation to the top story without retrofits.

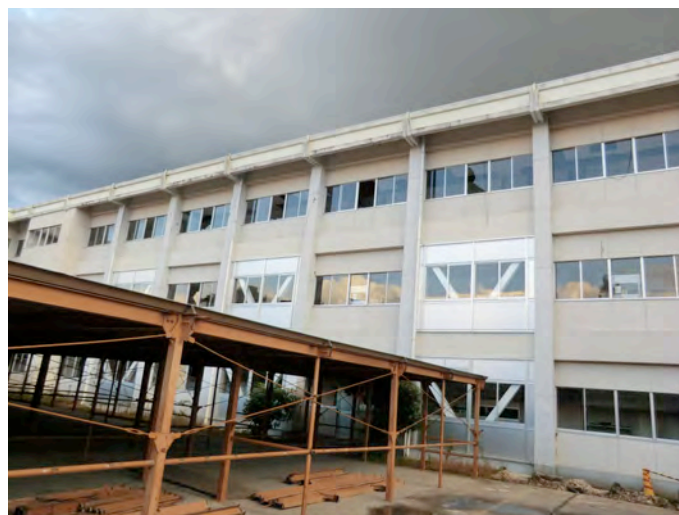
Photo. 1 North side view of the class-room building

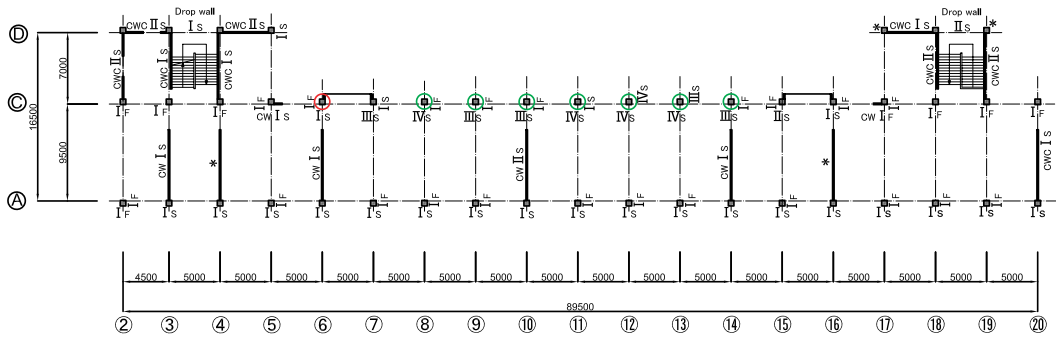
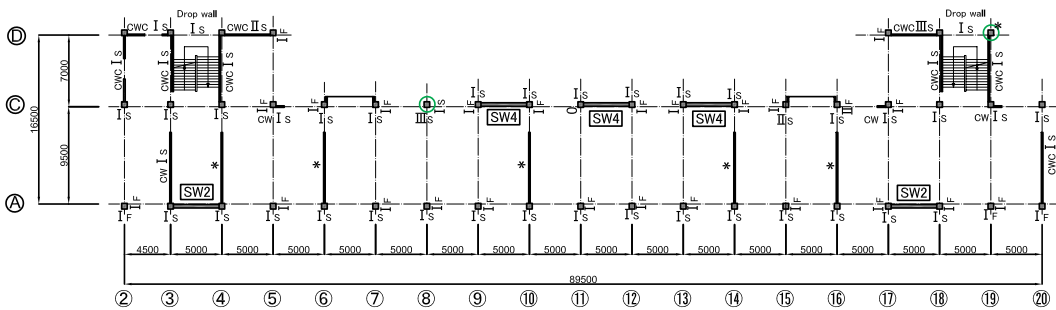
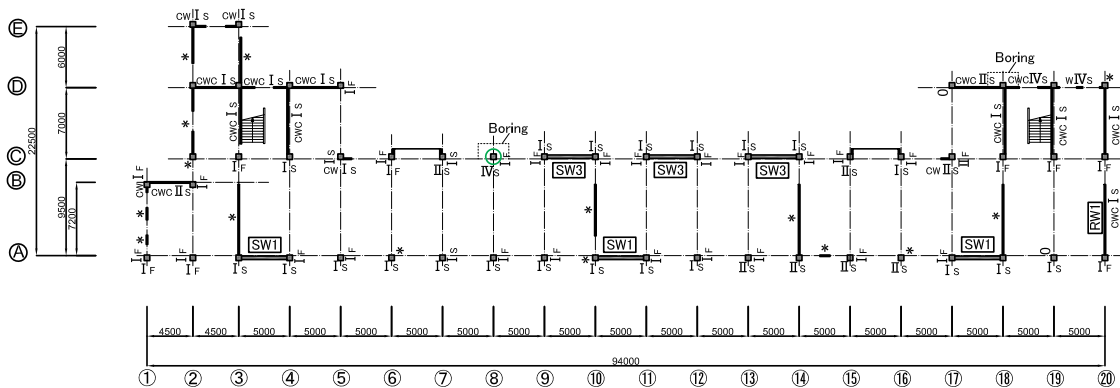
Fig. 2 Floor Plans of the class-room building

The damage rate of columns and walls is shown in plans of Fig.2 and framing elevations of Fig.3 by Roman numerals. Damages of columns and differential settlement of floor slab at the first story are shown in Photo.2 to 7. Four R/C columns at the third story, where no retrofits were conducted because of having sufficient seismic capacity, failed in shear by bi-directional horizontal loading due to the earthquake motion. Some columns adjacent to a unit bay strengthened by a steel-braced frame also exhibited severe shear cracks of Grade 3 or shear failure of Grade 4 at the first and second stories shown in Photo.3. Some boundary R/C columns of a steel-braced frame had minor or moderate shear cracks at the first and second stories. A few R/C columns at the south frame designated A frame, whose clear height was larger than that of the north frame designated C frame, also had minor shear cracks of Grade 1 or 2 at the first story.

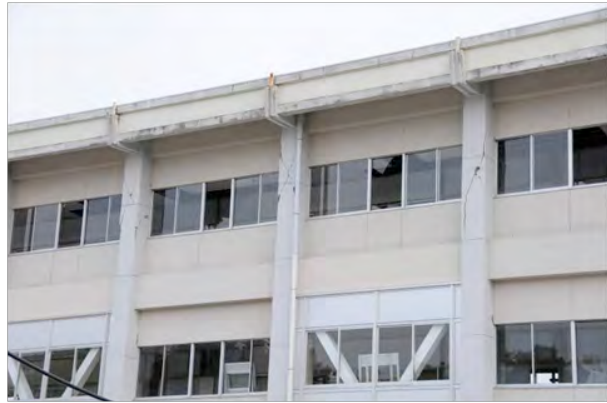
Photo. 2 Shear failure of columns in C frame at third story

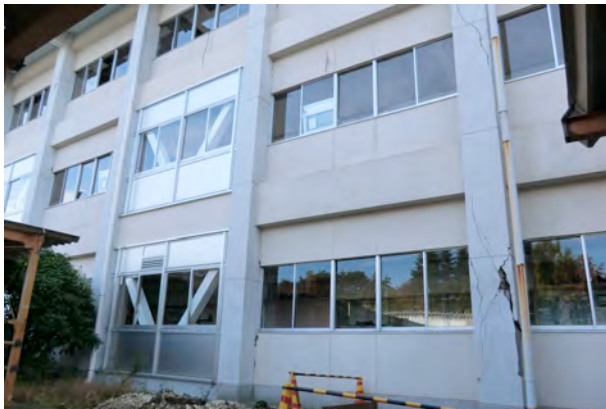
Photo. 3 Shear failure of column adjacent to unit bay strengthened by steel-braced frame

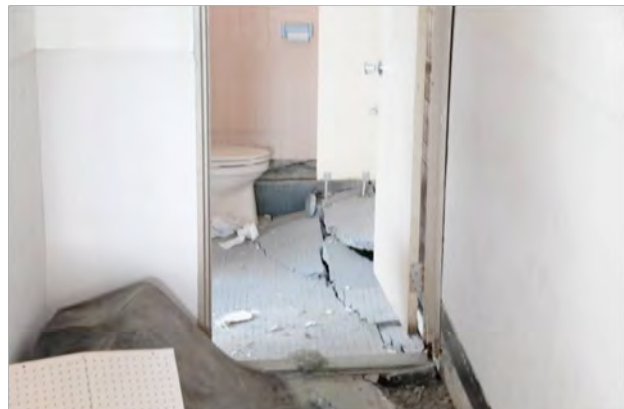
Photo. 4 Differential settlement of R/C floor slab at first floor

The first floor slab in a toilet room, which was projected to the north side of the building, sank 290 mm due to local settlement of the building since the whole building did not incline. Concrete brick walls and R/C shear walls were alternately placed between the class-rooms in a transverse direction.

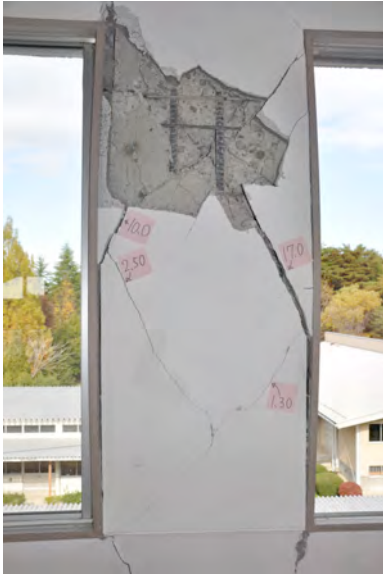
Photo. 5 Shear failure of C-13 column at third story

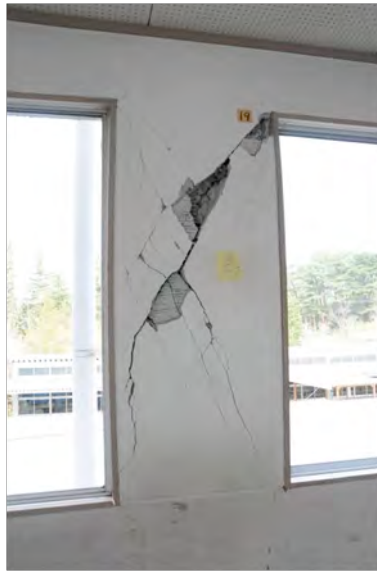
Photo. 6 Shear failure of C-8 column at second story

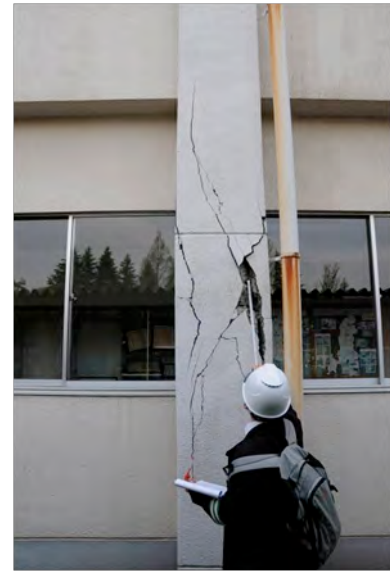
Photo. 7 Shear failure of C-8 column at first story

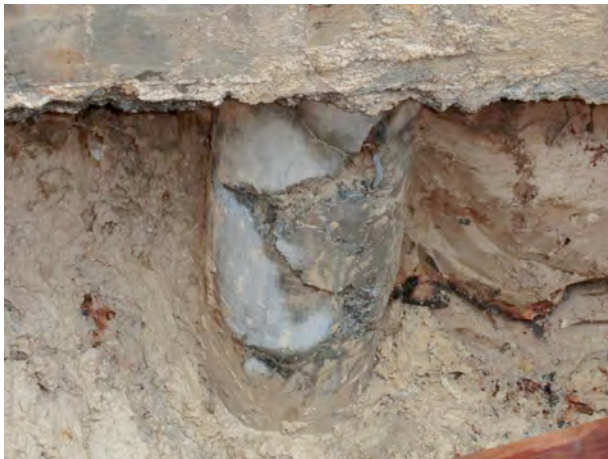
Photo. 8 Damage of piles

(a) Shear failure and bar buckling

Boring investigation to some R/C piles of the class-room building was simultaneously conducted by the town hall. Four piles driven at a north side of the building were revealed under the eighth column in C frame and the eighteenth column in D frame shown in Fig.3. A top of one pile under the eighteenth column in D frame failed in shear and longitudinal bars buckled as shown in Photo.8(a). The other pile broke off and slipped horizontally as shown in Photo.8(b). Shear and flexural cracks and spall-off of concrete were observed at a top of the piles under the eighth column in C frame. The damage level of the pile foundation was regarded as severe from the observation.

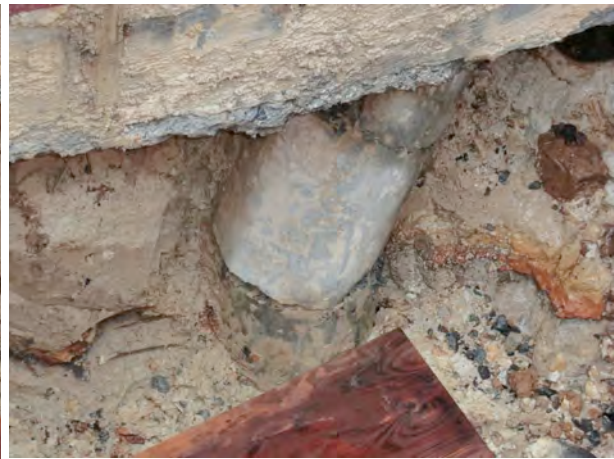
(b) Break-off and horizontal slip at pile top

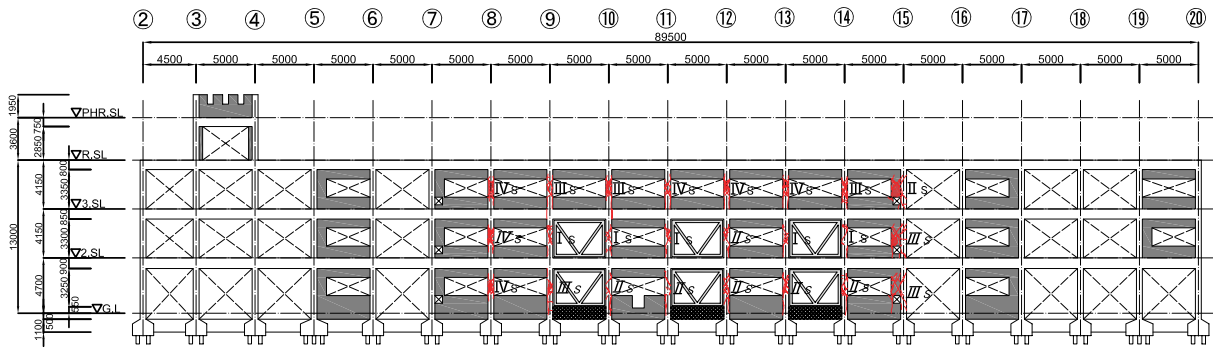
Crack patterns of columns neighboring to three steel-braced frames in C frame are shown in Fig.5. Shear cracks with a width of 0.2 mm to 1.5 mm were observed by the additional survey for the boundary R/C columns of steel-braced frames at the first and second stories shown in Photo.9. This indicates that behavior of two-story steel-braced frames during the earthquake was dominated by such a manner that lateral shear force was shared between two boundary R/C columns and diagonal steel chords in each unit. Moreover, flexural cracks developed at critical sections of boundary beams and transverse beams framing into the steel-braced frame and shear cracks did in a plastic hinge region of

Fig. 5 Crack patterns of columns neighboring to steel-braced frames in C frame

Steel-braced frames for the first and second stories were installed into the C frame removing both drop and spandrel walls as shown in Fig.5. Drop and spandrel walls adjacent to a steel-braced frame, however, remained without a seismic slit so as to separate a short boundary column from these secondary walls. It seems that this resulted in greater enhancement of the lateral stiffness in the first and second stories than expected for the seismic retrofit design. Since the lateral inter-story displacement for the third story became larger during the earthquake than that for the first and second stories, eventually short columns with a shear span ratio of 1.6 in C frame failed in shear in the third story. This points out that the estimation of the story stiffness according to the current standards for seismic performance evaluation of retrofitted R/C buildings, i.e., the structural design index SD , was likely to be inadequate when a seismic retrofit was carried out using steel-braced frames in such a manner that adjacent drop and spandrel walls were in service without any seismic slits, attributed to more stiffen the steel-braced frame.

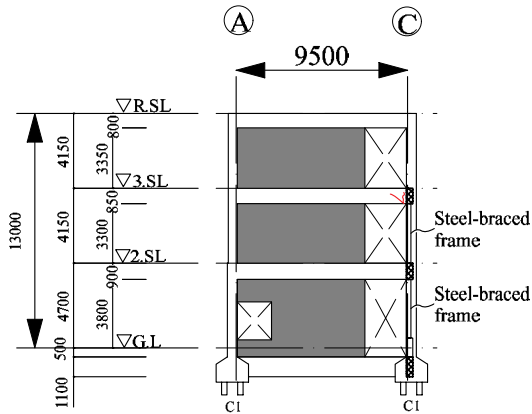
Fig. 6 Frame elevation of tenth frame
in transverse direction

the transverse beam in the third floor, which was a short span beam in the tenth frame for a transverse direction because a large opening was placed on a shear wall for a passage way as illustrated in Fig.6. This is a symptom that these beams resisted an uplift rotation of the rigid body consisting of a two-story steel-braced frame and two boundary R/C columns.

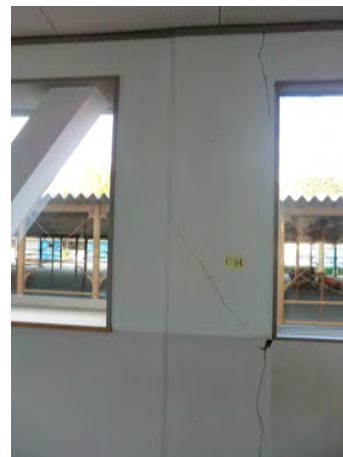
Photo. 9 Shear cracks of
C-14 column at first story
