IMPLICATIONS OF THE GREAT EAST JAPAN EARTHQUAKE FOR THE PACIFIC NORTHWEST REGION OF THE UNITED STATES

ABSTRACT: Engineers from the Structural Engineers Association of Washington studied the earthquake and tsunami damage caused by the Great East Japan Earthquake. This team's objective was to understand the effects of this event, because a similar earthquake and tsunami could occur along the Cascadia Subduction Zone, near the Pacific Northwest Coast of the United States. This paper is a brief summary of the team's observations and the lessons learned that may be applied to earthquake engineering and emergency planning practices in the Pacific Northwest region.

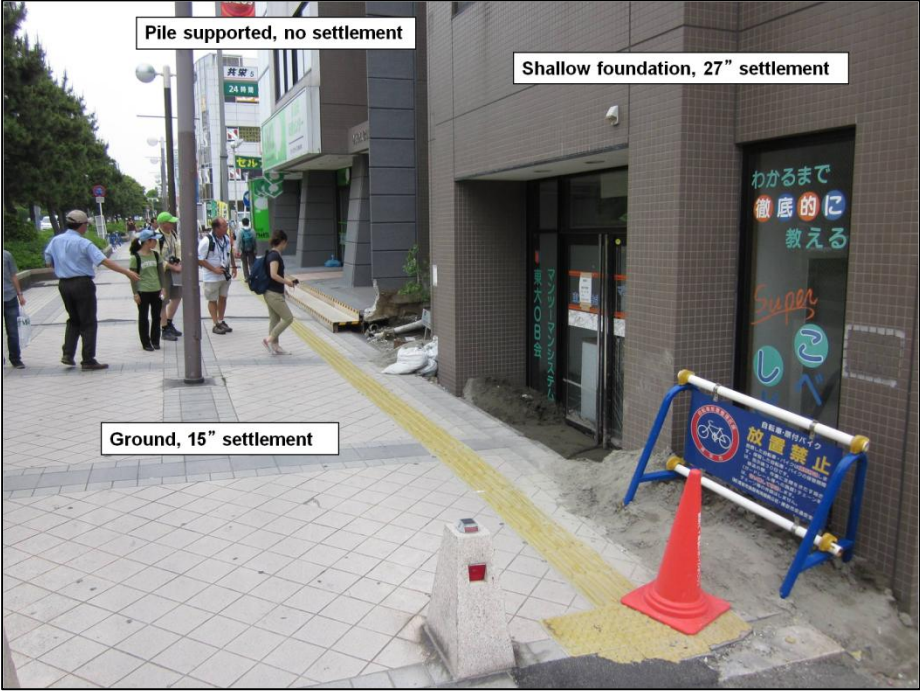
The team observed that ground improvement measures are effective in mitigating liquefaction-induced damage. Existing engineering methods appear to provide reasonable estimates of

Fig. 3 Performance differences between adjacent buildings supported on piles versus shallow foundations in Urayasu City (Lindquist)

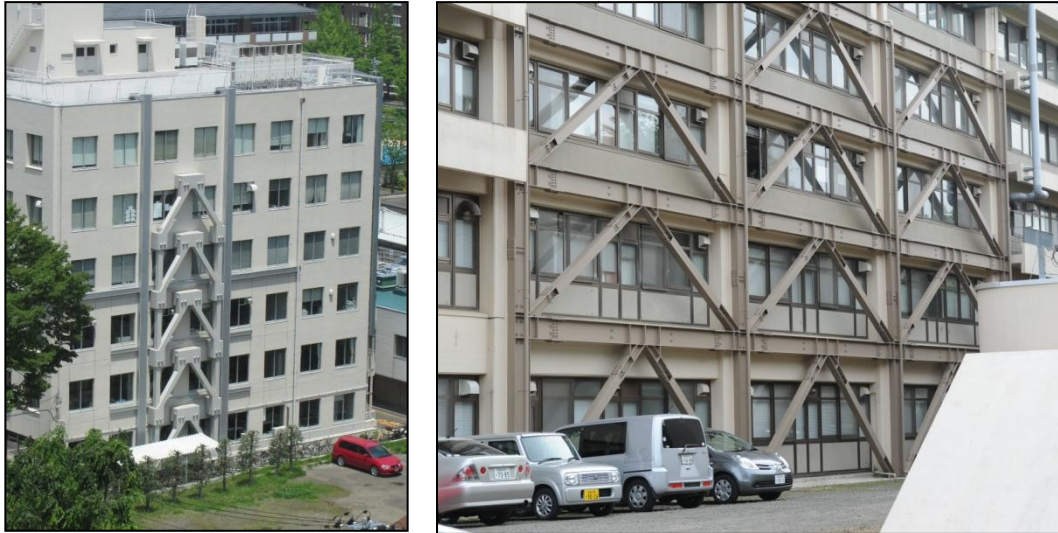
Seismically retrofitted buildings are common in Japan. Retrofitted buildings performed well, demonstrating that seismic retrofitting is a very effective way to preserve older buildings in a high seismic zone. Buildings in the Pacific Northwest are expected to perform similarly to buildings in Japan: newer buildings should do well but older buildings (without seismic retrofits) are likely to be damaged. Contents and equipment (non-structural elements) are likely to be heavily damaged in many buildings. Design beyond life safety (i.e., occupiable design) is needed for true seismic resilience of communities in the Pacific Northwest.

Fig. 4 Retrofitted buildings in central Sendai (left) and Tohoku University (right) (Siu)

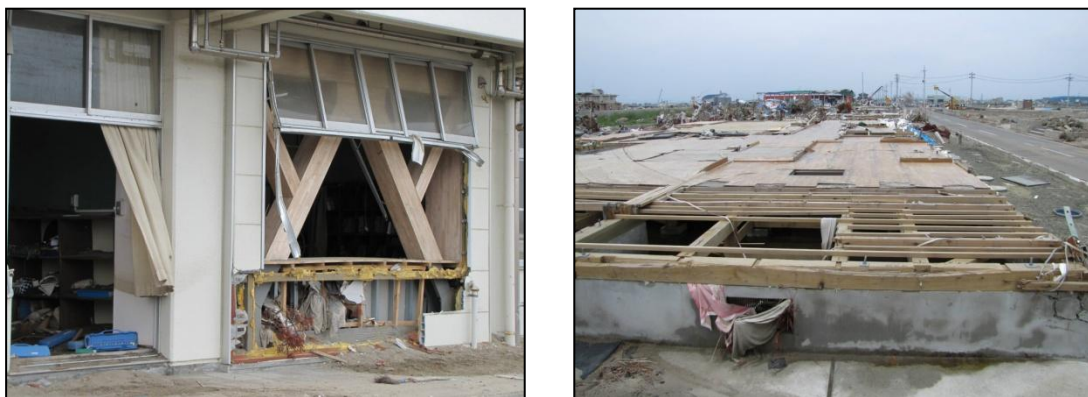
The region experienced more than two minutes of strong ground shaking followed by multiple aftershocks and tsunami inundations along the coast. Depending on the location, maximum wave heights ranged from 4.5 to 15 meters (15 to 50 feet) and overtopped coastal seawalls, as well as some multi-story structures that had been designated as vertical evacuation shelters. A seismic retrofit program instituted after the 1978 Miyagi-ken Oki earthquake proved effective. Retrofitted structures such as schools and hospitals survived the ground shaking and, in areas also inundated by tsunamis, provided reliable vertical evacuation shelters.

Fig. 5 Retrofitted school building (left) in Arahama Ward (Sendai) provided vertical shelter to the devastated community, where virtually no wooden structures remained (right) (Pierepiekarz)

Inundated wood-framed structures were mostly destroyed. Extensive debris impact damage to surviving wood-framed structures was evident. In inundation areas, erosion of building foundations and in-ground utilities was also very evident. Fire events followed tsunami inundation at a number of locations. Some inundated hybrid automobiles were reported to have shorted-circuited battery systems

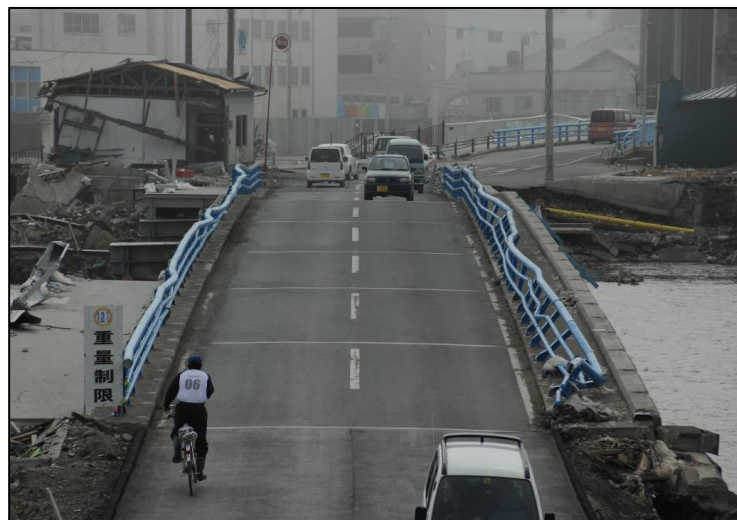
The following observations were made related to road and bridge performance. Ground-shaking damage to bridges was limited, due to adoption of modern seismic design codes and an aggressive seismic retrofit program implemented after the 1995 Kobe earthquake. Tsunami damage to bridges was primarily due to crossings with deep-profile girders, spans lacking vertical hold-down anchorage at supports, and scour at approaches. Many shallow-depth, short-span bridges survived many meters of tsunami inundation with repairable damage to their railings.

Fig. 6 Functional low-profile vehicle bridge in Ishinomaki City. Note damage from tsunami to leading edge of bridge walkway and guardrail on the left side of the photo (Swanson)

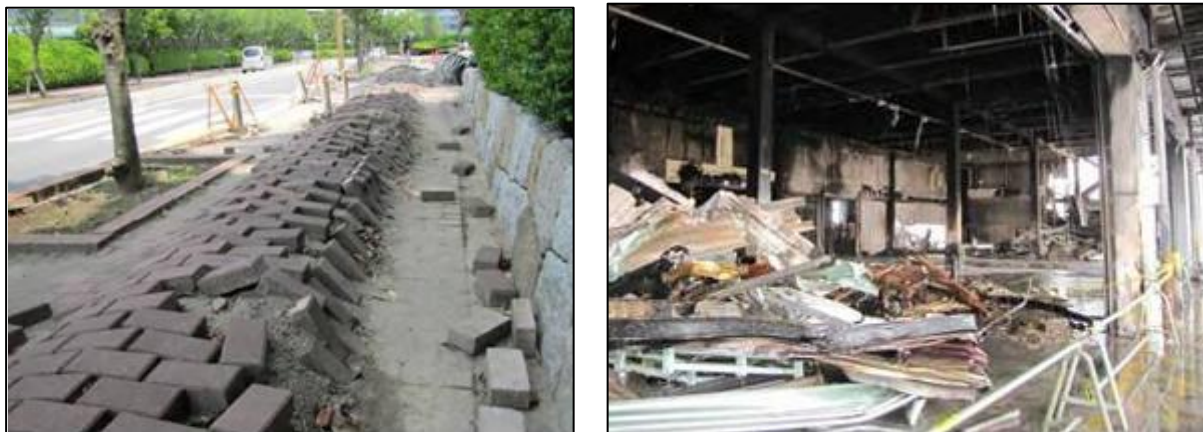
Fig. 7 Underground utility impacts due to soil liquefaction in Chiba (Tokyo metropolitan area) (left), and fire-following earthquake impacts at Sendai Airport cargo area (right) (Pierepiekarz)

Regarding water and sewer systems, it was observed that these systems were often disrupted by liquefaction damage to underground pipelines. In addition, coastal ground subsidence sometimes altered drainage patterns. Coastal water and sewer treatment facilities sometimes required extensive debris cleanup and repair of debris impact damage.
