# LIDAR MEASUREMENT OF THE BREACHED EARTH-FILL DAM IN THE MARCH 11<sup>th</sup> GREAT EAST JAPAN EARTHQUAKE

**ABSTRACT:** Fujinuma dam, an earth-fill dam for irrigation located in Sukagawa City, Fukushima prefecture, was breached in the March 11<sup>th</sup> Great East Japan Earthquake. The debris mass from the breached dam flushed a village lying its downstream leaving 8 dead and 1 missing. The authors made a survey along the stream channel of the debris flow. During their survey, the breached dam body was LiDAR surveyed for its entire 3D image. With the findings from the survey, this paper discusses a possible mechanism of dam breaching.

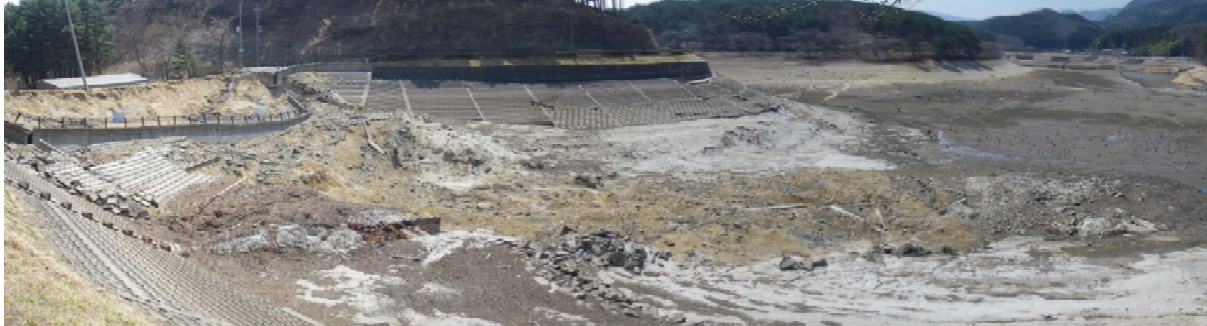
Photo 1 Sliding failure of small dam (April 15<sup>th</sup> at 37.299778, 140.195348)

Photo 1 shows the failure of the upstream slope of the small dam (13m high, 55m wide and 108m long). Almost the entire upstream slope slid down into the reservoir leaving its thin and fragile crest soil behind the dam body narrowly escaped from breaching probably because the larger dam breached first emptying the water of the reservoir. During the emptying process, the soil mass of the upstream slope of the small dam may have been carried further down toward the bottom of the reservoir.

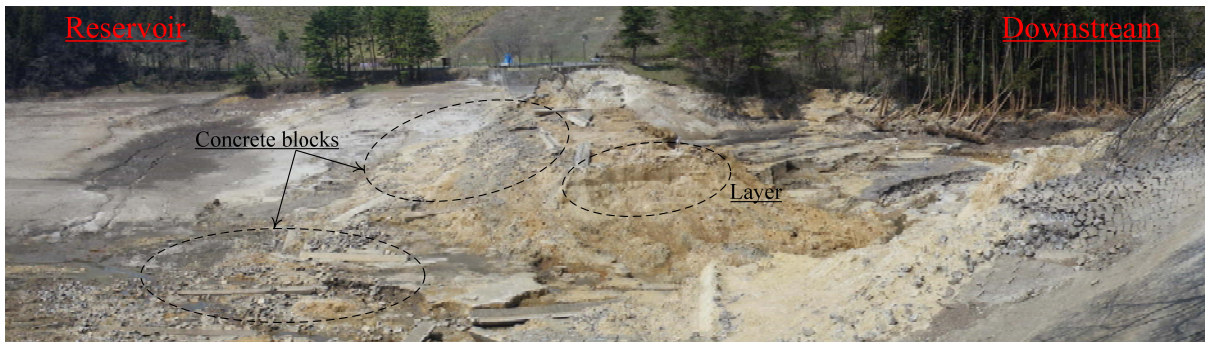
Photo 2 Breached dam body of large dam from right abutment (April 15<sup>th</sup> at 37.301265, 140.195401)

Fig. 3 shows the original cross section of the large dam. The large dam is 6 meters wide at its crest, 133 meters long with upstream surface concrete-block-faced. Photo 2 and 3 show the breached large dam body (Height 18.5m, Length 133m, Volume 99,000m<sup>3</sup>) from right and left abutments, respectively. The middle to right part of the dam body was scoured deep by the overtopped water. A clear laminar structure was seen on the exposed interior of the dam body. Dark-colored mudstone was exposed on the scoured abutment. 20 to 30 cm-thick Ignimbrite sand layers were also found bedding horizontally in the exposed dam body (See Photo 2) indicating that the dam body was constructed by compacting ignimbrite sand. The slide may have been followed by the subsidence of the entire dam body and thus water-overtopping.

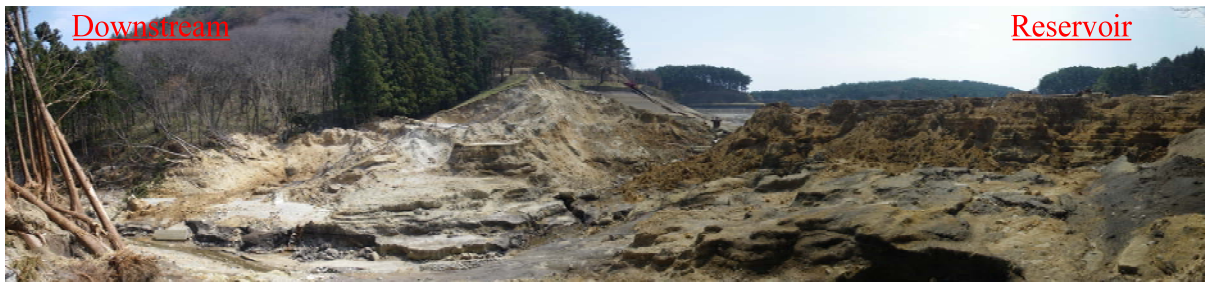
Photo 3 Breached dam body of large dam from left side (April 15<sup>th</sup> at 37.302465, 140.195223)

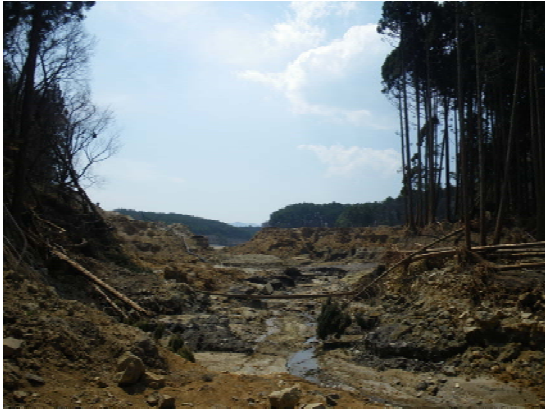
Photo 4 Breached dam body from downstream  
(April 15<sup>th</sup> at 37.302661, 140.196055)

The debris flow from the breached dam eroded its downstream valley and uprooted trees as shown in Photo 4. From mad marks remaining on valley walls, super-elevations were measured at several locations where the stream channel takes sharp turns, and the debris flow velocity was estimated to be around 10m/sec. Photo 6 and 7 show the road embankment being across a valley which was approximately 300m from the large dam and washed away by the debris flow together with a box culvert (1.5m-square, 0.14m-thickness).

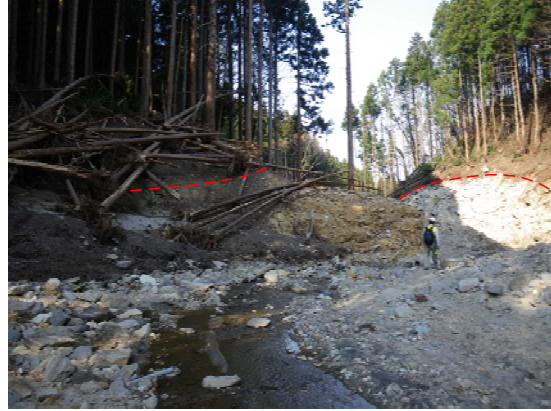
Photo 5 Mark of debris flows on valley walls  
(April 15<sup>th</sup> at 37.306236, 140.199503)

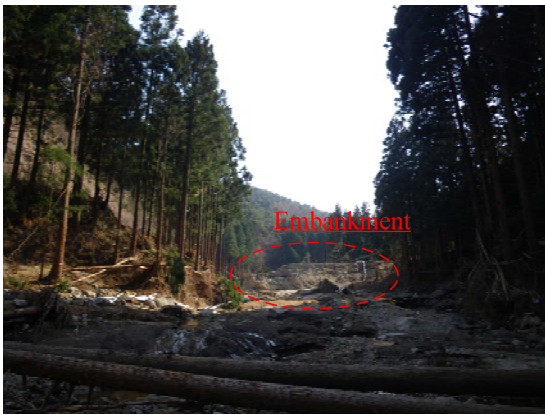
Photo 6 Breached road embankment  
(April 15<sup>th</sup> at 37.305036, 140.198236)

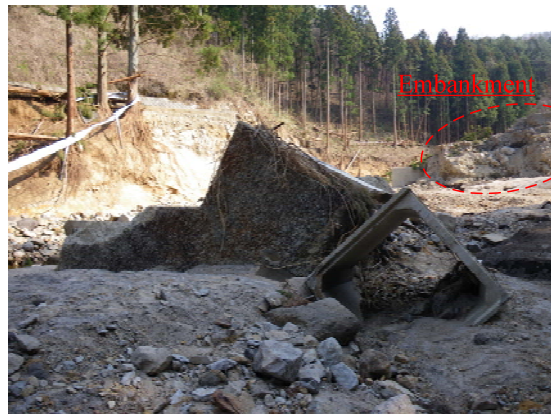
Photo 7 Washed out box culvert  
(April 15<sup>th</sup> at 37.304499, 140.197989)

The box culvert was carried over 48m distance from its original location. Even though the road embankment was flashed, rocks and trees are found clogging the stream indicating that the debris mass was temporarily stopped there owing to the presence of the embankment. The debris flow, when it reached the village, took a sharp 90 degrees clockwise turn along the existing river channel and flushed downstream village (See Photo 8).

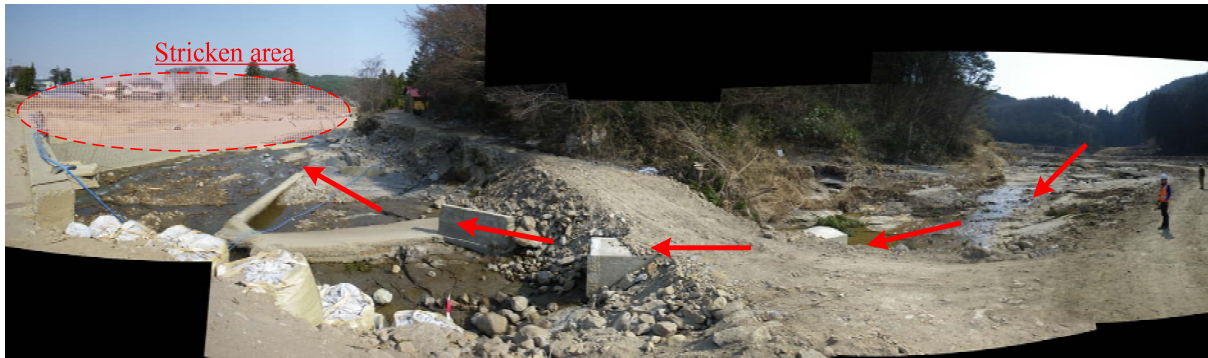
Photo 8 Path way of debris flow and downstream stricken area (April 15<sup>th</sup> at 37.308131, 140.202481)

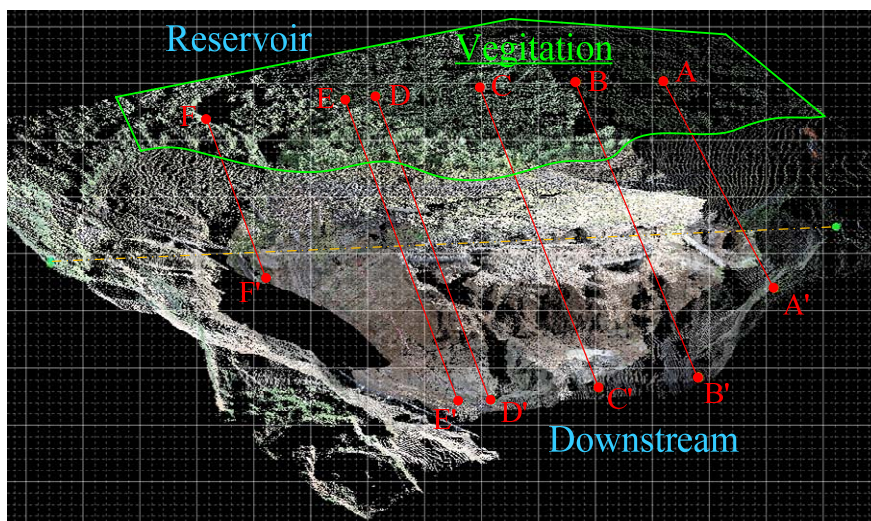
Fig. 5 Bird-eye view of the breached dam

Fig. 5 shows a bird-eye view of the breached dam body. There yet remained some areas hidden from laser light, which appeared black in this figure. 5 months after the earthquake, the bottom of the emptied reservoir was covered thick with vegetation. Fig. 6 is the contour map of the dam, with the coordinate origin set at 1.5m above the original dam body crest. This figure also show a longitudinal cross-section of the damaged dam body, where two lines indicate the top and bottom levels of original dam body, respectively. The top surface of the remaining left dam body is about 50m long, and about 8.5m below the original dam crest. Fig. 7 compares several cross-sections of the damaged dam body with their original ones. These cross sections in Fig. 7 respectively correspond to lines A-A', B-B', C-C', D-D', E-E' and F-F' in Fig. 5 and 6. With the presence of vegetation, every cross section after the earthquake shows an increase of the reservoir bottom by about 0 to 0.25m. It can be found from these figures that scouring of the soil mass was more serious near the middle to right part of the dam body than that near the left abutment. Therefore, it can be deduced that the right dam body, which is the highest part of the dam body constructed by compaction, slid first, causing either subsidence of the dam crest or razor-sharp earth wall to remain such that the water forced its way through this point. And then the overflowing water eroded both the upstream and downstream dam body.

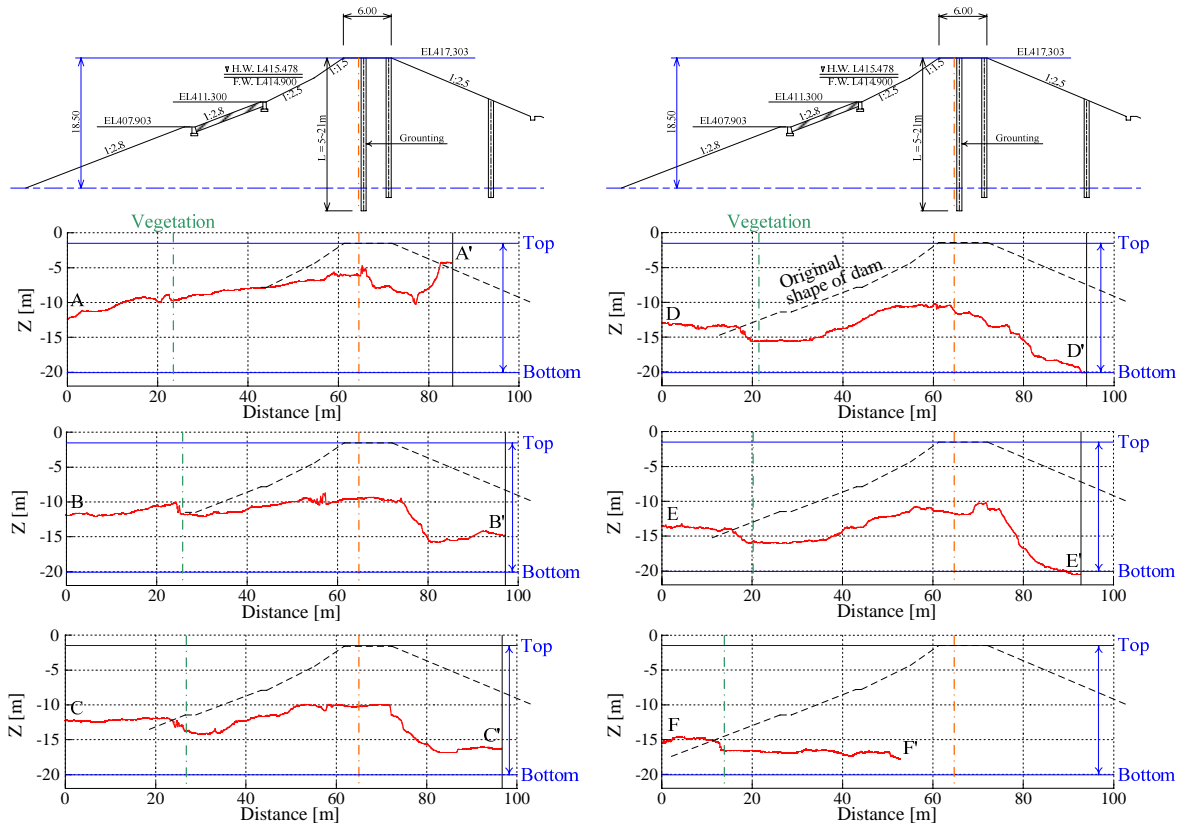
Fig. 7 Comparison of the obtained 3D image of the damaged dam with its original shape

The northeast large earth-fill dam of Fujinuma reservoir, located in Sukagawa city, Fukushima prefecture, was breached in the March 11<sup>th</sup> Great East Japan Earthquake. Its entire dam body was eroded deep by overflowing water. Particularly soil mass of its right side was completely washed away. The debris flow, whose speed is estimated to be around 10m/sec from mud marks remaining on valley walls, rushed down the valley and flushed at least 5 houses leaving 8 dead and 1 missing. Comparing a 3D image of entire dam obtained from LiDAR survey with its original shape, the right dam body whose height is 18.5m was completely washed out from its bottom. From the reconnaissance and the LiDAR survey, it was deduced that the upstream slope of right dam body which was the highest point of the dam body slid first, causing either subsidence of the dam crest or razor-sharp earth wall to remain such that the water forced its way through this point. The numerical simulation will be carried out for a further discussion about the mechanism of the dam failure in later publications.
