EARTHQUAKE DAMAGE INVESTIGATION OF GRAVITY-TYPE QUAY WALLS IN IBARAKI PORT

ABSTRACT: One of the most common used types of quay walls in Japan is gravity type with concrete caissons. A number of gravity-type quay walls have been constructed in Ibaraki Prefecture where huge ground motion occurred in the Great East Japan Earthquake of March 11, 2011. This paper reports on damage to gravity-type quay walls in the Port of Hitachinaka, which serves as a freight transport hub for the northern Kanto region.

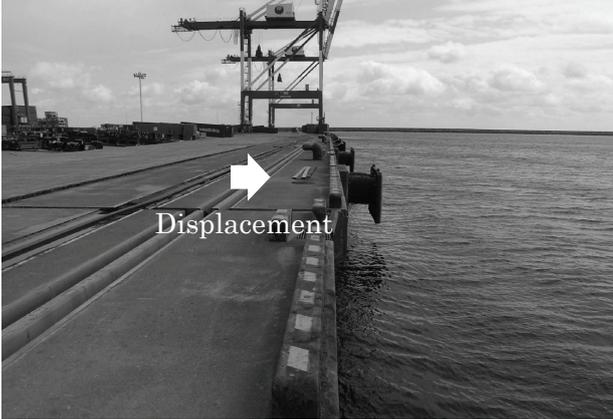
(a) Seaward displacement of caissons

Photo 1 shows several instances of damage observed at the -14 m deep quay wall. The seaward caisson displacement was up to 56 cm, as shown in Photo 1 (a), and the different displacements of

each caisson created a concave-convex quay wall surface. This displacement also resulted in subsidence of at least 113 cm in the backfilled ground, as shown in Photo 1 (b). The residual relative displacement between the seaward and landward crane foundations resulted in derailment damage to the crane wheels, as shown in Photo 1 (c). However, the quay walls were not completely destroyed because the non-liquefiable soil material prevented liquefaction in the backfill ground.

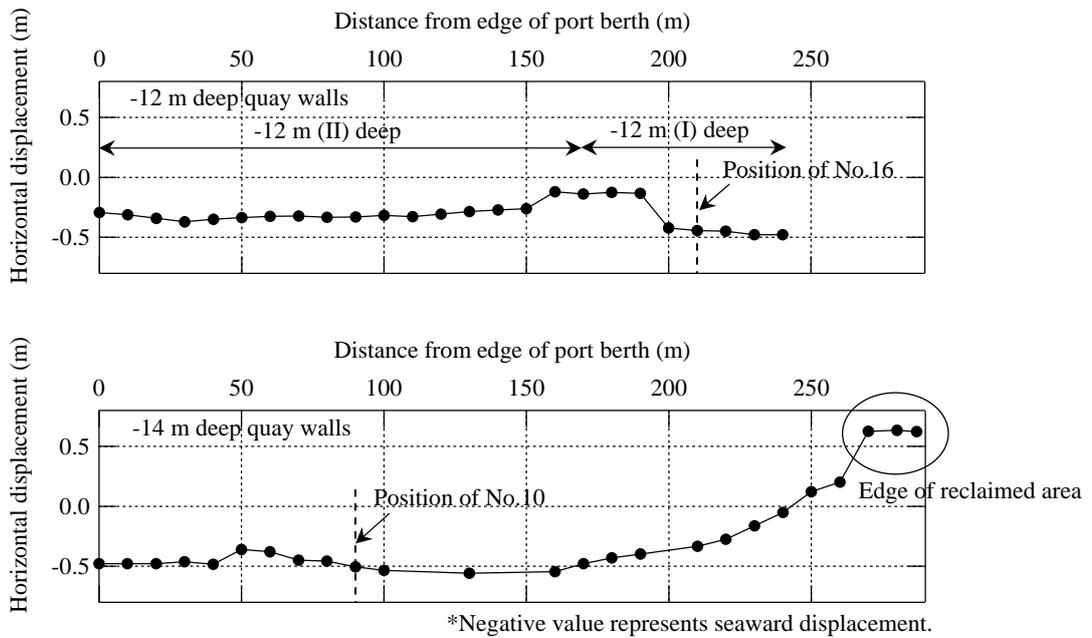
Fig. 8 Horizontal displacement of caissons

The horizontal displacements of the caissons as measured in an on-site survey are shown in Fig. 8, in which negative values represent seaward displacement. In both quay walls, most of the caissons moved seaward except for those near the edge of a reclaimed area. The maximum horizontal displacement was 56 cm for the -14 m deep quay wall. The edge of the reclaimed area corresponding to the corner of the quay walls exhibited behavior different from that of the standard area.

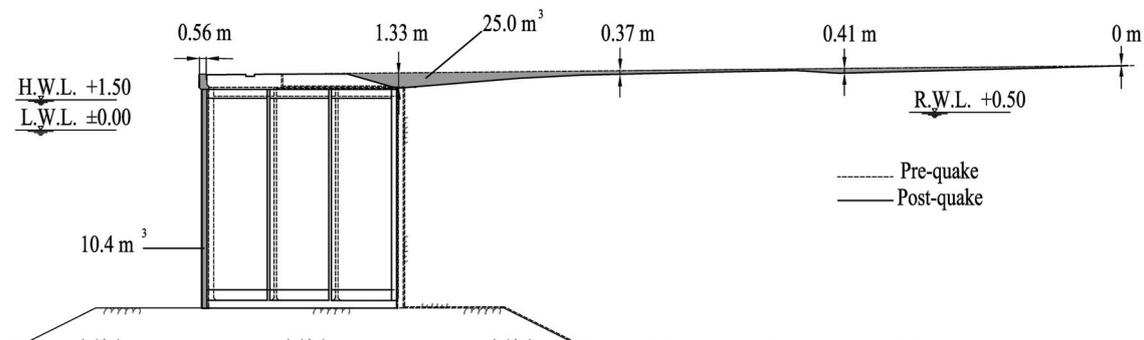
Fig. 9 Cross-section of pre- and post-earthquake

Figure 9 shows pre- and post-earthquake cross-sections of the -14 m deep quay wall. It illustrates only ground surface and caisson displacement because only measurement of surface displacement was conducted in the field. It can be seen that the incremental volume generated by caisson seaward movement was about 10.4 m^3 , and the decremental volume generated by backfill ground subsidence was about 25.0 m^3 . The volume balance resulting from these two values is 14.6 m^3 , indicating that the average volumetric strain of the backfill ground was not large.

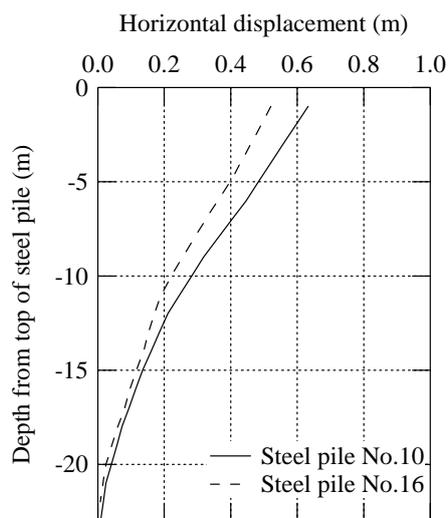
Fig. 11 Horizontal displacement of steel piles

The horizontal displacements of two representative steel piles are shown in Fig. 11, which indicates that the seaward displacements of the pile tops were 0.52 m and 0.63 m, and that the piles bent seaward from deep to shallow parts. The radius of the curvature calculated from the displacements shows that these piles reached their yield condition, indicating the need for replacement.
