# DAMAGE OF BRIDGES DUE TO THE 2011 GREAT EAST JAPAN EARTHQUAKE

Kazuhiko KAWASHIMA

**ABSTRACT:** This paper presents damage of bridges during the 2011 Great East Japan earthquake. Since the bridges in the north Miyagi-ken and south Iwate-ken suffered extensive damage during the 1978 Miyagi-ken-oki earthquake, damage of bridges during the 2011 Great East Japan earthquake is evaluated in comparison with the damage due to the 1978 Miyagi-ken-oki earthquake so that the effect of recent progress of seismic design can be evaluated. Tsunami-induced damage was extensive for bridges along the Pacific Coast. Typical feature of tsunami-induced damage is presented based on video movies.

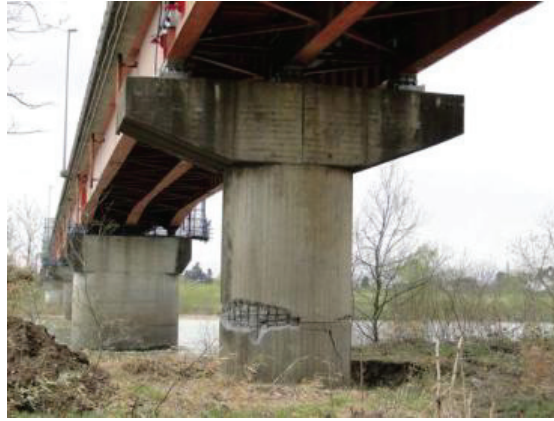
Photo 1 Flexure-shear failure of columns due to termination of longitudinal bars with insufficient development (Fuji Bridge) (courtesy of Dr. Hoshikuma, J., PWRI)

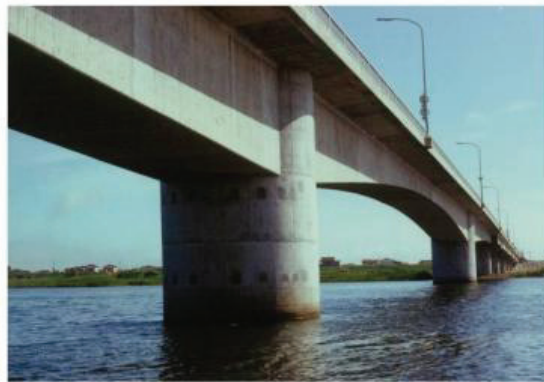
Photo 2 Yuriage Bridge

Yuriage Bridge (refer to Photo 2) suffered extensive damage at reinforced concrete hollow and solid columns, an end of prestressed concrete girders, and steel pin and roller bearings during the 1978 Miyagi-ken-oki earthquake as shown in Photo 3(a). Since the damaged columns were repaired and retrofitted using reinforced concrete jacketing, they did not suffer damage again. However steel pin and roller bearings suffered extensive damage again in the similar mode as shown in Photo 3 (b). It is obvious that steel pin and roller bearings are vulnerable to seismic action, because the stress builds up

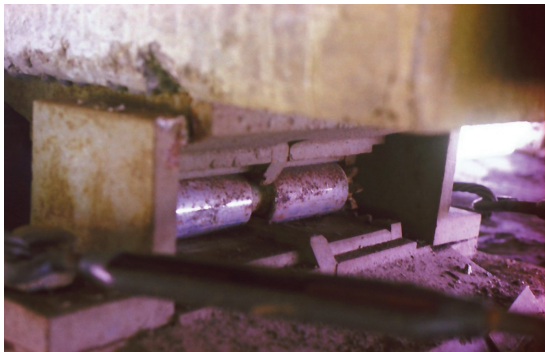
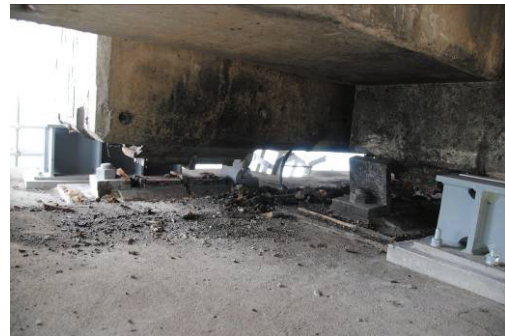
Photo 3 Damage of steel roller and pin bearings Yuriage Bridge

to failure by allowing no relative displacements at pin bearings and relative displacements accommodated in roller bearings are insufficient to real relative displacement under a strong excitation.

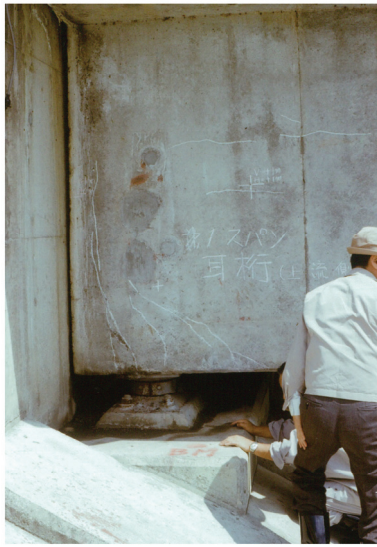
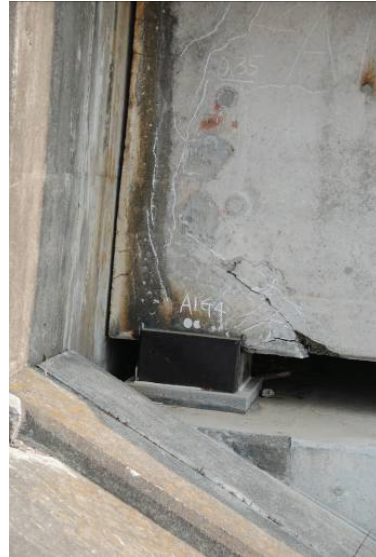
Furthermore, exactly the same end of a prestressed concrete girder which suffered damage during the 1978 Miyagi-ken-oki earthquake suffered again as shown in Photo 4. It was a critical zone due to concentration of seismic force, dead load reaction and PC anchor force.

Photo 4 Damage of a PC box girder bridge at the end support, Yuriage Bridge

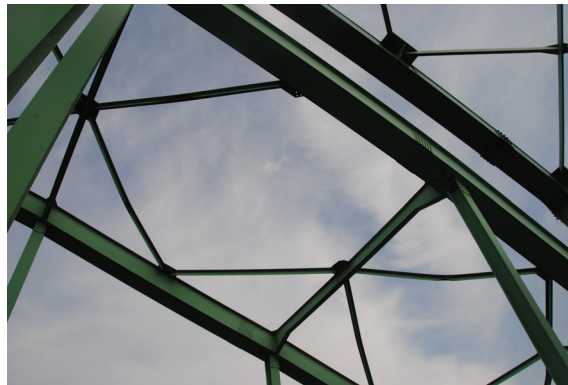
Photo 5 Rupture and buckling of upper braces, Tennoh Bridge, National Road No. 45

members. Photos 5 and 6 show rupture and local buckling of upper and lower braces. An end of a lower truss brace with a gusset plate was completely disconnected due to corrosion. Because similar disconnection was observed at other lower braces, it is likely that a large torsion response of the truss

bridge due to deterioration of torsional rigidity resulted in extensive rupture and buckling of upper and lower braces. This truss bridge was critical for collapse during the earthquake.

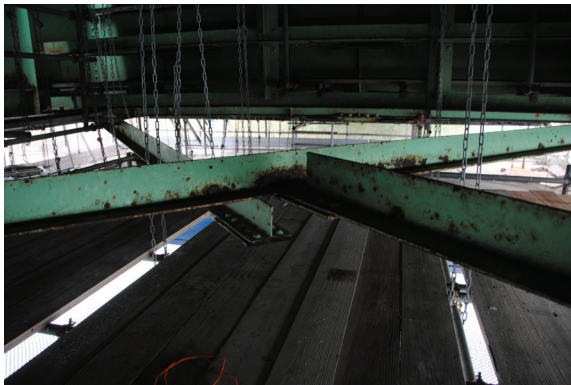
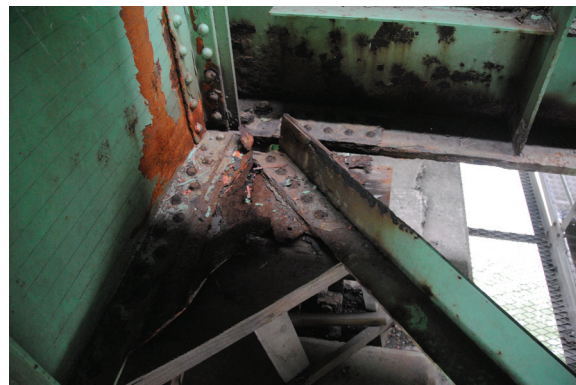
(a) rupture of a lower brace

(b) Disconnection at the end of a lower brace

Photo 6 Rupture of a lower brace and lost of connection at the end, Tennoh Bridge

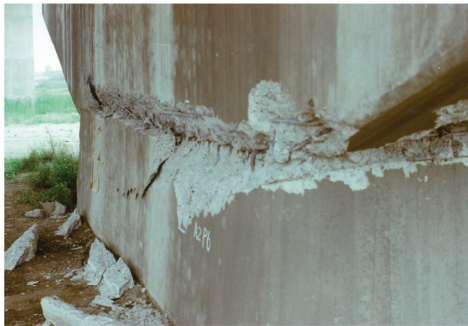
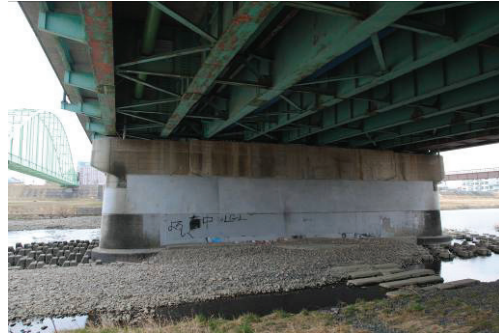
Damage of bridges which were already retrofitted suffered virtually no damage. For example, Sendai Bridge which is an extremely important bridge in Sendai City suffered extensive damage at reinforced concrete piers and steel bearings as shown in Photo 7(a) during the 1978 Miyagi-ken-oki earthquake.

Photo 7 Effect of seismic retrofitting of piers, Chiyoda Bridge, National Road No. 4

However this bridge suffered no damage during the 2011 Great East Japan earthquake, because columns were retrofitted as shown in Photo 7(b) and the original steel bearings were replaced with elastomeric bearings as shown in Photo 8.

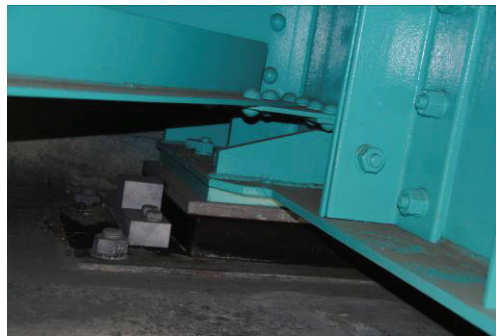
Photo 8 Elastomeric bearings which were set for replacement of original steel bearings suffered no damage, Sendai Bridge

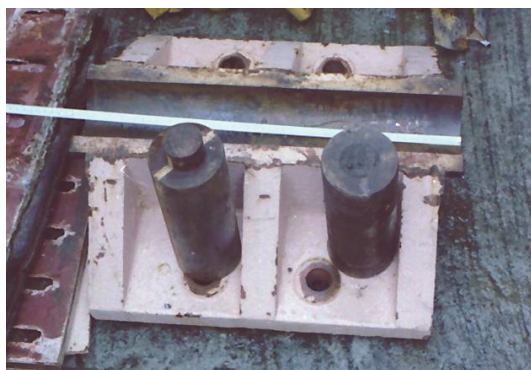
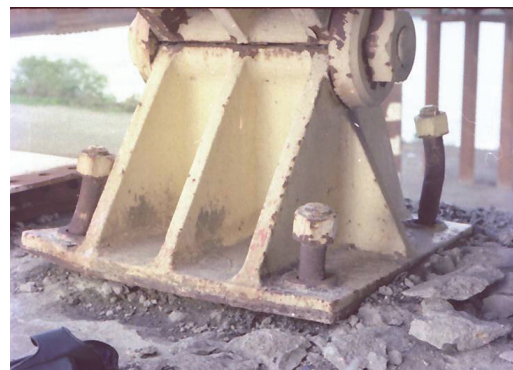
(a) Rupture of a pin in a pin bearing

(b) Pull-out of anchor bolts due to rocking response of a lower bearing

Photo 9 Damage of steel bearings during the 1978 Miyagi-ken-oki earthquake, Shin-Iino Bridge, National Road No. 45

Shin-Iino-gawa Bridge suffered extensive damage at steel pin and roller bearings as shown in Photo 9 during the 1978 Miyagi-ken-oki earthquake. It was retrofitted prior to the 2011 Great East Japan earthquake: 1) some reinforced concrete piers were retrofitted using steel jacketing, 2) nonlinear viscous dampers were installed, and 3) steel bearings were replaced with elastomeric bearings as shown in Photo 10. As a result, the bridge suffered no damage during the 2011 Great East Japan earthquake.

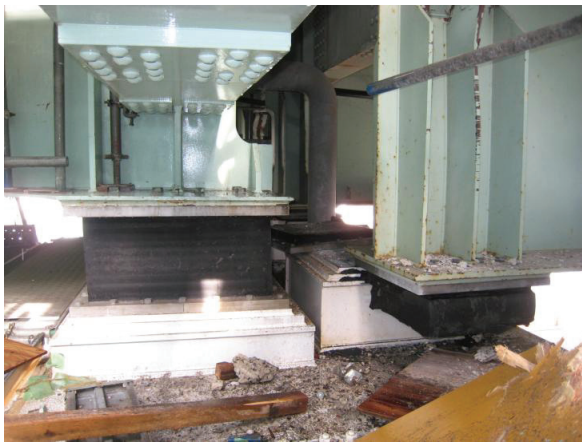
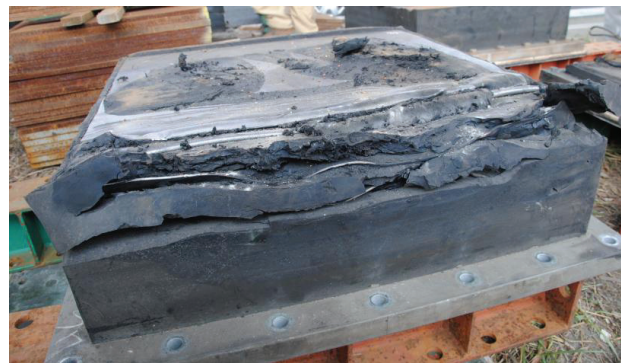
Elastomeric bearings generally performed quite well under the extreme ground motions as shown above. However it should be noticed that elastomeric bearings ruptured in some bridges. For example, several elastomeric bearings ruptured such that a deck offset by 0.5m in the transverse direction as shown in Photo13(a) at Sendai-Tobu Viaduct. Rubber layers detached from steel plates in addition to rupture of rubber layers as shown in Photo 13(b). Though detailing is not yet released, there may be two possible reasons for the damage. The first is a miss design and fabrication of the elastomeric bearings. The second is an interaction between adjacent decks. Since an expansion joint constrained relative displacement between adjacent decks in the transverse direction, it is possible that a larger displacement demand of a deck is imposed to an adjacent deck resulting in larger shear deformation in the damaged bearings (Quan and Kawashima 2009).

(a) Offset of left girder by 0.5m due to rupture of elastomeric bearings (NEXCO East)

(b) Rupture of an elastomeric bearing

Photo 13 Damage of elastomeric bearings at Sendai Tobu Expressway

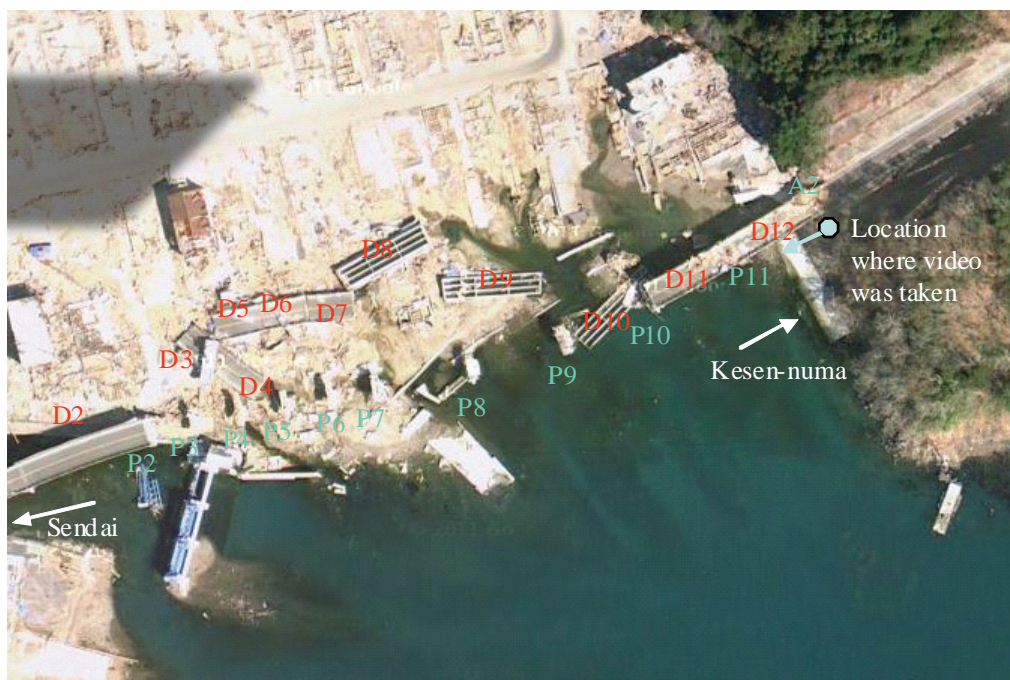
Photo 14 Utatsu Bridge (Google)

Utatsu Bridge built in 1972 at Minami-sanriku Town over Irimae Bay suffered extensive damage by tsunami as shown in Photo 14. It was a 303m long 12 simply supported PC girder bridge consisting of 3 types of superstructures with spans ranging from 14.4m to 40.7m as shown in Fig. 7. Diaphragms were set between PC girders at the ends and mid points. The girders had an inclination as large as 6% in the transverse direction due to curved alignment of the bridge. For example, the inclination was 4.8%, 3%, 3%, 1.1% (sea side down) at D3, D4, D5, and D6, respectively, then it changed to 2-5%, 9%, 4% and 2% (sea side up) at D8, D9 & D10, D11, and D12, respectively.

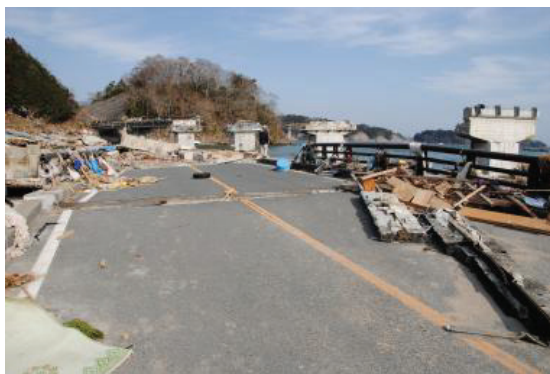
Photo 15 Decks D5-D7

The bridge was seismically retrofitted a few years ago. Columns were retrofitted by steel jacketing and unseating prevention devices were installed. The decks D1, D2, D11 and D12 remained but Decks D3-D10 were washed away. Decks D3-D7 were simply supported pre-tensioned PC girder bridges. As a part of the seismic retrofit, cable restrainers were set for tying together between D3-D7, and three steel stoppers were provided at the end of D3 and D7 for preventing excessive longitudinal deck movements. Though cable restrainers ruptured between D4 and D5, D3-D4 and D5-D6-D7 were still tied together after floated as shown in Photo 15. D8, D9 and D10 overturned when they were floated as shown in Photo 16.

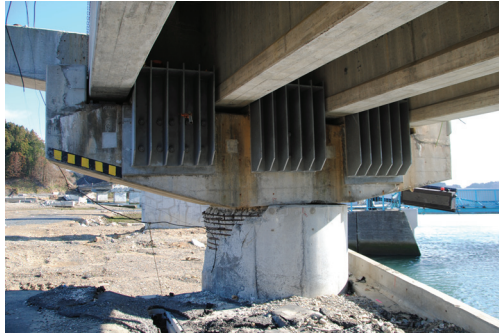
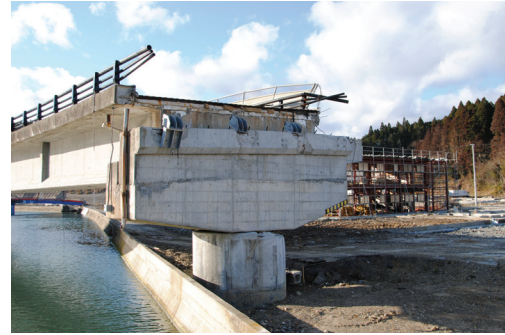
Only P2 suffered flexural failure as shown on Photo 17(a) at the land side. The column was retrofitted using a steel jacket. The damage was probably caused by ground-motion-induced seismic force based on an analysis of the moment capacity of retrofitted section. Since new ties in the jacket were flare welded, the ties were still confining the column though they yielded. D2 did not suffer damage and three stoppers for D2 on P2 were intact. On the other hand, three stoppers for D3 on P2 suffered damage as shown in Photo 17(b). This indicates that D3 offset when D3 was dragged laterally due to tsunami.

Photo 17 Flexural failure of P2

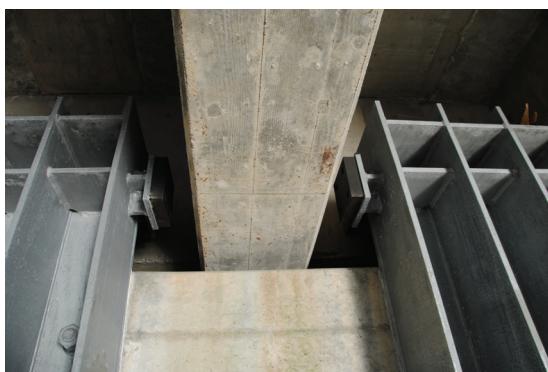
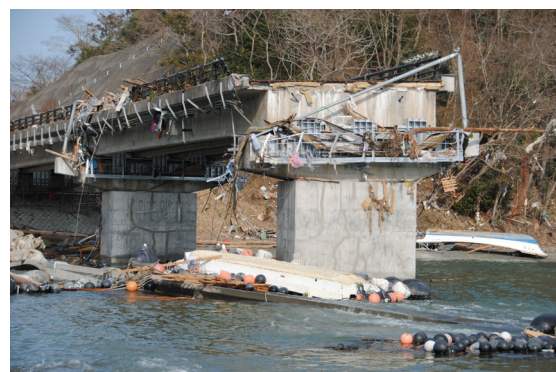
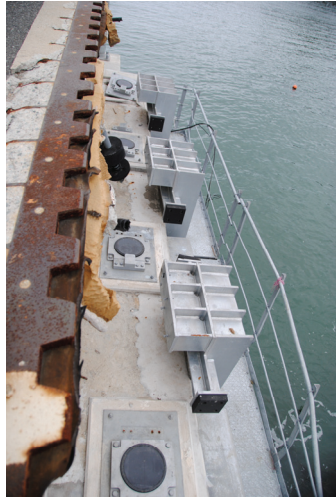
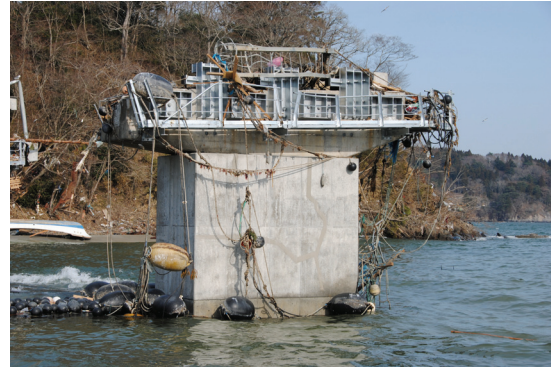
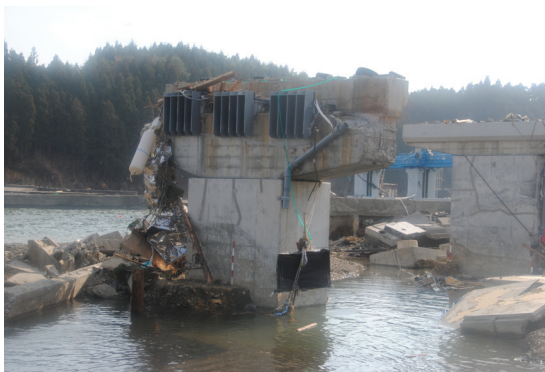
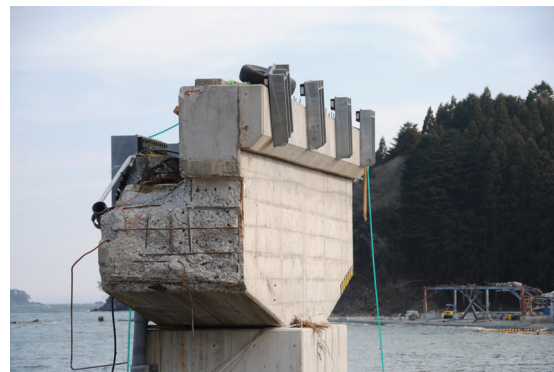
Photo 18 Damage of stoppers

Photo 18 (a) shows two steel longitudinal stoppers on Abutment 2. The main function of the stoppers was to prevent excessive deck displacement in the longitudinal direction, but they also restricted deck displacement in the transverse direction. Photo 18 (b) and (c) shows three stoppers and four pot bearings on P10. Three longitudinal stoppers did not suffer damage at all. All upper bearings were detached from the lower bearings and floated away together with D10. Three side stoppers in the sea side were removed due to rupture of four anchor bolts each. The sea most lower bearing slightly uplifted but other two lower bearings were in their original position without damage. From the fact that three stoppers neither suffered damage nor tilted, it was likely that D10 was uplifted over the stoppers before floated.

Photo 18(d) shows three steel longitudinal stoppers and four seat extenders for D9 on P9, and Photo 18 (e) shows three stoppers for D8 on P7. The stoppers for D8 and D9 neither tilted nor suffered damage. This also indicates that D8 and D9 were first uplifted before they were floated. Photo 18 (f) shows four stoppers for D7 on P7. The land side stopper slightly tilted with other three stoppers being not damaged at all. It indicates that D7 (one of the shortest deck) was uplifted toward the land side at the sea side but insufficiently at the land side before it was floated. Other shorter span decks (D2-D6) were simply dragged laterally.

If decks uplift before floated under tsunami action, it may be effective to install restrainers in the vertical direction between decks and substructures so that decks can be tied down to substructures (tsunami unseating prevention devices). Since installation of tsunami unseating prevention devices imposes an additional upward force to substructures, substructures have to be strengthen if they do not have enough capacity. However because an upward uplifting force is limited, such a strengthening is not generally required for most bridges unless bridges were not very old.

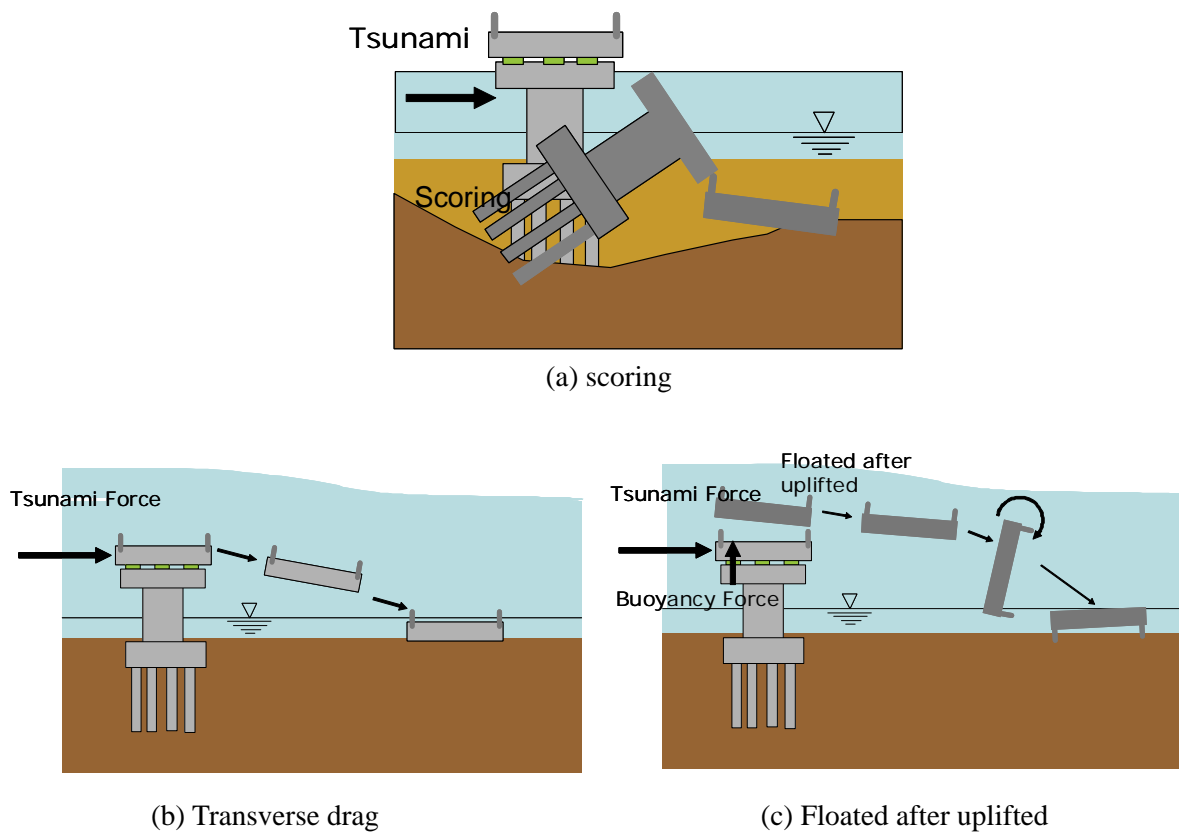
Fig. 8 shows possible failure mechanisms due to tsunami. As mentioned earlier, overturning of foundations due to scouring did not occur. The above mentioned damage indicates that Utatsu Bridge suffered damage due to the mechanism of (b) and (c).

Fig. 8 Possible damage mechanisms by tsunami

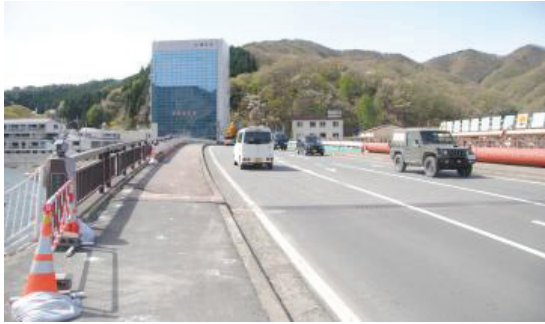
Photo 20 Yanoura Bridge, National Road 45, Kamaishi City

As shown in Photo 20, Yanoura Bridge suffered only minor damage on hand rails.
