LIQUEFACTION-INDUCED DAMAGE TO BUILDINGS IN URAYASU CITY DURING THE 2011 TOHOKU PACIFIC EARTHQUAKE

Kohji TOKIMATSU¹, Kota KATSUMATA²

ABSTRACT: An overview of the liquefaction-induced damage to buildings in Urayasu city during the 2011 Tohoku Pacific earthquake is presented, based on field reconnaissance made after the quake. It is shown that extensive soil liquefaction occurred in most of the areas reclaimed after 1968, accompanied by numerous sand boils and large ground settlement up to 60 cm as well as settlement/tilting of wooden and reinforced concrete buildings supported on spread foundations. The extent and distribution of the damage were significantly affected by local soil conditions including the thickness of reclaimed fills, the depth to the bedrock or natural site period, and whether remedial measures were taken against soil liquefaction, as well as structure soil structure interaction effects.

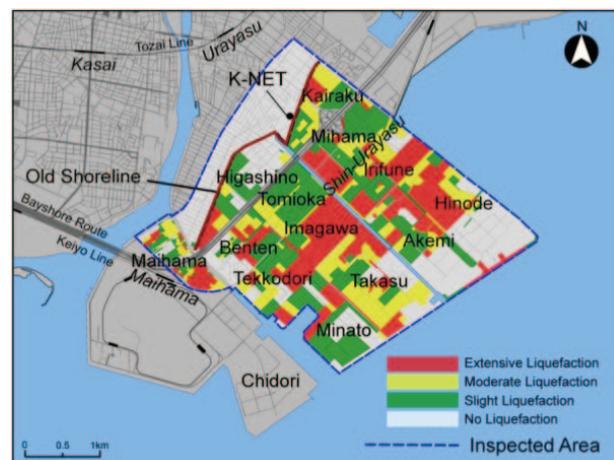
Based on the field performance of soils and buildings including ground settlements as well as settlements and tilting of houses, a damage distribution map was drawn in which the extent of soil liquefaction is classified into four categories (i.e., no, slight, moderate, and extensive) as shown in Fig. 12. It can be confirmed that, liquefaction-induced damage was not seen on the north of the old coastline

Fig. 12 Map showing extent of liquefaction damage⁴⁾

as of 1964 but was widely developed in the area reclaimed after that year. The areas that had experienced liquefaction in the 1987 Chiba-ken Toho-oki Earthquake did re-liquefy. The degree of damage, however, varies from place to place within the reclaimed areas. In particular, some of the reclaimed zone escaped any liquefaction damage probably due to ground treatment including remedial measures against soil liquefaction.

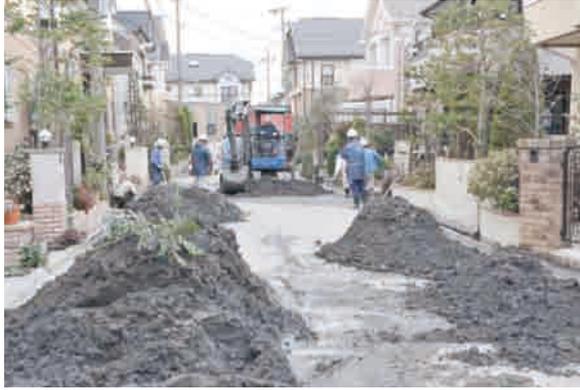
Photo 1 Sand boils stacked over the road

1) In areas where liquefaction occurred, many sand boils (Photo 1), ground settlements up to 60 cm as well as settlements and tilts of building and houses on spread foundations (Photos 2-4) were observed everywhere. Vertical gaps were created around pile-supported structures due to ground settlements (Photos 4-5), causing damage to piping and other facilities. Underground facilities, such as manholes, emergency water tanks and parking lots were uplifted (Photo 6), damage was done to tap

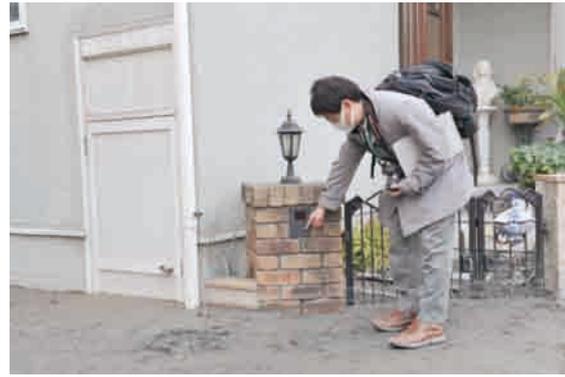
Photo 2 Wooden house suffering large settlement

3) RC houses, and houses whose first floor or semi-basement was made of reinforced concrete to prevent flood damage, suffered larger settlement, probably because their ground contact pressure was greater.

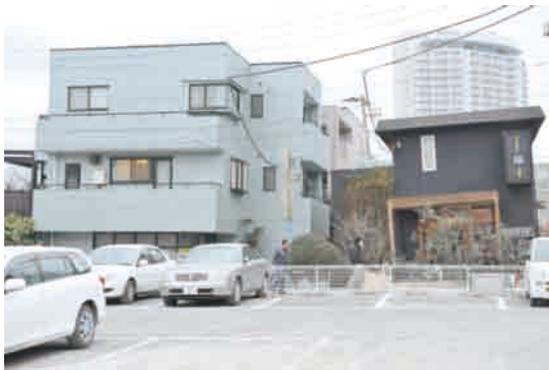
Photo 3 Buildings suffering large settlement and tilting⁴⁾

4) When buildings face each other across a street, they tend to tilt backward, away from each other, as in Photo 1 and Figures 13 and 14. When two buildings stand closely together, they often tilt toward each other, as in Photo 3 and Figures 13 and 14. Such unique tendency was probably caused by building-soil-building interaction effects in which the combined loads of the two adjacent buildings increased their settlements on the neighboring side.

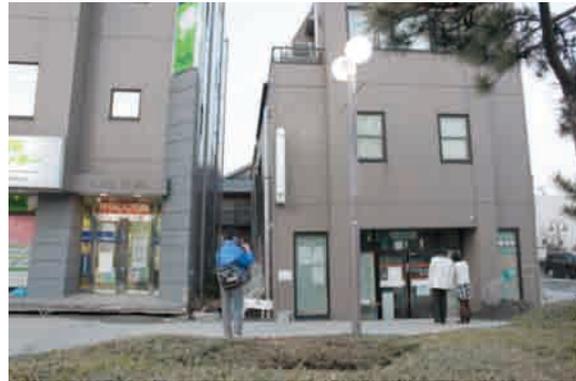
Photo 4 Buildings supported on pile (left) and spread (right) foundations⁴⁾

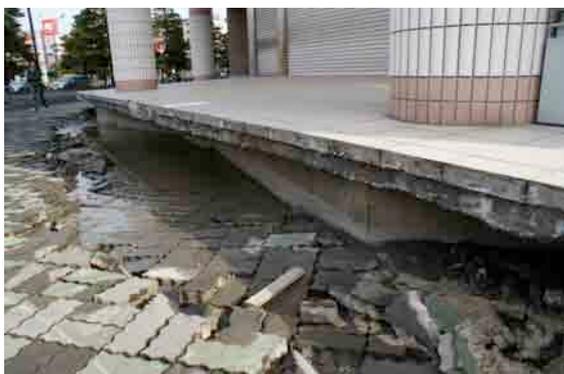
Photo 5 Pile-supported buildings suffering large ground settlement⁴⁾

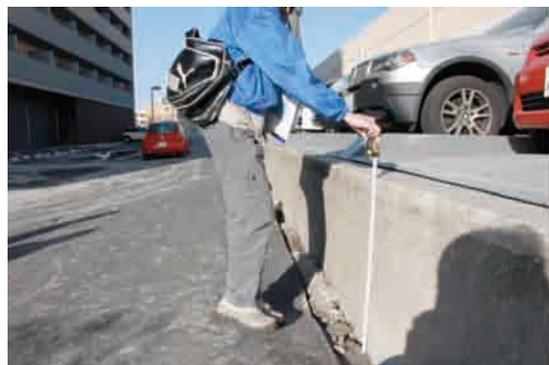
Photo 6 Uplifted underground parking garage⁴⁾

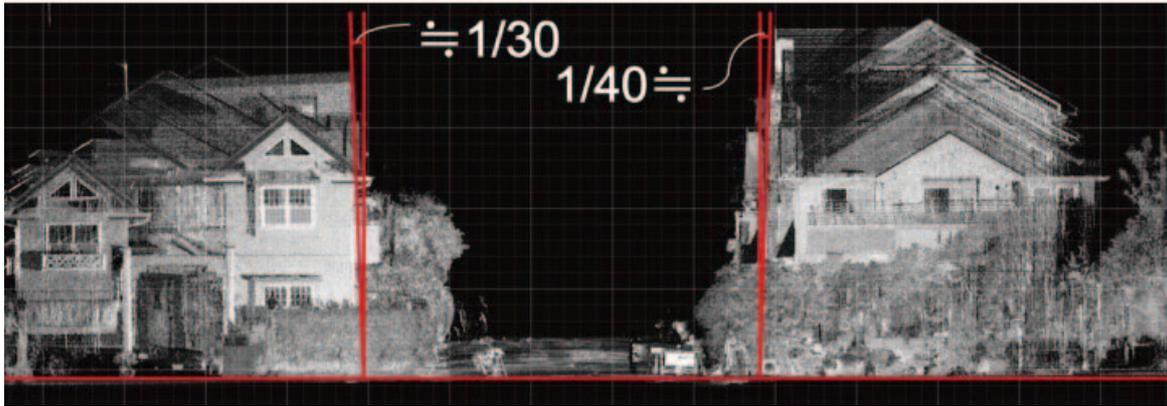
Fig. 13 Typical result of 3D laser scanning of buildings

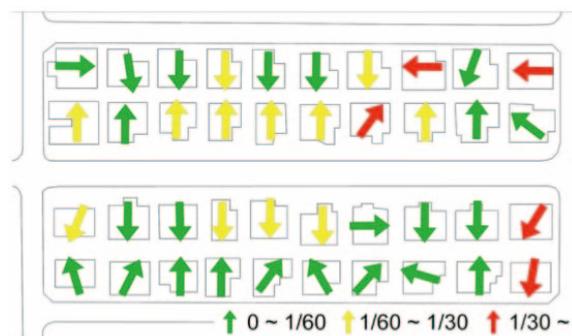
Fig. 14 Typical result of tilting angle and direction of houses in a district

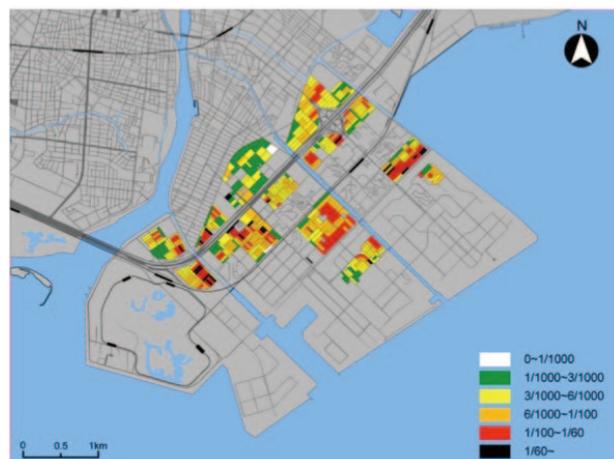
Figure 15 shows the distribution of average inclination angle of residential houses supported on spread foundations in each district, based on the survey on about 9,000 houses conducted by Urayasu city government.

Fig. 15 Map showing distribution of average inclination angle of houses⁷⁾

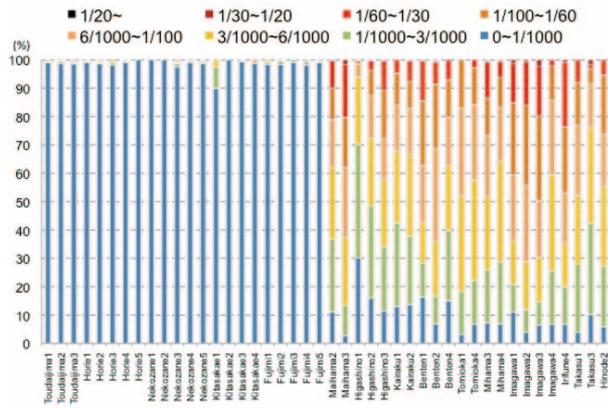
Fig. 16 District by district distribution of inclination angle of houses⁷⁾

Figure 16 summarizes the district-by-district distribution of damaged houses in terms of inclined angle. The figures show that the houses located on the non-liquefied north side of the old coastline had no damage, while those located in the reclaimed area suffered extensive damage. In particular, about 1/3-1/2 of the houses in the residential areas of Maihama 3-chome, Benten 1-chome, Imagawa 1 to 3-chome, and Irifune 4-chome tilted more than 1/100. These areas are classified in the category of extensive damage in Figure 12.

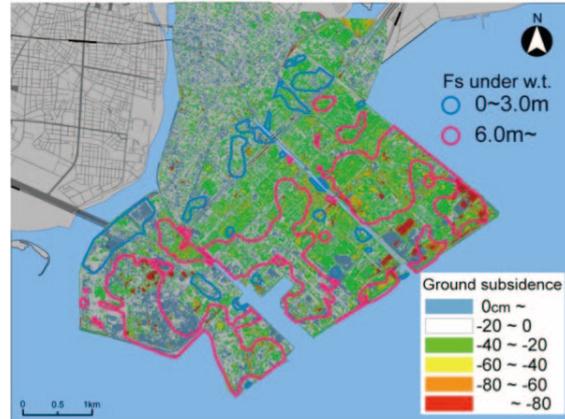
Fig. 17 Map showing vertical ground settlement between 2006 and 2011

Figure 17 shows ground subsidence estimated from the difference between the altitudes obtained before and after the quake. The ground in the liquefied area after the quake has settled 0.2 to 0.4 m on the average, with smaller settlements on the roads. The value of subsidence reached as much as 0.6 to 0.8 m in some areas. It seems that the area with larger ground settlements experienced more severe liquefaction damage to buildings.

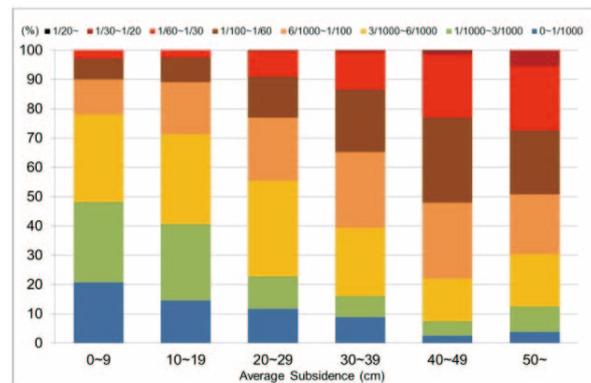
Figure 18 shows the distribution of inclination angle of residential houses with respect to ground subsidence. The figure apparently shows that the inclination angle tends to increase with increasing liquefaction-induced ground settlement. For example, houses tilted more than 1/100 are about 10% if the liquefaction-induced settlement (S) is less than 20 cm, whereas it becomes about 50% when S becomes greater than 40 cm.

Fig. 18 Relation between average ground settlement and average angle of inclination
