TSUNAMI DAMAGE TO BRIDGE STRUCTURES IN RIKUZEN-TAKADA CITY AND THE EMERGENCY ROAD NETWORK RECOVERY ACTIONS

Shigeki UNJOH¹

¹ Research Coordinator for Earthquake Disaster Prevention, National Institute for Land and Infrastructure Management, MLIT, Tsukuba, Japan, unjoh-s92ta@nilim.go.jp

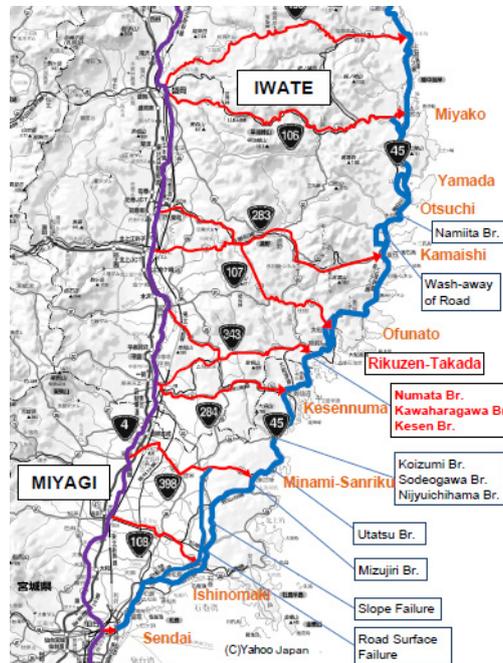
Fig.1 Damage on National Highway Route 45 (Tohoku Bureau of MLIT, 2011a)

The national highway route 45 connects Sendai City with Aomori City along the Pacific “Sanriku” coast of Miyagi, Iwate and Aomori prefectures. During the 2011 Great East Japan Earthquake, road function of 22 locations was disrupted and 5 bridges were washed out caused by the destructive tsunami. Fig.1 shows the highway network in the Pacific side of Miyagi and Iwate prefectures and the damaged section of the national highway route 45 (Tohoku Bureau of MLIT, 2011a). Typical heavy damage to bridges was the wash-out of superstructures as shown in Photo 1. The strong tsunami failed bearing supports and washed out the superstructures. On the other hand, the most of substructures of the bridges, in which the superstructures were washed out, survived with only minor damage.

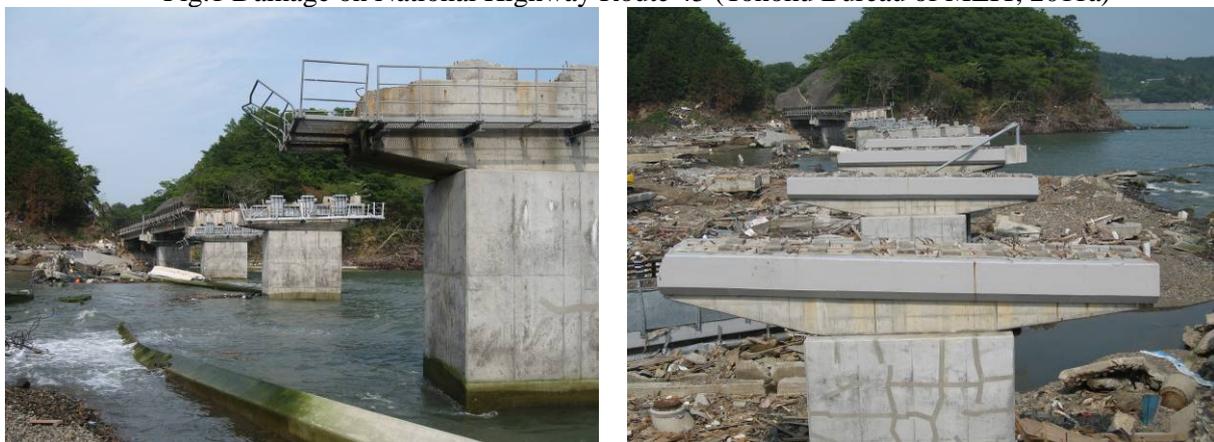
Photo 1 Typical Heavy Damage of Bridges: Wash-out of Superstructures by Tsunami

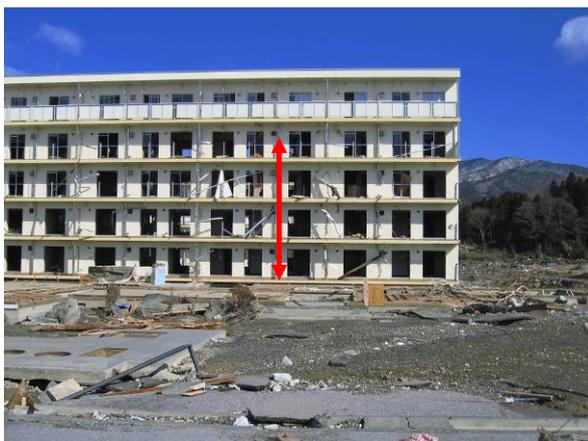
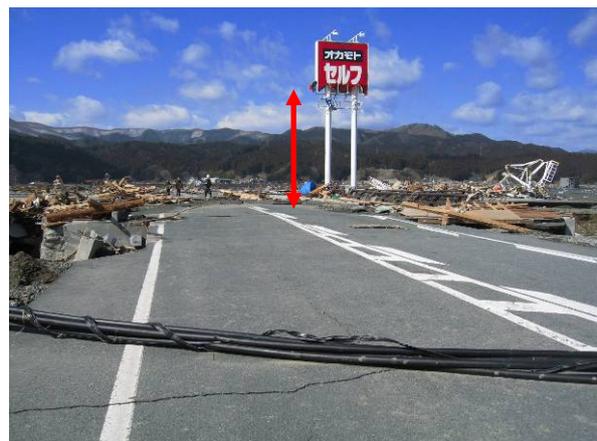
Photo 2 shows the evidences of the attacked tsunami height left at the buildings and the signboard along the coast area in Rikuzen-Takada city. The height was estimated as around 10m from the ground level. Everything was destroyed and washed out, and almost nothing except large buildings was left in the coastal area. On the other hand, a massive amount of debris was swept and left on the landward side apart from the coast line, and the roads was completely closed by that. Photo 3 shows a large amount of debris and the urgently opened roads.

Photo 2 Tsunami Height in Rikuzen-Takada City: Around 10m

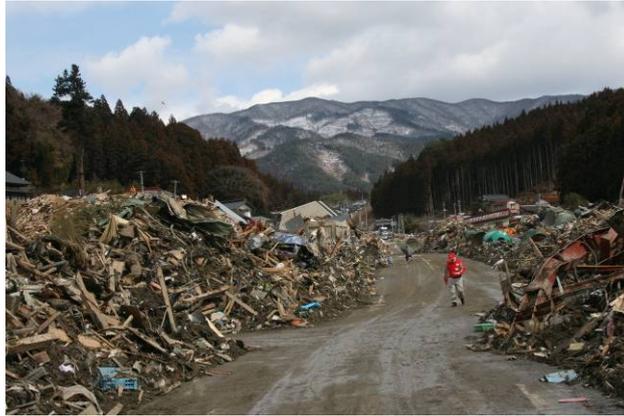
Photo 3 A Massive Amount of Debris on Roads and Urgently Opened Road

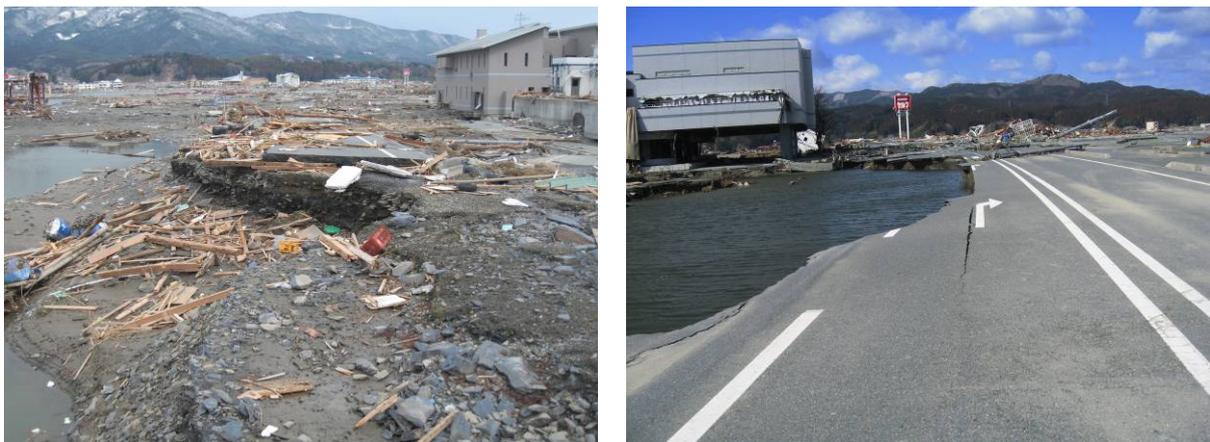
National highway route 45 was along the coast line and 4 sections were completely disrupted by the damage of bridges. In the Rikuzen-Takada city, there were 4 bridges and 2 culverts on national highway route 45 and 6 bridges on local highways. Photo 4 shows the aerial photo of Rikuzen-Takada city, in which red circles and red dotted lines show the locations of 12 bridges and the affected area by tsunami, respectively. Three bridges out of 12 were heavily damaged by the tsunami, which were on national highway route 45 as shown in Fig. 2. Superstructures of two bridges were completely washed out and the backfill soils of the abutments were heavily scoured. The details of damage and the repair of the bridges will be discussed later. Furthermore, the peeling-off of road pavement and the scouring of soil sections due to the tsunami were also observed at several locations as shown in Photo 5.

Photo 5 Peeling-off of Road Pavement and Scouring of Soil Sections

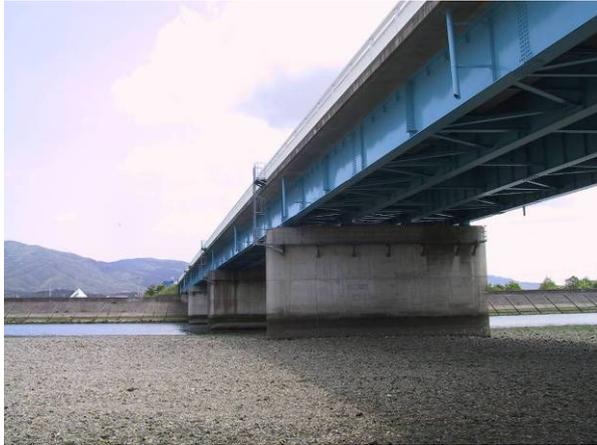
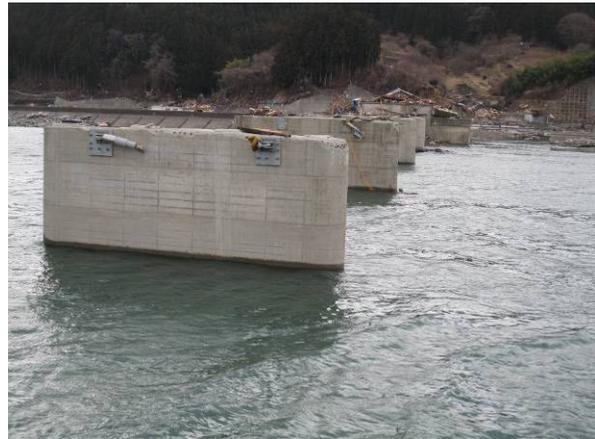
Photo 6 shows the Kesen bridge before the 2011 earthquake and the damaged by tsunami. Steel girders were washed out toward the upstream side as shown in Photo 7. The wash-out distance was estimated as 400m from the original location. The concrete slab and steel girders were completely separated and the steel girders were heavily deformed as U-shaped or V-shaped. The rubber bearings were broken at the rubber layers, and the damper rods or the set bolts of all the viscous dampers were fractured. Backfill soil at one of the abutments was also heavily scoured as shown in Photo 8.

Photo 6 Damage of Kesen Bridge (1)
(Left: Original Bridge before the 2011 Earthquake, Right: Wash-out of Superstructures)

The repair method for the Kesen bridge, in which the superstructures were completely washed out, was discussed in order to quickly recover the road function. The possible methods were: 1) to construct temporary girders on the existing piers, 2) to construct temporary bridge beside the damaged bridge. Finally, considering the stability of survived piers and the final permanent construction in near future, MLIT decided to select the method 2) and completed in June 10 as shown in Photo 13. The final rehabilitation method of the bridge will be determined based on the final recovery planning of the Rikuzen-Takada city.

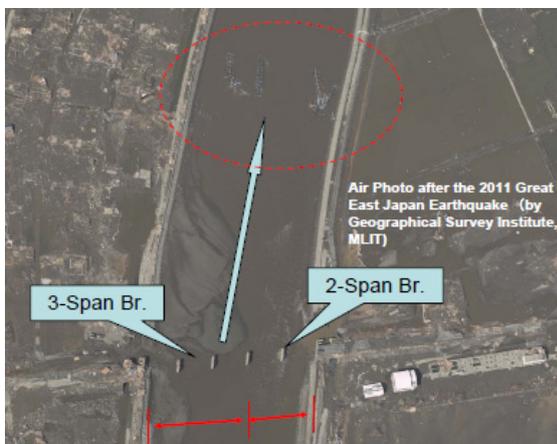
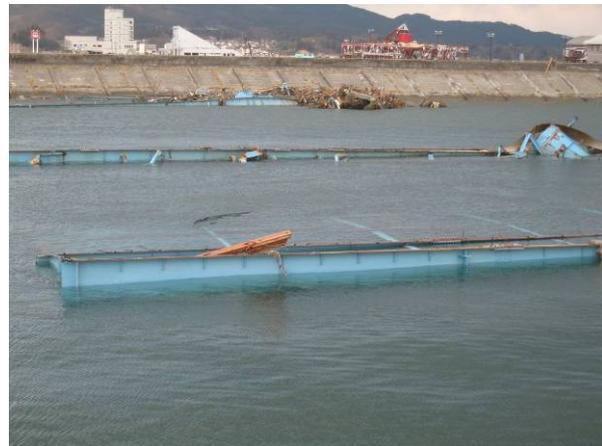
Photo 7 Damage of Kesen Bridge (2)
(Left: Distance of Washed-out Superstructure, Right: Deformed Steel Girders)

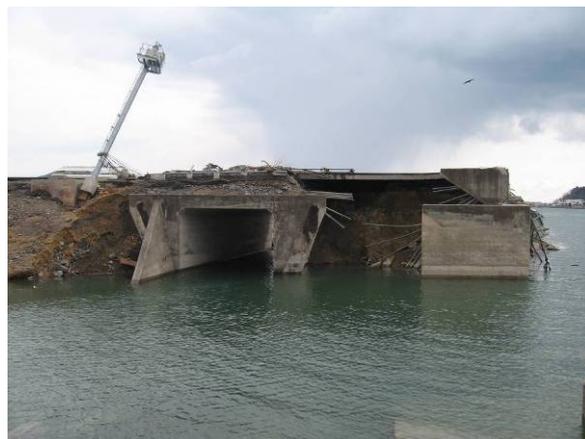
Photo 8 Scouring of Abutment Backfill of Kesen Bridge

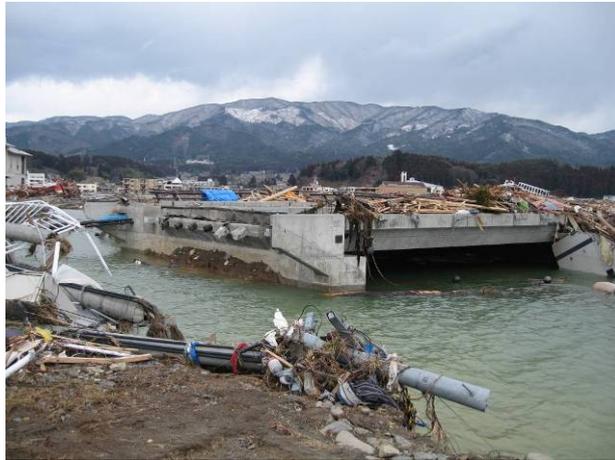
The backfill soil of one abutment was heavily washed out over about 20m long as shown in Photo 9. The bridge did not suffer any significant damage. Any remarkable displacement was not found at the concrete girders, and the unseating devices by PC cables which connected superstructure and abutment parapet walls were still effective. The possibility of scouring effect was estimated to occur around the abutment foundations but the vertical stability was estimated to be enough because the concrete piles were used.

Photo 9 Wash-out of Backfill Soil of Kawaharagawa Bridge

The repair method for the Kawaharagawa bridge, in which the abutment backfill was heavily washed out over 20 m, was discussed in order to quickly recover the road function. The possible methods were: 1) to construct temporary girders on the existing bridge to pass over the wash-out section, 2) to fill soils into the wash-out section. The investigation and discussion were made on the stability of the existing abutment to support the temporary girders. Finally, considering the process from the temporary to permanent repairs of the scoured abutment, MLIT decided to select the method 1) and completed on March 25 as shown in Photo 14. Then the backfill soil was filled at the wash-out sections finally.

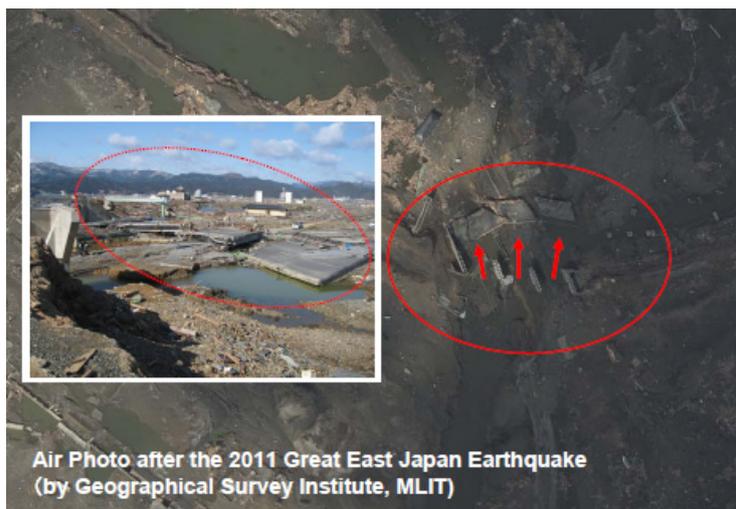
Three spans were washed out to the mountain side just beside the bridge as shown in Photo 10. Back fill soil of both abutments were heavily scoured and lost as shown in Photo 11.

Photo 10 Damage of Numata Bridge (1): Wash-out of 3 Spans

The repair method for the Numata bridge, in which 3 span were washed out and the backfill soils at abutments were heavily scoured, was discussed in order to quickly recover the road function. The Ofunato railway under the bridge was destructively damaged all along the line and the railway operation stopped because of the emergency treatment. Therefore, the temporary road was constructed just beside the bridge, instead of repairing the Numata bridge itself by using temporary bridges, and opened on March 25. The final rehabilitation method of the bridge will be determined based on the final recovery planning of the Rikuzen-Takada city and the Ofunato railway.

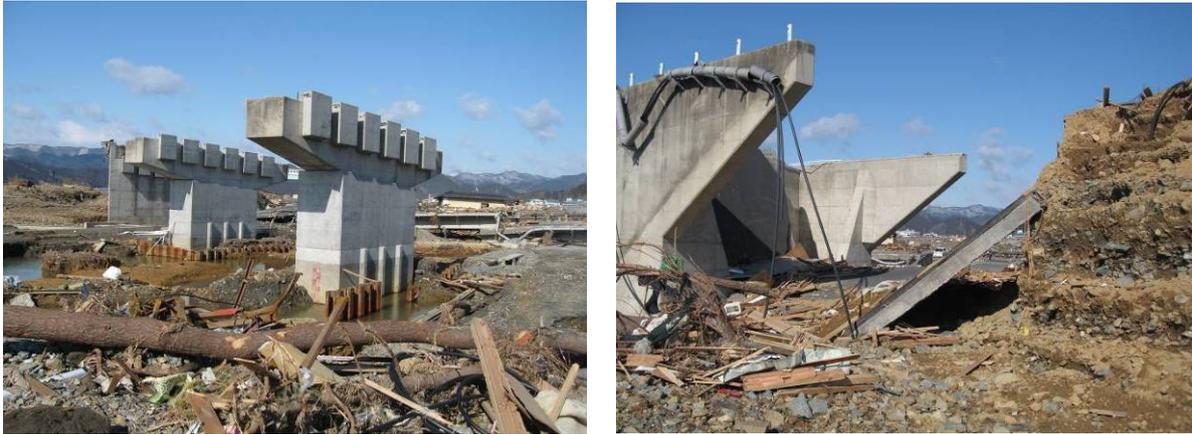
Photo 11 Damage of Numata Bridge
(Left: Survived Piers, Right: Heavy Scouring of Backfill Soil at Abutment)

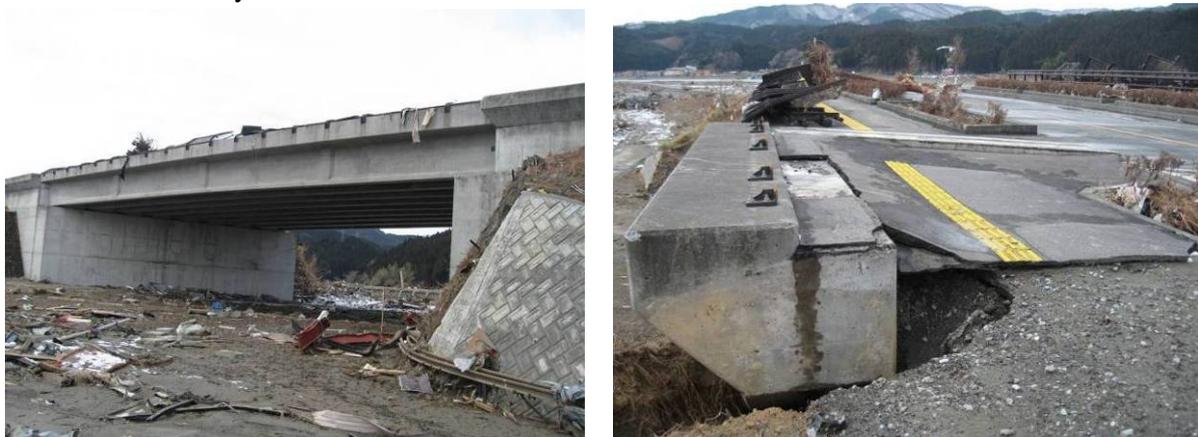
Nanakiri bridge is a simply-supported PC T-girder bridge with length of 36.5m as shown in Photo 12. The bridge was constructed in 1998. The slight scouring was found around both sides of abutment and the bridge railings were completely deformed toward the mountain side, but the bridge itself was evaluated as almost no damage and usable for the emergency route. Then the recovery works of the national highway route 45 was made using national highway route 340 as well as from the east side.

Photo 12 Investigation of Nanakiri Bridge
(Left: Side View, Right: Slight Scouring of Backfill Soil at Abutment)
