DAMAGE TO REINFORCED CONCRETE BOXED WALL-BUILDINGS IN THE 2011 GREAT EAST JAPAN EARTHQUAKE

ABSTRACT: Post-earthquake damage evaluation for 634 public apartment buildings having boxed wall type structure (WRC, WPCa PS and ribbed panel) was conducted within the city of Sendai by AIJ Committee on boxed wall structures. Of the 496 buildings having a reinforced concrete boxed wall (WRC) structure, 97.4% were found to be undamaged or to have only slight damage. Among the remaining 2.6%, only one building had moderate damage and no buildings had severe damage. The others had minor damage. All of the 47 buildings having a precast prestressed reinforced concrete boxed wall (WPCa PS) structure in Sendai were found to have suffered no or slight damage. Of the 91 buildings having a boxed wall of thin ribbed concrete panel (ribbed panel) structure, 72.5% were found to have suffered no or slight damage. Among the remaining 27.5%, 11 buildings were moderately damaged and 1 building was severely damaged. The ribbed panel buildings suffered relatively higher damage. This is because 71 out of the 91 ribbed panel buildings were constructed before the new earthquake-resistance standards 1981.

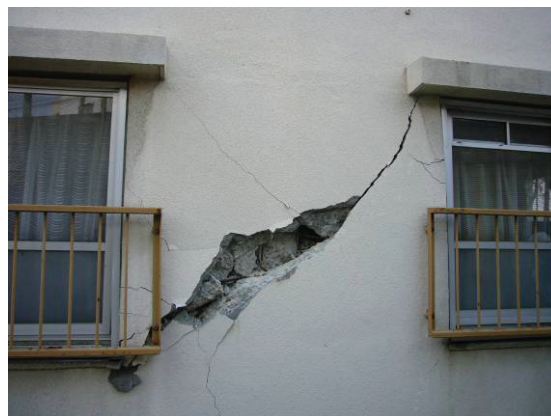
In one of the star houses that was determined to have suffered minor damage, shear failure was observed in a bearing wall on the first floor. Photograph 2 shows the shear failure of the bearing wall on the first floor on the east side of the structure. On the south side of the building, ground settled along the slope. The ground deformation may have been one of the causes of the damage on the east side.

Photo 2 Shear failure of the bearing wall of the first floor at east side

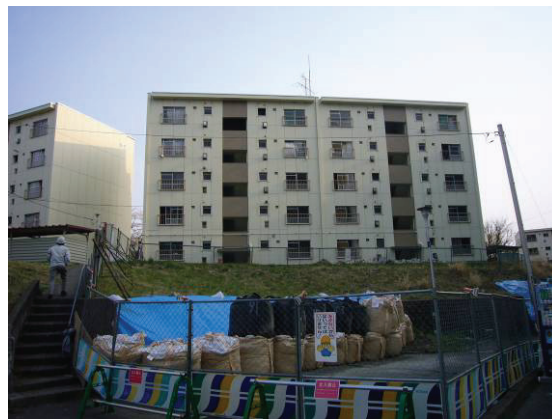
In the apartment complex, ground deformation caused part of the retaining wall to collapse and a five-story apartment building on the side of the retaining wall was inclined. Photograph 3 gives an overview of the inclined apartment building and the partially collapsed retaining wall. Photograph 4 shows the damage to the surrounding ground. The angle of inclination of the apartment building was 22/1000 on the short side and 9/1000 on the long side. The damage to the foundation was determined to be minor. Angle of inclination was measured at four corners of the building using one-meter-long inclinometers. Seismic intensity 6 upper was registered in the apartment complex.

As for the damage to the superstructure of the inclined apartment building, no cracks were observed on the exterior walls on the side of the balcony. Other exterior walls were covered with insulating panels and therefore no damage information was available.

Photo 3 Overview of the apartment inclined and the retaining wall collapsed partially

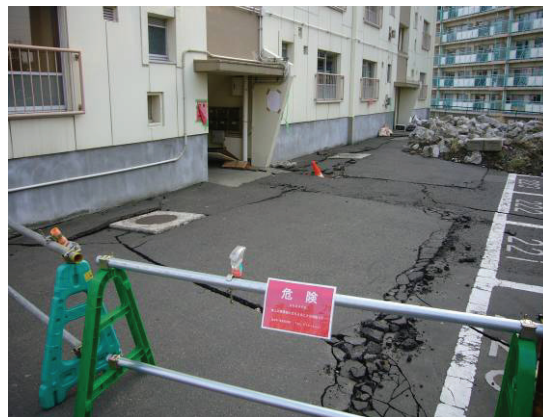
Photo 4 Damage of the ground around the apartment

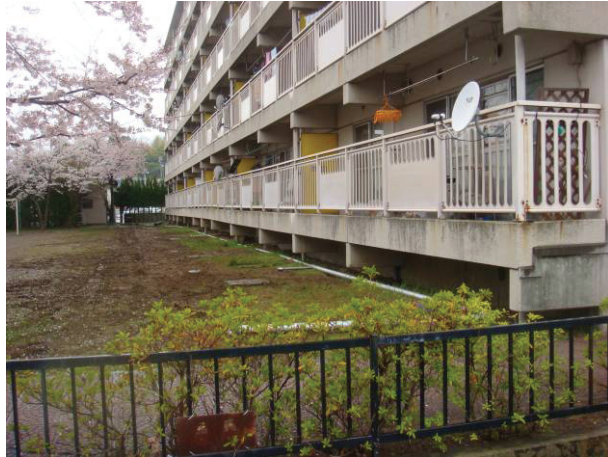
Relative settlement of 43 mm was observed between axes X8 and X9 (5100 mm span) on the first floor on the south side (balcony side). The inclined angle is 1/118 rad. Photograph 6 shows the settlement of the east side of the center.

Photo 6 View of ground subsidence around d-apartment

The damage degree of the superstructure was determined to be minor as a result of examination of the degree of damage to the first-floor bearing wall on the balcony side and second-floor floor beam where damage was visually confirmed. Subsequent detailed surveys found that there was a high possibility of piles failing and that settlement of more than 100 mm occurred. Then, the damage degree of the foundation was determined to be severe .

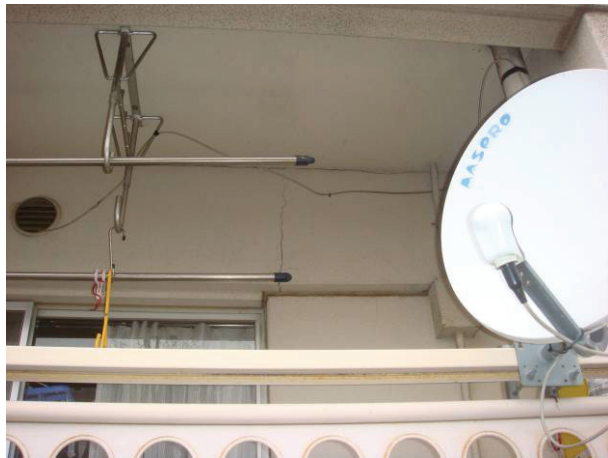
Vertical and shear cracks were found in the foundation beam and vertical cracks at the end of longitudinal beams on the second to fifth floors between axes X8 and X9. The cracks are attributable to the settlement of the ground. The cracking at the end of axis X9 in a beam on the second floor are shown in Photograph 7.

Photo 7 View of the crack at the beam of 2nd floor of d- apartment

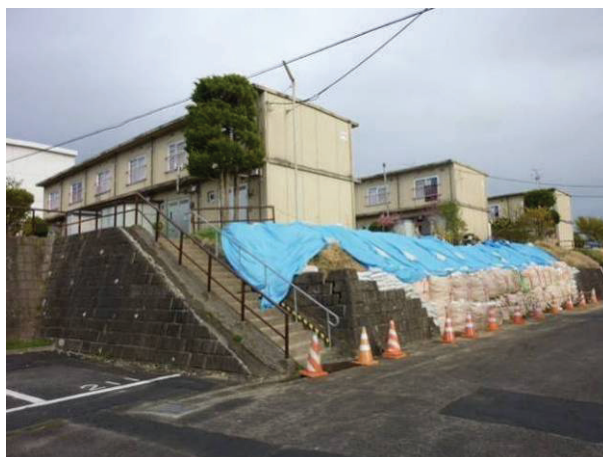
A building that was determined to have been severely damaged was built on a spread foundation on a fill above the retaining wall. The retaining wall collapsed (Photograph 8) and the building was deformed downward from the center.

Photo 8 Mass production type public apartments and damage of the retaining wall

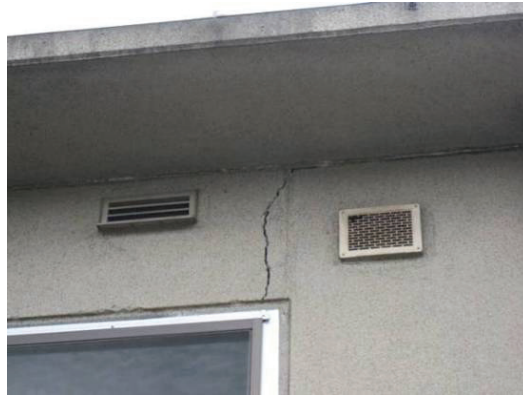
- (i) Vertical crack at the vertical joint between the bearing and hanging walls (Photograph 9)
- (ii) Vertical crack at the vertical joint between the bearing and spandrel walls
- (iii) Flexural crack at the foot of the bearing wall where the wall thickness changes (boundary between a 120-mm-thick rib around the bearing wall and a 40-mm-thick area other than the rib)
- (iv) Shear crack in the bearing wall (Photograph 10)
- (v) Horizontal crack in the bearing wall at the height of the hanging wall
- (vi) Vertical crack at the vertical joint between bearing walls or at the vertical joint between the transverse bearing wall and column form
- (vii) Vertical crack in the foundation and failure of foundation beam due to ground settlement or fissure

Damage (i) and (ii) were confirmed most frequently. The results are the same as the damage to mass-produced public apartment buildings in the past earthquakes. In the buildings constructed after the enforcement of the new code, improvements have been made in detail and damage is incurred less frequently.

Photo 9 Crack at vertical joint between bearing wall and hanging wall

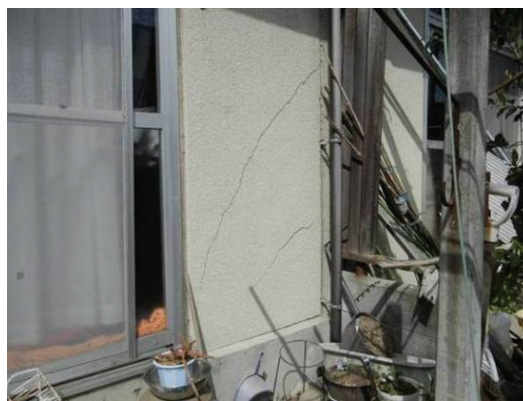
Photo 10 Shear crack of the bearing wall

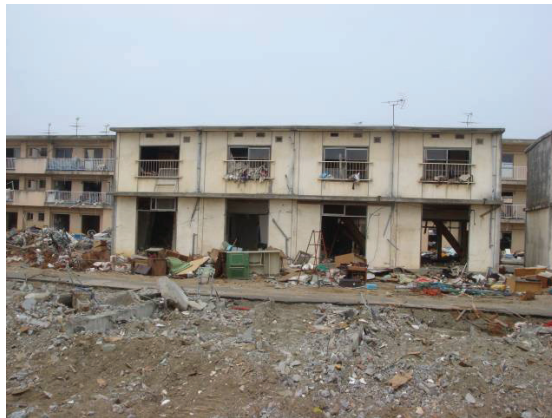
Visual inspections were made for public apartment buildings that suffered tsunami damage in the coastal areas in Miyagi Prefecture. Photograph 11 shows the tsunami damage to a two-story mass-produced public apartment building in the Yuriage area in Natori City. The first floor was greatly damaged by the tsunami. Ribbed panels themselves were damaged in some cases. Photograph 12 shows the damage to a three-story WPCa PS building in the Yuriage area. No severe damage was found on the exterior wall. Photographs 13 shows the damage to three-storied WRC buildings in Minami-sanriku-cho. Debris from the tsunami remains on the roof, suggesting that the tsunami reached the top of the building. No severe damage was observed in the bearing wall or wall beam although partial damage was observed on the balcony.

Photo 11 Mass production type public apartment building damaged by tsunami in Natori

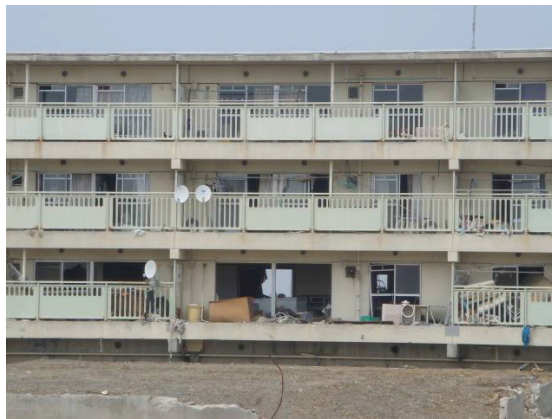
Photo 12 WPCa PS apartment building damaged by tsunami in Natori

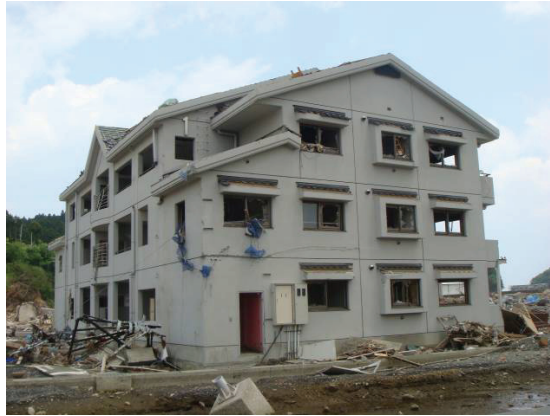
Photo 13 WRC apartment building damaged by tsunami in Minami Sanriku
