DAMAGE CAUSED TO SHINKANSEN STRUCTURES BY THE GREAT EAST JAPAN EARTHQUAKE AND EARLY RESTORATION

Masashi KOBAYASHI¹, Koichiro MIZUNO², and Tadayoshi ISHIBASHI³

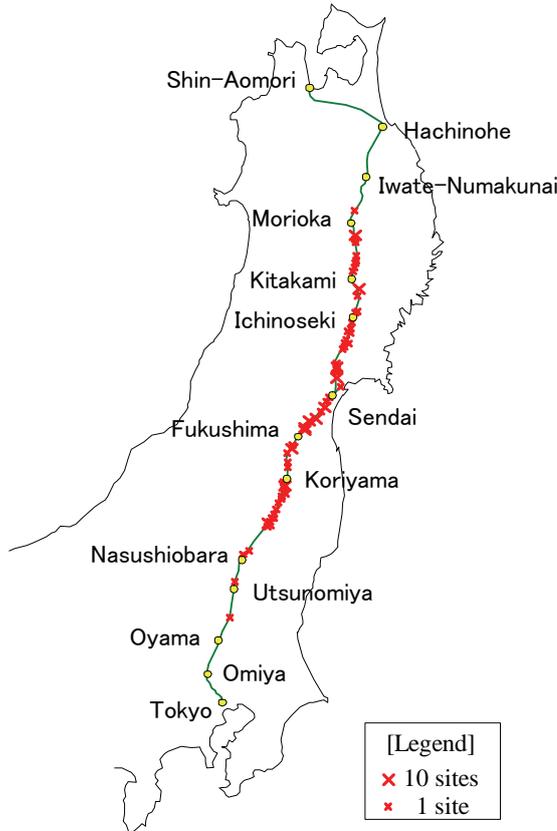
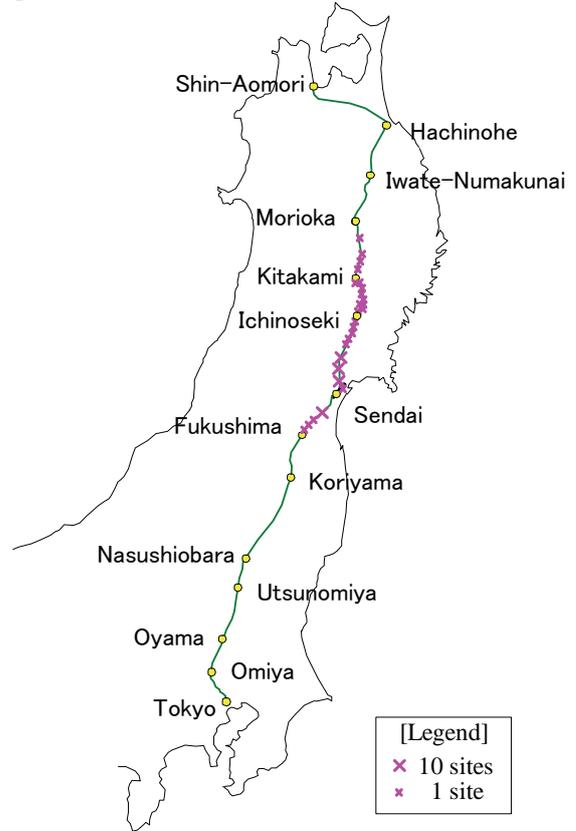
Fig. 2 Numbers and distribution of the damaged structures in the Tohoku Shinkansen Line

To investigate the severity of the damage, immediate observations were made along the Tohoku Shinkansen. Fig. 2 shows the numbers and distribution of the damaged structures along the Tohoku Shinkansen Line. This figure excludes the damage to electrical structures such as electric poles and overhead wires. Shown in Fig. 2, the Shinkansen sustained damage at approximately 1,200 sites along about 500 km between Omiya and Iwate-Numakunai stations. Although there was some damage to viaduct columns, fatal damage such as the fall of bridge girders, which had occurred in the 1995 Hyogoken-Nambu Earthquake, was not observed. Main examples of the damage to JR East's railway structures were damage to viaduct columns at about 100 sites, displacement of bridge girders at 2 sites, and damage to bridge shoes at about 20 sites.

As mentioned above, the characteristic of the earthquake is a large number of strong aftershocks. The aftershock on April 7 caused damage to the Tohoku Shinkansen structures at about 550 sites. The extent of the damaged structures caused by this aftershock was narrower than the extent of the main shock. However, more severe damage was observed at several locations such as between Sendai to Ichinoseki stations. Crippling damage was not confirmed. The aftershock on April 7 also caused the suspension of the Shinkansen operations. Main examples of damage caused by the aftershock on April 7 were damage to viaduct columns at about 20 sites, displacement of bridge girders at 7 sites, and damage to bridge shoes at about 10 sites.

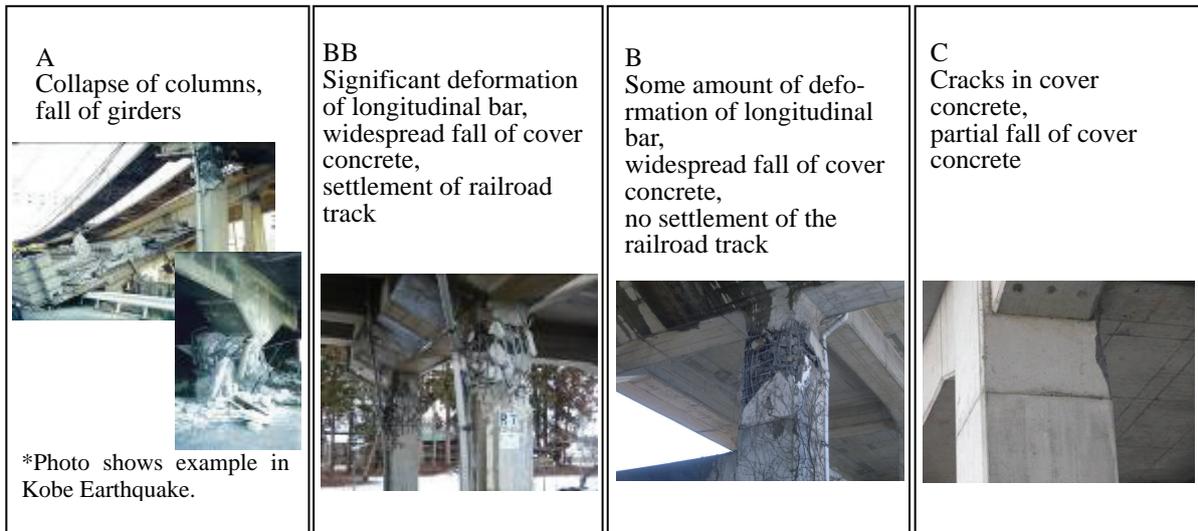
Fig. 3 Gradation of seismic damage caused to RC column members

Fig. 3 shows the gradation of seismic damage caused to RC column members, the photos in Fig. 3 showing typical seismic damage of each level (Ishibashi et al. 1997). We consider that these levels could be classified by the degree of damage of RC members and restorability such as duration of work etc. In Fig. 3, damage level “A” indicates situations where the collapse of a structure such as RC columns or fall of the bridge girders is observed. Damage level “BB” shows situations where significant deformation of longitudinal reinforcing bar, widespread fall of cover concrete of RC columns, cracks penetrating into core concrete, and settlement of railroad track are observed. Damage level “B” indicates situations where some amount of deformation of longitudinal reinforcing bar, widespread fall of cover concrete of RC columns, and cracks penetrating into core concrete are observed, but settlement of railroad track is not observed. Damage level “C” shows situations where cracks in cover concrete and partial fall of cover concrete are observed, while settlement of railroad track is not observed. We consider that levels A, BB, and B are the types of damage sufficient to suspend Shinkansen operations. Furthermore, we consider that damage level C should not suspend the operations, but requires restoration in terms of durability.

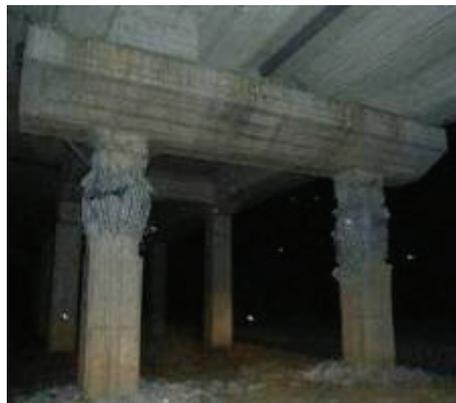
Photo 1 Example of seismic damage of RC viaduct columns (damage level BB)

The example of the severest seismic damage of RC columns by the main shock is shown in Photo 1. We evaluated this seismic damage as BB. The seismic damage was located in the vicinity of the upper edge of columns. Settlement of railroad track of about 50 mm was also observed at this site. The damaged structure shown in Photo 1 is an RC rigid frame viaduct with 1 story and 3 spans, and supports the simple RC girders. The damaged columns are located at end of the block and their length is about 0.4 m shorter than the length of the columns located at the intermediate part of the block. It is found that the seismic damaged columns with track settlement are about 10 in total when we add the numbers of damaged columns caused by the main earthquake on March 11 and aftershock on April 7. Among these, damaged columns with falling of core concrete were observed. We assume that the column with prominent protrusion of core concrete damaged by the main quake was affected by its long duration.

Photo 6 shows the restored columns which sustained level BB damage. The repair procedure of the damaged columns in level BB as follows: First, steel temporary support was placed beneath the cross beam, and then the longitudinal reinforcing bars were cut off tentatively. Next, the concrete slab supporting the railroad track was lifted by jacks. After being jacked up, the longitudinal reinforcing bars were rearranged at the appropriate position, and were connected up to the cut reinforcing bars with welded joint. After the treatments of the longitudinal bars, the transverse reinforcing bars were set at proper position. Then, the chemical materials were grouted between the cracks. And finally, the mortars were grouted to recover the member. With this course of work, we consider that the permanent repair work to restore the seismic performance of the damaged columns in level BB up to the original level or higher was conducted. Further, the work duration at the site shown in Photo 6 was about 7 days.

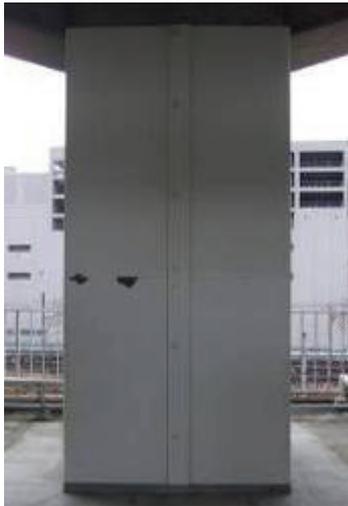
Photo 2 Impact by earthquakes on columns with seismic rehabilitation by Steel plate jacketing method using indented joints

columns for seismic rehabilitations of RC columns. Meanwhile, columns in limiting situations need to be reinforced by original techniques developed by JR East. Examples of impact on aseismically reinforced RC viaducts by the earthquakes of March 11 and April 7 are shown in Photos 2 to 4. In Photo 2, we observed that the column with the seismic rehabilitation only had the remarkably minor damage where the paint on the steel plate came off at butt joint. Furthermore, as shown in Photos 3 and 4, very minor damage was observed in columns that were aseismically reinforced by techniques developed by JR East. Thus, it is confirmed that the aseismically reinforced columns of RC railway viaducts suffered significantly less damage. Additionally, we consider that JR East's seismic rehabilitations of RC railway columns could be effective in preventing seismic damage.

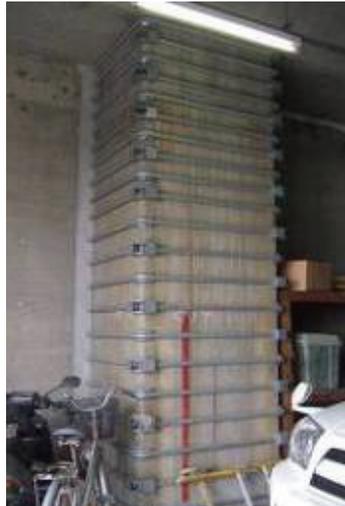
Photo 3 Impact by earthquakes on columns with seismic rehabilitation by Rib-Bar method

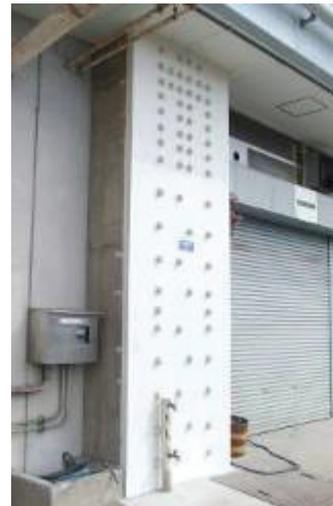
Photo 4 Impact by earthquakes on columns with seismic rehabilitation by Single-face method

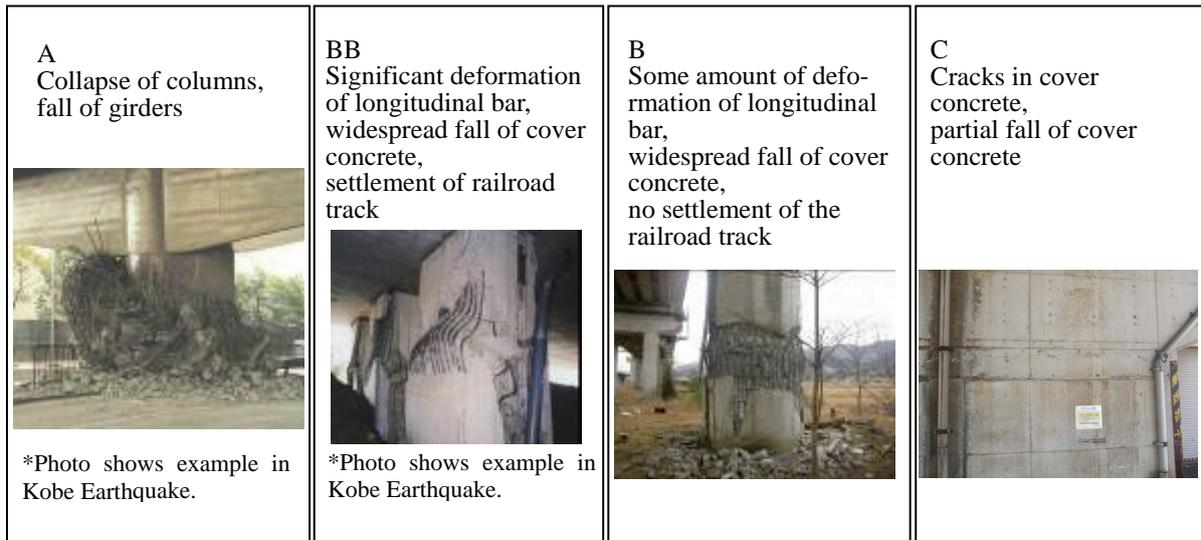
Fig. 4 Gradation of seismic damage caused to RC bridge pier members

Fig. 4 shows gradation of seismic damage caused to RC bridge pier members, and the photos in Fig. 4 show typical seismic damage of each level. Each damage level was determined by the same situations as RC viaduct in Fig. 3.

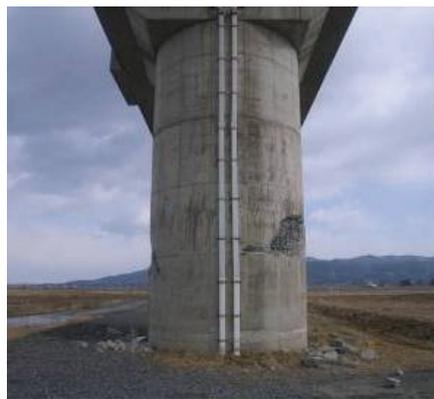
An example of seismic damage in RC piers by the main shock is shown in Photo 5. We evaluated this seismic damage as B. The damaged structure shown in Photo 5 is on RC bridge pier 4.5 m in

Photo 5 Example of seismic damage of RC bridge piers (damage level B)

diameter and 18.0 m in height, and supports pre-stressed concrete (PC) box-shaped girders. The box girders are 50 m and 35 m in length. We observed partial falls of cover concrete and cracks at cut-off at the seismically damaged pier.

pier was as follows. The chemical grouting between the cracks was conducted first. And then, the transverse reinforcing bars were rearranged at the appropriate position. Finally, the cover was refilled with mortar. Further, the work duration at the site shown in Photo 7 was only about 8 days.

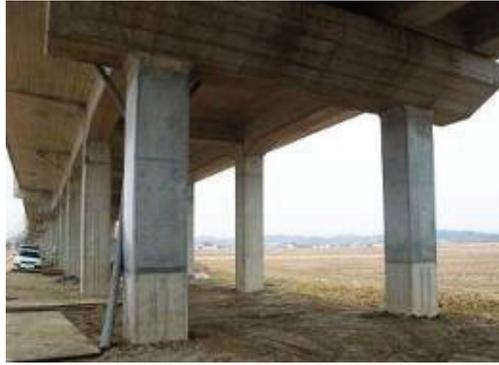
Photo 6 Restored RC columns

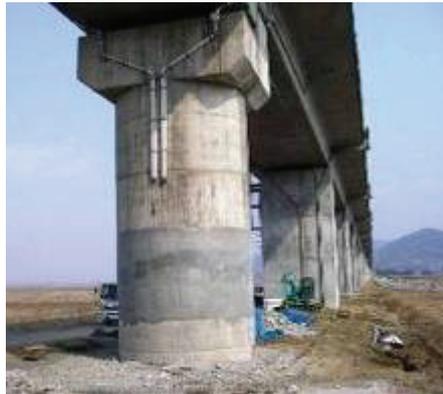
Photo 7 Restored RC pier

The repair work of RC piers was also carried out taking priority of the damage level of the members. Photo 7 shows the restored pier which sustained level B damage. The repair procedure of this damaged
