22 FEBRUARY 2011 CHRISTCHURCH EARTHQUAKE AND IMPLICATIONS FOR THE DESIGN OF CONCRETE STRUCTURES

Kenneth J. ELWOOD¹, Stefano PAMPANIN², Weng Yuen KAM³

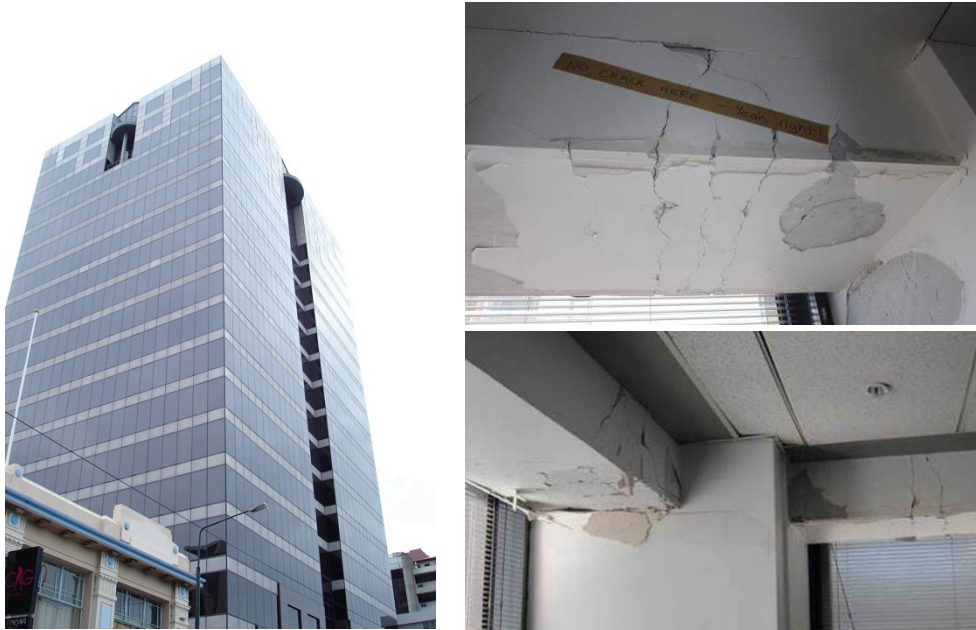
While potentially satisfying the objectives of the code, the level of damage observed in many concrete buildings was severe, leading to a large percentage of buildings currently considered uneconomical to repair. Potentially more than 50% of buildings in the CBD will be demolished as a result of damage from the February earthquake (EERI 2011). Fig. 3 shows beam hinging observed in a 22-storey moment frame building. The damage was consistent with the prevalent capacity-design

philosophy, protecting the columns from damage and concentrating nonlinear response in the beam hinges. However, wide residual cracks in the beams have raised concerns regarding low-cycle fatigue of the reinforcement and repairability of the building. Moving forward, the financial risk and damage acceptance of ductile RC systems may require further considerations. It is not clear if the performance of this and other buildings in Christchurch is acceptable to society or if society is willing to pay more for better performance in future earthquakes. However, to enable the selection of different performance levels in the future, the engineering community should use the impacts of the Christchurch earthquake to promote the further development and implementation of performance-based seismic design approaches (e.g. ATC-58 2011).

Fig. 3 Beam cracking in 22-story RC moment frame (precast emulating cast-in-place)

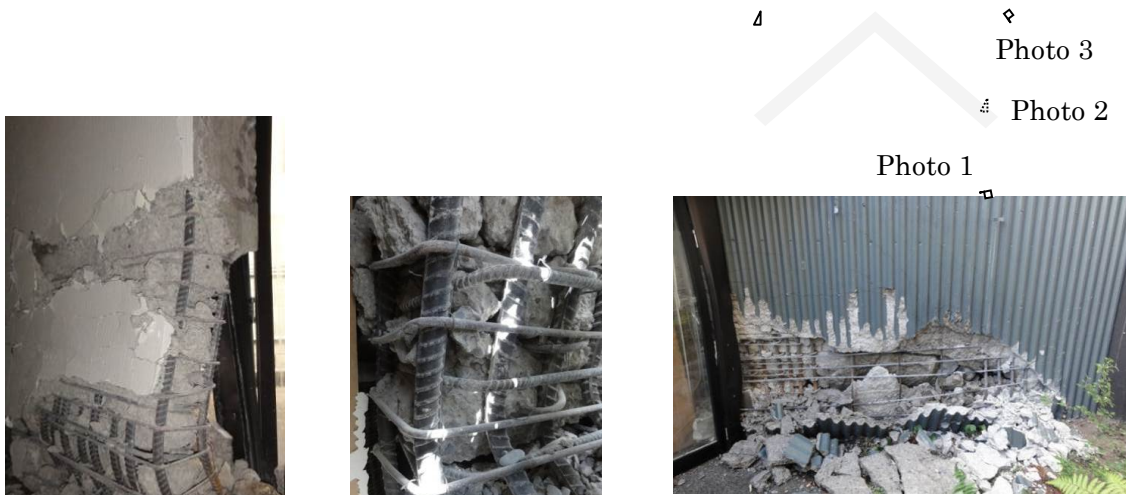
Figure 4 shows the overall buckling of one outstanding leg of a V-shaped (or L-shaped) shear wall in a 7-story building. The width of the buckled web was 300 mm, with an unsupported wall height of 2.66m, resulting in a height-to-thickness (slenderness) ratio of 8.9. The boundary zone extended approximately 1.2 m into the 4m long web. The boundary steel at the damaged end of the wall consisted of 16-24mm deformed bars confined by 10 mm smooth bars at 120 mm, with a 180 degree hook on every other longitudinal bar.

Fig. 4 Seven-storey 1980s office block with compression failure of the V-shaped RC shear wall.

The wall buckled over a height of approximately 1 m and crushing extended over 3 meters into the web. Horizontal cracks (approximately 1-1.5 mm width) were visible at the buckled end of the web, while inclined cracks in both directions at approximately 45 degrees were apparent in the middle of the web over the first story height. Well distributed, primarily horizontal, cracking with widths less than 1.5 mm, were observed in the lower half of the first story of the generally undamaged flange. The damage pattern shown in **Error! Reference source not found.** suggests that the web may have initially experienced flexural tension yielding of the boundary steel, followed by buckling of the unsupported web over the relatively short plastic hinge length. The L-shaped cross-section would have resulted in a deep compression zone with high compression strains at the damaged end of the web wall. Stability of the compression zone may have been compromised by a reduction in the web out-of-plane bending stiffness due to open flexural tension cracks from previous cycles.

Buckling in a wall with a height to thickness ratio of less than 10, a limit used in several international codes avoid out-of-plane instability, suggests that a limit on h/t may not be enough to prevent wall buckling. Building on the work by Paulay and Priestley (1993), further research is needed to determine a relationship between wall buckling, length of plastic hinge and axial stiffness of the compression zone after bar yielding.

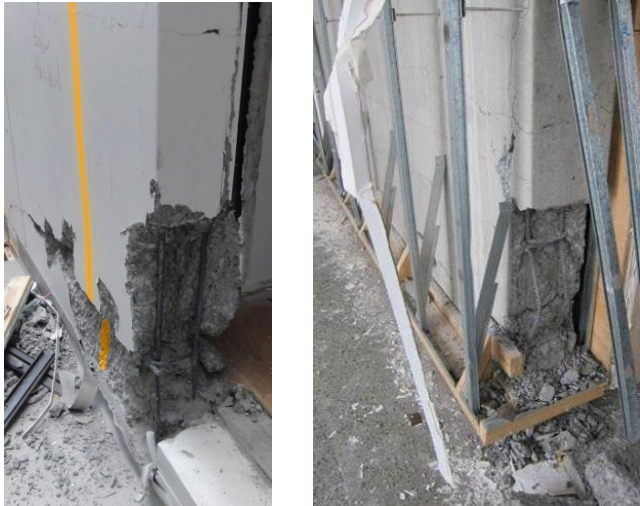
Fracture of very light longitudinal reinforcement was also noted in modern high-rise buildings. In some cases (e.g. Figure 5), wide spacing of transverse reinforcement may have led to bar buckling prior to bar fracture. The architectural design of the building in Figure 5 included numerous walls, making it possible to achieve the higher base shear required for a low ductility (nominal or limited ductile) structural system and thus avoiding the need for full ductile detailing. In some lightly reinforced shear walls only exhibiting symptoms of flexural cracking, bar fracture of longitudinal bars was detected only after removal of cover concrete. This has significant implications for both design of lightly reinforced walls but also inspection of similar walls after future earthquakes. Engineers performing post-earthquake assessments need to be cautious when assessing the extent of damage to lightly reinforced shear walls.

Fig. 5 Buckled and fractured bars in lightly reinforced slender RC shear walls.

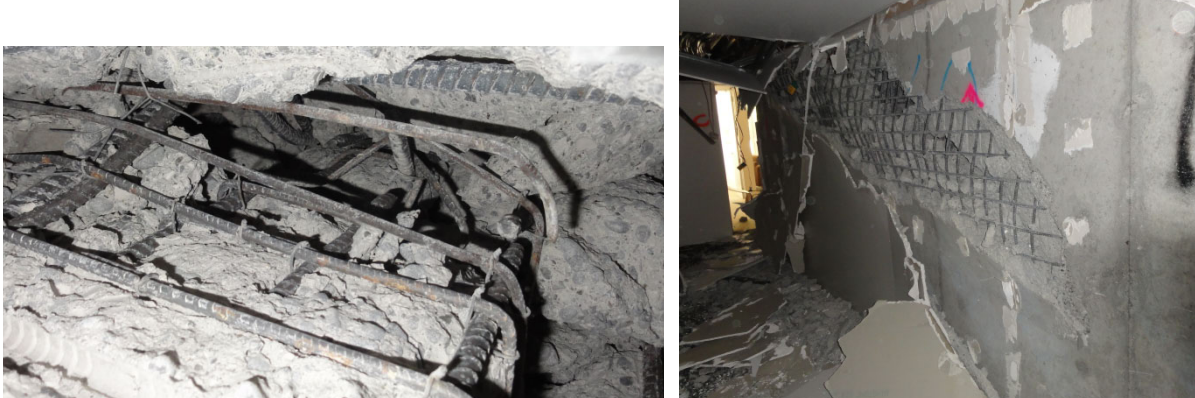
Fracture of boundary reinforcement was also observed in the 200 mm thick wall shown in Figure 6. This 7-meter long wall (coupled with a 2-meter wall) was the primary E-W lateral force resisting system for an 8-story plus basement condominium. For the bottom four stories the wall was reinforced with 12 mm deformed bars at 100 mm in both directions, each face. The boundaries, extending 980 mm from each end, were confined with 6mm smooth hoops at 60 mm, supporting at least every other longitudinal bar.

As shown in Photo 1 of Figure 6, fracture of at least four of the 12mm end bars occurred at the top

of the ground floor. Core concrete generally remained intact in the confined boundary (except where fracture of bars occurred); however, crushing of the core extended into the unconfined web for approximately 3 m from the end of the confined region. The crushing in the web exposed spliced transverse bars, which could not contain the core concrete once the cover was spalled. The damage in the web extended diagonally downward from the fractured boundary, suggesting that high shear stresses may have also contributed to the observed damage.

Fig. 6 Boundary bar fracture and web crushing in modern 8-story apartment building.

In terms of future code development, the concrete crushing within the web of the wall in Figure 6 suggests that cross ties may be required outside the confined end zones and splices should be avoided in transverse bars. Additionally, bar fracture of the lightly reinforced walls shown in Figures 5 and 6 suggests that the minimum reinforcement provisions for boundary zones of shear walls should be reviewed.

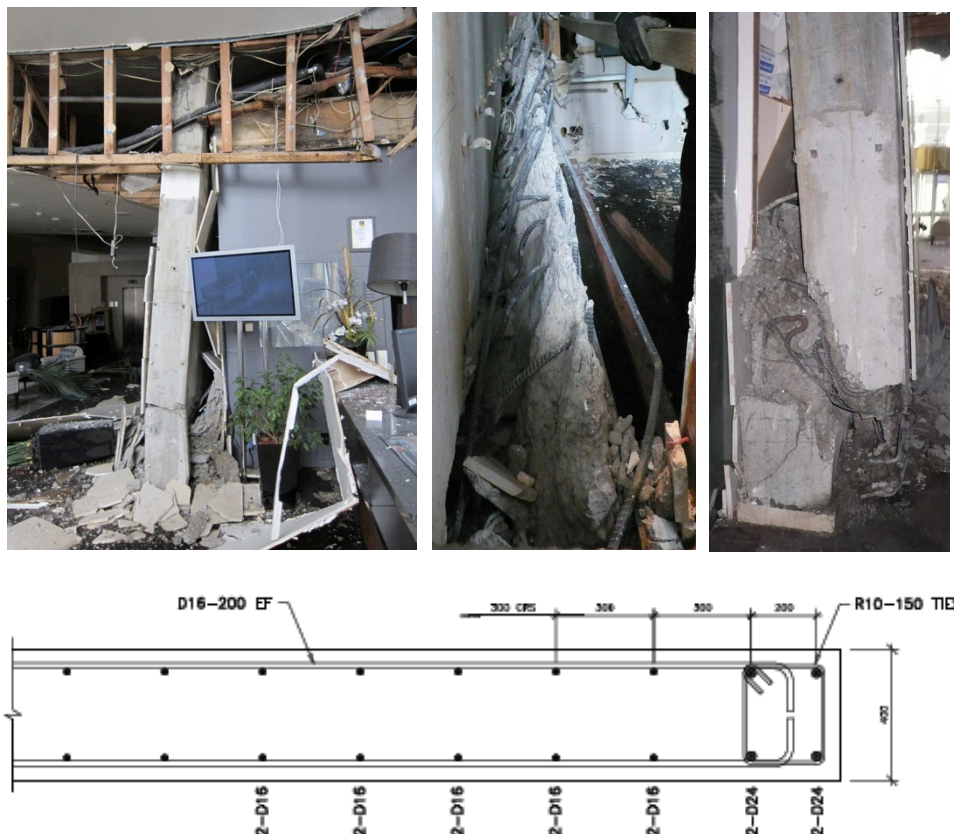
Figure 7 shows severe damage to a shear wall in the 22-story Hotel Grand Chancellor, designed and constructed in mid 1980s. Shortening of the ground-floor wall by approximately 800 mm led to a visible lean of the building and restricted access to the potential fall zone around the building. Significant structural layout irregularities influenced the seismic response of the building; most notably the east side of the building was cantilevered over an access lane. Furthermore, the seismic force resisting system for the lower 14 storeys consisted of shear walls, while perimeter moment frames were used for the upper stories. (Description below focuses on the performance of the damaged

Damage shown in Figure 7 indicates that the wall displaced downward along a diagonal failure plane through the thickness of the wall. The failure plane, extending the full length of the wall, appeared to initiate at the top of the lap splice in the web vertical reinforcement. The limited hoops in the boundary appeared to have opened allowing the boundary longitudinal bars to deform with the shortening of the wall. Crushing of concrete was also noted at the top of the lobby wall, likely to accommodate the out-of-plane movement of the wall as it slid down the diagonal failure plane.

The wall shown in Figure 7 was likely supporting very high axial loads from several sources. First, the wall supported a disproportionately high tributary area since it acted as a prop for the cantilevered bay on the east side of the building. Secondly, the corner column of the upper tower perimeter moment frame would have imparted high axial loads to the wall due to overturning moments, particularly with any bi-directional movement to the south-east. Thirdly, vertical excitation of the cantilever structure could have exacerbated the axial load on the wall. Finally, the structural wall would have also attracted in-plane loads due to N-S earthquake excitation, leading to flexural compression stresses on one end of the wall. Considering the potential for simultaneous compression from all sources of axial loads described above, it is expected that the combined axial load and bending in the wall likely exceeded the concrete compression strain capacity given the limited tie reinforcement provided at the base of the wall.

Some out-of-plane drift of the wall during the earthquake excitation and the plane of weakness created at the end of the splice of the web vertical reinforcement at the base of the wall, likely further contributed to the location of failure observed in Figure 7. Future research is needed on the influence of the out-of-plane movement of shear walls when combined with high axial loads.

Fig. 7 Crushing and out-of-plane movement of shear wall in 22-story Hotel Grand Chancellor (Middle and right photos from Dunning and Thornton (2011))

Observed wall crushing failures, including that shown in Figure 7, suggest that it is best to avoid compression-controlled walls. It should be recognized, however, that the true axial loads on walls are not well known, in part due to growth of a wall during shaking and the outrigger effect from gravity columns. Codified limits on wall axial loads are being considered by the New Zealand Department of Building and Housing in response to the damage observed in Christchurch (DBH, 2011).

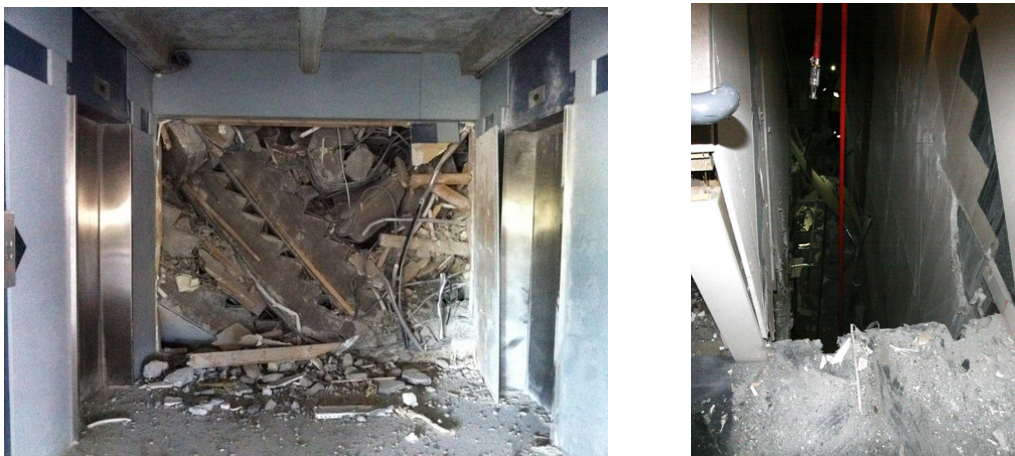
Fig. 8 Collapse of precast stairs

Precast stair units collapsed in at least four multi-story buildings, and were severely damaged in several other cases, as a result of the 22 February 2011 Christchurch Earthquake. Figure 8 shows collapsed stair units from the 18-storey Forsyth Barr Building (described in detail by Beca (2011)) and the Hotel Grand Chancellor. Stair damage was particularly prevalent in buildings relying on moment-frames for lateral load resistance, although stair damage was also noted in some shear wall buildings. Collapse of stairs not only pose an immediate life safety hazard during the earthquake, but can result in death or injury after the earthquake as occupant attempt to evacuate the building in dark conditions without prior knowledge of the stair collapses. Loss of egress routes as a result of the stair collapses necessitated the evacuation of occupants from windows of high-rise buildings following the Christchurch earthquake.

Stairs are typically designed not to resist building deformations during earthquakes. Movement of the building relative to the stairs is generally accommodated by seismic gaps and seating provided at one end of the stair unit. The seismic gap and seating support must be sized for the expected drift demands during an earthquake. The drift demands from the 22 February earthquake exceeded the 500-year design drift demands required by the New Zealand loading standard (NZS 1170.5, 2004) for most building periods. Review of stair collapses in the Forsyth Barr building (Beca, 2011) indicates that the seismic gap provided was not large enough to avoid closure of the seismic gap and development of compression forces in the precast stair units. Debris or construction imperfections may

have further decreased the seismic gap, increasing the likelihood of compression in the stair units. Expected compression loads could have resulted in yielding at the landing and shortening of the stair units (Beca 2011). Upon reversal of drift demands on the building, the shortened stairs were particularly vulnerable to unseating and collapse. Limited seating support would have also increased the likelihood of progressive collapse once collapse was initiated at one story.

Although damage to stairs was noted in some buildings with shear walls, damage observed in Christchurch suggests that buildings with moment frames may be particularly vulnerable to stair collapse. Hinging of beams in moment frames leads to shear distortions in a building frame bay resulting in lengthening of bay diagonal, and hence, more movement at the stair support. Furthermore, hinging in beams can result in beam elongation, if not sufficiently restrained by the diaphragm, leading to further displacement demands at the stair support. Stair collapses in the Clarendon Towers, where precast diaphragms detached from the exterior frames (see Figure 9), have been, in part, attributed to the additional deformation demands from beam elongation (Bull 2011).

The poor performance of stairs in the Christchurch earthquake raises several important considerations for the design and evaluation of buildings internationally. Considering the need to provide egress for occupants of damaged buildings after a major earthquake, it is important that the drift demand used to size the gap and seating be reflective of that expected in the maximum considered earthquake. In light of the uncertainty in the ground motions, differences in the linear and nonlinear displacement profile of the building, and the lack of redundancy when seating support is lost, a detail insensitive to construction tolerances or obstructions and allowing for larger than design displacements should be adopted. Ideally to avoid unintended compression in the stair unit, seismic gaps should be avoided by allowing the stair unit to slide on the top of the slab surface (Beca 2011).

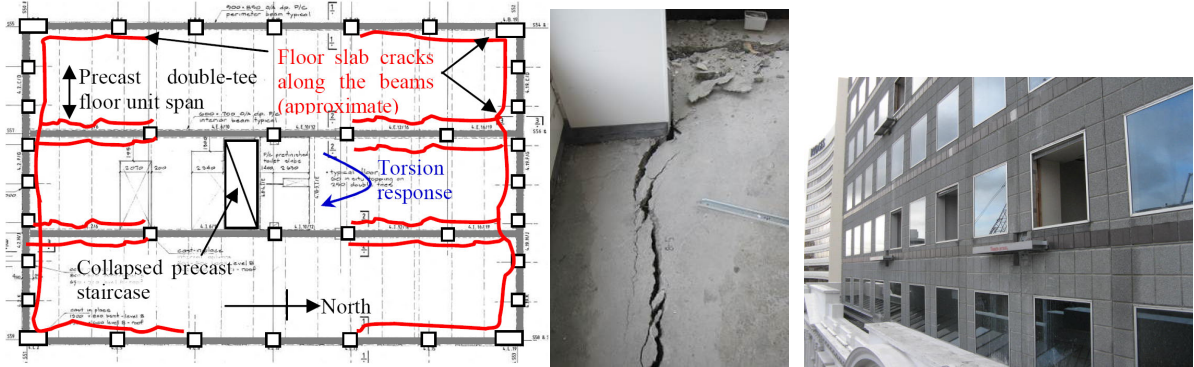
Fig. 9 Separation of precast floor slabs from supporting perimeter moment frame in 18-storey office building. Photo to right (courtesy of D. Bull) shows temporary supports for columns after earthquake.

Figure 9 illustrates an extreme example in which extensive floor diaphragm damage with near loss of precast flooring unit supports was accompanied by beam elongation in a perimeter moment frame. The building shown in Figure 9 is a 17-storey building with ductile perimeter moment frames, internal gravity frames and flange-hung supported precast double-tee flooring. 60mm topping with cold-drawn wire mesh reinforcement is used. The perimeter frames have typical 500x850mm deep precast beams with 600mm square and 800mm square columns. The beam spans are typically 2900mm in the East-West direction and 5800mm to 6500mm in the North-South direction.

Ductile beam hinging mechanism in the North-South perimeter frames was observed (and repaired) after the 4 September 2010 earthquake. In the 22 February event, the beams in the East-West perimeter frames experienced hinging. However, as the North-South perimeter frames were previously hinged and softened, the torsional resistance expected from the overall system would have decreased. Consequently, the building may have exhibited a moderate level of torsional response, which amplified the demand on the Northern East-West perimeter frame.

Due to the high beam depth-to-span ratio (850/2900), the beam elongation effects (geometrical elongation and plastic cyclic cracking) were significantly more pronounced in the East-West perimeter frames. As expected, the elongation of beams created tension in the connection between the precast floors and supporting perimeter beams. The largest horizontal crack parallel to the double-tee flange support was approximately 20mm to 40mm wide. Slab mesh fracture was observed in floor topping close to the beam plastic hinges. In several locations at the Northern bays, the precast floors have dropped vertically by approximately 10 to 15mm, indicative of loss of precast floor seating support.

While floor collapse did not occur, the separation of perimeter frames from the diaphragms at multiple levels in the Clarendon Towers (Figure 9) raises concerns of possible much greater consequences due to column buckling in aftershocks. To address this risk of collapse in future aftershocks, pairs of 25 mm rods spanning the full width of the building and attached to spreader beams were installed at each vulnerable column at four heavily damaged levels (see Figure 9). Where similar precast floor systems are used, it is important to ensure there is strong connection between the diaphragm and the frames through a well reinforced topping slab in order to ensure separation between the frames and precast components is minimized. Welded-wire mesh should be avoided in topping for precast diaphragms given their limited strain capacity. Only ductile welded-wire mesh has been allowed in New Zealand since 2005 (DBH 2005).

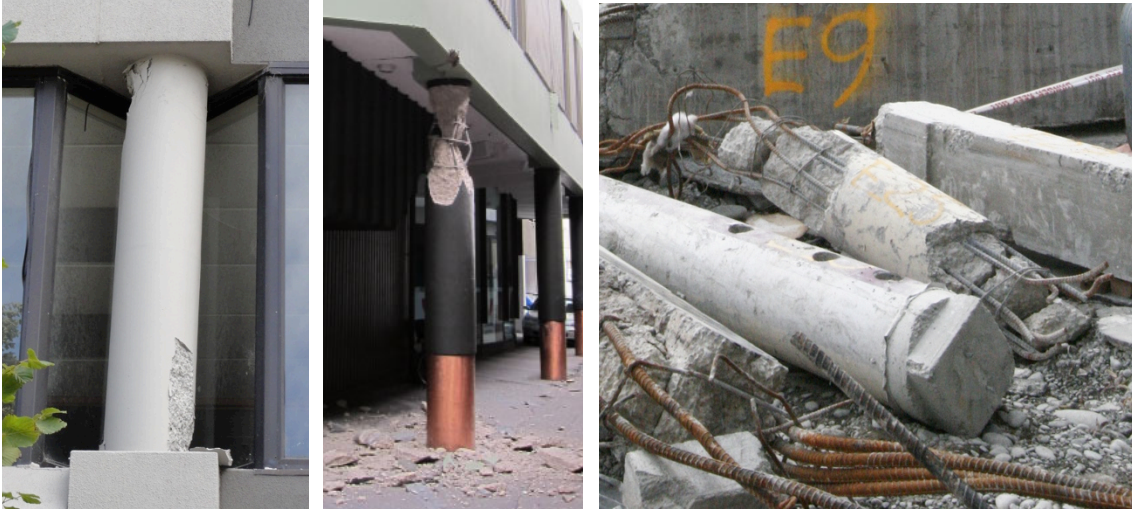
Fig. 10 Damage to gravity columns

The Christchurch earthquake also reinforced the need to consider deformation compatibility of the gravity system with the seismic force resisting system, particularly for so-called “gravity columns” not assumed to resist lateral loads but essential for gravity load support. Figure 10 shows varying levels of damage to gravity columns in three different buildings. Photo on right shows one of the critical weaknesses of the collapsed CTV Building, 400mm diameter columns with 6mm ties at 250mm (for further details on the CTV building see Kam et al. (2011)).

The gravity system must be able to accommodate the deformations imposed by the seismic force resisting system during strong ground shaking. After the axial load failure of several gravity columns during the 1994 Northridge Earthquake, ACI 318 introduced provisions for “components not part of the lateral force resisting system”. For columns deformation compatibility must be explicitly checked or confinement must be provided to ensure adequate deformation capacity. Similar provisions have been adopted in other international codes; however, continued research is required given the challenges of evaluating both deformation demands and capacity accurately.
