LESSONS FOR CALTRANS FROM THE 2011 GREAT EAST JAPAN EARTHQUAKE AND TSUNAMI

Mark Yashinsky

Senior Bridge Engineer, Caltrans Office of Earthquake Engineering, Sacramento, CA 95816,
yashinsky@sbcglobal.net

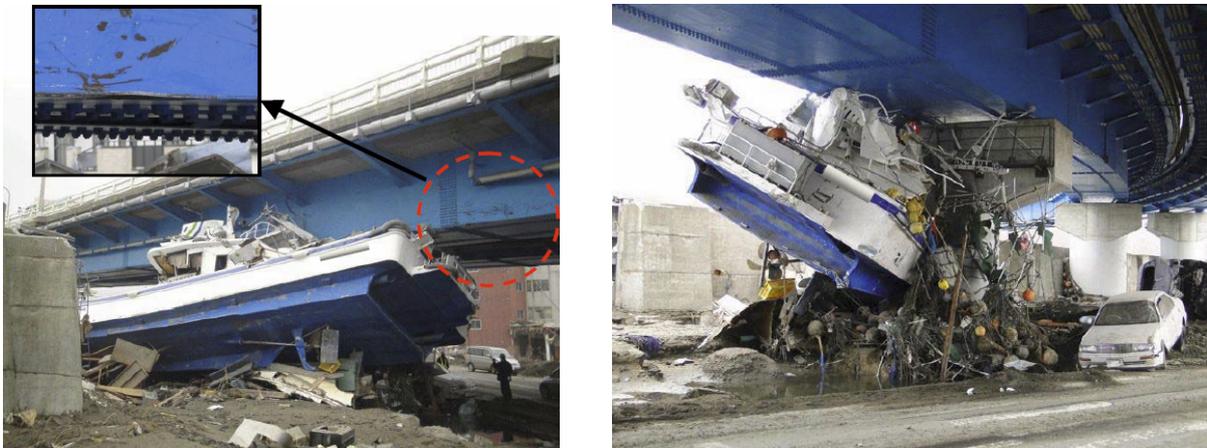
An examination of these bridges after the earthquake revealed only minor damage. None of the columns were damaged despite having been struck by several boats (Fig. 4). This good performance was due to the columns having been previously retrofitted with steel casings.

Fig. 4 During the tsunami several boats struck the Miyako Bridge (NILIM, 2011)

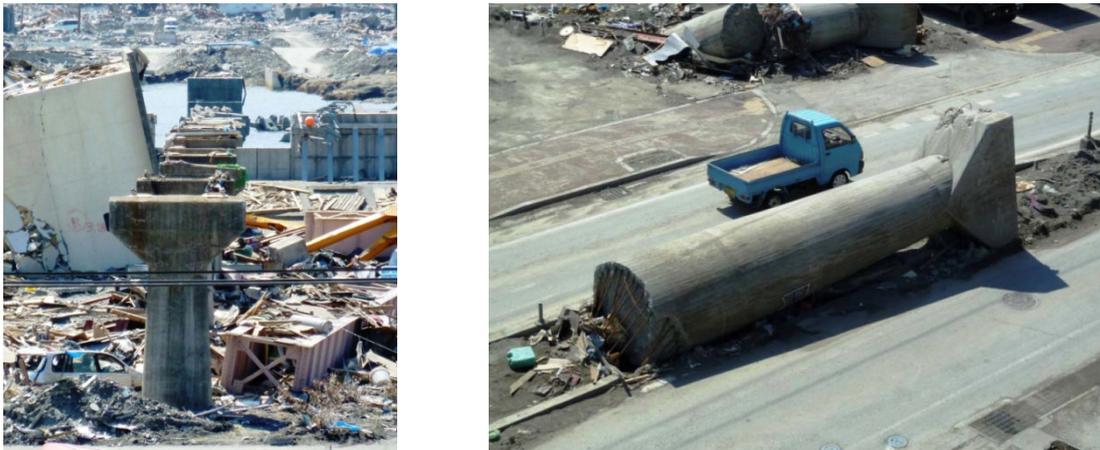
In contrast to the good performance of bridge columns on the Miyako Bridge, in Otsuchi not only was the superstructure on a railway bridge washed away but one of the columns was knocked over (Fig. 5). If this bridge had the proper development of its reinforcement and good confinement, then the column most likely would have remained standing.

Fig. 5 Undamaged and damaged columns on railway bridge in Otsuchi (Robertson, 2011)

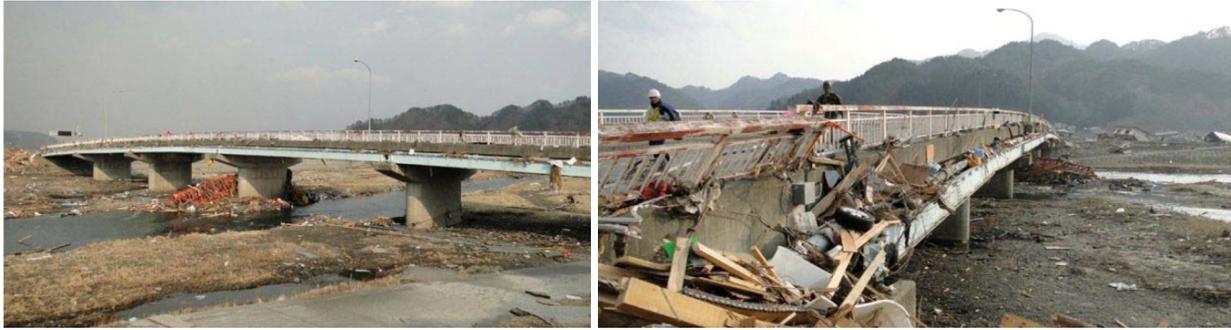
Even when a tsunami wave overtopped a bridge it often remained undamaged. For instance, there were several bridges (Fig. 6) in Ohamawatari along Iyoushi Bay (near a damaged seawall) that were covered in debris due to tsunami inundation. However they suffered only minor damage. Moreover, these bridges were not especially well designed for lateral loads. They were precast girder bridges sitting on seat-type abutments and hammerhead bent caps. We saw this in many other locations.

Fig. 6 Bridge across river in Ohamawatari was covered with debris but undamaged (NILIM, 2011)

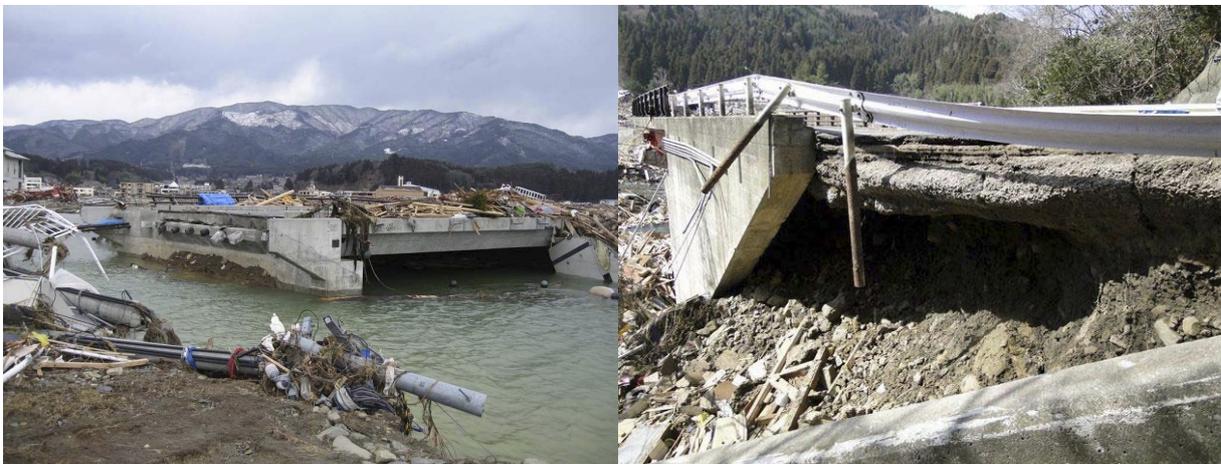
Another bridge-related problem was scouring of abutment backfills (Fig. 7). It didn't appear that one kind of embankment cover was more effective than another. Rip-rap, masonry blocks, asphalt and Portland cement concrete were all removed along with the embankments by the tsunami waves. In fact, tetra-pods (a registered trademark and also a generic term that refers to concrete blocks with several legs arranged along the shore to stop waves), other energy-dissipating systems, and even forests along seaside communities were all removed by tsunami waves. Scouring of the soil behind abutments was the most common type of bridge damage observed during the tsunami.

Fig. 7 Embankment scour at Kawaharagawa and Katagishi Bridges along Route 45 (NILIM, 2011)

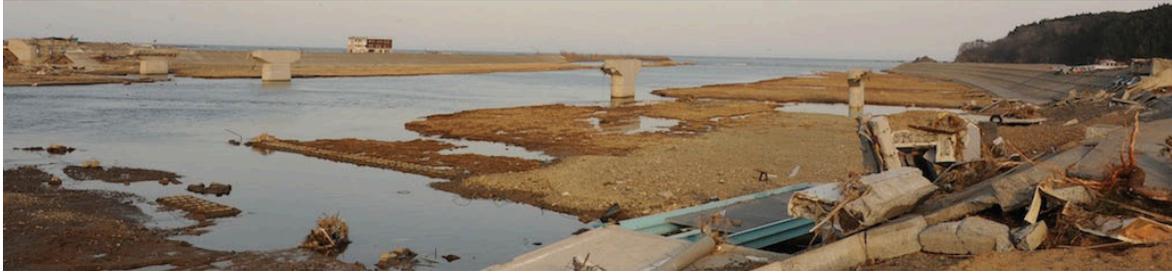
Tsunami waves also scour riverbeds. Sediments are removed on the downstream side of obstacles and are deposited on the upstream side of the next obstacle. There were locations of pier damage that looked to be caused by scouring of the foundations. For instance, in Motoyoshi-cho there were two bridges that lost piers. In Fig. 8, we can see that Pier #3 of the Koizumi Bridge (in the center of the river) is missing. A little upstream is a bridge carrying the JR Kesen-Numa line (Figure 9) with several piers overturned in a manner suggesting the foundations were not well constructed. However, railway bridges generally weren't as well constructed as highway bridges and both of these bridges could have had pier damage due to ground shaking or due to the tsunami waves, which were particularly violent at this location.

Fig. 8 Damage to Koizumi Bridge due to the tsunami (Kawashima, 2011).

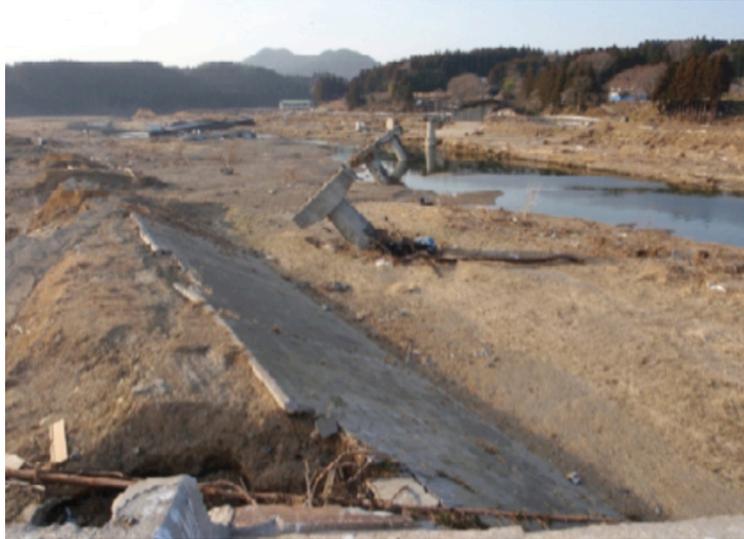
Fig. 9 Damage to JR Kesen-Numa Bridge just upstream from the Koizumi Bridge (Kawashima, 2011)

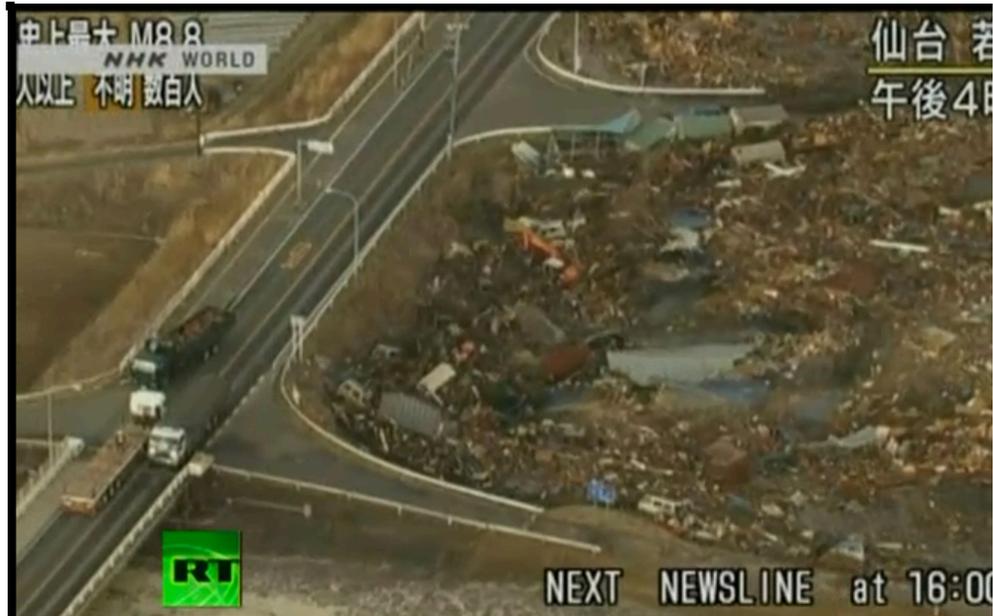
The Ministry of Land, Infrastructure, and Transportation (MLIT) was put in charge of the recovery for the first 20 days after the tsunami. They praised an emergency action plan (similar to Caltrans) that allowed them to hire contractors without competitive bidding to quickly remove debris from the roadways. Highway 45 was praised as being the one seawall that was effective at stopping the tsunami (see Fig. 10).

Figure 10. The embankment supporting Route 45 was the barrier that stopped the tsunami (TV Asahi)

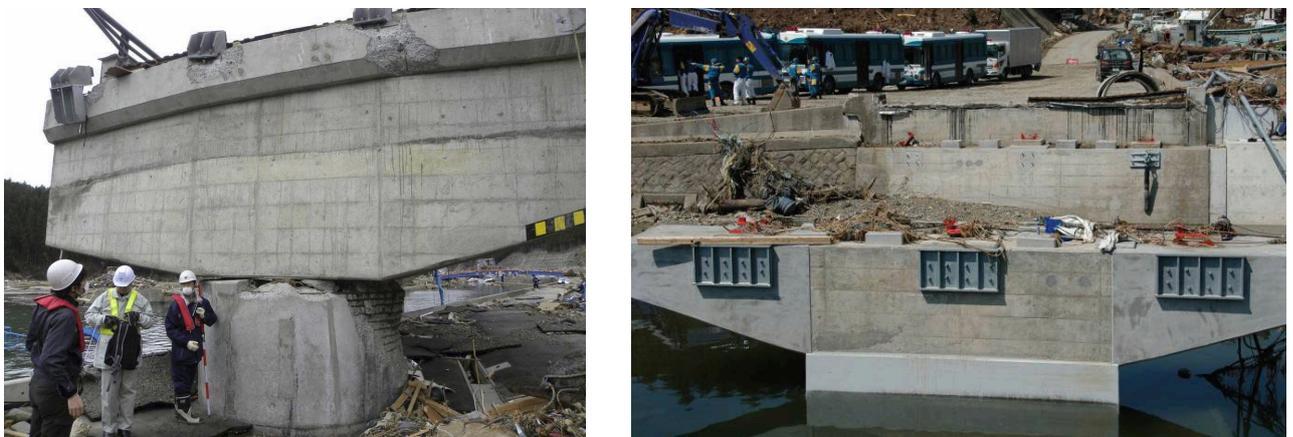
The idea that a bridge designed for strong ground shaking will perform well for a tsunami may not hold true when it comes to restraining the superstructure. There were many examples where cable restrainers, damping devices, and steel brackets snapped in two as girders pulled away from the piers and abutments (Fig. 11). However, the restraints didn't seem designed to resist large forces. Are tsunami forces higher or lower than the forces caused by ground shaking? We might not want to design restrainers for such a large force that they end up damaging the substructure. It may be better to let the girders float away and quickly replace them than to damage the substructure and end up building a new bridge after the tsunami.

Fig. 11 Broken brackets and restrainers on Utatsu Hashi and Yokozu Kyo Bridges (NILIM, 2011)

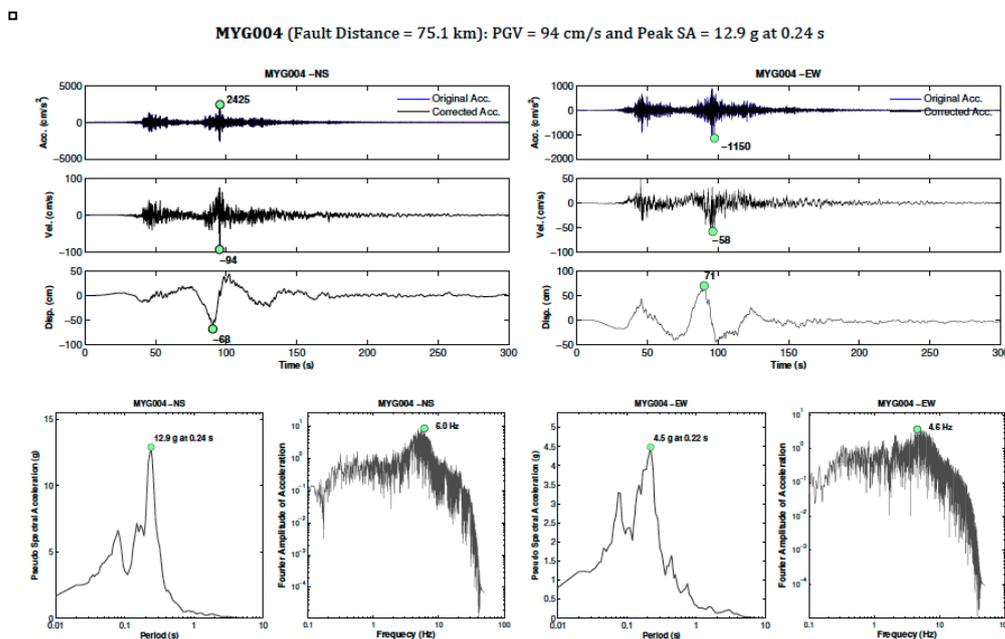
One of Caltrans concerns is the high level of ground shaking recorded during this earthquake. One instrument (MYG004) recorded PGA of 2.5g and a spectral acceleration (at 0.24 seconds) of 12.9g (Figure 12). The site was 81 km from the rupture and had a shear wave velocity of 500 m/s. Caltrans designs bridges for PGA less than 1.0g and spectral acceleration generally less than 2g.

Fig. 12 Time history and response spectra recorded at instrument MYG004 during the Tohoku EQ

However, There was no bridge (or building) damage in Tsukidate (where the recording was made) according to Prof. Ikuo Towhata [5], a well-known geotechnical engineering professor at the University of Tokyo. Moreover, the recording shows a sharp spike in the recording suggesting there was some banging near the instrument. Most likely this recording is an outlier of the data and can be safely ignored.

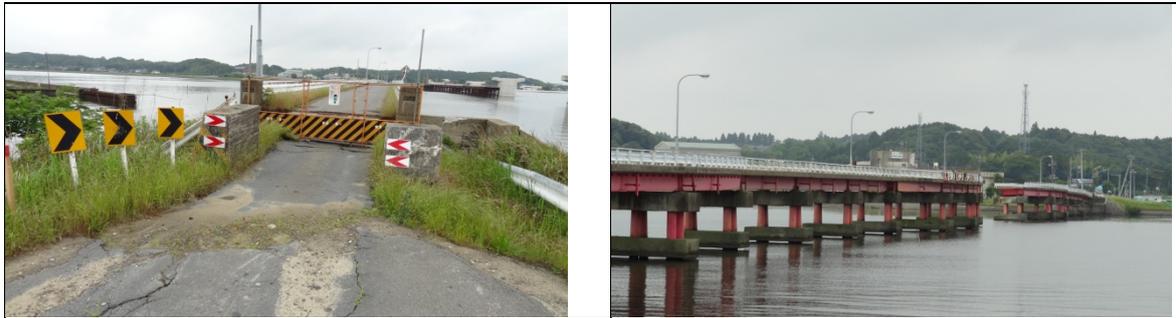
the 1995 M6.9 Kobe earthquake. Strong ground shaking is expected close to the fault rather than 81 km away. Only a few bridges collapsed due to ground shaking and this was often the result of liquefaction and lateral spreading. For instance, the Rokko Bridge had settlement of the approaches and the loss of two piers and three spans (Fig. 13). This is similar to the damage that occurred to the Showa Bridge during the 1964 Niigata earthquake and probably had the same cause, loss of strength and stiffness of the surrounding soil due to liquefaction.

Fig. 13 Damage to Rokko Bridge in Ibaraki Prefecture

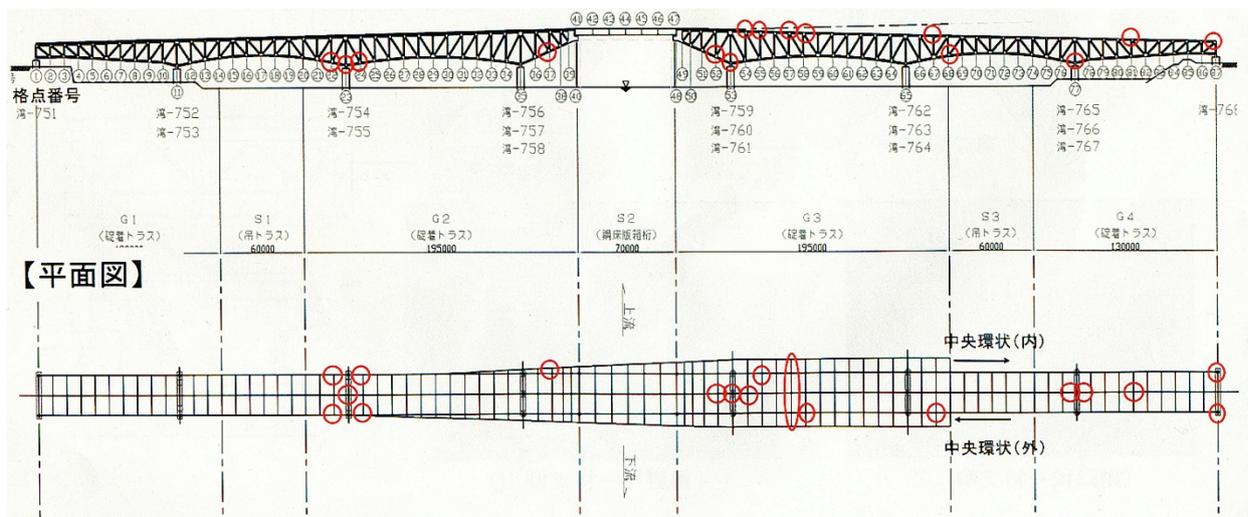
There was a lot of damage to truss bridges due to buckled cross bracing, broken bearings and expansion joint devices, and torn and buckled gusset plates. An interesting example of this type of damage occurred to the Kosoku-Arakawa Truss Bay Shore Bridge (built in 1978) just north of Tokyo Bay. As shown in Fig. 14 below, the bridge is an 840 m long, seven span truss bridge with a drop-in steel girder center span. The truss elements are held together with gusset plates that were too thin for the seismic forces. About twenty plates buckled in compression or were torn apart in tension (usually both) as shown in Fig. 15. Gusset plates should be capacity-protected members and stronger than the members they connect. Fortunately, the bridge did not fall apart and the Metropolitan Expressway Corporation was able to replace all the damaged gusset plates.

Fig. 14 Drawing of the Kosoku-Arakawa Bridge showing locations of gusset plate damage

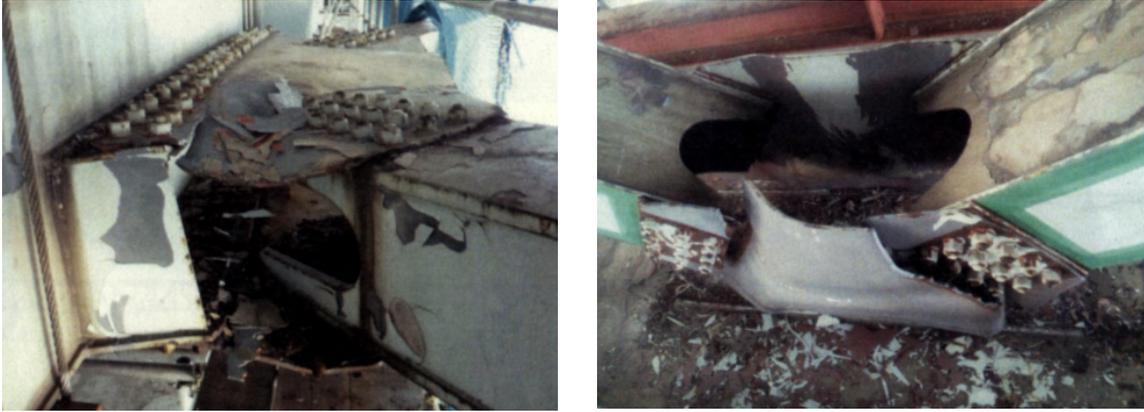
Fig. 15 Gusset plate damage for horizontal and vertical members

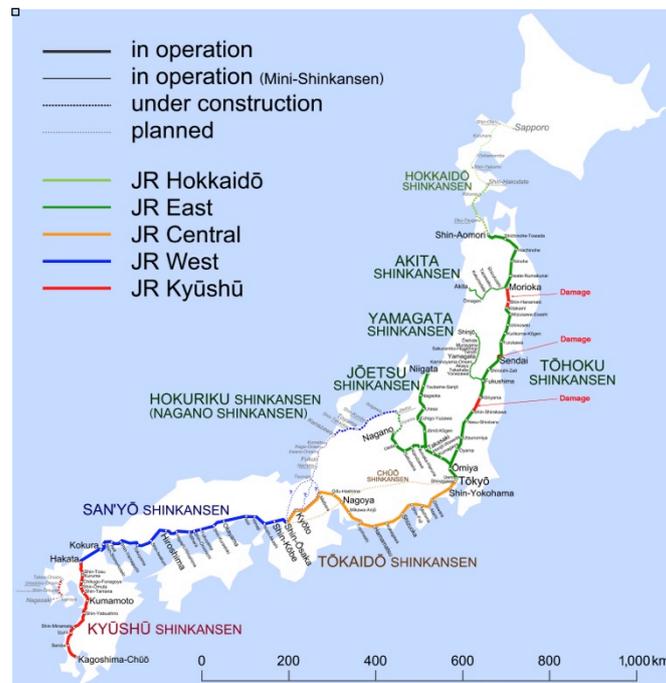
During the Tohoku earthquake, viaducts were damaged in Koriyama (Fukushima Prefecture), in Sendai (Miyagi Prefecture) and in Kitakami, Hanamaki, and Morioka (Iwate Prefecture) as shown in Fig. 16.

Fig. 16 Map of Shinkansen with locations of damage during earthquake

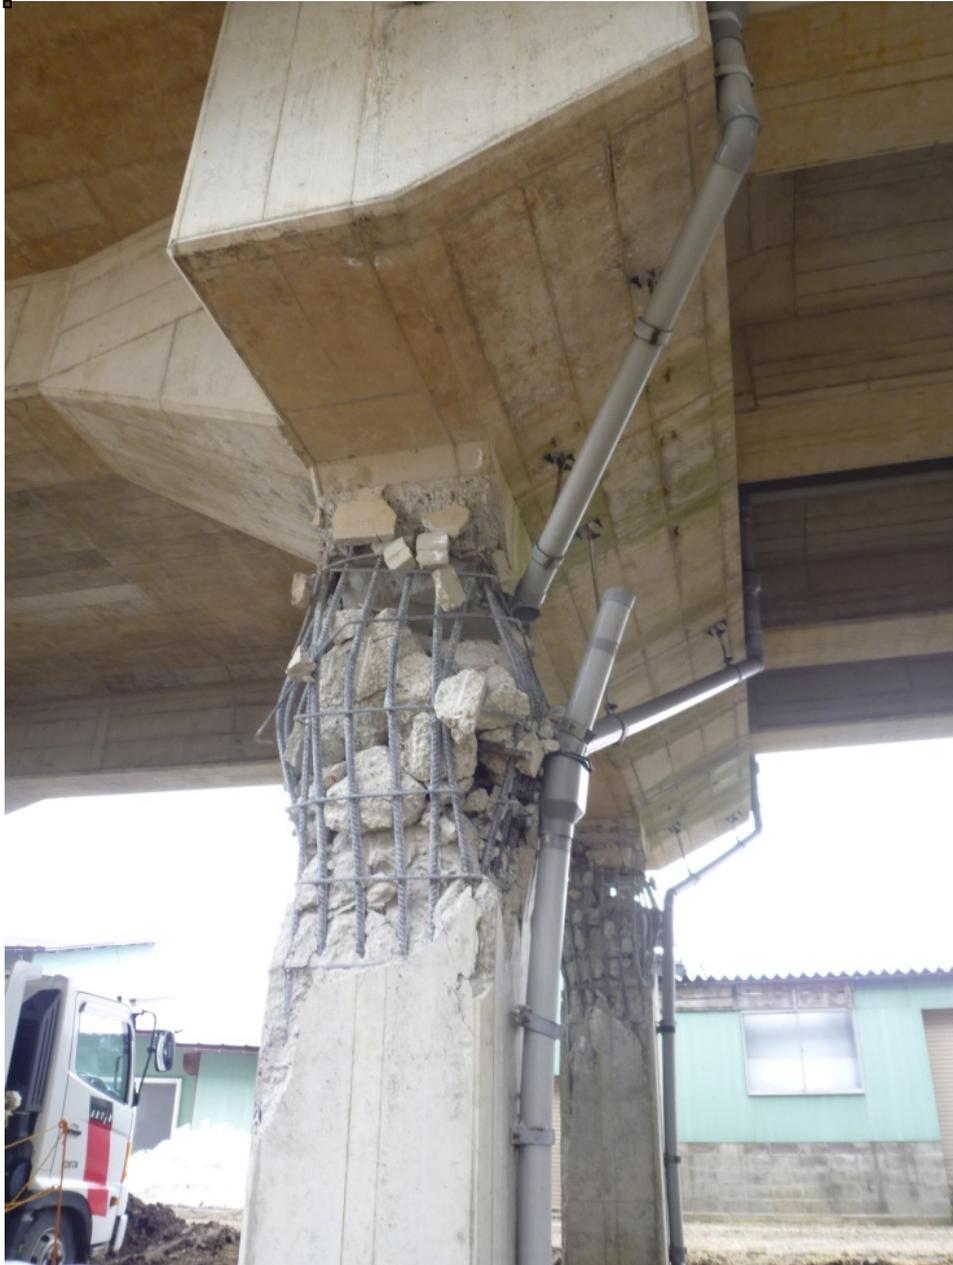
A very typical example of the damage to the Tohoku Shinkansen Line is shown in Fig. 17 on the Hanimaki Viaduct in Sendai. This viaduct is composed of four span frames with drop-in spans between the frames. The end bents are shorter and stiffer to carry the drop-caps which support the drop-in spans. Almost all the damage to the Shinkansen Line were to the stiffer columns on the end bents (There was also a lot of damage to transverse beams used to stiffen tall bents).

Fig. 17 Damage to Shinkansen Viaducts in Hanamaki
