SEISMIC BEHAVIOR OF RETROFITTED BRIDGES DURING THE 2011 GREAT EAST JAPAN EARTHQUAKE

Jun-ichi HOSHIKUMA¹, Guangfeng ZHANG² and Junichi SAKAI³

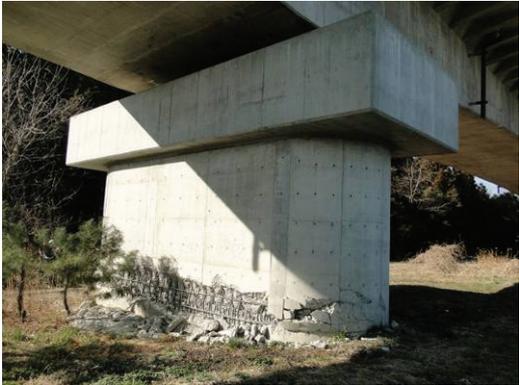
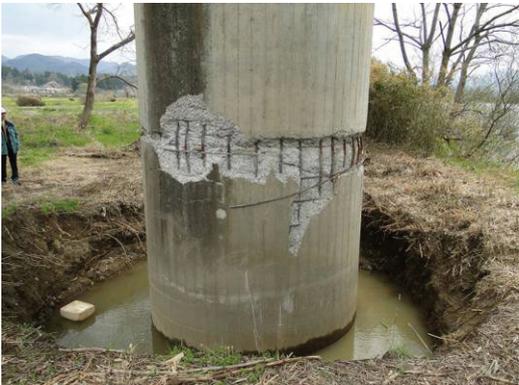
Photo 1 Damage of Reinforced Concrete Columns at Cut-off Section of Longitudinal Reinforcement

Intensive damage due to the ground motion was developed in many unretrofitted bridges designed in accordance with pre-1980 design specifications. Almost of damage modes of those bridges have ever been observed in the past earthquakes. Photos 1 to 3 show the damage to reinforced concrete piers, steel bearing supports and the attachment of the bearing support to pier top or the superstructure, respectively. Photo 4 shows the residual inclination of substructure due to the damage of the pile cap for caisson foundation.

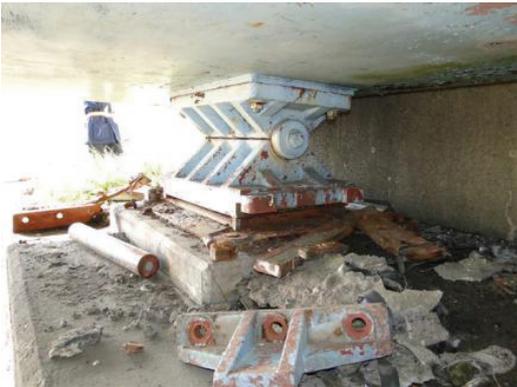
Photo 2 Damage of Steel Bearing Support

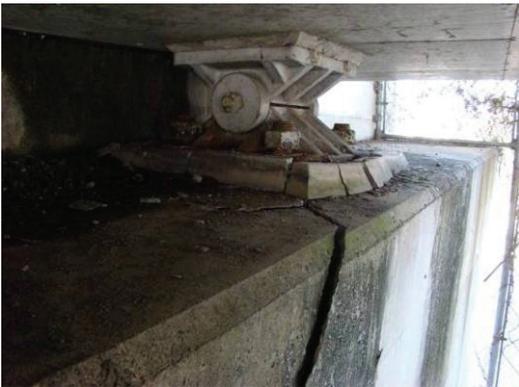
Photo 3 Damage of Pier Top

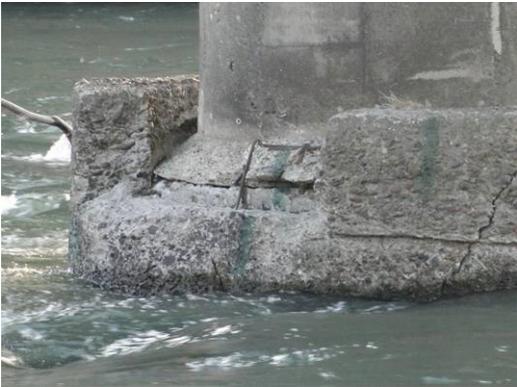
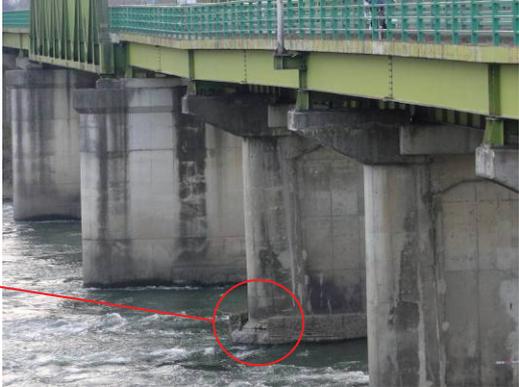
Photo 4 Residual Inclination of Substructure and Damage of Pile Cap for Caisson Foundation

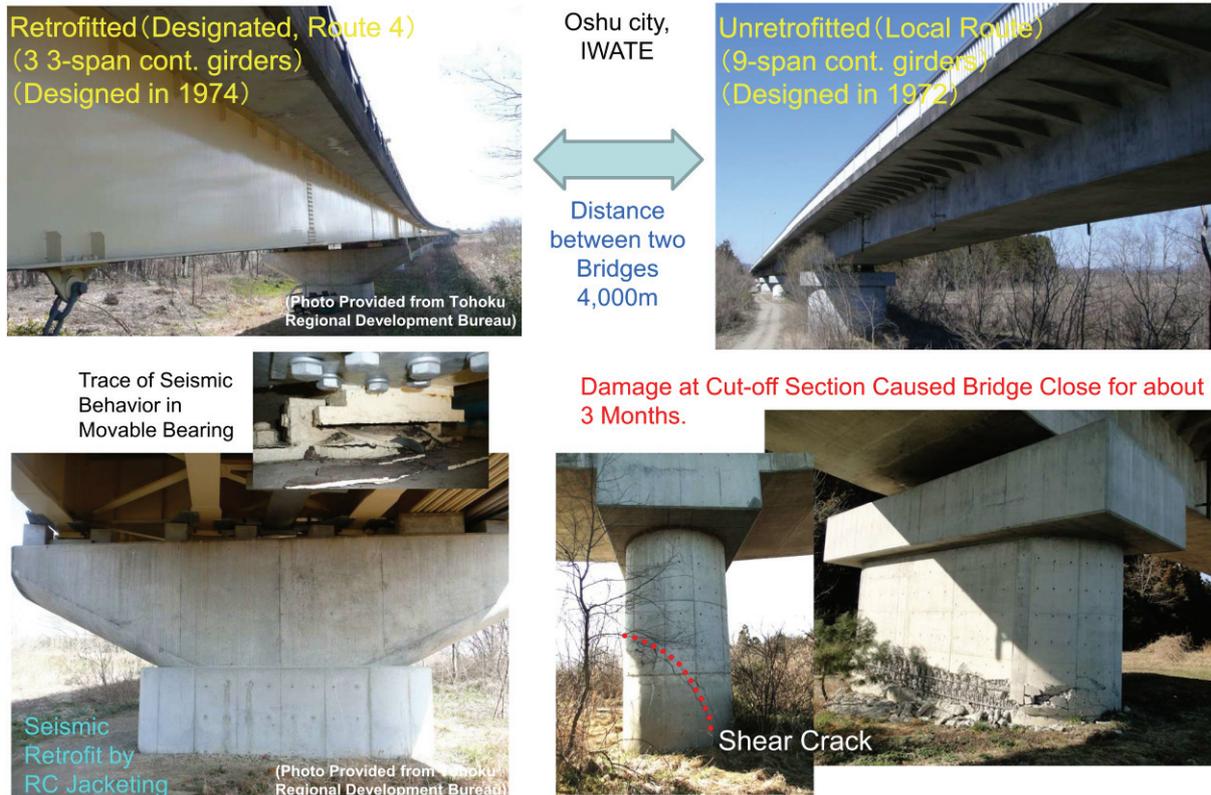
Photo 5 Comparison of Seismic Performance between Adjacent Two Bridges
(Kanagasaki Ohashi Bridge and Esaki Ohashi Bridge)

Photo 5 exemplifies the effectiveness of the seismic retrofit for bridge columns. The unretrofitted bridge (Esaki Ohashi Bridge) shown in the right side of Photo 5 suffered from severe shear damage in concrete columns. Esaki Ohashi Bridge is 9-span continuous concrete box girder bridge designed in 1972 design specification. Near Esaki Ohashi Bridge (as close as 4,000m), there is the other bridge (Kanagasaki Ohashi Bridge) as shown in the left side of Photo 5, where this is three 3-span continuous steel girders bridge designed in 1974 and the columns were retrofitted by concrete jacketing. No

structural damage was observed in this retrofitted bridge. Comparison of the seismic performance with these two bridges indicates that the seismic retrofit for bridge columns work effectively, although structural type of these bridges are different and thus the natural period is not equivalent between two bridges.

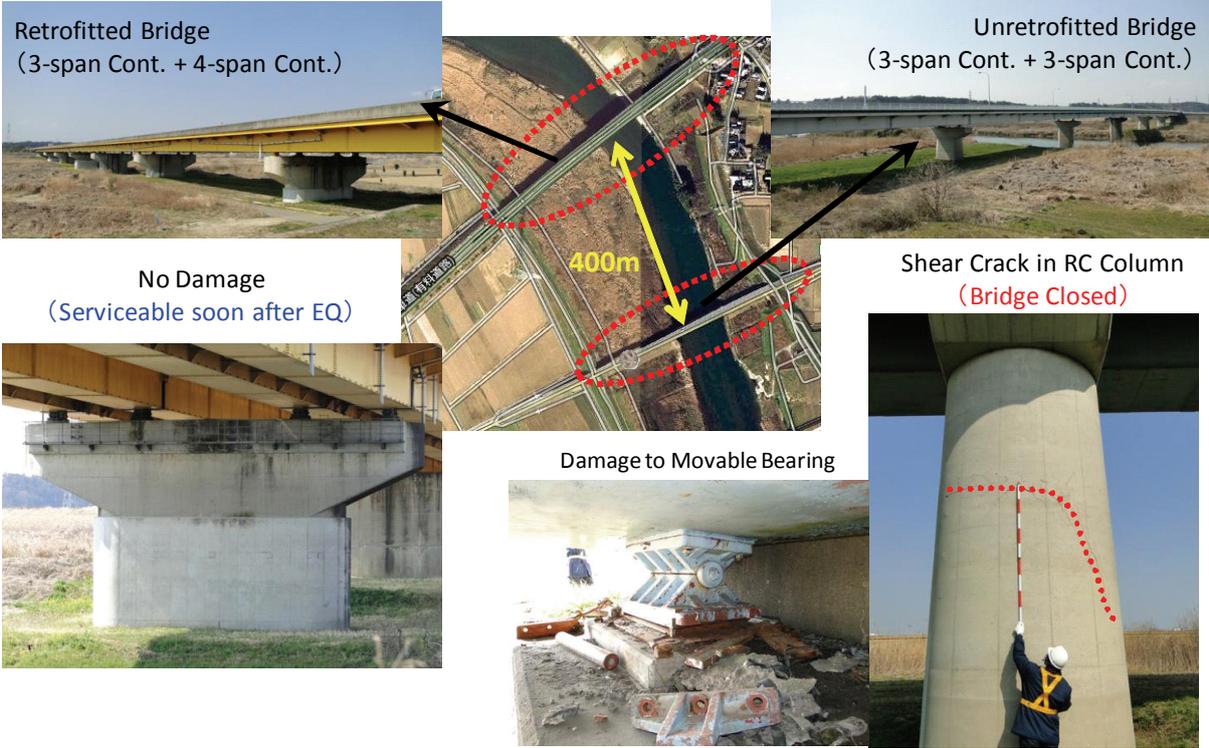
Photo 6 shows the other example of the comparison of the damage between seismic retrofitted bridge and unretrofitted bridge. As seen in Photo 6, there are two adjacent river-crossing bridges. Since one bridge (Nakagawa Bridge) is on the designate emergency route, bridge columns designed with the pre-1980 specifications have already been retrofitted by reinforced concrete jacketing. The other bridge (Kunita Ohashi Bridge) is on the local roadway and the bridge columns have not yet been retrofitted at the earthquake. Although Kunita Ohashi Bridge suffered from the vulnerable damage and thus lost the serviceability for the bridge, Nakagawa Bridge did not suffer from the damage and kept the serviceability soon after the earthquake. Seismic performance shown in these two bridges clearly exhibits the effectiveness of the seismic retrofit.

Photo 6 Comparison of Seismic Performance between Adjacent Two Bridges (Nakagawa Bridge and Kunita Ohashi Bridge)

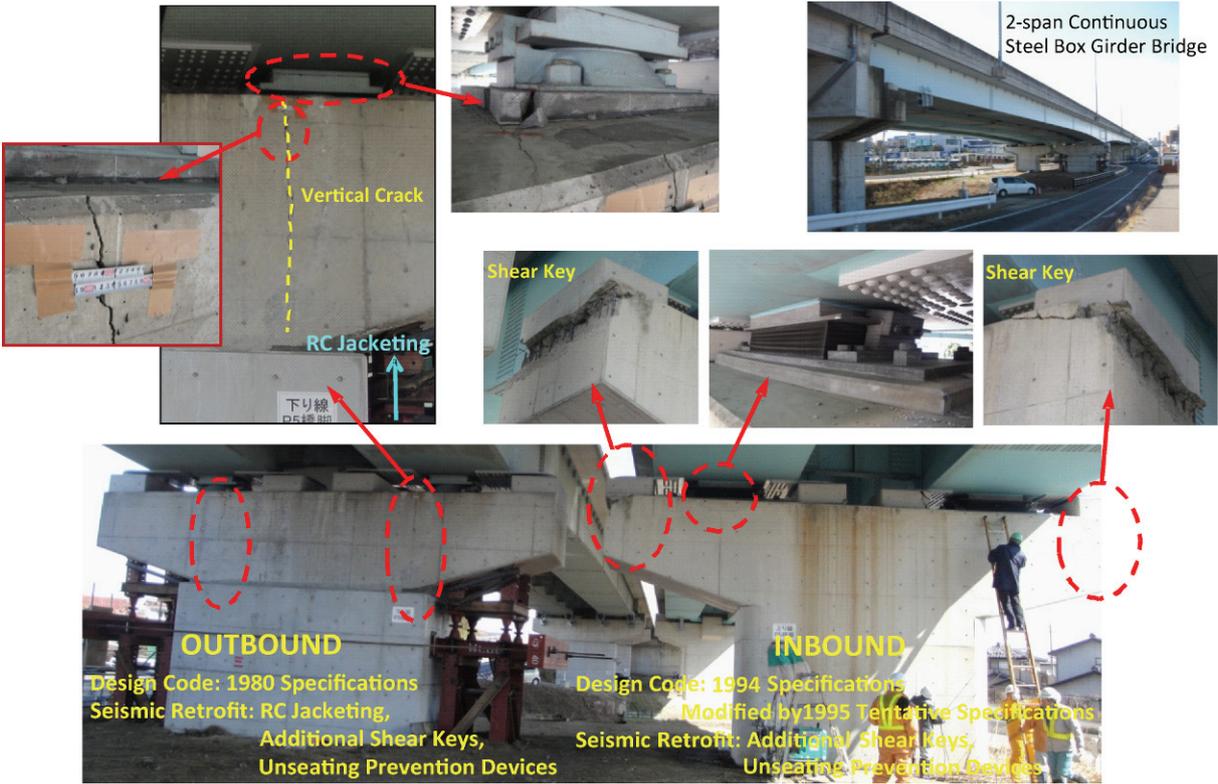
There are a few remarkable damage examples in the retrofitted bridges. Photo 7 shows adjacent two reinforced concrete columns in Kameda Ohashi Bridge. Each column supports 2-span continuous steel box girder at the middle. The outbound column was designed with 1980 specifications and retrofitted by reinforced concrete jacketing for strengthening the cut-off section without increasing the flexural strength of the column base. Furthermore, additional shear keys were anchored to cap beam to supplement the strength of the existing steel bearings. Although no damage was found to the steel bearings and shear keys, vertical cracks of nearly 10mm width were observed at the section of cap beam as shown in Photo 7. The inbound column was designed with 1994 specifications basically and

some modifications were made based on the 1995 tentative specifications (published soon after 1995 Kobe Earthquake). In the inbound column, elastometric rubber bearings were deformed in the transverse direction and the side stoppers were failed. Concrete of the cap beam edge portion attaching the supplemental shear keys also spalled off (see in Photo 7) due to the transverse seismic force induced by the inertia of the superstructure, while vertical crack observed in the cap beam of the outbound column was not developed in the inbound cap beam.

Amount of tensile steel bar in the cap beam was different between two columns. Tensile reinforcement ratio of the cap beam is 0.40% in the inbound column, while 0.24% in the outbound column. The section of the cap beam has been designed predominantly by the live load rather than the seismic effect. Actually the design live load is different between two columns, because the design specifications of the live load revised and larger live load was considered into the design of the inbound column. The difference of strength of the cap beam would affect the failure mode for the large seismic lateral force.

Table 1 shows the analytical result of the strength capacity of some sections in two columns when the transverse seismic force applies at the superstructure. The result of the push-over analysis indicates that the section of the cap beam shoulder (Section 3 in Table 1) in the outbound column is the first failure section regardless the effect of the seismic retrofit, while the section of the column base is the first failure section so that the cap beam be protected in the inbound column. These results coincide with actual behavior of the columns observed after the earthquake.

Photo 7 Comparison of Damage Mode between Adjacent Two Bridge Columns (Kameda Ohashi Bridge)

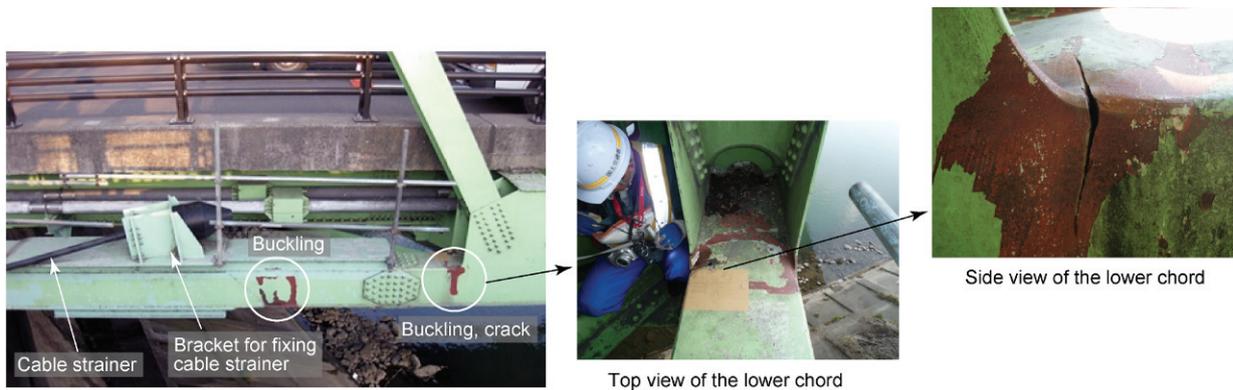
Photo 8 shows the other example of the damage in the retrofitted bridge. Osaragi Ohashi Bridge is a 3-span continuous steel truss bridge and the cable restrainers are installed so as to prevent from unseating of the superstructure in the event of unexpected failure of bearing supports during an earthquake. In this steel truss bridge, the cable restrainers were attached to the lower chord with steel bracket and additional steel plate for strengthening of the section of attachment as shown in Photo 8. Any bearing supports didn't suffer from the damage due to the earthquake and there was no evidence of the superstructure movement, which indicated that the cable restrainers didn't work during the earthquake. However, the lower chord was slightly buckled at near the section of attachment for the cable restrainer. This damage was caused by the seismic force transmitted from the fix bearing support

(not from the cable restrainer). Significant change of the stiffness and strength at the section of the attachment may cause the buckling due to the cyclic loading.

Photo 8 Damage of the lower chord of truss bridge (Osaragi Ohashi Bridge)
