# STUDY OF LOW-RISE RC BUILDINGS WITH RELATIVELY HIGH SEISMIC CAPACITY DAMAGED BY GREAT EAST JAPAN EARTHQUAKE 2011

**ABSTRACT:** This paper investigates the damage of several low-rise RC buildings caused by the Great East Japan earthquake in Sendai city. The selected building are evaluated to have high seismic capacity, index  $I_s > 0.7$ , using Japanese Standard for Seismic Evaluation of Existing RC Buildings. Causes of the damage are discussed. Moreover, pushover analysis was carried out to those buildings. In general, pushover analysis predicted well the damage level, but there were some differences in plastic hinge locations when compared to the actual damage.

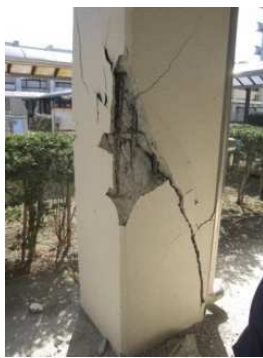
The N Lecture building had a severe shear failure in many of its columns in the 1<sup>st</sup> story in the longitudinal direction (see Fig.6). The damage to columns progressed much due to the 7<sup>th</sup> of April aftershock earthquake (see Fig.7). Less damage in the 2<sup>nd</sup> story but shear cracks were also noticed. First floor plan with damage classes of columns in the longitudinal direction are classified based on the “Post-earthquake damage evaluation standards of Japan” (JBDPA 2001a) and shown in Fig 8. Two columns were damaged by previous earthquake and strengthened by FRB sheets jacketing are marked as (未 unknown) in Fig. 8. It is marked unknown because damage to concrete was invisible by the FRP jacket. The details of this repair were unavailable. However, the transverse direction was slightly damaged.

Fig.6 After 11th of March earthquake

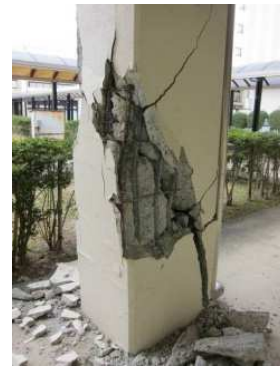
Fig.7 After 7<sup>th</sup> of April aftershock earthquake

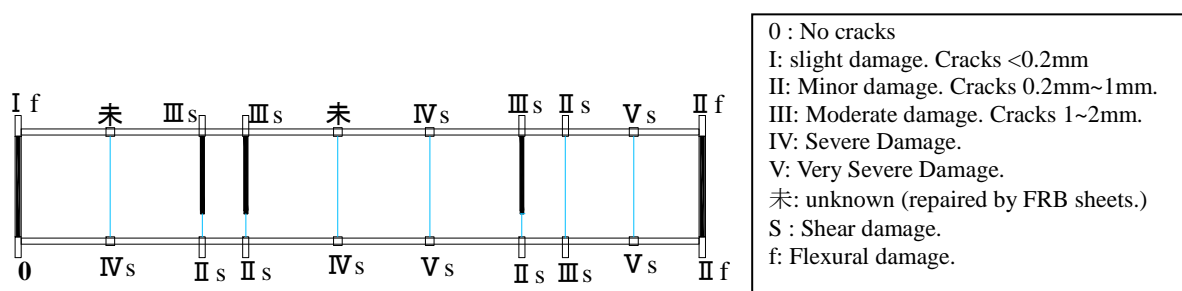
Fig8. 1<sup>st</sup> floor plan and damaged observed in longitudinal direction For N lecture building

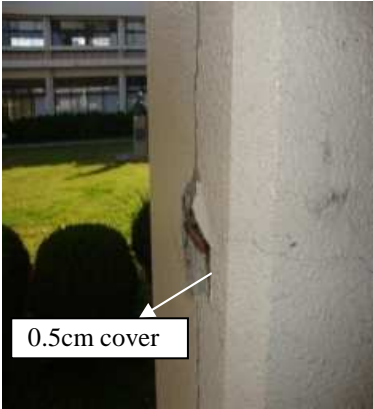
As shown in Table.1 the  $I_s$  index and  $C_{TU} \cdot S_D$  index which represent the base shear for both of the buildings are almost the same, but the N lecture building had a greater damage than expected in the seismic evaluation. This is thought to be of the poor construction of columns. The cover around the

stirrups is so thin in some cases 0.5 cm (see Fig.15). Moreover, the ends of bars should be hooked by bending through 180° in mild-steel bars and 135° in deformed bar. But in this case it was bent by angle of 90° as shown in Fig.16. Therefore, the bond between the concrete and stirrups is weak and the stirrups didn't reach its maximum yielding point and slipped. The stirrups are not really helping shear strength. The N Lecture building depends in its seismic capacity mainly on shear columns. In the other hand, the S Lecture building depends mainly on the wall for its seismic capacity. The shear capacity for the columns didn't reach its maximum strength since most of the seismic load was carried by the wall which was not affected by the poor detailing of the stirrups.

Fig15. Cover of 0.5cm

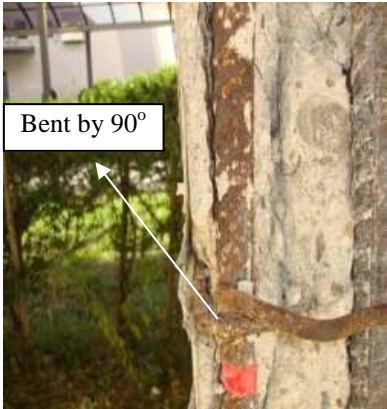
Fig16. 90° hooks

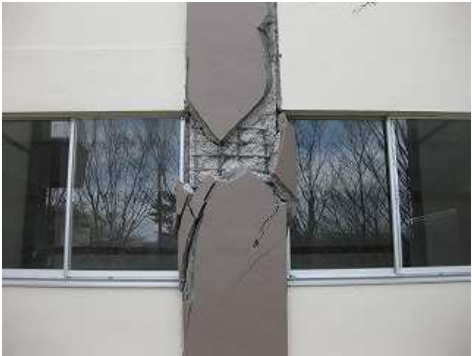
The longitudinal direction of building (B) had shear failure in many of its columns (see Fig.18) and shear cracks in some wing walls (see Fig.19). Cracks in slab and beams were also observed. The transverse direction had slight damage. Damage was concentrated in the 1<sup>st</sup> floor of building (B).

Fig18. Shear failure in column. Building (B)

According to structural drawings, slits are inserted between columns and interior infill concrete walls. However, these slits weren't inserted properly. Columns which were assumed to have flexural failure had actually failed in shear (see Fig. 18). Therefore, two cases are assumed for building (B); with slits and without slits.

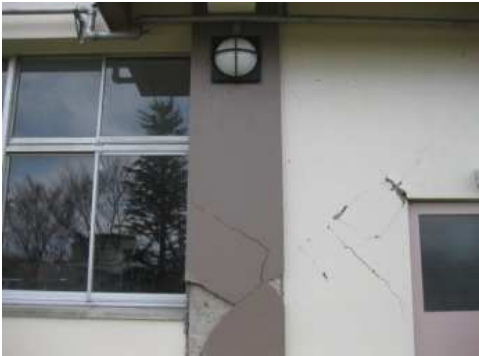
Fig19 Shear Crack in side walls. Building (B)

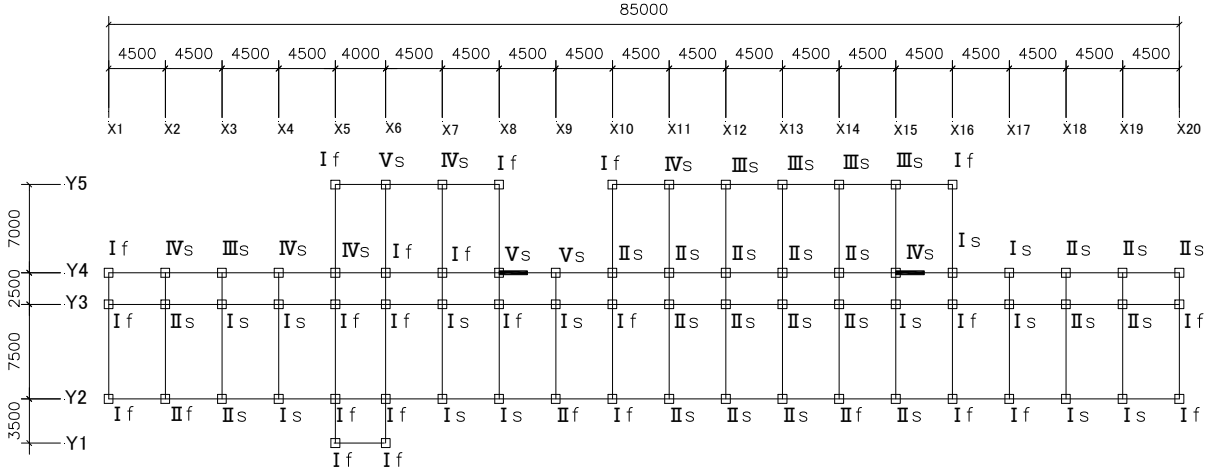
Typical story plan and its damage to the longitudinal direction of building (B) are shown in Fig. 20. Typical member's size and reinforcement is shown in Fig. 21.

Fig. 20 1<sup>st</sup> floor plan and damaged observed in longitudinal direction of building (B)
