DAMAGE OF RUBBER BEARINGS AND DAMPERS OF BRIDGES IN 2011 GREAT EAST JAPAN EARTHQUAKE

Yoshikazu TAKAHASHI¹

ABSTRACT: In the 2011 Great East Japan Earthquake, many structures were heavily damaged by Tsunami, but most structures designed by post-1990 code were not damaged by ground motion. However in some bridges designed by post-1995 code, rubber bearings and dampers were severely damaged. In this earthquake, cracks of rubber bearings were observed in the wide region in the east part of Japan, and in Sendai area the rupture of bearings were occurred in two highway viaducts. The paper summarizes damage of rubber bearings and dampers of bridges.

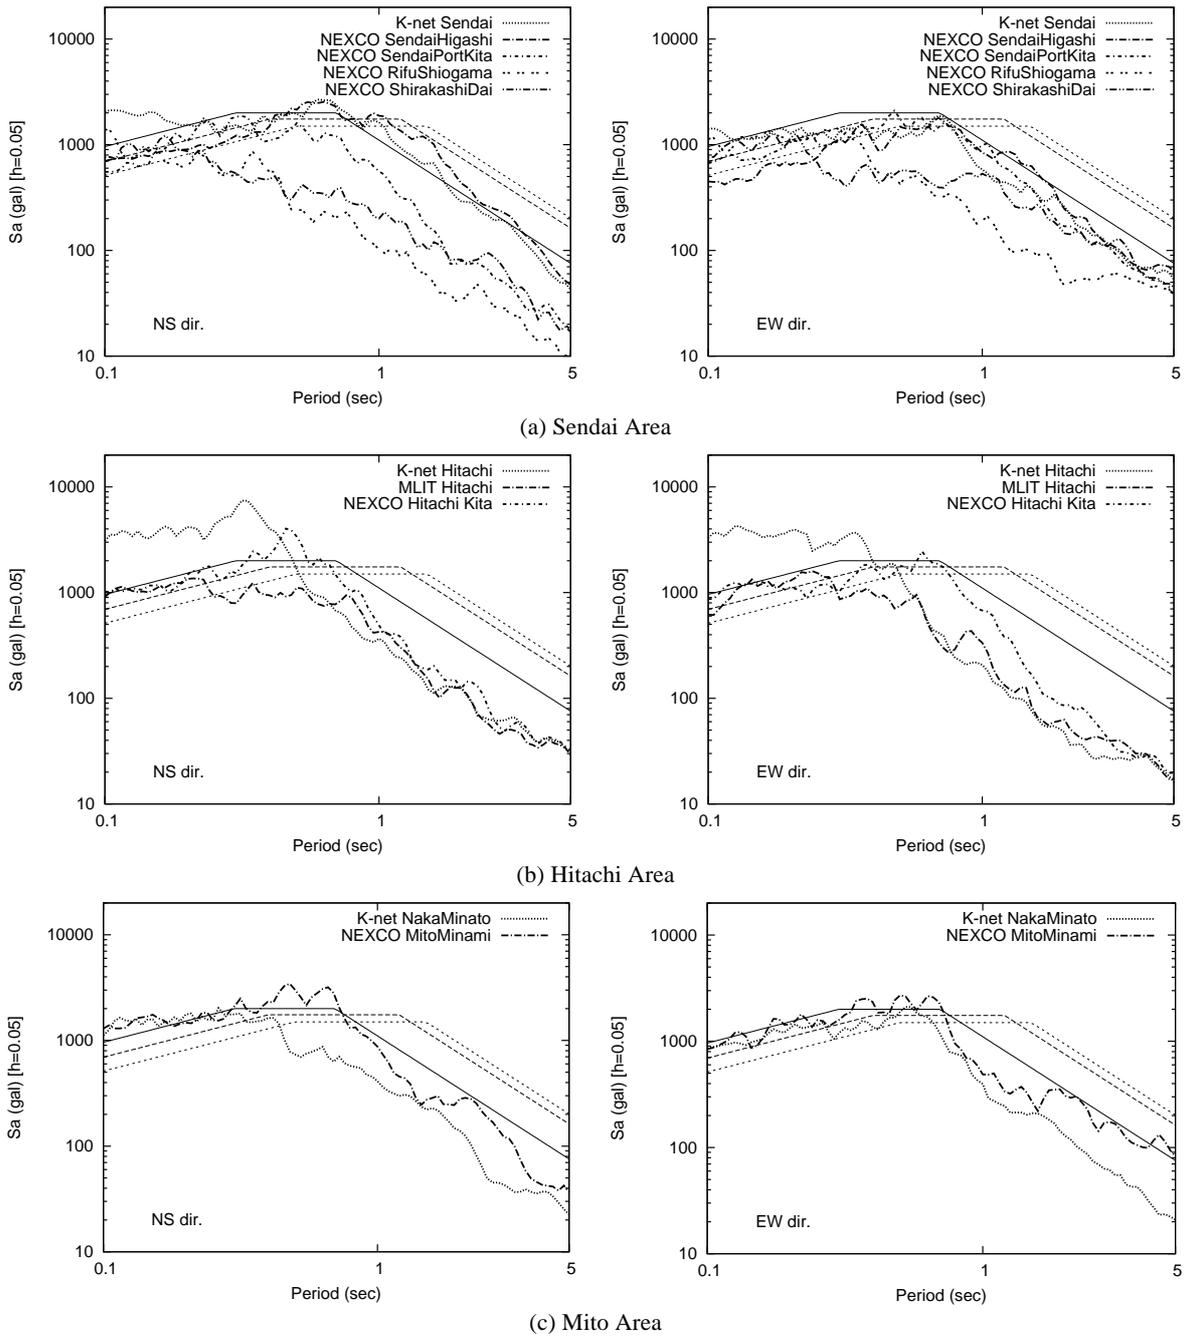
Fig. 3 Response Spectra with JRA Design Spectra (L2-Type II)

Fig. 2 shows the distribution of seismograph stations around the bridges and the response spectra are shown in Fig. 3. In Sendai area, K-net Sendai and NEXCO Sendai Higashi are similar to the Design Spectra of Level II – Type II (Soil Type I), but the other ground motion are smaller than the Design Spectra especially in 0.5-5 second.

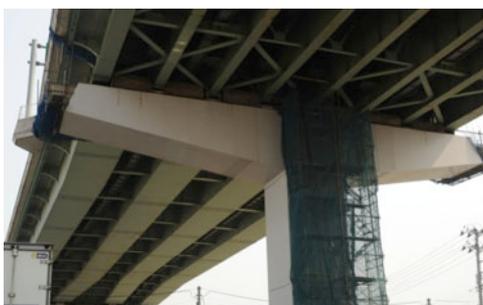
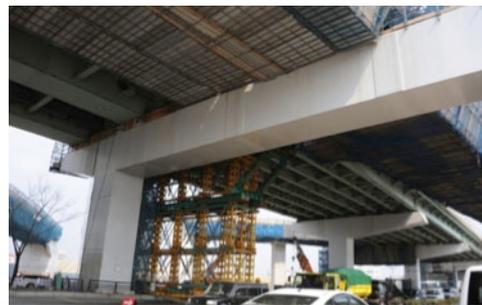
Photo 1 Tobu Viaduct (Left: Pier 52, Right: Pier 56)

Tobu viaduct (Photo 1) is located between Sendai Higashi IC and Sendai Port Kita IC in Sendai Tobu Toll Road. Photo 2 shows the ruptured elastomeric bearings. This rupture caused that the deck offset in the transverse direction and settled aside the ruptured bearings. Rubber layers detached from steel plates as well as rupture inside rubber layers. Fig. 4 shows the location of rupture of elastomeric bearings, and the damage is concentrated at the edge of the girders (on Piers 52 and 56). At Piers 52 and 56, the superstructure changes from steel I-girders to steel box girder and the substructure also changes from single-column piers to two-column piers. It is pointed out that one of the possible reasons for the rupture of elastomeric bearings is that the interaction between adjacent bridges with different natural periods was not properly considered in design of elastomeric bearings.

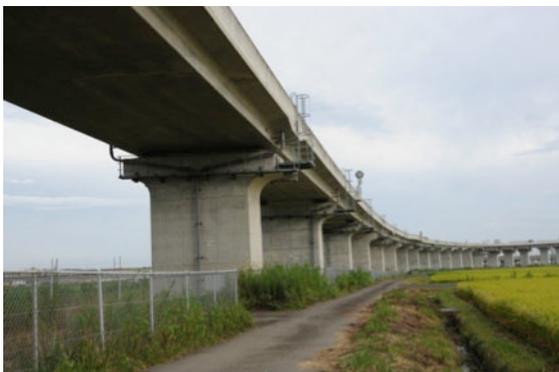
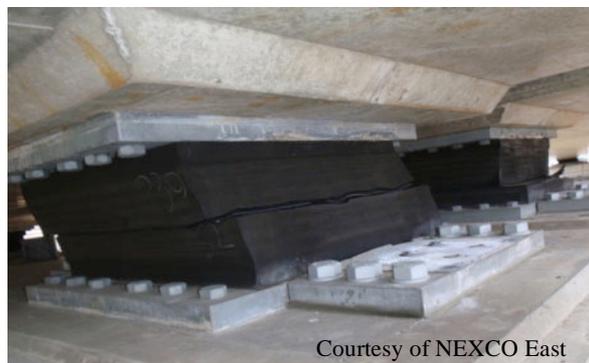
Photo 3 Rifu Viaduct and rupture of elastomeric bearings

Rifu viaduct is located between Rifu JCT and Rifu Shirakashi IC in Sendai Hokubu Toll Road. Several elastomeric bearings ruptured in the transverse direction as shown in Photo 3. Fortunately this rupture didn't cause that the deck settled aside the ruptured bearings. Fig. 5 shows the location of rupture of elastomeric bearings. The urgent safety inspection after March 11 reported that 3 bearings ruptured. After the aftershock of Magnitude 7.4 on April 7, the urgent inspection was conducted again and it was found that another 8 bearings ruptured. Since the section area of the elastomeric bearings was larger than the conventional steel bearings, they could support the girders after their breakage but couldn't provide the function of resist lateral force. The big aftershock gave us another important lesson how to provide not only the vertical support but also the lateral resistance in the restoration process.

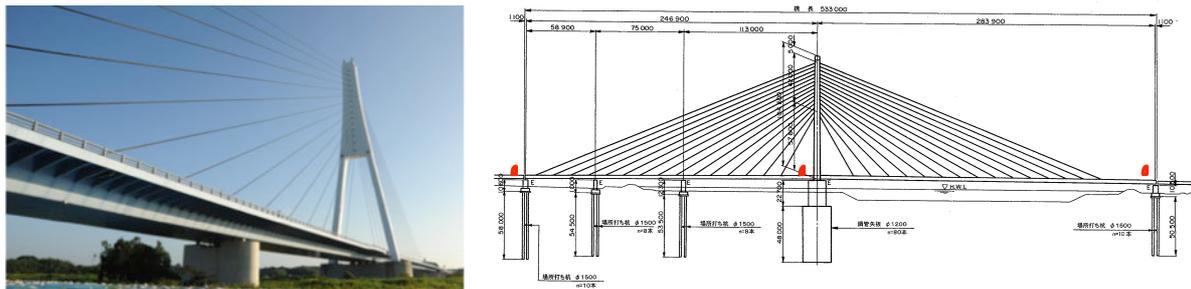
Fig. 6 Shin Nakagawa Bridge and location of ruptured elastomeric bearings

Shin Nakagawa Bridge (Fig. 6) is the cable-stayed bridge located at Mito City in Ibaragi Prefecture. The steel box girder is supported by one tower and 5 piers. The bridge was completed in 1999. The 4 elastomeric bearings were installed on the piers and the bearings on 3 piers were ruptured in the longitudinal direction (Photo 5). The bearings deformed about 45 cm and hit the prevention devices of excessive movement.

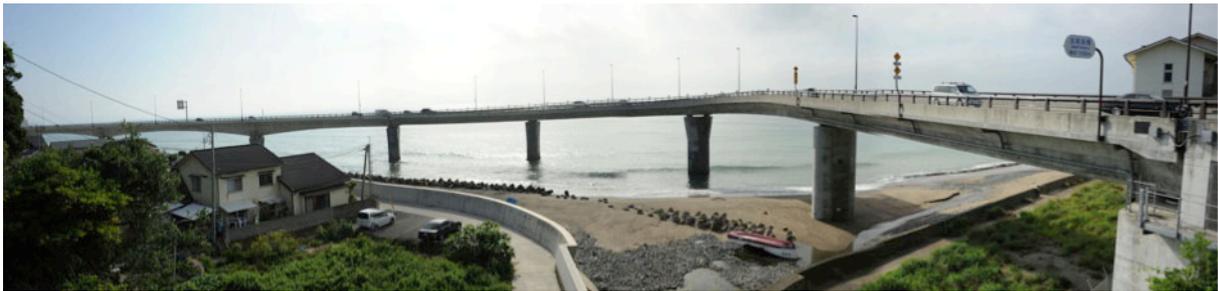
Photo 6 Asahi Viaduct

Asahi Viaduct (Photo 6) is located at Hitachi City in Ibaragi Prefecture. The viaduct consists of 4-span and 7-span continuous PC box girders. The bridge was completed in 2008. The 2 and 3 lead rubber bearings were installed on the piers and the abutments, respectively, and one bearing on the abutment was cracked in the earthquake (Photo 7). Since the bridge is located along the coastline, the bearings were coated by rubber for prevention of corrosion. But the side stoppers of the bearings bite into the rubber coat and prevent the deformation of the bearings.

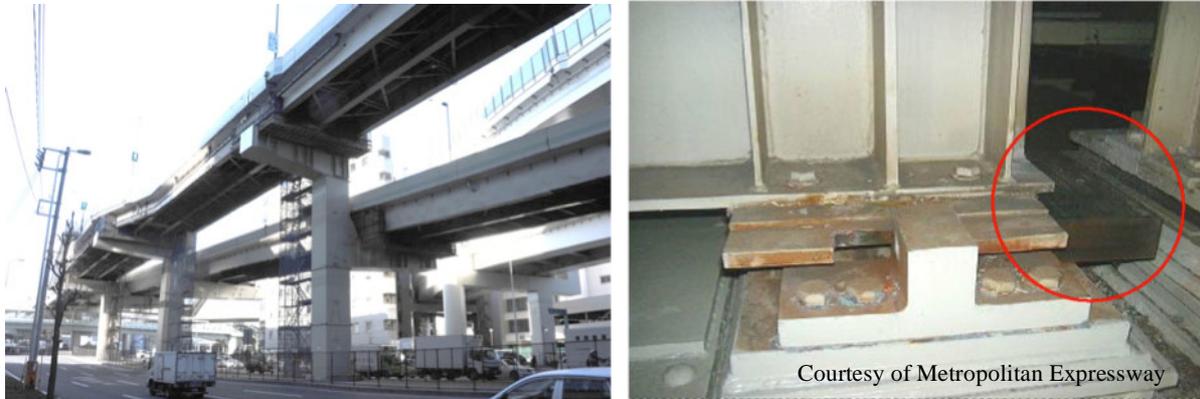
Photo 8 Kinko JCT Viaduct and damage of rubber pad

Kinko JCT (Photo 8) is located at Yokohama City in Kanagawa Prefecture. The superstructure is simple steel I girder and supported by rubber pad type bearings. The side blocks were damaged and one bearing moved away from the original position.

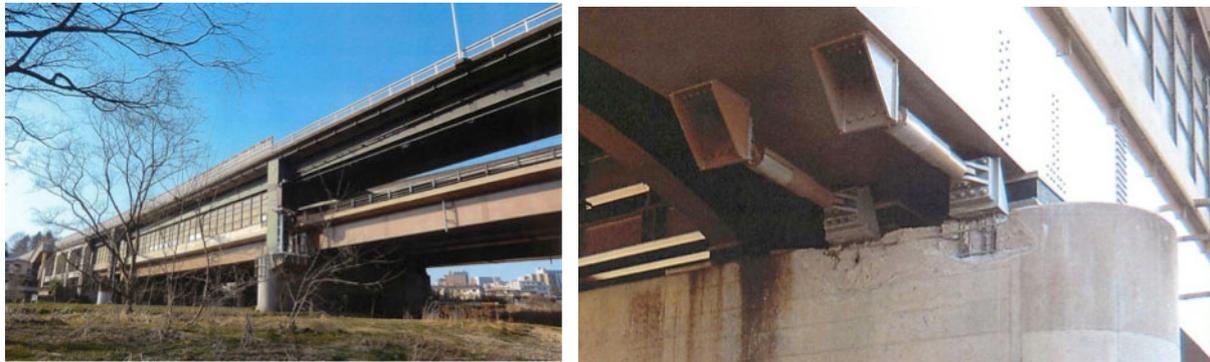
Photo 9 Nakanose bridge and damage of anchors of dampers

Dampers were installed in many bridges in Sendai area. There is no report that damper itself was damaged by ground motion. But the attachments and the anchors of some dampers were damaged. These dampers were installed in the seismic retrofit program but were not properly considered in design of the attachments. According to the damage, the strong motion must input into these bridges. Since no measurement systems were installed in almost all bridges, it is difficult to evaluate the effect of the dampers on the seismic response of bridges.
