DAMAGE OF BUILDINGS AND ACTIONS TAKEN DURING THE 2011 GREAT EAST JAPAN EARTHQUAKE IN THE DISASTER PREVENTION FACILITIES

Taiki SAITO¹

ABSTRACT: Questionnaire survey was conducted in nine disaster prevention facilities in Miyagi, Saitama, Tokyo, Kanagawa and Osaka Prefectures about damage of buildings and actions taken during the 2011 Great East Japan Earthquake on March 11, 2011. All facilities are located in high-rise buildings. Questionnaire to building administrators consists of questions about the damage of building and countermeasures taken at the moment of earthquake. Questionnaire to staff in the facilities includes questions about the behavior and emotion (fear and anxiety) during earthquake shaking and damage of contents in the office. Finally, suggestions to improve countermeasures in the disaster prevention facilities in high-rise buildings are pointed out.

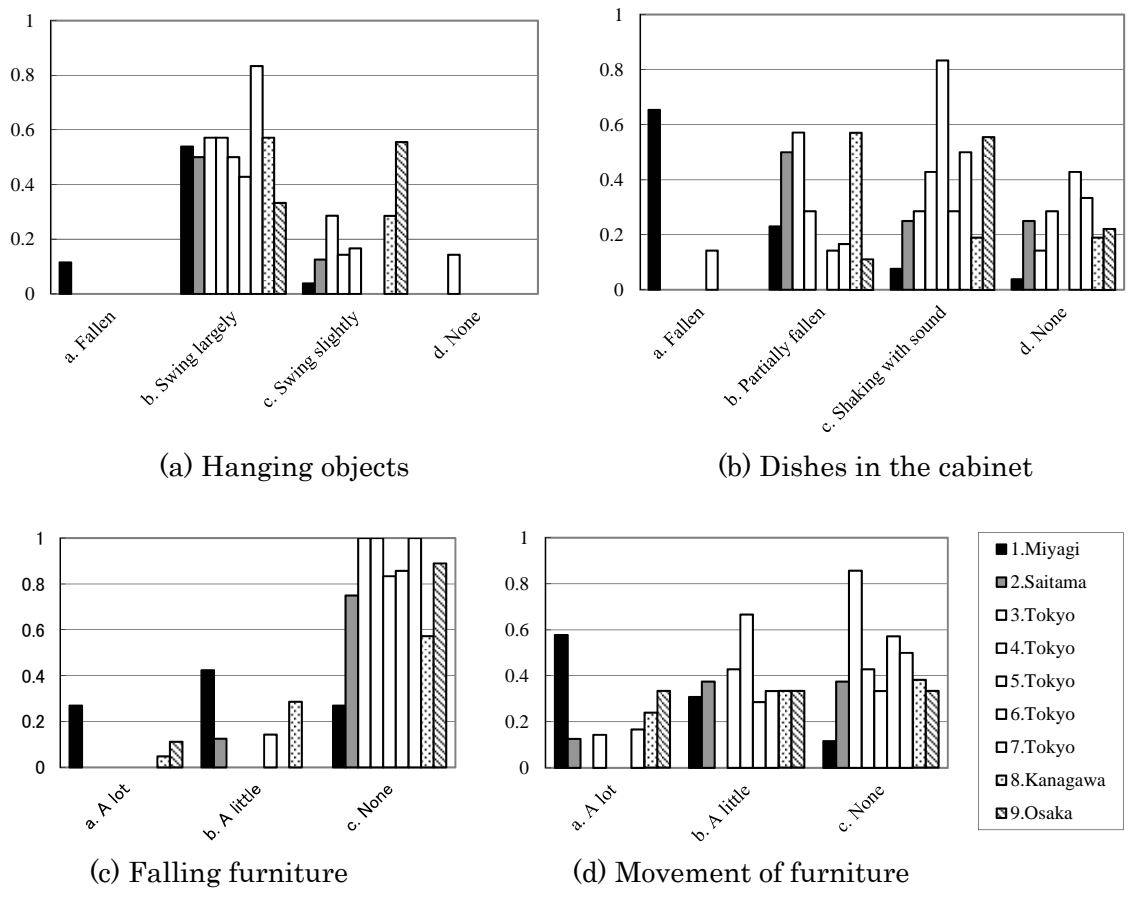
Figure 7 How was the damage inside of building?

Figure 7 shows the answers about the damage inside building. Many facilities answered “Shaking largely” for hanging objects which is inferred the effect of long period components of tremor. As for dishes in the cabinet, many answers of “Fallen” and “Partially fallen” are observed in the facilities near the epicenter, “Miyagi” and “Saitama.” Falling furniture did not happen so much except “Miyagi.” On the other hand, there are answers of “A lot” for the movement of furniture such as a copy machine with casters. It also reflects the fact of long duration of tremor.
