# RESULTS OF FIRST RECONNAISSANCE ON DAMAGE TO REINFORCED MASONRY BUILDINGS AND GARDEN WALLS CAUSED BY THE GREAT EAST JAPAN EARTHQUAKE IN 2011

**ABSTRACT:** This paper reports results of the first reconnaissance on the damage to reinforced masonry buildings and garden walls. Along the Miyagi coast, some partially grouted masonry buildings were observed that had fallen over or collapsed as a result of tsunami, or tilted as a result of wash out of soil under the foundation. Partial collapse of concrete masonry nonbearing walls was also observed. Concrete masonry garden walls were observed that had collapsed due to the ground motions and the tsunami. Much damage to unreinforced stone masonry garden walls was observed.

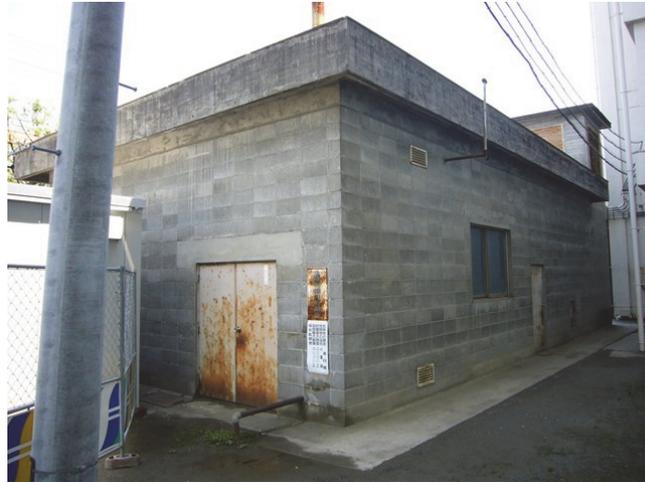
A one-story building of this type with plan dimensions of 14.2 m by 7.4 m in Wakabayashi Ward in Sendai is shown in Photo 1. It is a building for boiler room in a junior high school. The thickness of the hollow concrete block is 150 mm and no obvious damage to the masonry structure was observed. This building also survived the 1978 Miyagiken-oki earthquake without damage (AIJ 1980).

Photo 1 A partially grouted concrete masonry building without any damage

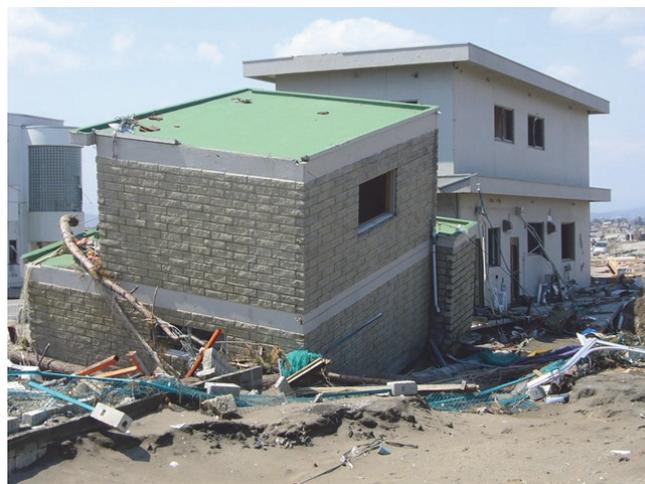
Two buildings of partially grouted concrete masonry stand side by side in Arahama district in Sendai located 100 meters from a coastal seawall (Photo 2). Plan view dimensions of the building in the front on the figure are 6.0 m by 5.6 m, while the masonry units are decorative. Dimensions of the masonry units are 450 mm in length, 150 mm in height and 150 mm in thickness. Although the building was rotated because the foundation was washed away, there were no cracks observed on the masonry wall.

The building that can be seen behind the mentioned one on Photo 2 is a reinforced masonry with hollow concrete blocks with finishing mortar. Dimensions in the plan view are 14.8 m by 9.4 m. This building suffered inundation and the soil beneath it was partially washed away, but no rotation or structural damage was observed in this case. Most probably, the building of front of this one took almost all the impact from the tsunami waves.

Photo 2 Damaged two-story partially grouted concrete masonry houses

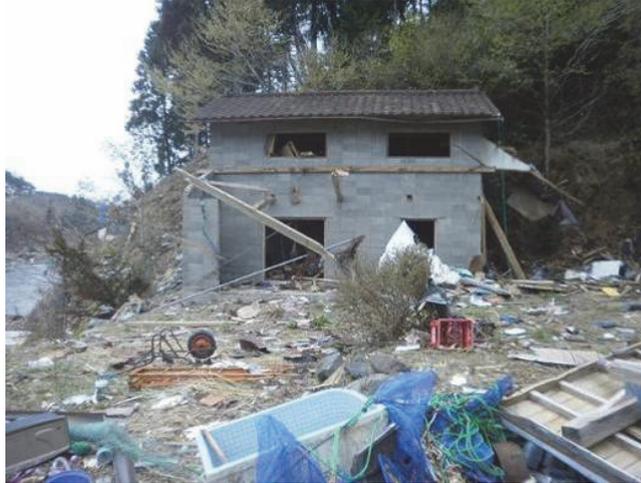
A partially grouted masonry building with hollow concrete blocks (150 mm thick) in northern Minami-Sanriku, shown in Photo 3, was also affected by the tsunami. The building is located 400 m from the inclined embankment. Base dimensions of the building are 7.5 m by 3.9 m. Tiled roof is formed from timber truss elements. There is an interior wall on the first floor in the span direction, while there is no wall on the second floor. Although its foundation is 6.0 m above the sea level, the tsunami affected the building up to the height of the second floor ceiling. Cracks occurred in the wall on the first floor. Collapsed timber buildings in the vicinity of the present structure suggest better performance of concrete block buildings in tsunami attacks.

Photo 3 A partially grouted concrete masonry building slightly damaged by tsunami

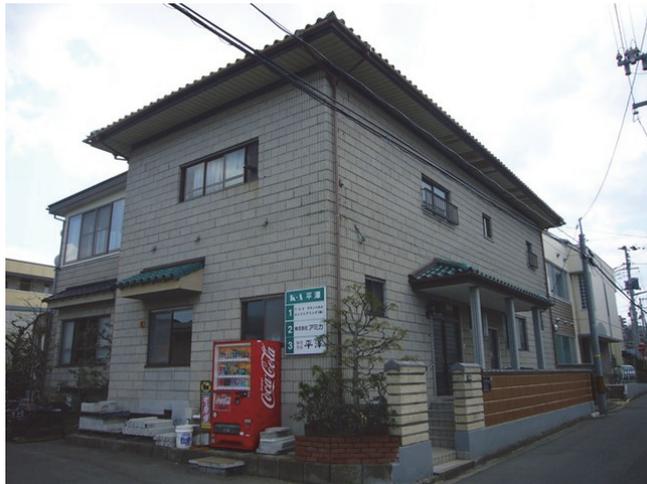
Photo 4 shows a two-story fully grouted masonry residential building built in 1980 in Taihaku Ward in Sendai. Plan view dimensions of the building are 15.0m x 12.4m. Thickness of concrete masonry units is 190 mm. Although this building is located in the area that experienced seismic intensity of 6-upper on JMA (Japan Meteorological Agency) scale, the building remains undamaged.

Photo 4 A fully grouted concrete masonry house without any damage

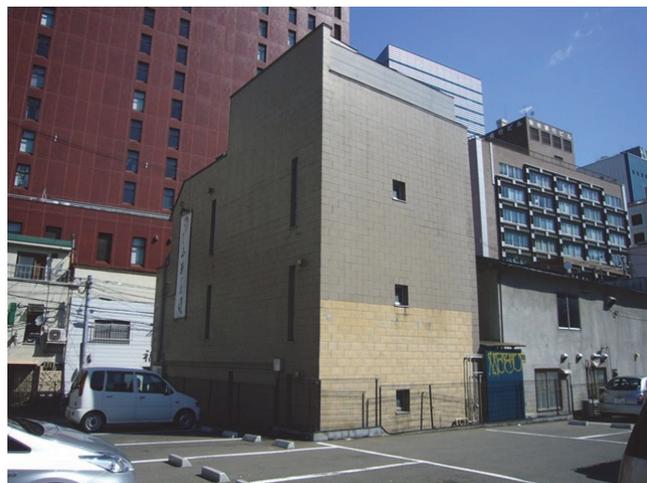
Photo 5 shows a three-story commercial building, which is located in Aoba Ward in Sendai. Plan dimensions of the building are 11.5m x 6.1m, while the thickness of concrete blocks is 190 mm. Earthquake ground motion with seismic intensity of 5-upper did not cause structural damage on this building.

Photo 5 Undamaged fully grouted commercial building

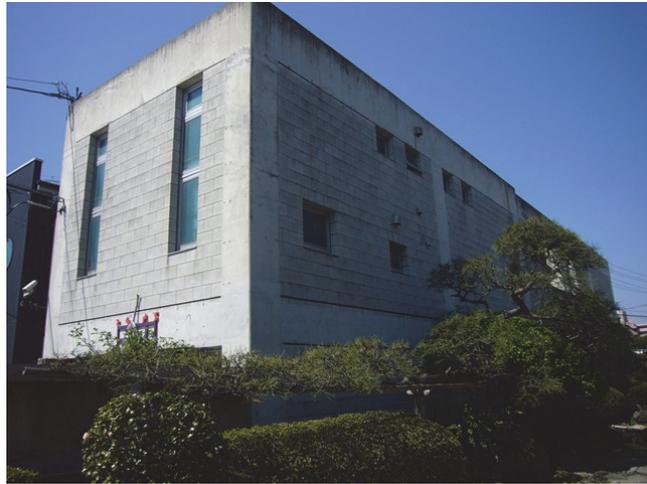
Photo 6 shows a two-story building in Izumi Ward in Sendai. The building has infilled concrete hollow masonry in the R/C frames. Although this area experienced seismic intensity of 6-upper, damage on the infilled masonry as well as R/C frames was not observed during the investigation.

Photo 6 Undamaged R/C building with concrete masonry nonbearing walls

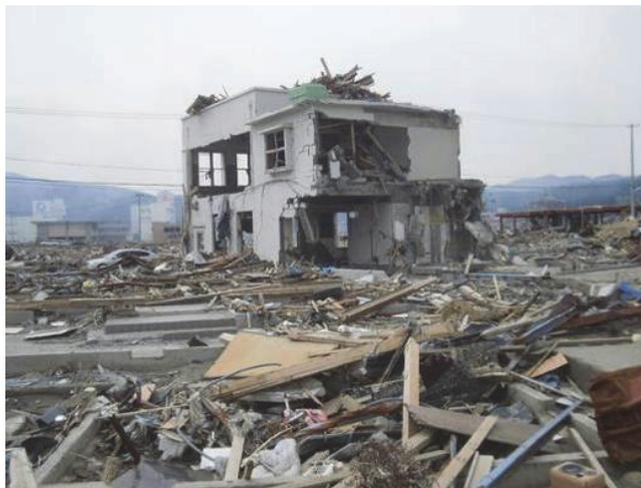
Structures with concrete masonry nonbearing walls affected by tsunami are considered in the following. Photo 7 shows a bank building located on the intersection of National Road Route 398 and National Road Route 45 in the Minami-Sanriku. The whole residential area in the seaside plain was heavily impacted by tsunami and almost all buildings located around this building had been destroyed. The structural system of this two-story building is reinforced concrete frame with four columns and with infill walls of nonbearing concrete masonry. The building had a reinforced masonry extension at the first floor made of hollow concrete blocks without R/C columns. The concrete masonry units are

concrete hollow blocks with dimensions of 400x200x190 mm. This extension had collapsed and been washed away. It was observed on the reinforcing round bars (8 mm) that they were significantly deteriorated by corrosion.

Photo 7 Damaged R/C building with concrete masonry nonbearing walls

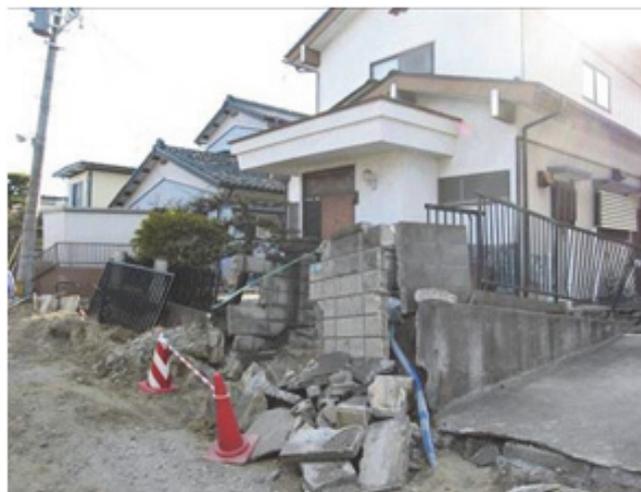
Photo 8 shows a concrete masonry garden wall in Aoba Ward in Sendai. The wall partially collapsed due to significant deformation of the ground, while the part of the wall next to the entrance gate has relatively minor damage. It is made of six layers of decorative concrete masonry with unit dimensions of 190 (height) x 490 (length) x 100 (thickness) mm. The wall was connected to an intersecting wall with horizontal reinforcing bars spaced at 600 mm.

Photo 8 Collapse of concrete masonry garden wall due to bad soil conditions

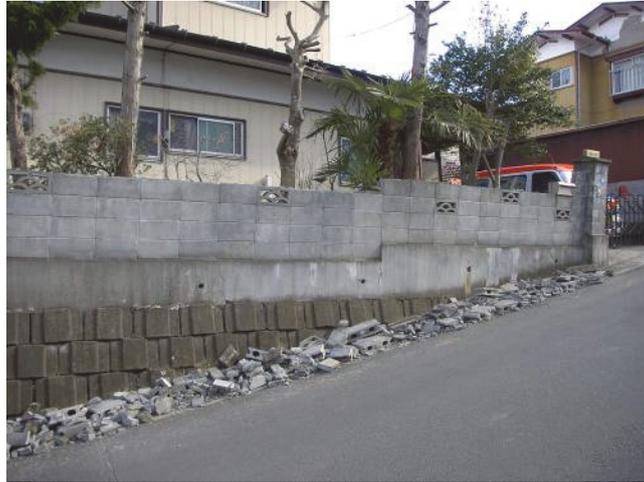
Photo 9 shows another concrete masonry garden wall located in Aoba Ward in Sendai. The wall is facing the street which is inclined about 30 degrees in east-west direction. Due to the inclination of the ground, six layers of concrete blocks (190x390x100 mm) are stacked in a staircase formation to fit the slope. Vertical reinforcement is placed at spacing of 800 mm. However, the vertical reinforcement did not extend into the upper two layers. Furthermore, there were no horizontal reinforcing bars at the top of the wall. Therefore, these blocks fell down.

Photo 9 Falling of concrete blocks

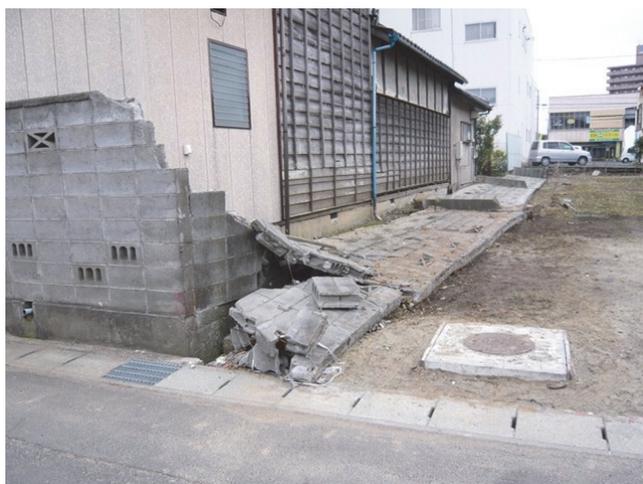
Photo 10 shows a concrete masonry wall overturned and collapsed completely. This wall was located in Natori, where the recorded seismic intensity was 6-upper. The reasons of the collapse are 1) no anchorage into foundation for vertical reinforcing bars, and 2) insufficient length of the buttress wall as well as insufficient depth of the embedment of the foundation. This wall did not meet the criteria of the current provisions of the BSL Enforcement Orders.

Photo 10 Collapse of concrete masonry garden wall due to bad construction

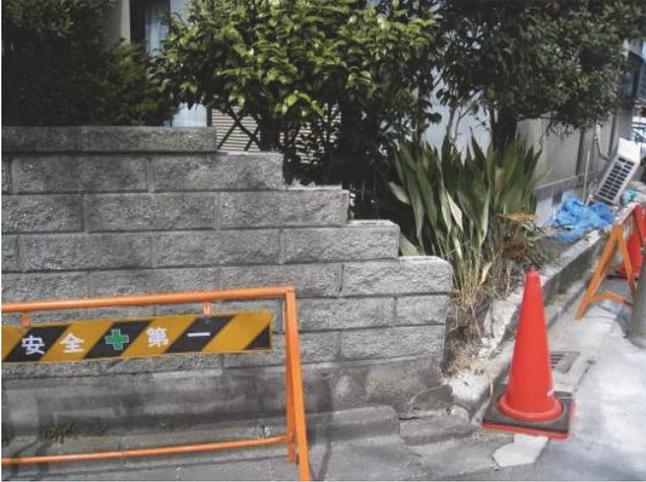
Photo 11 shows a concrete masonry wall located at Shinden district of Miyagino Ward in Sendai. The collapse of the wall was caused by soft soil conditions and insufficient anchorage length of vertical reinforcements. Decorative concrete blocks (with dimensions of 140x490x100 mm) were placed on the continuous footing of 300 mm height in six layers. There was no horizontal reinforcement in the wall. While the wall's vertical reinforcement consisted of 9 mm round bars spaced at 1000 mm.

Photo 11 Insufficient anchorage of vertical reinforcing bars

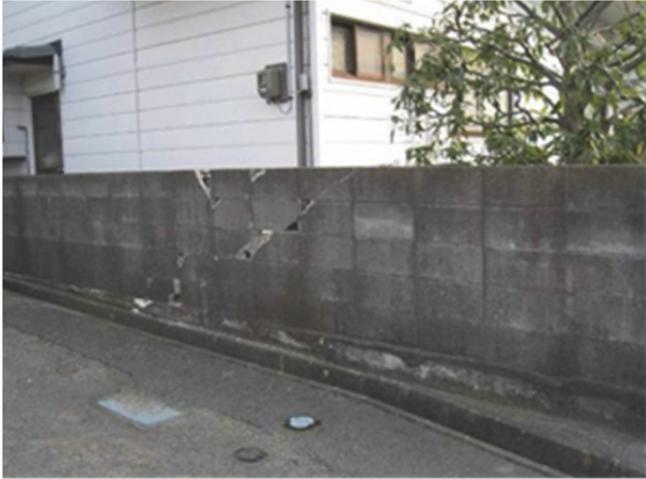
Photo 12 shows a long concrete masonry wall at Uematsu district in Natori. The wall consists of concrete blocks (190x390x100 mm) stacked in 5 layers. Since height of the wall was not over a limit of 1.2 m, buttress walls were not provided. Observed diagonal cracks are the result of insufficient length of lap splice of top reinforcing bars under seismic action. Thickness of the concrete cover around top horizontal bars was about 10mm. These observations suggest that it is necessary to improve details of top of the walls including coping unit.

Photo 12 Cracks on concrete masonry garden wall

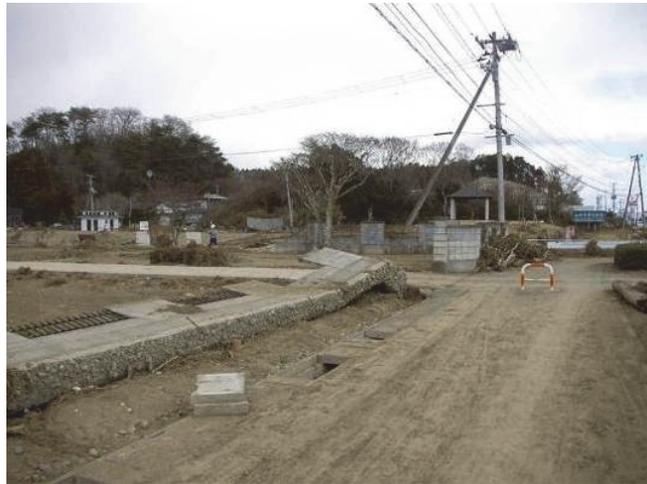
In the following text the summary of damage to concrete masonry walls caused by tsunami is presented. Photo 13 shows masonry wall composed of hollow concrete blocks (190x390x100 mm) with incorporated metal fence located in Naruse district in Higashi-Matsushima. Total height of the wall is about 1.0 m. Although wall remained in one piece, it was overturned by tsunami wave. There are many similar walls in the same area that remained undamaged. Cause for the collapse of this wall is a short anchorage into the ground.

Photo 13 Concrete masonry wall overturned by tsunami

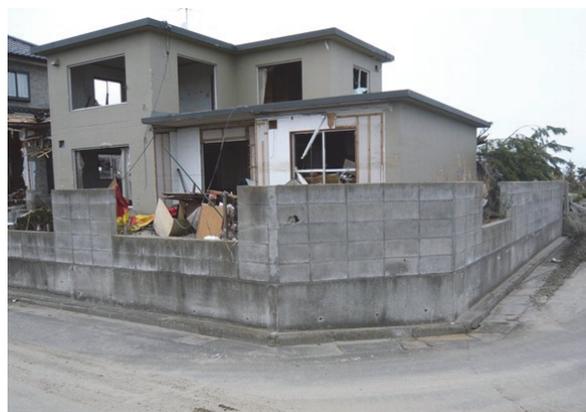
Photo 14 shows concrete masonry garden wall located in Yuriage district in Natori, where is seriously damaged by tsunami. Part of the wall made of concrete masonry blocks remained undamaged, but the metal fence is missing. This shows that intersecting walls perform better in the tsunami attack.

Photo 14 Undamaged concrete masonry garden wall by tsunami wave

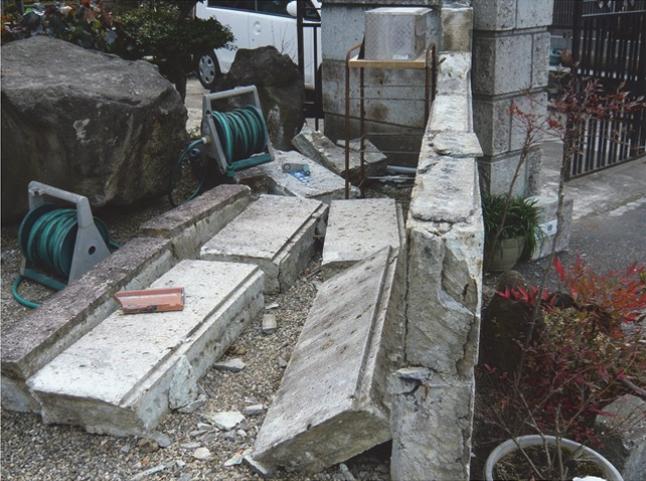
Photo 15 shows collapsed stone masonry garden wall which was built with only unreinforced mortar located in Masuda district in Natori. Strength of this wall comes from adhesive strength of mortar and the resistance of dowels used in the wall construction. The earthquake significantly damaged many walls of this type.

Photo 15 Damage to stone masonry garden wall

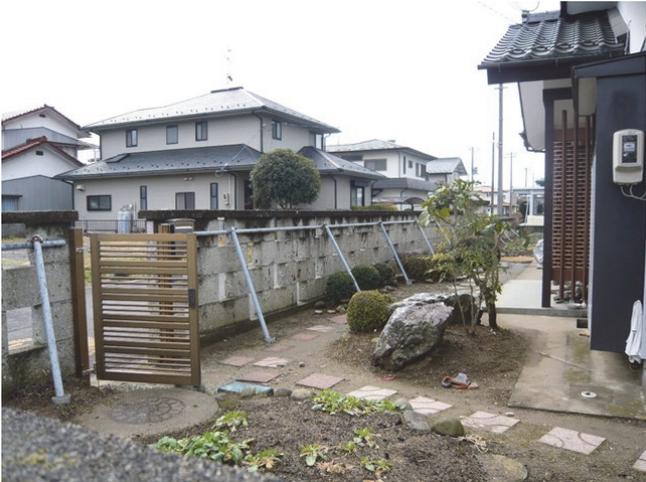
On the other hand, Photo 16 shows stone masonry garden wall retrofitted with a steel structure. It can be observed that the wall remained undamaged.

Photo 16 Stone masonry garden wall retrofitted with steel structure
