MICROTREMOR MEASUREMENTS OF THE HIGH-RISE BUILDINGS LEANED BY THE 2011 OFF THE PACIFIC COAST OF TOHOKU EARTHQUAKE

Kazuya MITSUJI¹, Zhiwei LIU², Susumu OHNO² and Masato MOTOSAKA³

Key Words: The 2011 off the pacific coast of Tohoku earthquake, microtremor measurement, damage investigation, high-rise building, dynamic characteristics

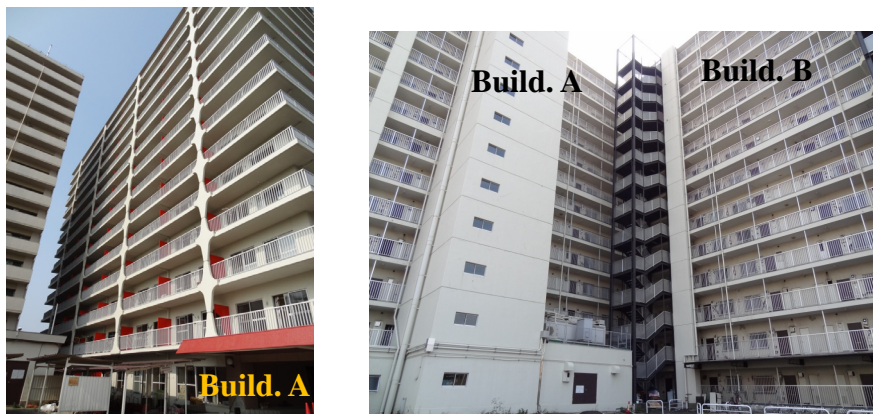
Photo 1 Exterior appearance of the damaged housing complex

Schematic plan and façade of the housing complex of STM are illustrated in Fig. 6. Photos of the exterior appearance of the buildings are shown in Photo 1. Housing complex STM consists of the two buildings. Both of them are SRC 14-storey buildings supported by pile foundations. Height of both buildings is about 40m. Construction of the buildings have completed in 1976. After the completion, the buildings suffered severe shaking and were heavily damaged by 1978 Miyagi off shore earthquake ($M_j=7.4$).

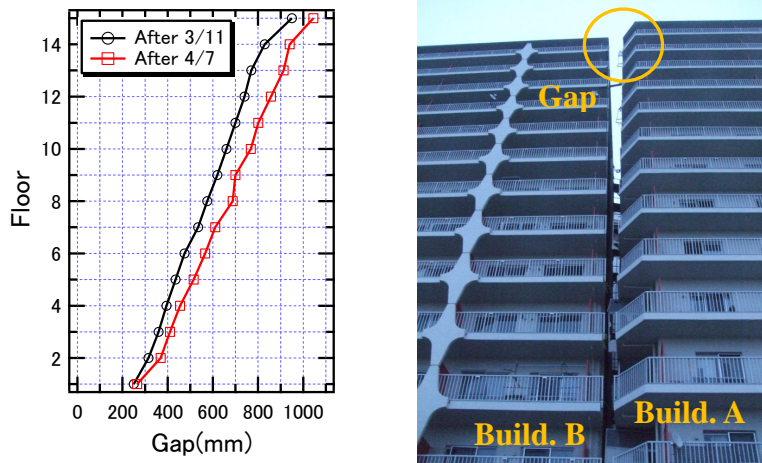
Fig. 7 Measured gap between the building A and B

After the main shock of 2011/03/11, the buildings have been heavily damaged by strong shaking again. Building A and B were connected by expansion joint that were demolished by dynamic behavior of the buildings. Building A and B forms L-shape plan shown in Fig. 6. Dynamic behavior of each building is completely different, because strong axes cross each other. Most characteristic damage is that building A indicates remarkable inclination in NS direction as shown in the photo in

Fig. 7. Inclination of the building A creates the large gap between the building A and B. Inclination of the building was not observed in the damage by the 1978 earthquake even though severe damage was observed at the pile head in some pile groups. Gap had been measured by the municipal office of Sendai city after the main shock. The authors also measured gap between the buildings at all the floors in October 2011. Measured gap at each floor between the buildings are shown in the left figure of Fig. 7. The figure clearly indicated gap at each floor increased after the aftershock of 04/07. Gap between two buildings was about 1,000mm at the roof floor and 200mm at the first floor. Angle of the inclination of the building A was estimated about 1/60 to 1/40. Outstanding inclination as building A was not recognized in the building B.

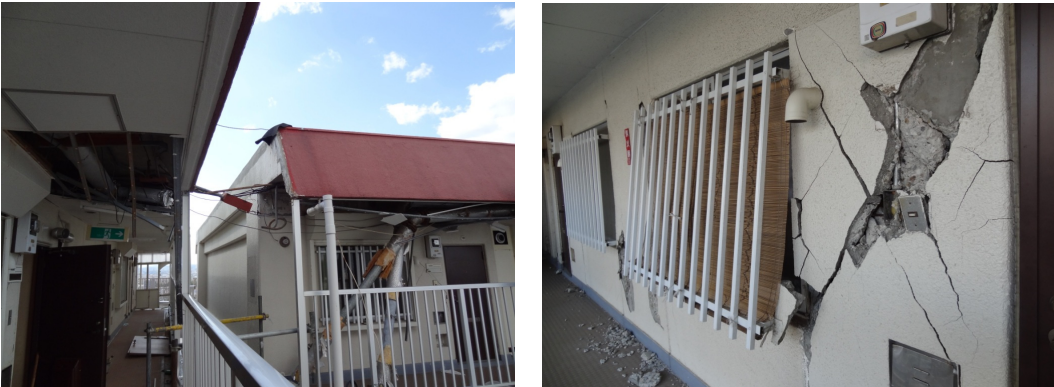
Photo 2 Gap between the buildings at the 14th floor and damaged non-structural wall

The state of the damaged buildings is shown in Photo 2 and 3. The left photo of Photo 2 is the gap between the building A and B at the 14th floor that is the largest gap of over 1000mm. Large width shear cracks are observed in almost all the non-structural walls facing corridors and balconies as shown in the right photo of Photo 2. This phenomenon was also observed in the damage by the 1978 earthquake.

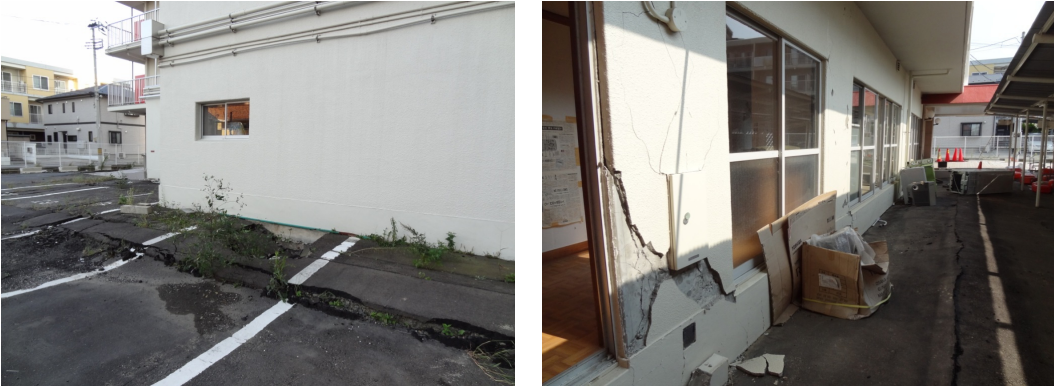
Photo 3 Damage around the foundation and damaged non-structural wall at the first floor

The left photo of Photo 3 shows damage around the foundation of the north side of the building A. After the main shock of 2011/03/11, building A leans to the south. Difference in the level shown in the right photo of Photo 3 is considered to have been generated by the uplifting behavior induced by the inclination of the building A. This difference in the level is about 14cm, and settlement around the building is about 20 to 25cm. The left photo of Photo 3 shows damage of non-structural wall of the

south facade at the first floor of the building A. Severe shear crack is observed as well as the upper floors. Large gap running on the ground is recognized the right photo of Photo 3. This large gap is also considered to have induced by the uplifting behavior of the building A to the south.

As mentioned above, the building A leans to the south. The inclination is considered to be the effect of the uplifting behavior caused by heavy damage at the pile head of some pile groups. Damage around the foundation of the building A indicates the inclination of the building. Moreover, the angle of the inclination of each housing unit at all the floors was measured by the electrical spirit level. Results show that the angle of the inclination of the housing unit floor is about 1/40 to 1/60 corresponding to the estimated angle of the gap between the buildings.

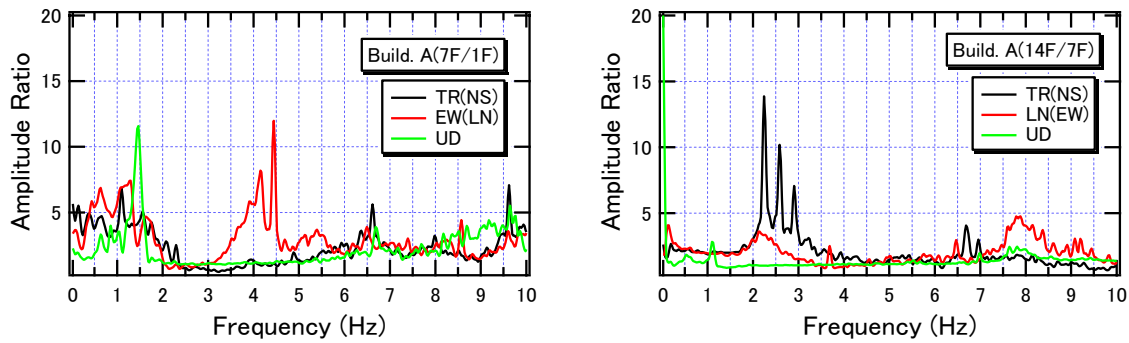
Fig. 8 Amplitude ratios between 7F /1F and 14F/7F of the building A

Amplitude ratios between 7F/1F and 14F/7F of the building A are shown in Fig. 8. In case of the building A, transverse direction of the building corresponds to NS direction, longitudinal direction to EW direction as indicated in Fig. 6. The peak considered the first natural frequency of the building appears around 1Hz in both of TR and LN direction in the case of 7F/1F. LN direction has the second peak around 4Hz that is distinctive of the direction. The range of the peak around the first natural frequency tends to be wide in the two horizontal directions. The day when the microtremor measurements conducted was quite windy. Especially, the wind in NS direction corresponding to TR direction of the building was severely strong. Therefore, the results suggest that the effect of the windy condition might appear in the vibration characteristics of the building. In the results of 14F/7F, peaks can be observed around 2Hz. While TR direction has three sharp peaks between 2Hz and 3Hz, the peak around 2Hz in LN direction looks ambiguous.

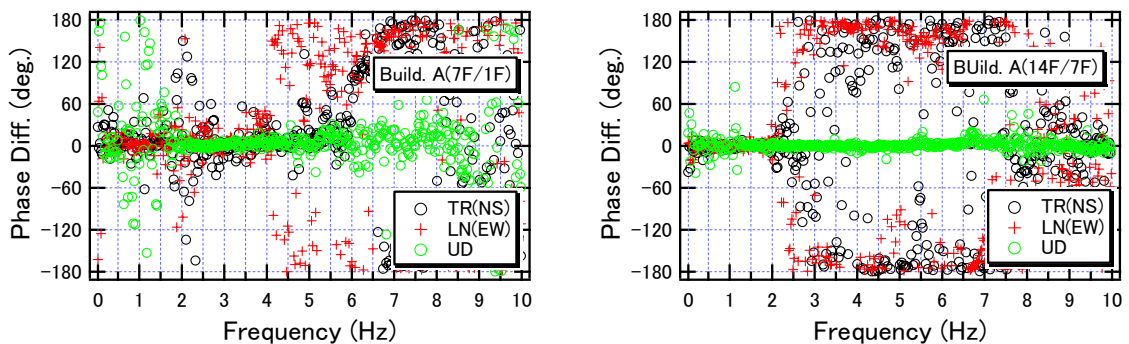
Fig. 9 Phase differences between 7F /1F and 14F/7F of the building A

Fig. 9 shows phase difference of 7F/1F and 14F/7F. If the peak around 1Hz of 7F/1F is considered the first natural frequency, behavior of phase difference looks odd. The behavior of phase difference around 1Hz in 7F/1F may indicates the effect of strong wind. Strange behavior around 1Hz such as 7F/1F cannot be observed in the result of 14F/7F.

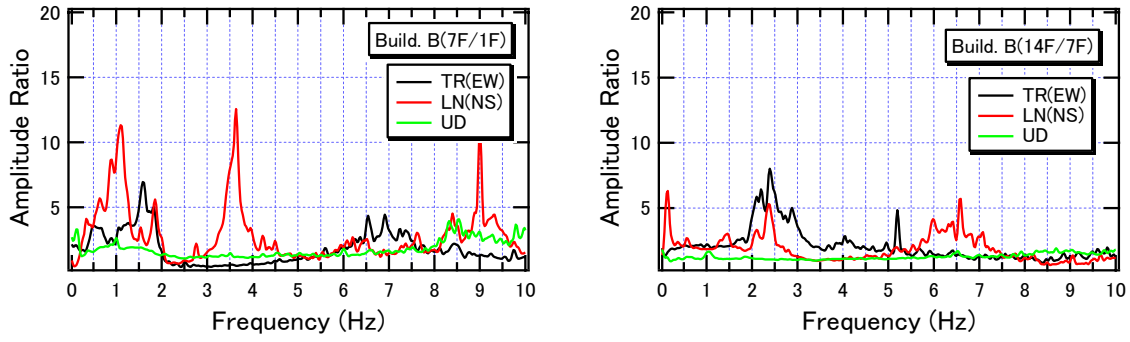
Fig. 10 Amplitude ratios between 7F /1F and 14F/7F of the building B

Amplitude ratios between 7F/1F and 14F/7F of the building B are shown in Fig. 10. In case of the building B, It should be noted that transverse direction of the building corresponds to EW direction, longitudinal direction to NS direction as indicated in Fig. 6. Those are different from the building A. The peak considered the first natural frequency of the building appears clearly around 1Hz in both of TR and LN direction in the case of 7F/1F. In LN direction, the second peak can be clearly found between 3Hz and 4Hz. Amplitude ratios of 14F/7F indicate that the first peaks appear around 2Hz in horizontal directions as well as the building A.

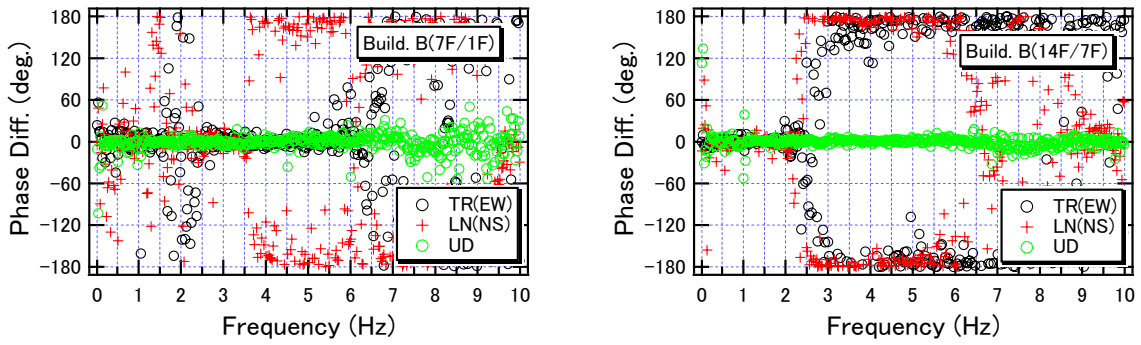
Fig. 11 Phase differences between 7F /1F and 14F/7F of the building B

Phase difference around 2Hz in the case of 7F/1F may indicate the effect of strong wind similarly as the building A. The effect of strong wind seems not to be observed in phase difference of 14F/7F.

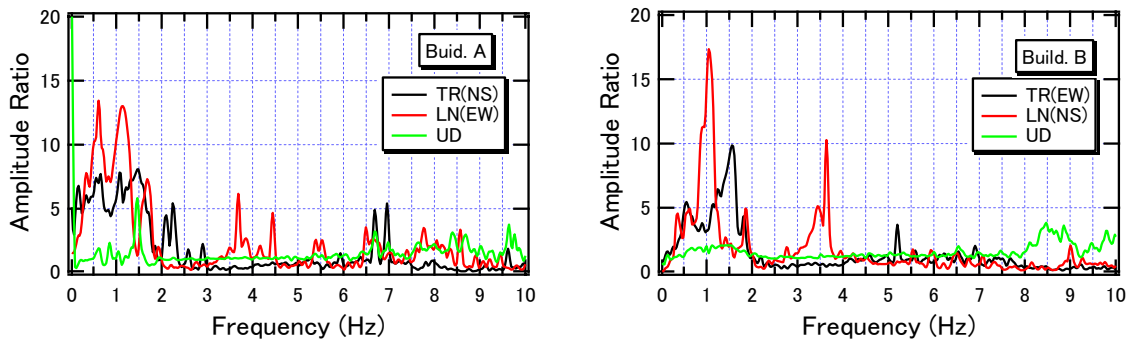
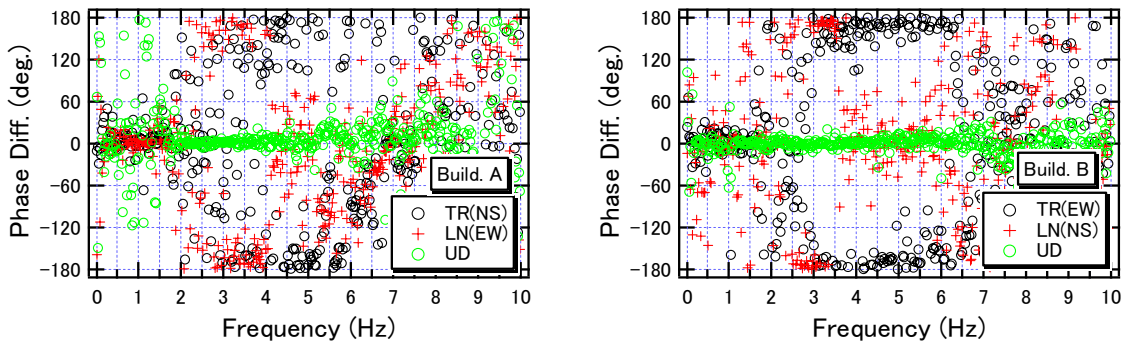
Combining transfer function of 7F/1F and 14/7F, transfer function between 14F/1F is estimated. Estimated amplitude ratios and phase differences between 14F/1F are shown in Fig. 10 and Fig. 11, respectively. Left figures are the results of the building A, and right figures are those of the building B. Amplitude ratios of the building A show the peaks around 1Hz having the relatively wide range. Especially, the peak in LN direction split into two peaks around 1Hz. LN direction has also the second peak between 3Hz and 4Hz. Amplitude ratios of the building B have clear peaks around 1Hz in both horizontal directions. LN direction has the second peak between 3Hz and 4Hz as well as the building A. Namely, TR direction has one peak around 1Hz, on the other hand, LN direction has two peaks around 1Hz and between 3Hz and 4Hz. This result can be interpreted as the fact that dynamic behavior of TR direction is close to that of rigid medium with rocking motion at the bottom. Phase difference in UD direction of the building A fluctuates around 1Hz. Broaden wide range of the first natural frequency and phase difference behavior around 1Hz in the building A can be considered to be relevant to the effect of strong wind.

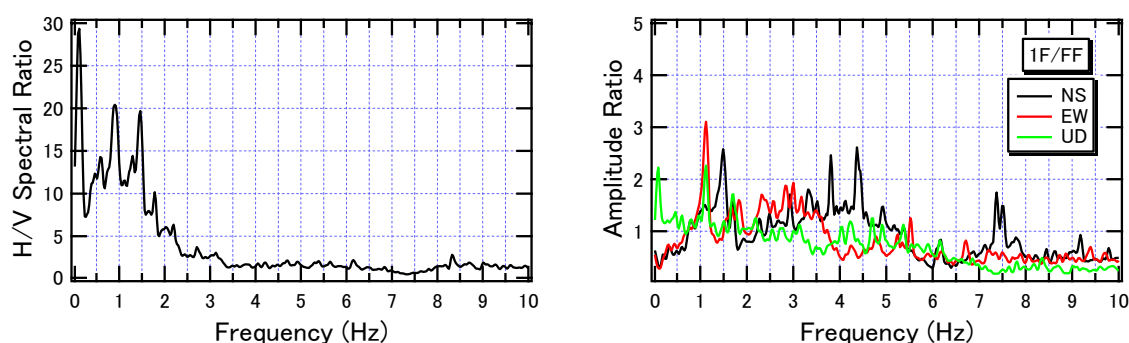
Fig. 14 H/V spectrum of the ground and amplitude ratios between 1F and the free field

Measurement to obtain the dynamic characteristics of the ground was also carried out. Results of the ground are expressed by “FF (Free field)”. H/V spectrum and amplitude ratios between 1F and FF are shown in Fig. 14. The peak of H/V spectrum exists around 1Hz. This result doesn’t meet agree with the results from the theoretical transfer function using estimated shear wave velocity data shown in Fig. 5. Peaks are also observed around the natural frequency of the buildings in amplitude ratios of 1F/FF.
