Mechanism of Slope Failures in Residential Land on Fill during Great East Japan Earthquake

ABSTRACT: As a result of the Great East Japan Earthquake, five slope failures occurred in a residential area on artificial valley fills in Taiyo New Town, Yamamoto, Miyagi Prefecture. The fill material is sandy, derived from the weathering of tuffaceous sandstone which formed the natural ground. Cyclic triaxial tests showed that the fill, which has about $F_c=20\%$, has very low liquefaction resistance, which decreased with application of initial shear stress. Thus, the slope failure in Taiyo New Town can be attributed to the liquefaction of the fill material induced by the intense shaking.

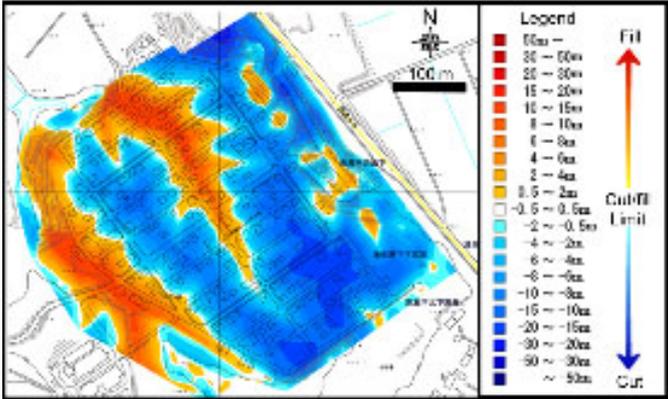
The site of the residential area was developed in the 1970s by cutting and leveling off some parts of the hills and using the materials as fill for the valleys. Figure 1 shows the depth distribution of cuts and fills in Taiyo New Town. To level off the residential land, cuts were made on the hills as high as 8-10m, while valley floors as deep as 10-15 m were filled up using the same materials that were cut from the elevated regions. It can be observed that deep valleys existed in the central portion and in western boundary of the site. The eastern side of the site adjacent to Route 6 was also filled up, with embankment having slope of 1:1.5. The elevation of the filled-up residential site was about 35 m above mean sea level. It has an area of about 0.12 km² and when the earthquake struck, more than 200 houses have been built at the site.

Figure 1. The housing site foundation map of Taiyo New Town, showing the thickness distribution of cut and fill sections (Fukken Gijutsu Consultant, 2008)

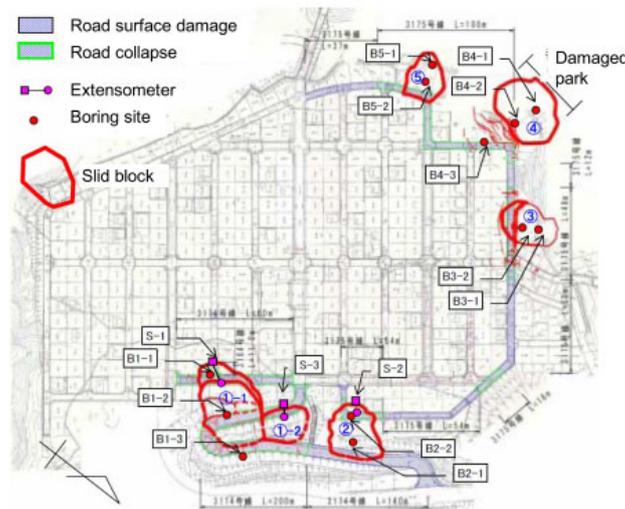
Following the 2011 earthquake, slope failures occurred at five sites within the Taiyo New Town housing site. The locations of the slope failure are shown in Figure 4. These failed or slid blocks were sequentially numbered, starting with Failed Block 1 on the eastern boundary of the housing site, going counterclockwise to Failed Block 5 on the western side. Block 1 consisted of two landslides, referred to as Block 1-1 and Block 1-2, respectively. Also shown in the figure are the locations of damaged roads due to the slope failure and damaged road pavements. Extensometers were placed on the eastern boundary to monitor the movement of the fill. In addition, several standard penetrations tests were performed within the fill and adjacent to the failed blocks.

Figure 4. Location of failed slopes in Taiyo New Town

Comparing the locations of the failed blocks in the housing site (Figure 4) with the foundation ground map shown in Figure 1, it is clear that all failed slopes occurred either on the edge of the valley fill or on the shoulder of the embankment. This suggests that the fill material, rather than the natural ground, was involved in the slope failures.

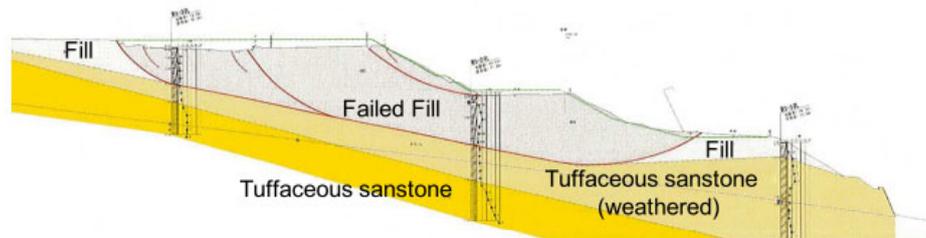
Block 1 consisted of two slope failures. The first sliding block, 1-1, caused settlement at the crest and laterally flowed down the sloping ground, as shown schematically in Figure 5. As a result, a house located on the laterally moving ground tilted and a 1m high vertical offset was also created. Extensional cracks were also observed on the ground and road pavements. The adjacent failed block, 1-2, was smaller in scope and induced cracking on the road as the sliding mass slid. In both cases, the surface of the road downslope was pushed up.

Figure 5. Cross-sectional profile of failed slope in Block 1-1

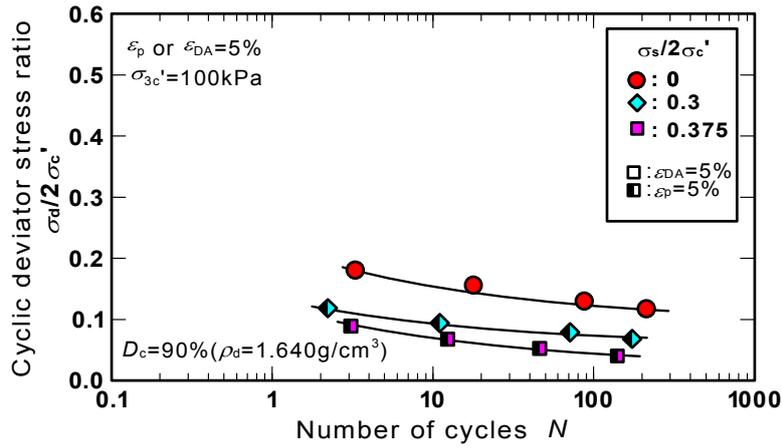
Cyclic undrained triaxial tests were performed on reconstituted samples under isotropically consolidated condition, and the liquefaction resistance curve obtained for a double amplitude axial strain $\varepsilon_{DA}=5\%$ is shown by the solid circles in Figure 10. It is seen that the liquefaction resistance of the material is quite low, indicating the susceptibility of the material to large deformation when shaken under saturated condition. This may be due to the high fines content of the soil and the density used to prepare the reconstituted specimen. Note that for soil specimens with $D_c=90\%$, the dry density of the soil was taken as 1.64 g/cm^3 . According to Yamamoto Town Office, dry densities ranging from $1.44\text{-}1.54 \text{ g/cm}^3$ were obtained at the site based on previous site investigations. Thus, although the density of the specimen used in the test was higher than the in-situ values, the liquefaction resistance of the soil was low. Although the location of the water table during the earthquake was not confirmed, this type of material will liquefy easily when subjected to cyclic shearing induced by earthquake, and will fail due to reduction in effective stress.

Figure 10. Liquefaction resistance curves of isotropically and anisotropically consolidated samples

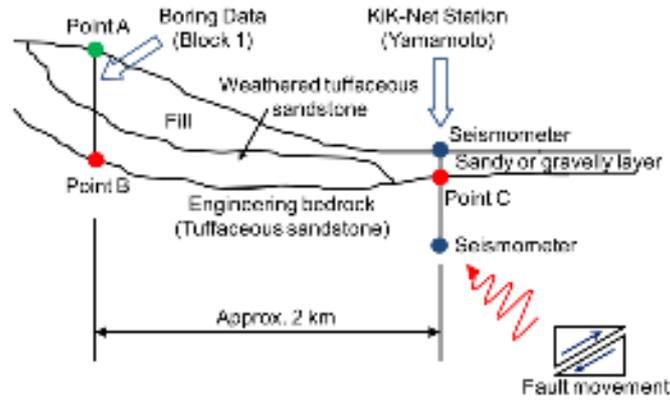
Next, the strong motion obtained at Point C was used as input (2E) at Point B to determine the surface acceleration at Point A. Since Point C and Point B are just 2km apart, attenuation of motion was not considered. Again, seismic response analyses were conducted and the results obtained showed PGAs at point A of 1322.6 and 1171.3 cm/sec^2 in N-S and E-W directions, respectively. Using the equation for lateral seismic coefficient, k_h , proposed by Noda et al. (1975), the obtained PGAs correspond to $k_h=0.368$ and 0.354, respectively.

Figure 13. Schematic diagram showing how the PGA on top of the fill was calculated from KiK-Net recorded motions
